# BULKHEAD & DOCK CONDITION REPORT

## Alsdorf Park City of Pompano Beach

December 2018, Updated March 2019

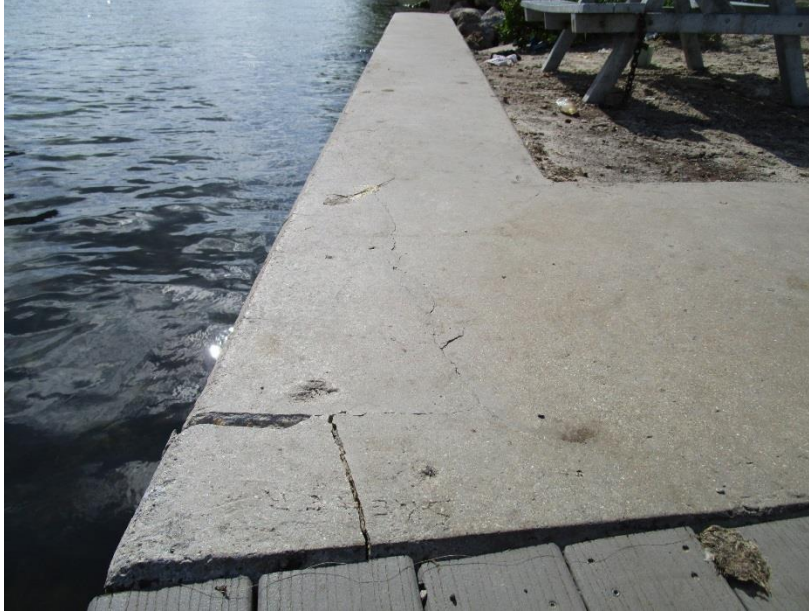
Commencing at the south end of the bulkhead section along the ICWW, the top surface of the concrete cap was observed to be in fair to poor condition with numerous surface cracks, damaged concrete, spalling and rust staining. The concrete T-piles showed signs of age with extensive deterioration but overall this section of bulkhead was observed to be in relatively stable condition. **(Plates A through D)**

**Plate A**  
**South View at East End along ICWW**  
**Note major crack at corner**

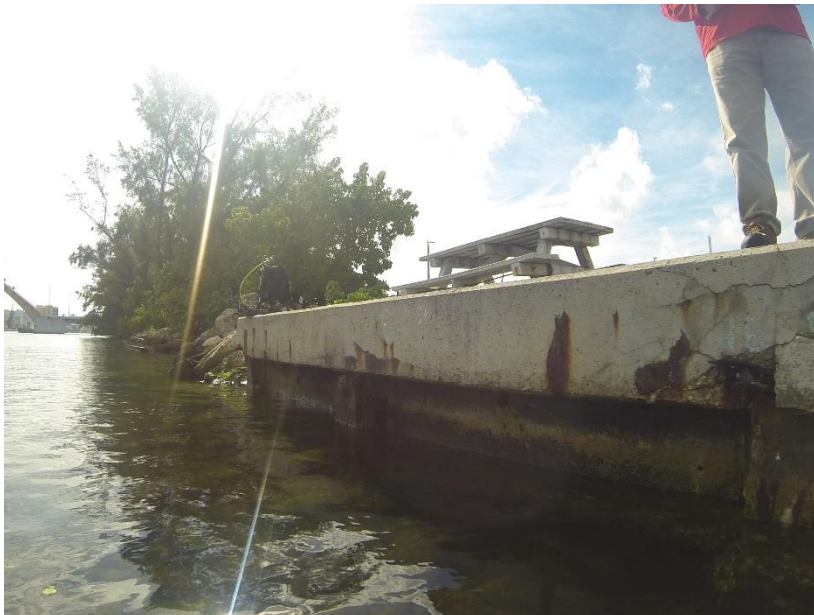
**Plate B**  
**Southerly View at East End along ICWW.**  
**Significant spalling, cracks and staining**

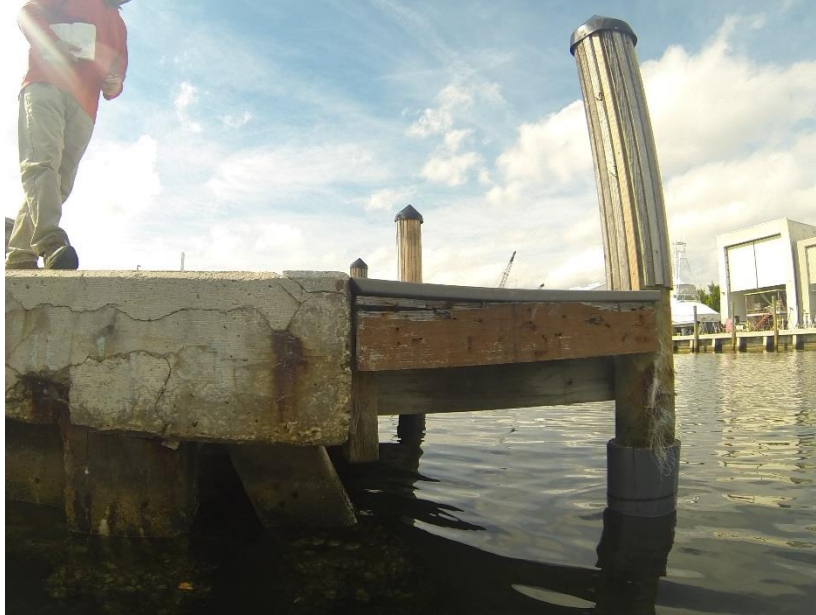
**Plate C**  
**West View at East End along ICWW.**  
**Significant spalling, cracks and staining**

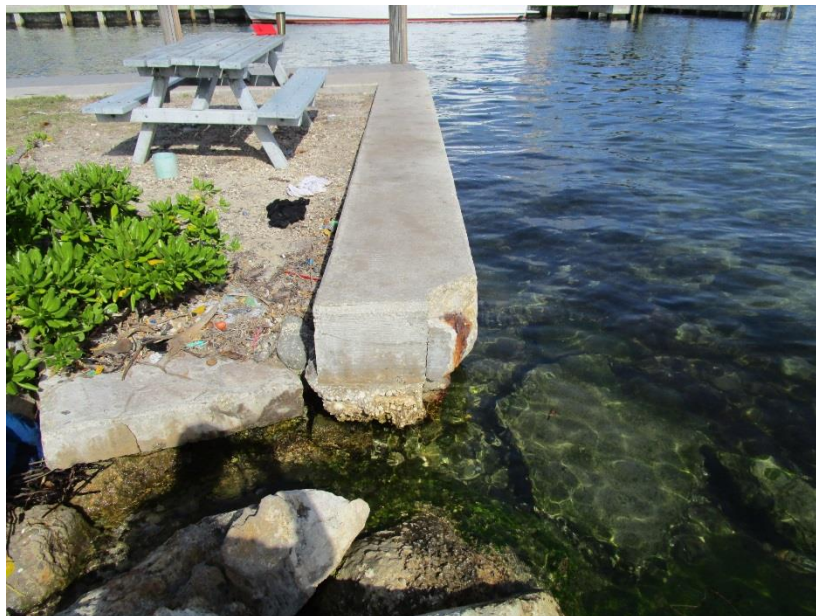
**Plate D**  
**North View at East End along ICWW.**  
**Major crack / loss of concrete and spalling corner.**

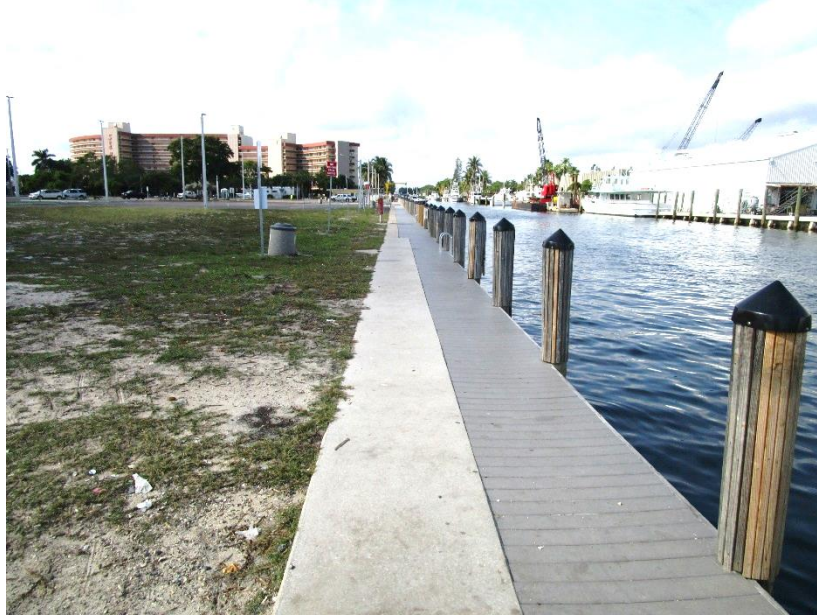
Proceeding west into the Calaban Canal, the easterly 80 feet of bulkhead is laterally reinforced by concrete batter piles, which appeared to have been added to the original bulkhead structure as part of previous repair work. This easterly section of bulkhead also appeared to have a newer concrete cap, approximately 40 inches in width and 24 inches in depth, which apparently was constructed concurrent with the addition of batter piles. The upper side of the concrete cap was observed to be in fair condition with minor cracks and minimal signs of deterioration. (**Plates E and F**). This repaired section of bulkhead has rock rip rap stacked along the base of the vertical panels.

**Plate E**  
**West View from East end of bulkhead**

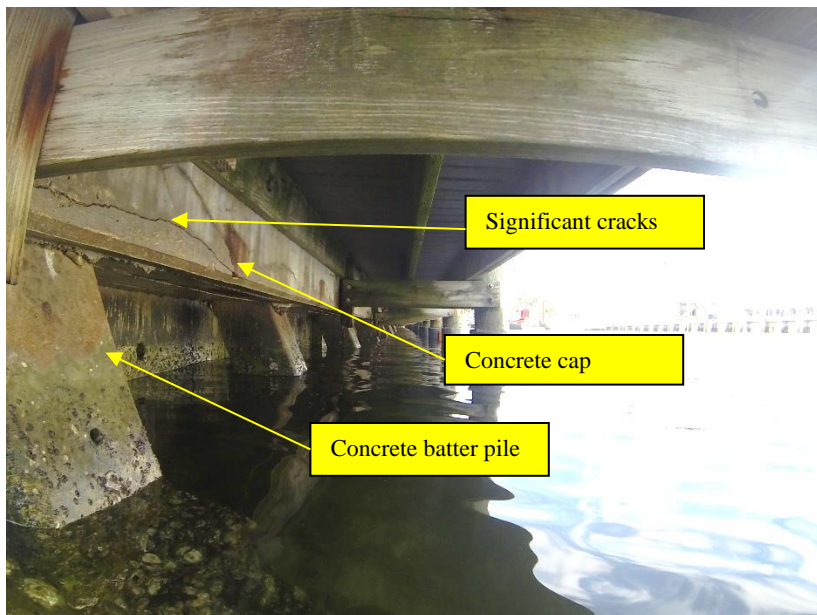
**Plate F**  
**West view from East end of bulkhead looking underneath dock.**  
**Bulkhead and dock components.**

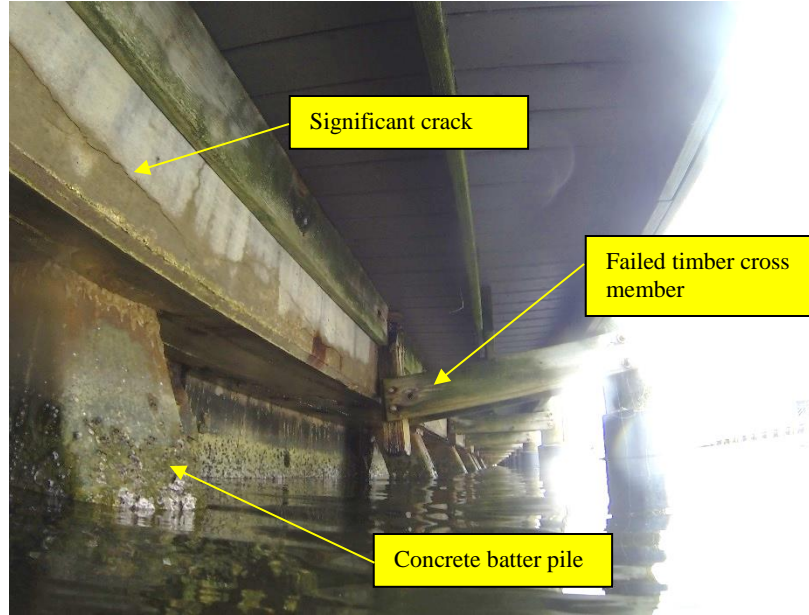
The batter piles along the first section of bulkhead were observed to be in good condition with no significant cracks or sign of deterioration. The outer face of the bulkhead cap, beneath the dock, was observed to have several cracks with several severe cracks at the east end near the entrance to the ICWW. (**Plates F and G**) One area of the concrete cap was observed to have exposed gravel or aggregate material along the lower corner of the outside face indicative of poor quality control during the repair / replacement of the cap. The condition of the T-piles, apparently part of the original construction, showed significant signs of deterioration. (**Plate H**) The concrete panels, also apparently part of the original construction, were observed to have some cracking, but extensive marine growth prohibited visual observations over much of the panel areas below water. Along this section of bulkhead, the marginal dock was observed to be in poor condition with sections of the dock framing that have failed and/or severely deteriorated. (**Plates G, H and I**)

**Plate G**  
**West view from East end of bulkhead looking underneath dock.**  
**Failed timber cross member**

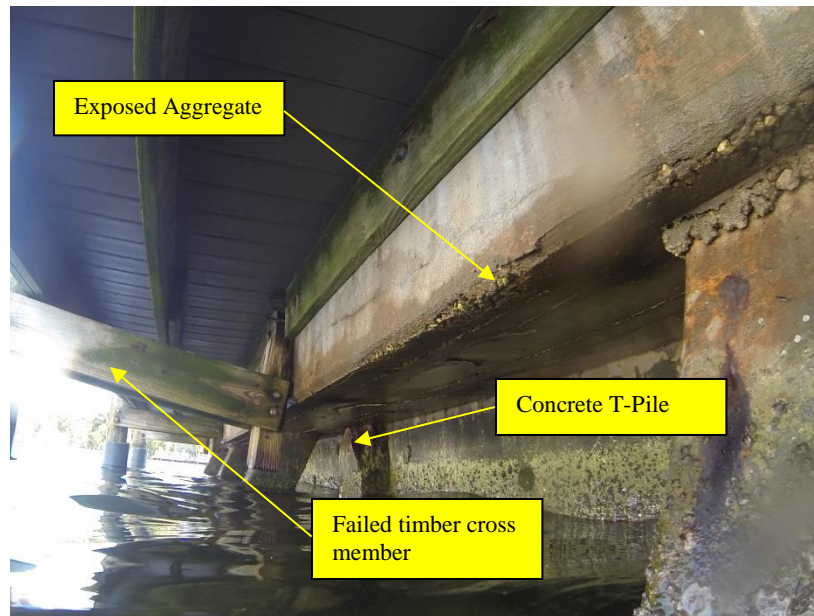
**Plate H**  
**East view from East end of bulkhead looking underneath dock.**  
**Failed timber cross member**

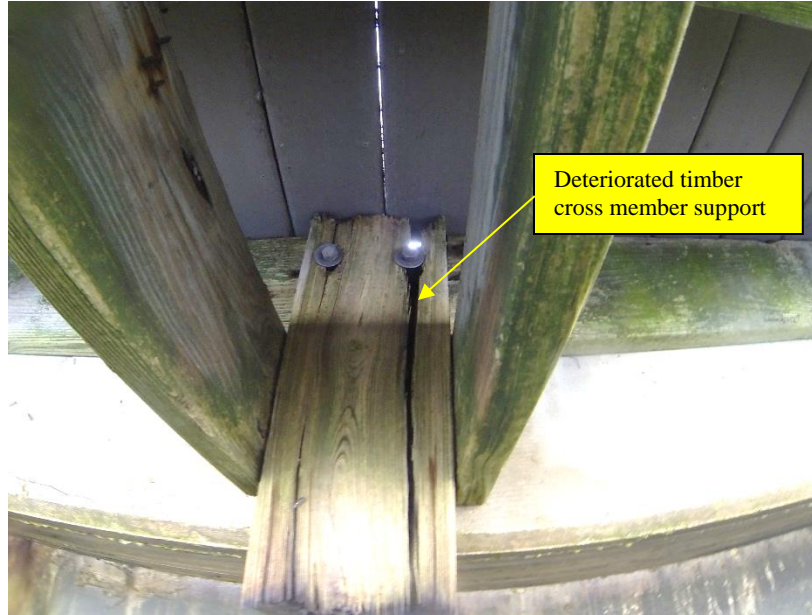
**Plate I**  
**Cracked / deteriorated timber cross member support**

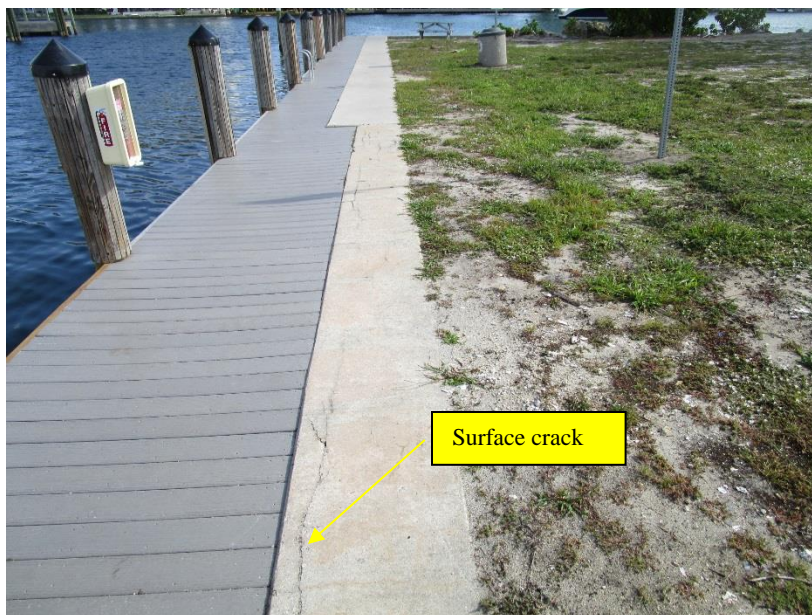
Proceeding westerly, the concrete cap transitions to what appears to be an older cap measuring 24 inches in width and 12 inches in depth. This apparent older section of cap was observed to be poor condition with significant cracks along the top face of the cap. The ground behind the cap was observed to be stable with no significant signs of settlement indicative of possible material loss through the wall. Based on the 2016 investigation there were significant depression areas behind the wall and signs of material loss, so it is evident the City has been performing some degree of maintenance along the bulkhead. (**Plates J through N**)

**Plate J**  
**East view at transition from repaired bulkhead section to original bulkhead structure**

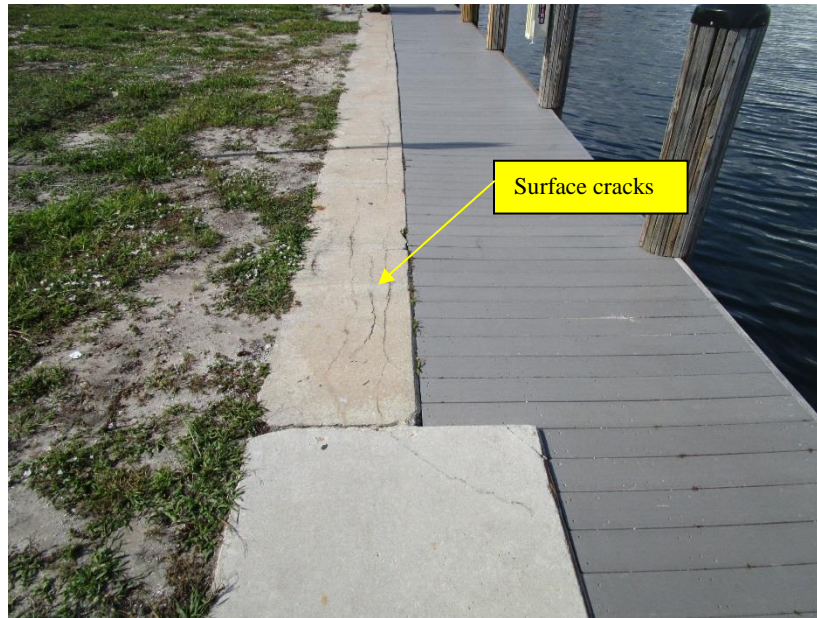
**Plate K**  
**West view at transition from repaired bulkhead section to original bulkhead structure**

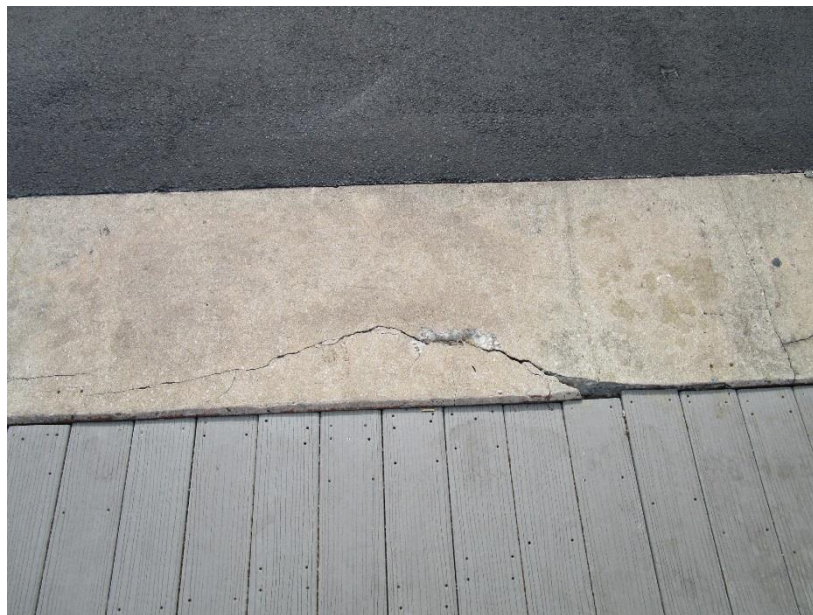
**Plate L**  
**Significant cracks in concrete cap**

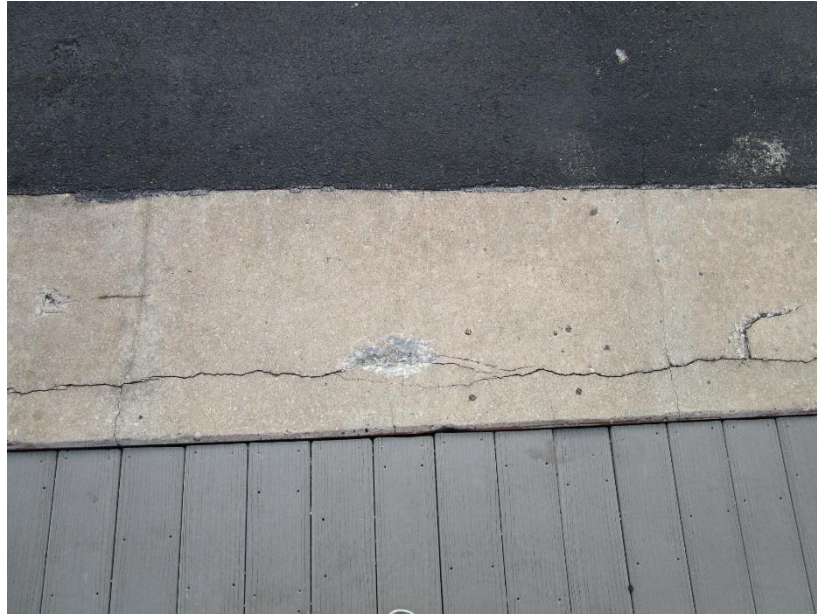
**Plate M**  
**Significant cracks in concrete cap**

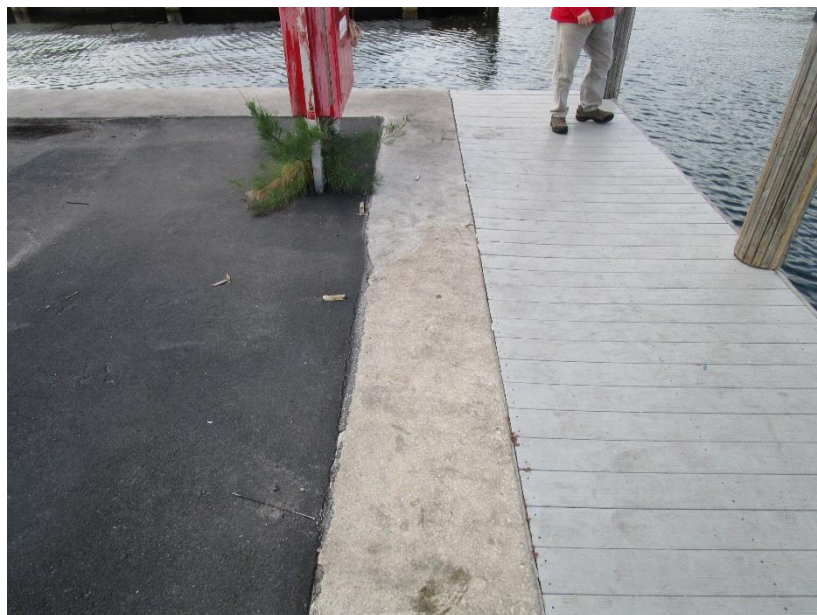
**Plate N**  
**West end of bulkhead under current assessment**

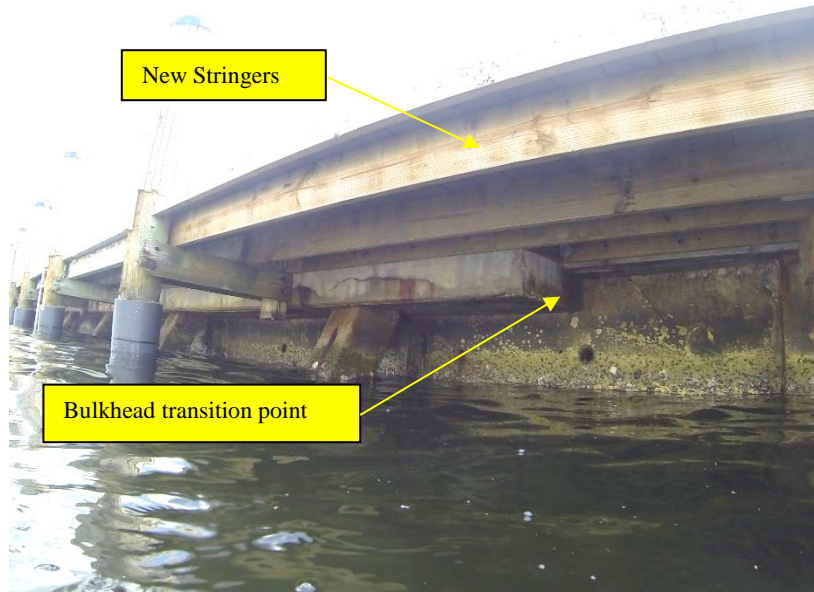
At the bulkhead transition location, a section of the dock was repaired using new timber piles and timber framing with the original decking reattached to the underlying substructure. (**Plates O and P**) Along this section of the bulkhead continuing west to the boat ramp, the condition of the cap is extremely poor with extensive signs of deterioration, cracking and exposed rebar. As evidenced in the 2016 investigation, it appeared that the original cap was over-poured with a new cap at some point in the past. Large sections of the apparent over-pour were severely deteriorated with large cracks and missing concrete. (**Plates Q, R and S**) The cap condition is in such a poor state that the stability of the dock is a severe issue as the ledger board attached to the outer face of the cap could fail due to cracks and loss of concrete. (**Plates T and U**) The vertical piles and panels along this section of bulkhead were observed to have random cracks of varying degrees of severity.

**Plate O**  
**View beneath dock at bulkhead transition point**  
**Note repaired section of timber dock**

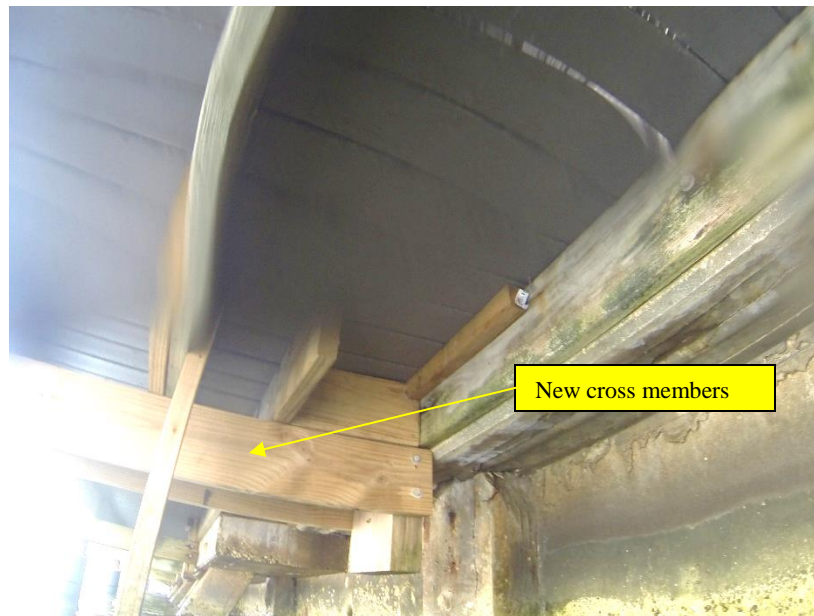
**Plate P**  
**View beneath dock at bulkhead transition point**  
**Note repaired section of timber dock**

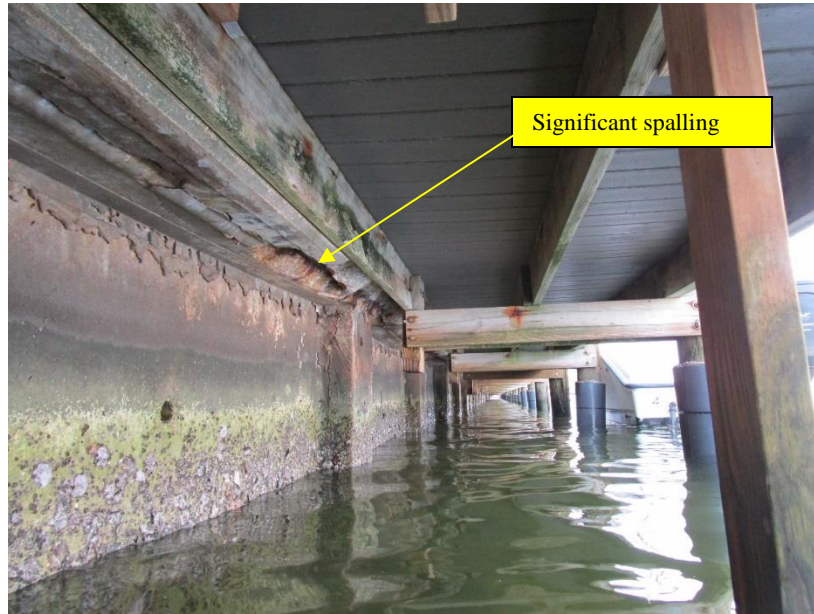
**Plate Q**  
**Typical condition of bulkhead cap and timber dock**

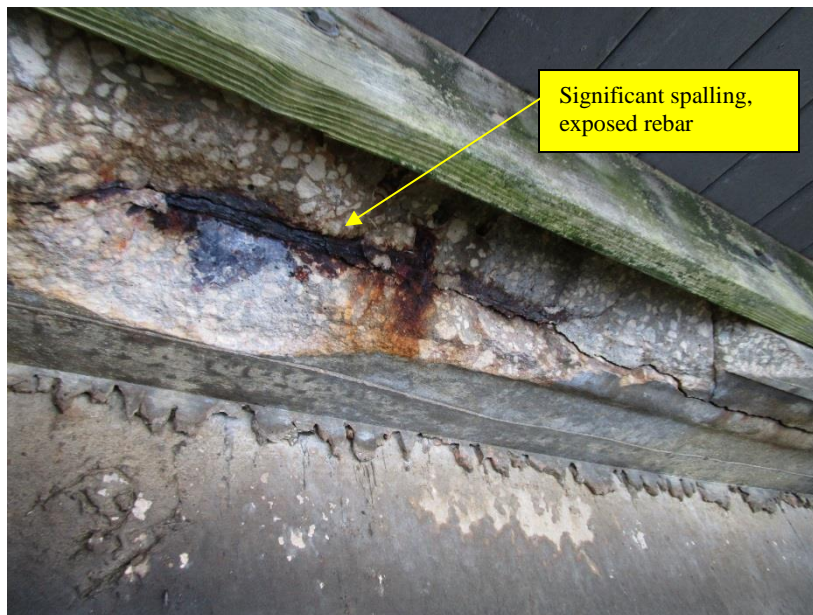
**Plate R**  
**Typical condition of bulkhead cap**

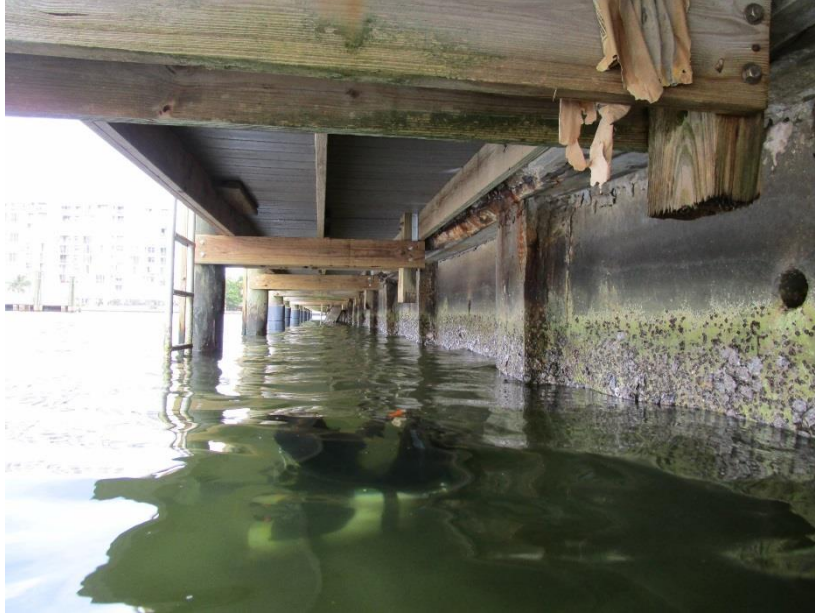
**Plate S**  
**Typical condition of bulkhead cap and dock**

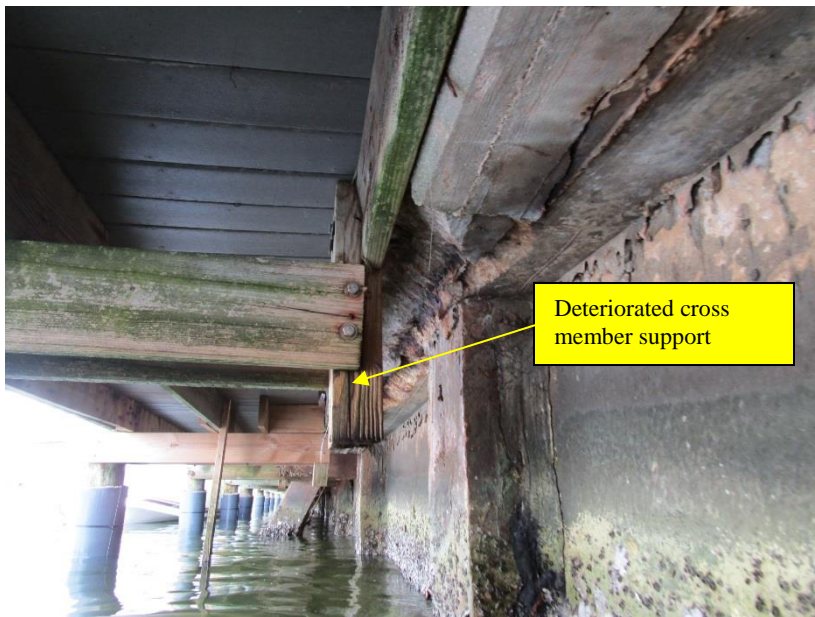
**Plate T**  
**Typical condition of bulkhead cap and dock**

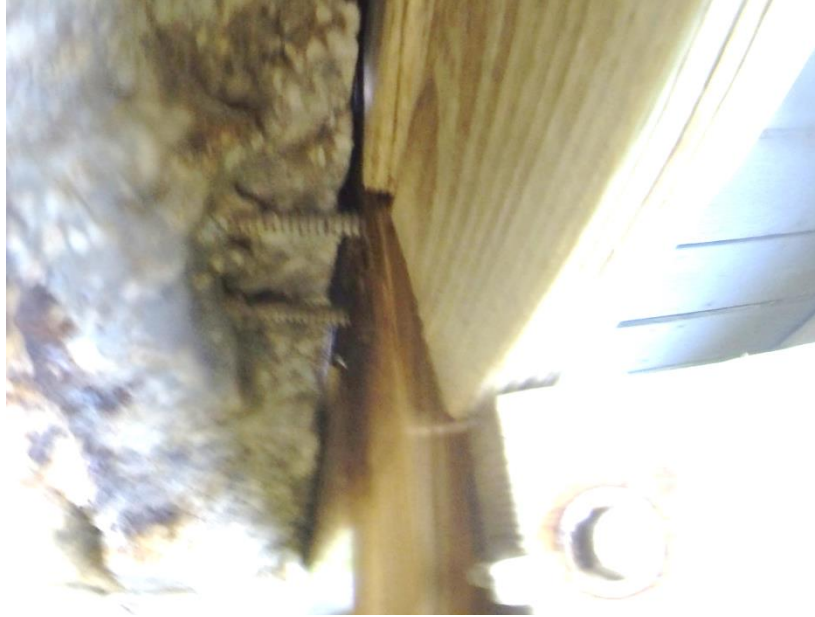
**Plate U**  
**Severely spalled concrete with evidence that cross member support connections are in poor condition**
