ARBORIST REPORT

872 McNab Rd.
Pompano Beach, FL 33030

Treage LLC was contacted by Andres Montero of AMLA Studio in July 2023 to conduct a Certified Arborist Report at 872 McNab Rd., Pompano Beach, FL.

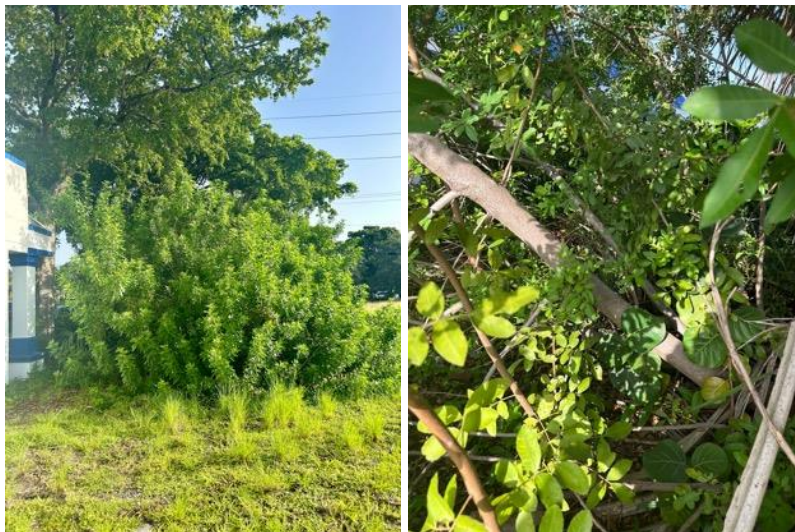
Tree #2 – *Schinus terebinthifolia*, Brazilian Pepper – this tree is growing directly south of Tree #1. It consists of multiple small trunks/sprouts and is very overgrown. This is considered a Nuisance Species that must be removed with a no-fee permit.

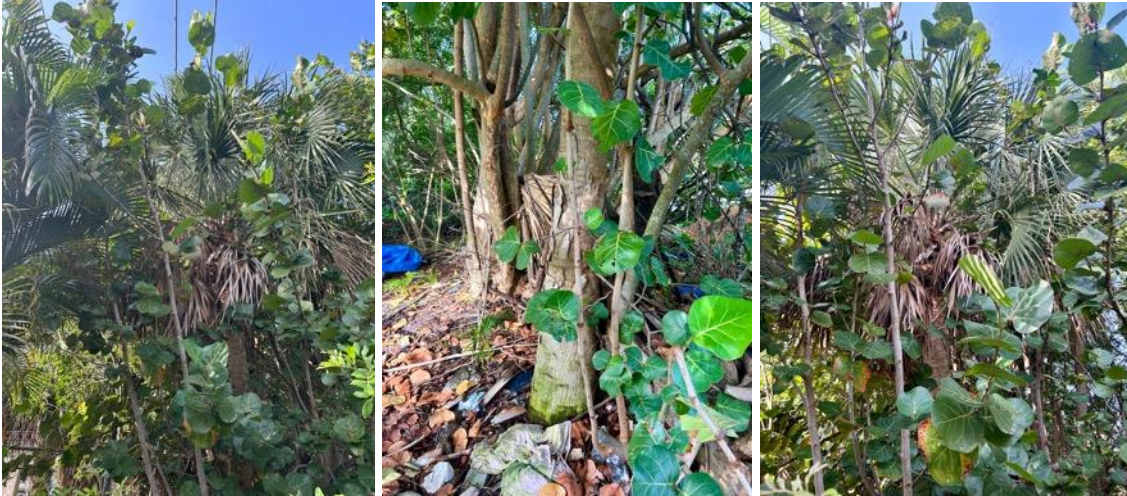
Tree #3 – *Sabal palmetto*, Sabal Palm – this tree is located on the southeast side of the property within 4' of the chain link fence separating the adjacent property. It is very crowded and overgrown but otherwise in fair condition. It will require a permit if it is to be removed, or protection during construction per measures below. As an alternative, it is a possible candidate for relocation.

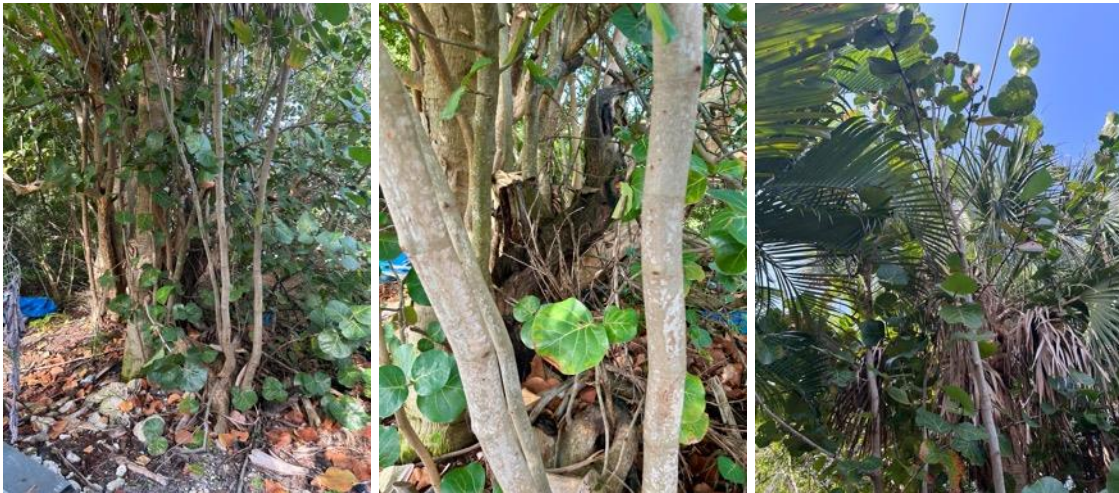
Tree #4 – *Coccoloba uvifera*, Seagrape – this tree is growing directly west of Tree #3. It has a large dead/decayed trunk that terminates at approximately 5' height and only small upright sprouts remaining. This tree is very crowded and overgrown and it has a poor branching structure. Overall, it is in moderate to poor condition.

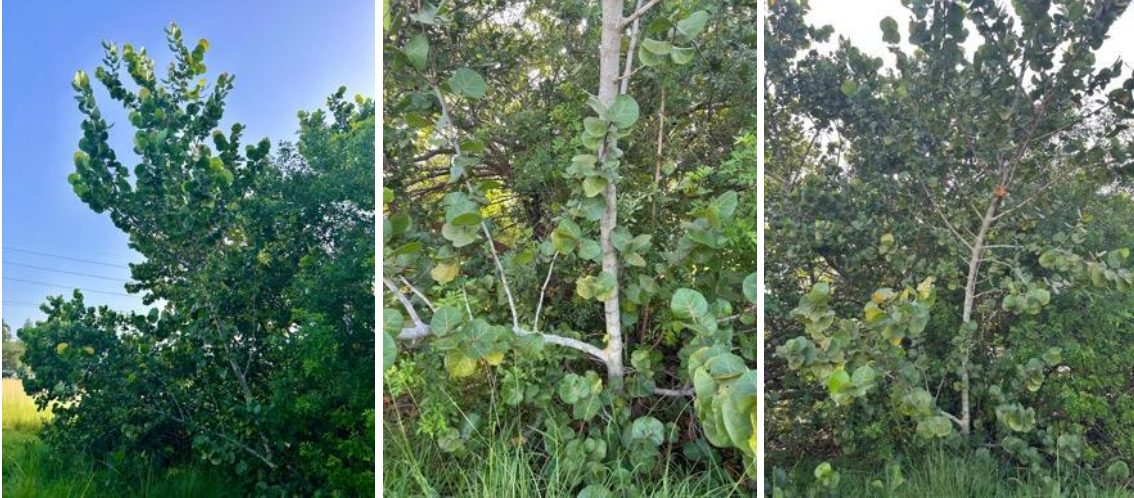
Tree #7 – *Coccoloba uvifera*, Seagrape – this is a small volunteer growing on the west side of the overgrown cluster of vegetation containing Trees #4-6. It is crowded and leaning as a result with an overall weak structure/growth habit. This tree is in moderate condition. It will require a permit if it is to be removed, or protection during construction per measures below. As an alternative, it is a possible candidate for relocation.

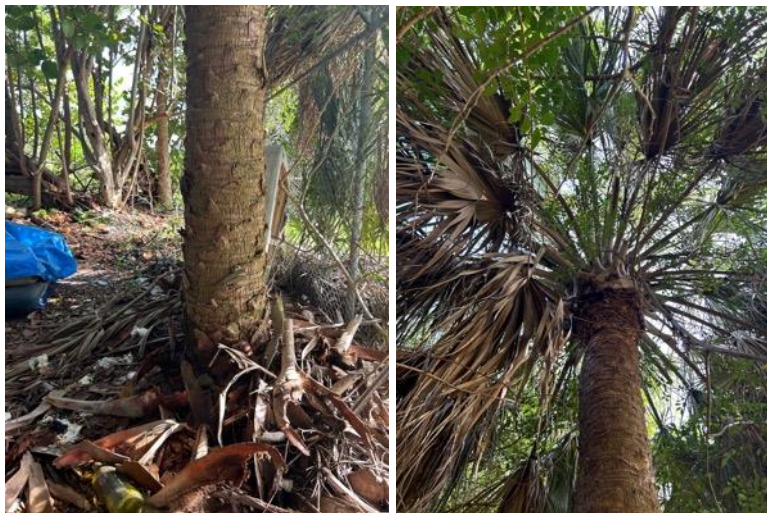
Tree #8 – *Sabal palmetto*, Sabal Palm – this palm is growing within 3.5' of the chain link fence slightly south of Tree #3. It is very crowded and overgrown, but otherwise in fair condition. It will require a permit if it is to be removed, or protection during construction per measures below. As an alternative, it is a possible candidate for relocation.

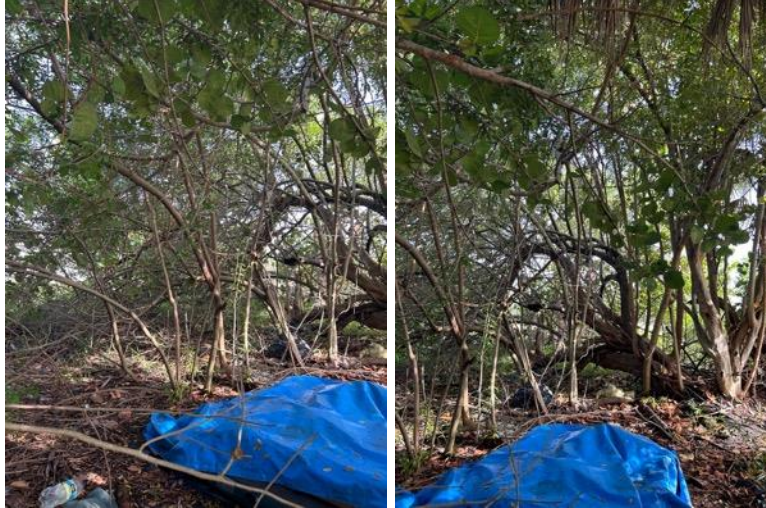
Note: there are several small Brazilian Pepper volunteers, all under 3" DBH, growing under the canopy of Tree #5. They are under regulation size and were not individually counted. These are Nuisance Species that should be eligible for removal without a separate permit (to be confirmed by the City).

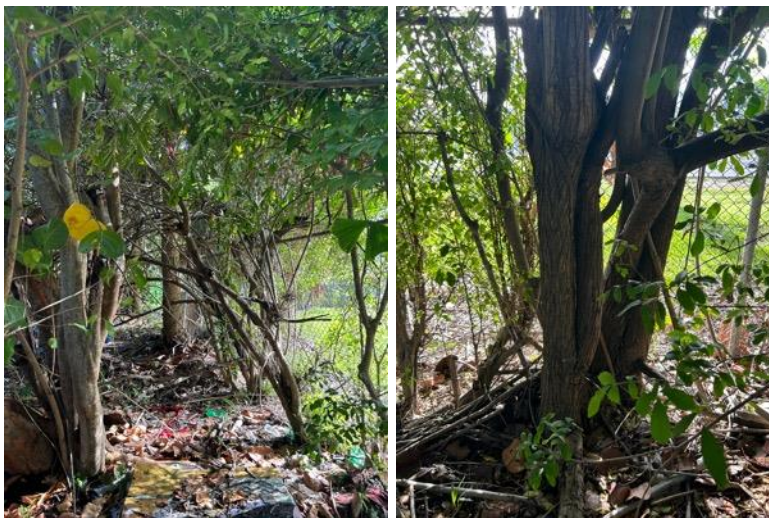
Tree #9 – *Schinus terebinthifolia*, Brazilian Pepper – this tree is growing slightly south of Tree #8 along the fence line. It is very overgrown, crowded, and in moderate condition. It is a Nuisance Species that will require removal with a no-fee permit.

Tree #10 – *Schinus terebinthifolia*, Brazilian Pepper – this tree is growing slightly south of Tree #9 along the fence line. It is very overgrown, crowded, and in moderate condition. It is a Nuisance Species that will require removal with a no-fee permit.

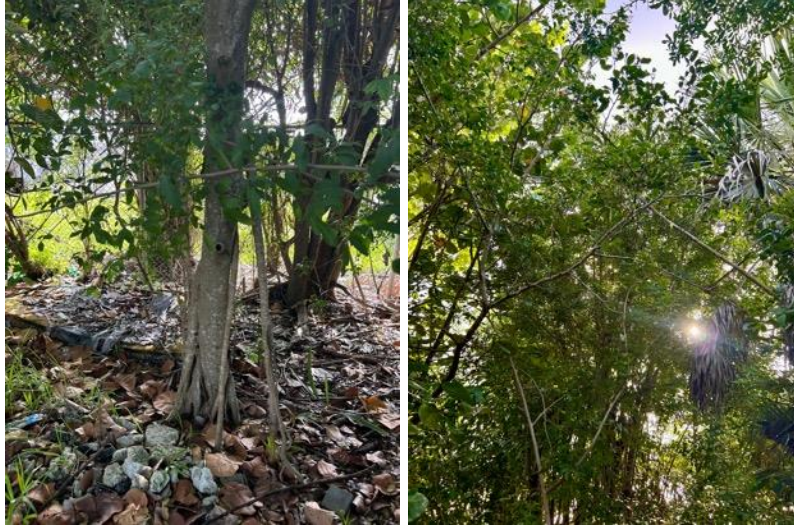
Tree #11 – *Ficus benjamina*, Weeping Fig – this tree is located slightly west of Tree #10. It is very crowded and overgrown and leaning somewhat as a result. Overall, it is in moderate condition. It will require a permit if it is removed, or protection during construction per measures below if it remains.

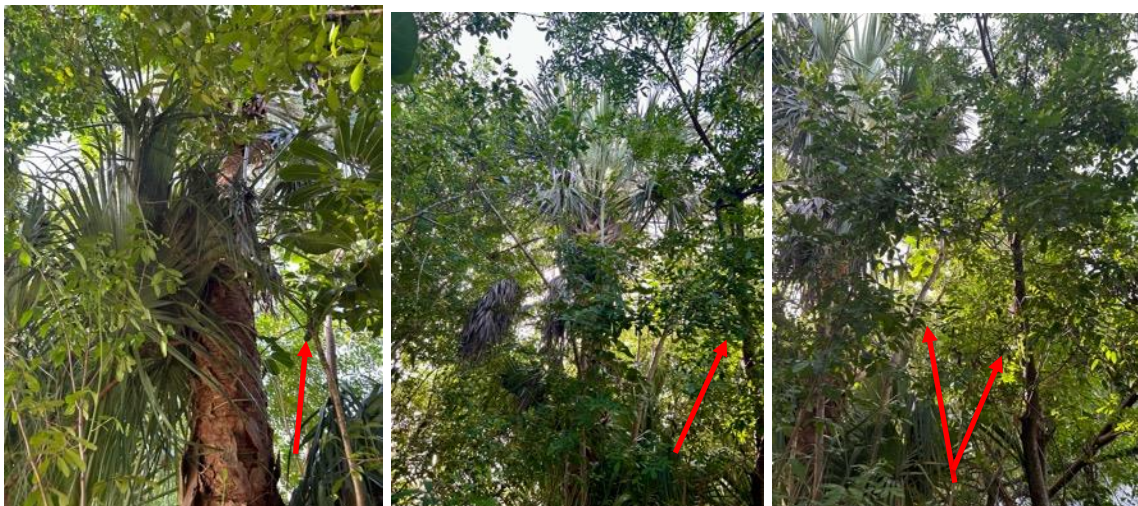
Tree #14 – *Schefflera actinophylla*, Umbrella Tree – this tree is growing on the west side of, and against, Tree #13. It is very crowded with a weak structure as a result. This is a Nuisance Species that requires removal with a no-fee permit.

Tree #15 – *Schinus terebinthifolia*, Brazilian Pepper – this tree is growing slightly west of Trees #13-14 along the west fence line. It is crowded, overgrown, and in moderate condition. It is a Nuisance Species that will require removal with a no-fee permit.

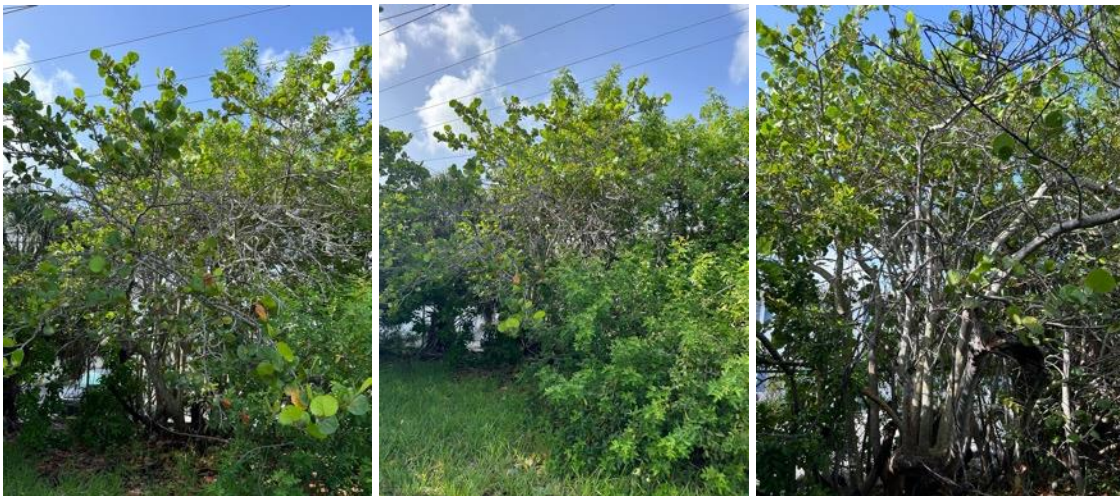
Tree #17 – *Coccoloba uvifera*, Seagrape – this refers to an overgrown cluster of Seagrape located slightly west of Tree #16 along the fence line. It consists of multiple small diameter trunks/sprouts. It has a poor branching structure with moderate deadwood and significant decay present, and it is growing in close proximity to utility wires. This tree is recommended for maintenance pruning/canopy cleaning and subsequent further evaluation to determine its disposition. It will require a permit and mitigation if it is removed.

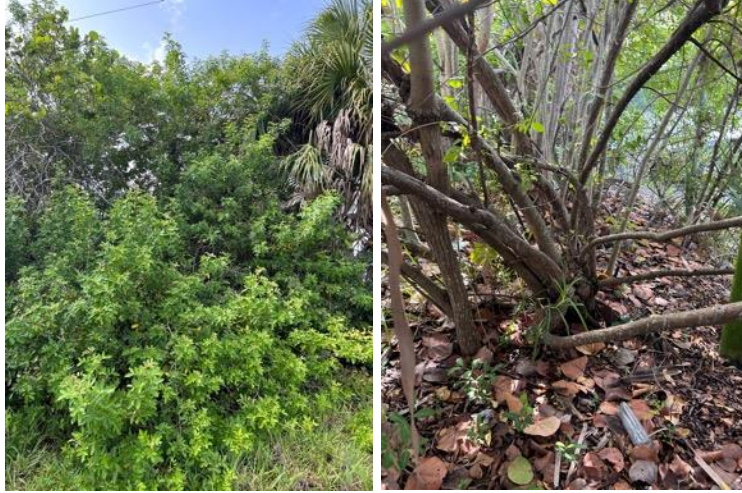
Tree #18 – *Schinus terebinthifolia*, Brazilian Pepper – this tree is growing just west of Tree #17. It is overgrown, unmaintained, and is a Nuisance Species that must be removed with a no-fee permit.

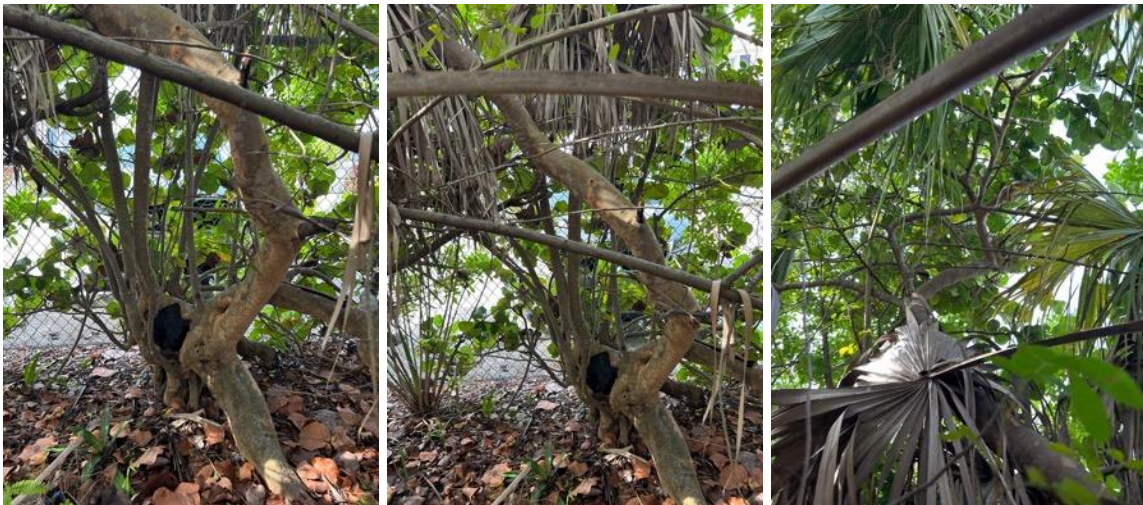
Tree #19 – *Coccoloba uvifera*, Seagrape – this tree is growing against the fence just west of Tree #18. There is one limb that bends and extends backward over the neighboring property and otherwise there are only small sprouts originating above a decay cavity at the base of the trunk. Overall, this tree is in poor condition. It is most likely a good candidate for removal due to its condition.

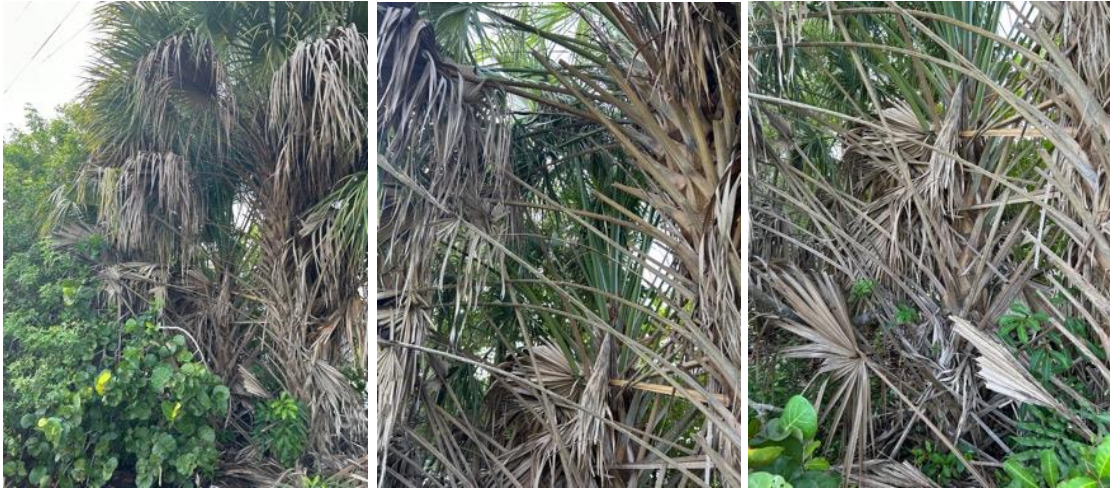
Tree #20– *Sabal palmetto*, Sabal Palm – this tree is growing against Tree #19 in a cluster of Sabal Palms. It is extremely crowded. It does not appear to have any clear trunk at 4.5' height, so it may be eligible for removal without a permit, to be confirmed by the City.

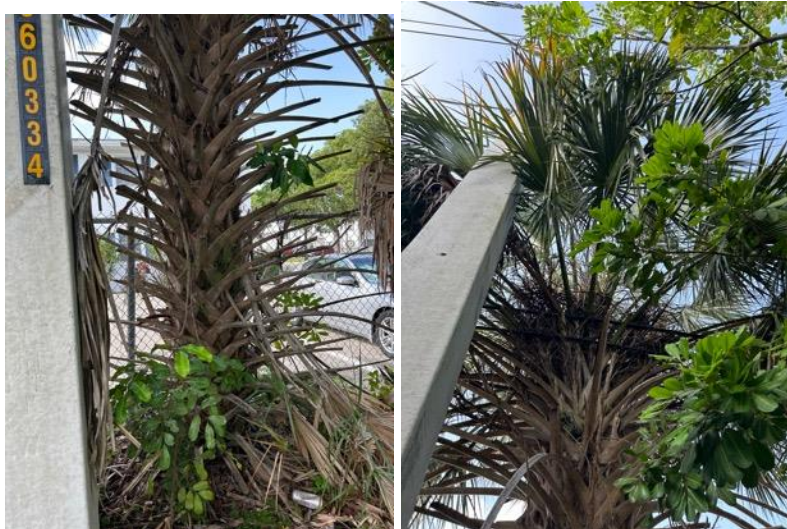
Tree #23 – *Sabal palmetto*, Sabal Palm – this tree is growing just west of Tree #22 and a utility pole near the south fence line. It is very crowded but otherwise in fair condition. It is growing among the adjacent utility lines. It still has its boots present. This tree could remain with protection during construction, but it is growing in very close proximity to a utility pole/utility lines. As an alternative, it may be a decent candidate for relocation onsite per specifications below. Otherwise, it will require a permit and mitigation if it is removed.

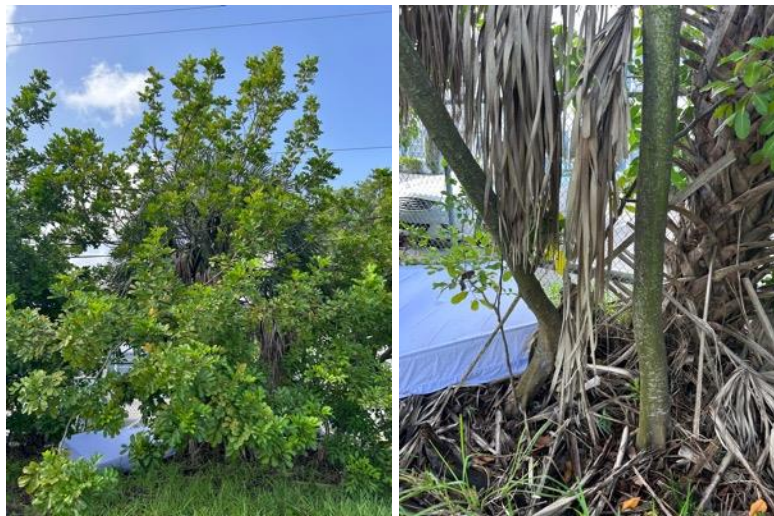
Tree #26-27 - *Cupaniopsis anacardioides*, Carrotwood – this refers to 2 small Carrotwood trees growing just west of Tree #25. They are crowded and leaning as a result. These are a Nuisance Species that require removal with a no-fee permit.

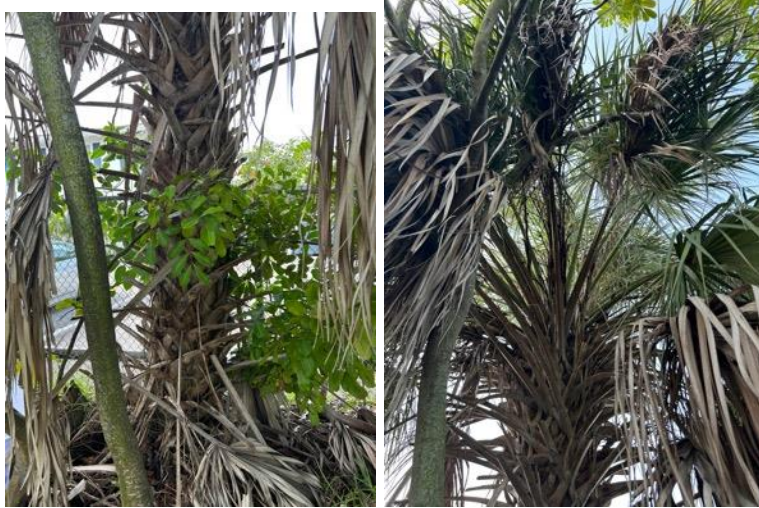
Tree #28 – *Sabal palmetto*, Sabal Palm – this tree is growing against the fence just west of Tree #27. It is crowded, overgrown, and unmaintained, and it still has its boots intact, but overall it is in fair condition. It is a decent candidate to remain due to its location and compact root zone. If it is removed, it will require a permit and mitigation.

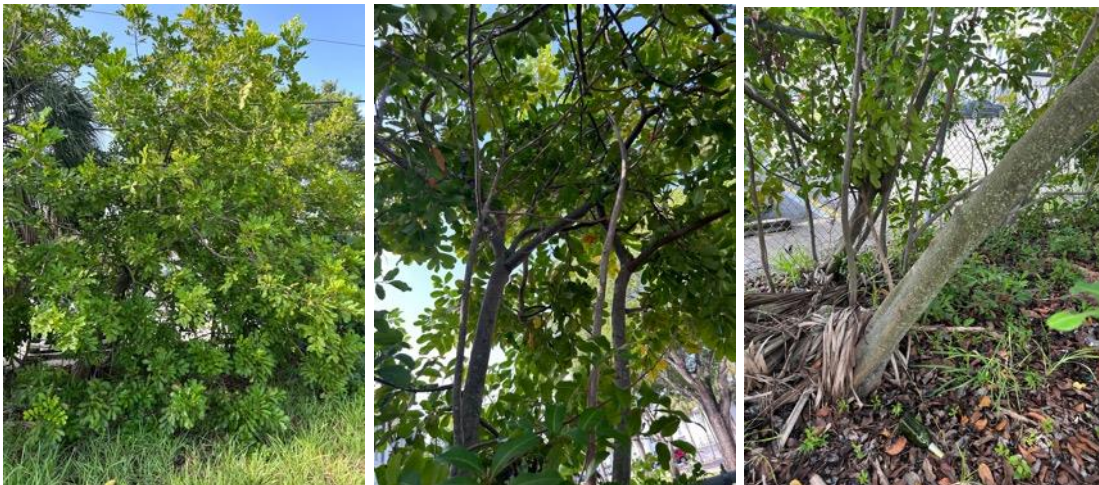
Tree #29 - *Cupaniopsis anacardioides*, Carrotwood – this tree is growing just west of Tree #28 near the property line. It is crowded and leaning in poor condition. This is a Nuisance Species that requires removal with a no-fee permit.

Tree #30 - *Cupaniopsis anacardioides*, Carrotwood – this tree is growing just behind Tree #29 near the property line. It is crowded and in poor condition with small tears present. This is a Nuisance Species that requires removal with a no-fee permit.

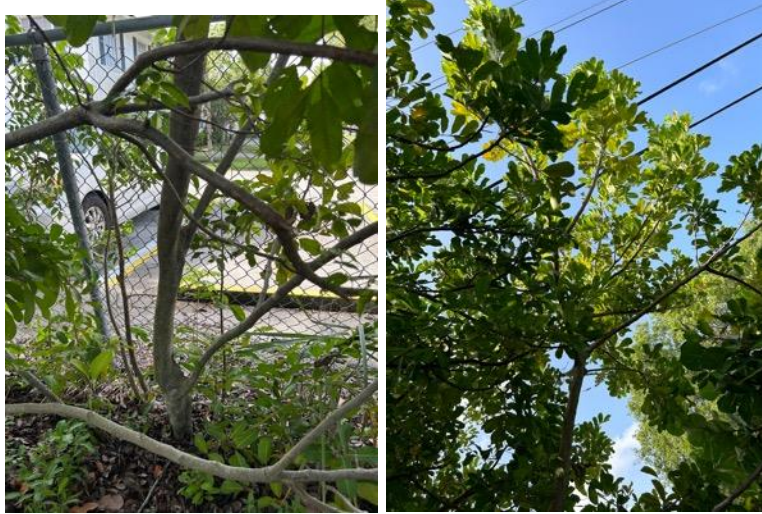
Tree #31 - *Cupaniopsis anacardioides*, Carrotwood – this tree is growing just west of Tree #30 near the property line. It is crowded and in poor condition. This is a Nuisance Species that requires removal with a no-fee permit.

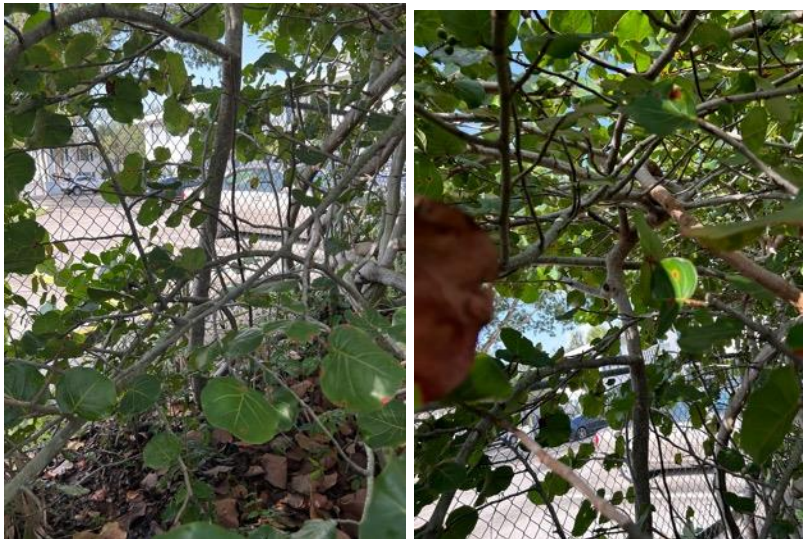
Tree #32 – *Coccoloba uvifera*, Seagrape – this is a small individual that is likely a volunteer. It has a poor branching structure and weak growth habit due to very crowded conditions. It has a single trunk that bends at nearly a 90 degree angle at approximately 5' height and its maximum height is 10'. This tree is just over regulation size, so it will most likely require a permit and mitigation for removal.

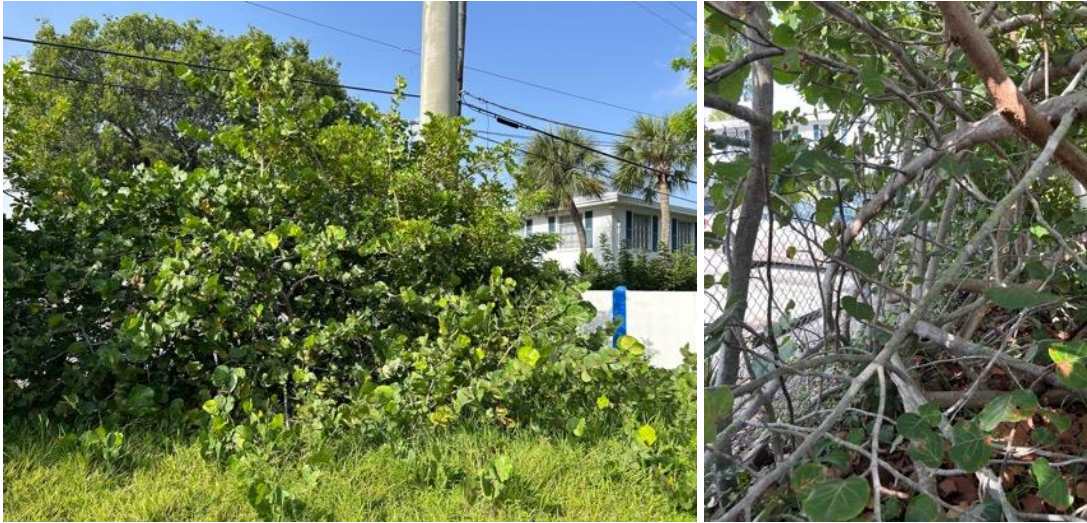
Tree #33 – *Coccoloba uvifera*, Seagrape – this cluster is located near the southwest corner of the property just west of Tree #32. It consists of multiple small diameter sprouts growing mostly horizontally due to crowding; there are only 2 sprouts over regulation height. It is crowded, overgrown and unmaintained. Overall, it is in moderate condition. It will require protection during construction and is recommended for maintenance pruning/cleaning if it remains; otherwise, it will require a permit and mitigation if it is removed.

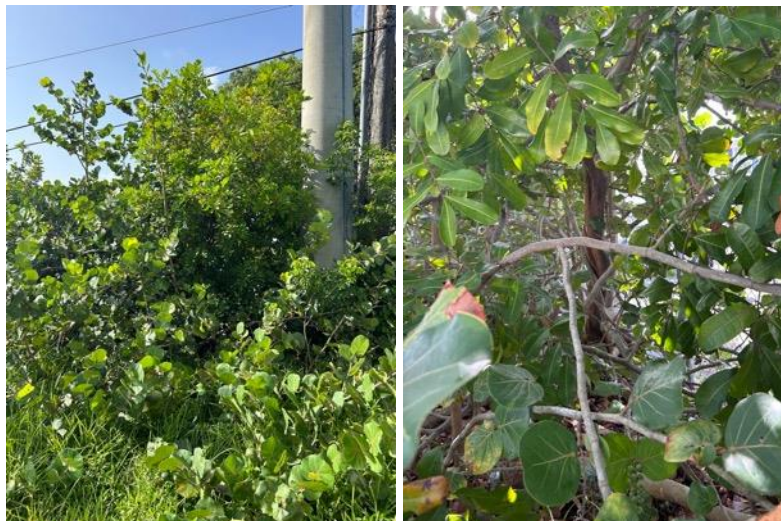
Tree #34 - *Cupaniopsis anacardioides*, Carrotwood – this tree is growing on the southwest side of the property near the fence line. It is crowded and overgrown with a weak structure. This is a Nuisance Species that requires removal with a no-fee permit.

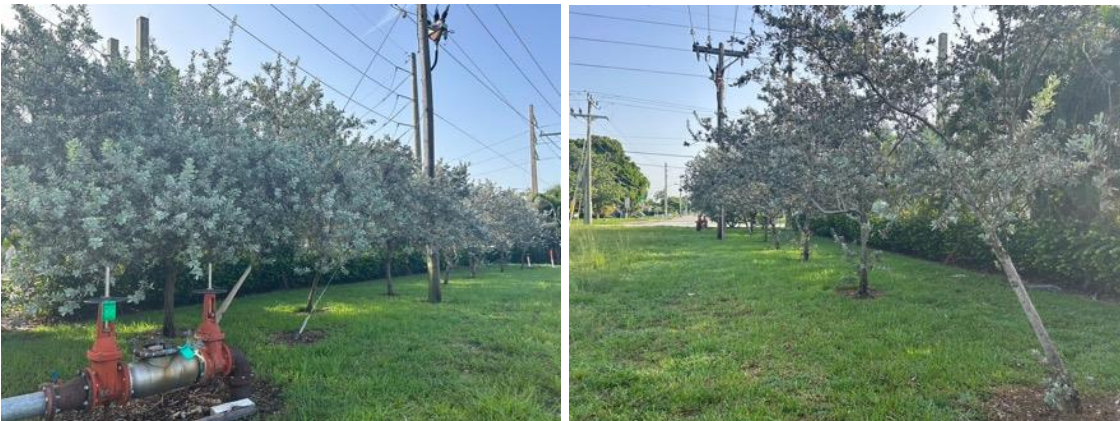
***Conocarpus erectus* var. *sericeus*, Silver Buttonwood** – this refers to a row of 7 somewhat recently planted Silver Buttonwoods located on the property to the east. They are not expected to be impacted and their TPZ's should not extend over the property line, but protection measures below apply.
