Re: Arborist Findings at 200 Park Central Boulevard, Pompano Beach, FL

I visited the above-mentioned property on Saturday, February 4th, 2023 to evaluate +/- 121 trees, take photographs (Specimen sized trees only), perform relocation evaluations, calculate appraisal values (Rule 14-10 2020), and note any defects.

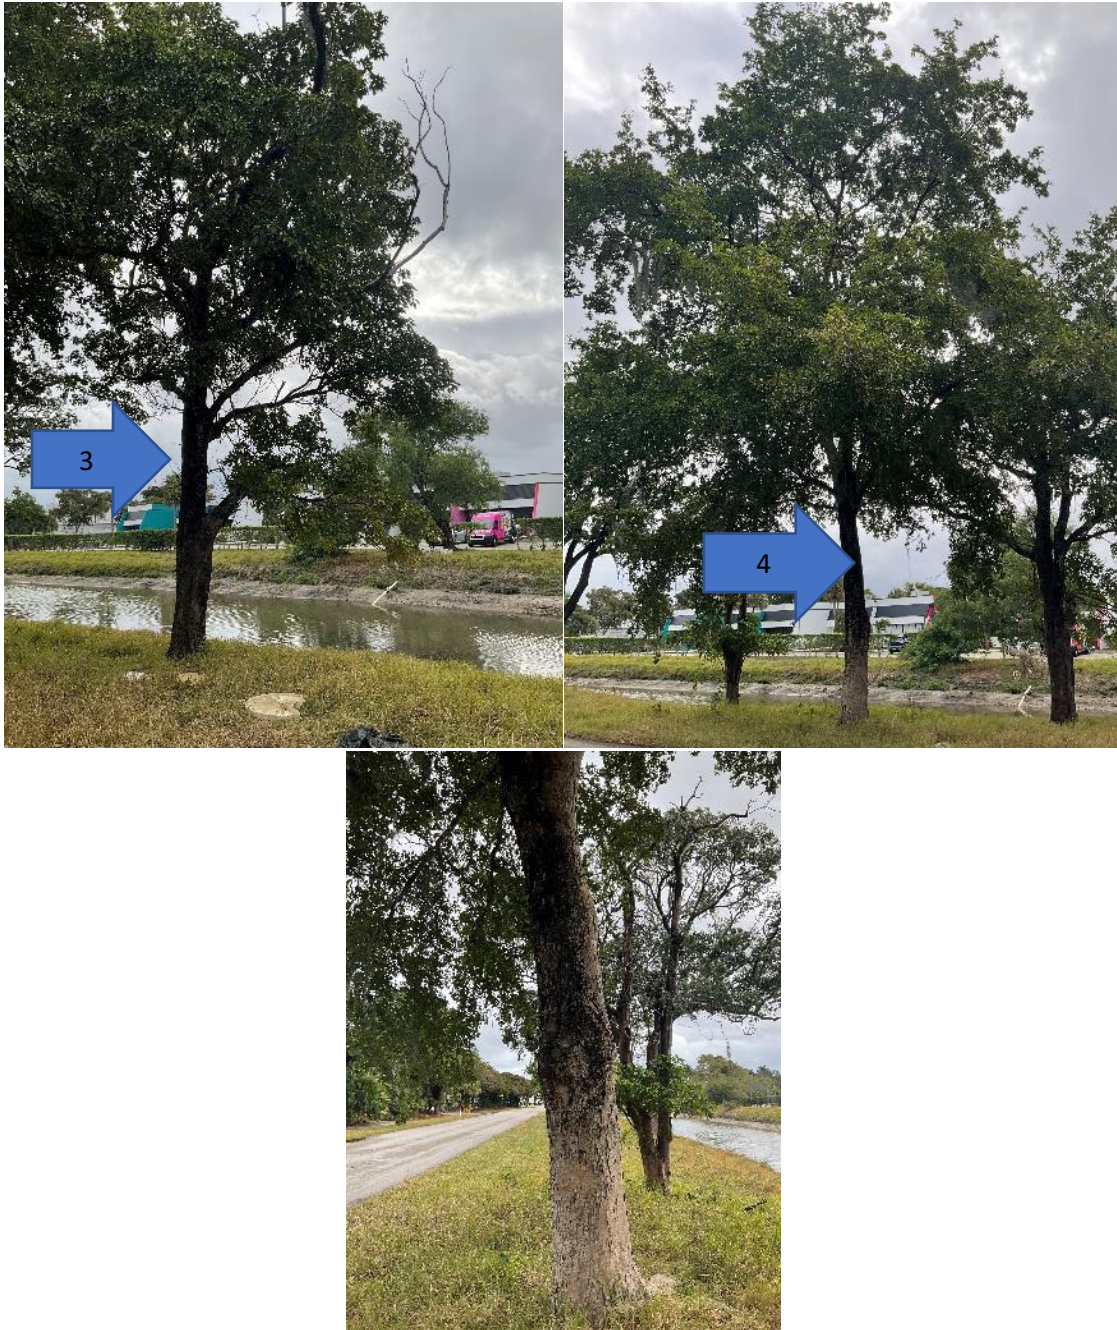
Trees Three & Four

Bishopwood (*Bischofia javanica*) Tree #3, and Black Olive (*Bucida buceras*) Tree #4, facing south. Note Tree #3 is a Florida Invasive Species Council Category I Invasive, and Tree #4 has poor structure, deadwood, flush cuts, and visual evidence of decay.

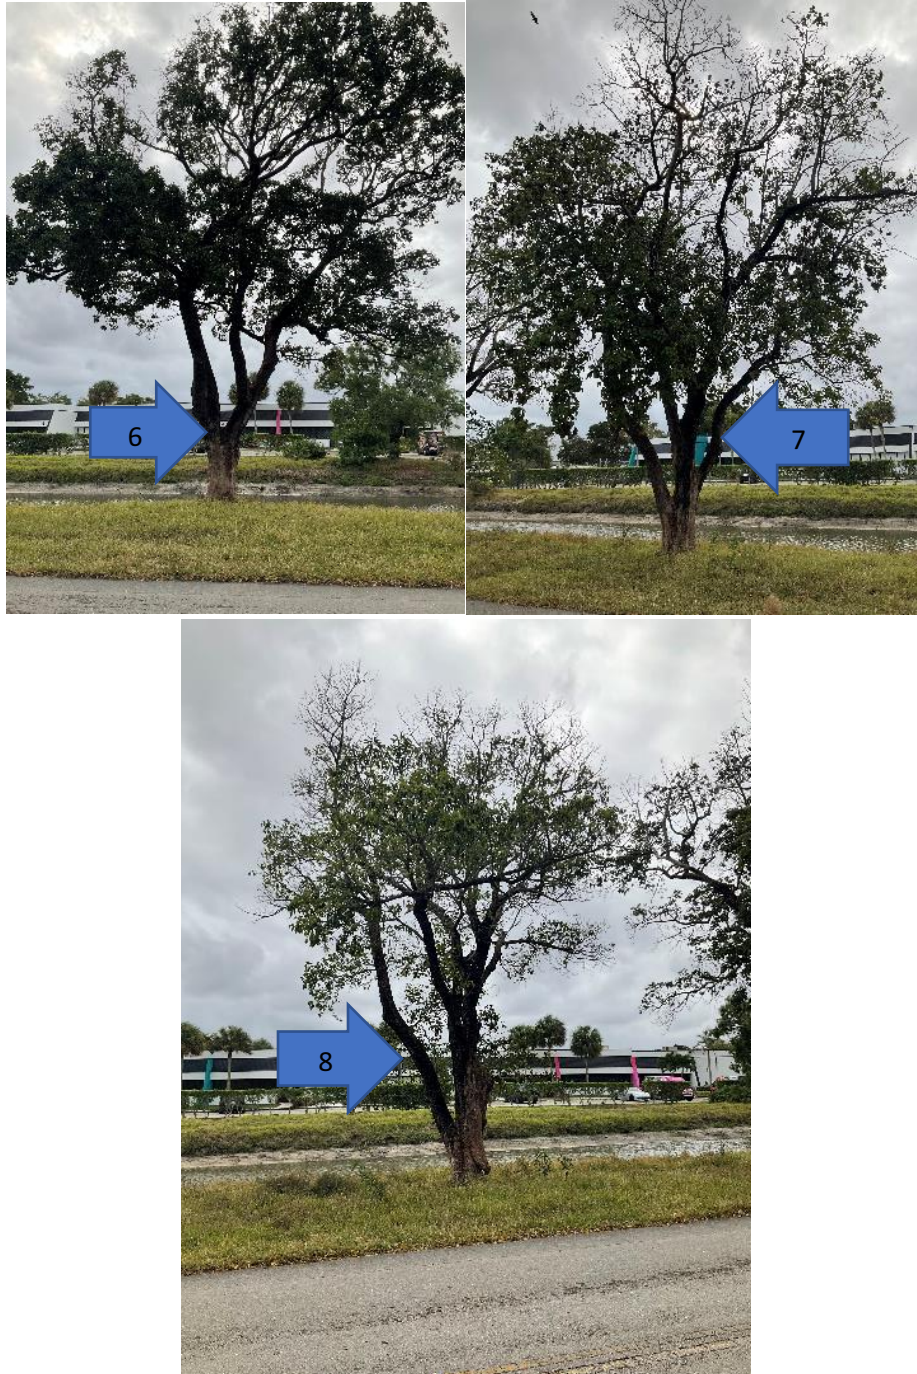
Trees Six, Seven, & Eight

Bishopwood trees (*Bischofia javanica*), facing south. Note all trees are Florida Invasive Species Council Category I Invasives.

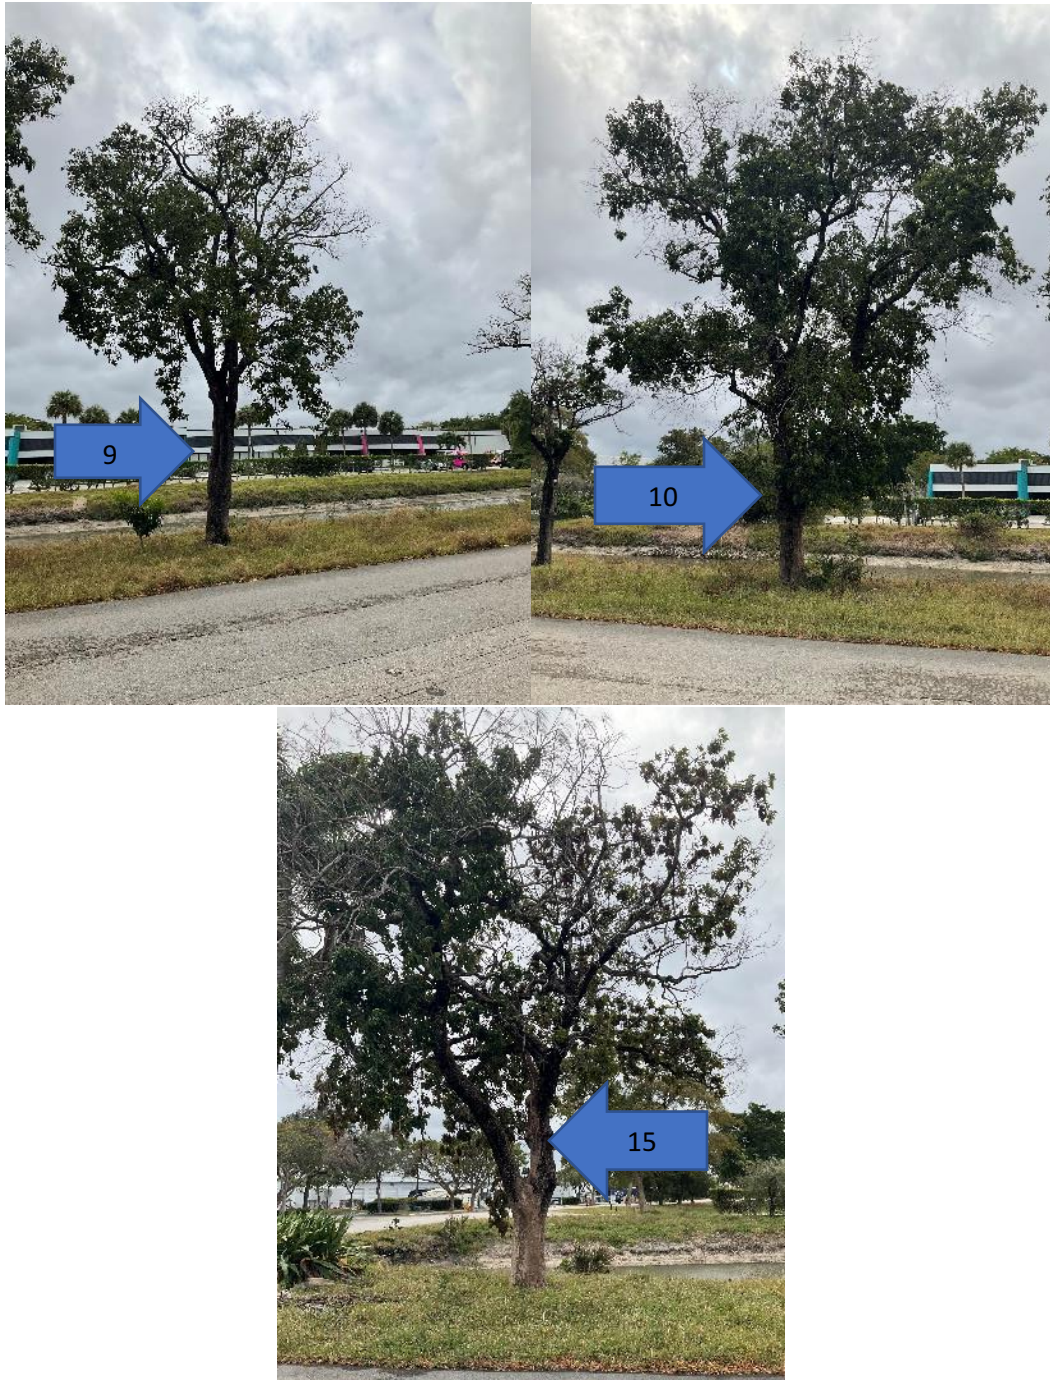
Trees Nine, Ten, & 15

Bishopwood trees (*Bischofia javanica*), facing south. Note all trees are Florida Invasive Species Council Category I Invasives.

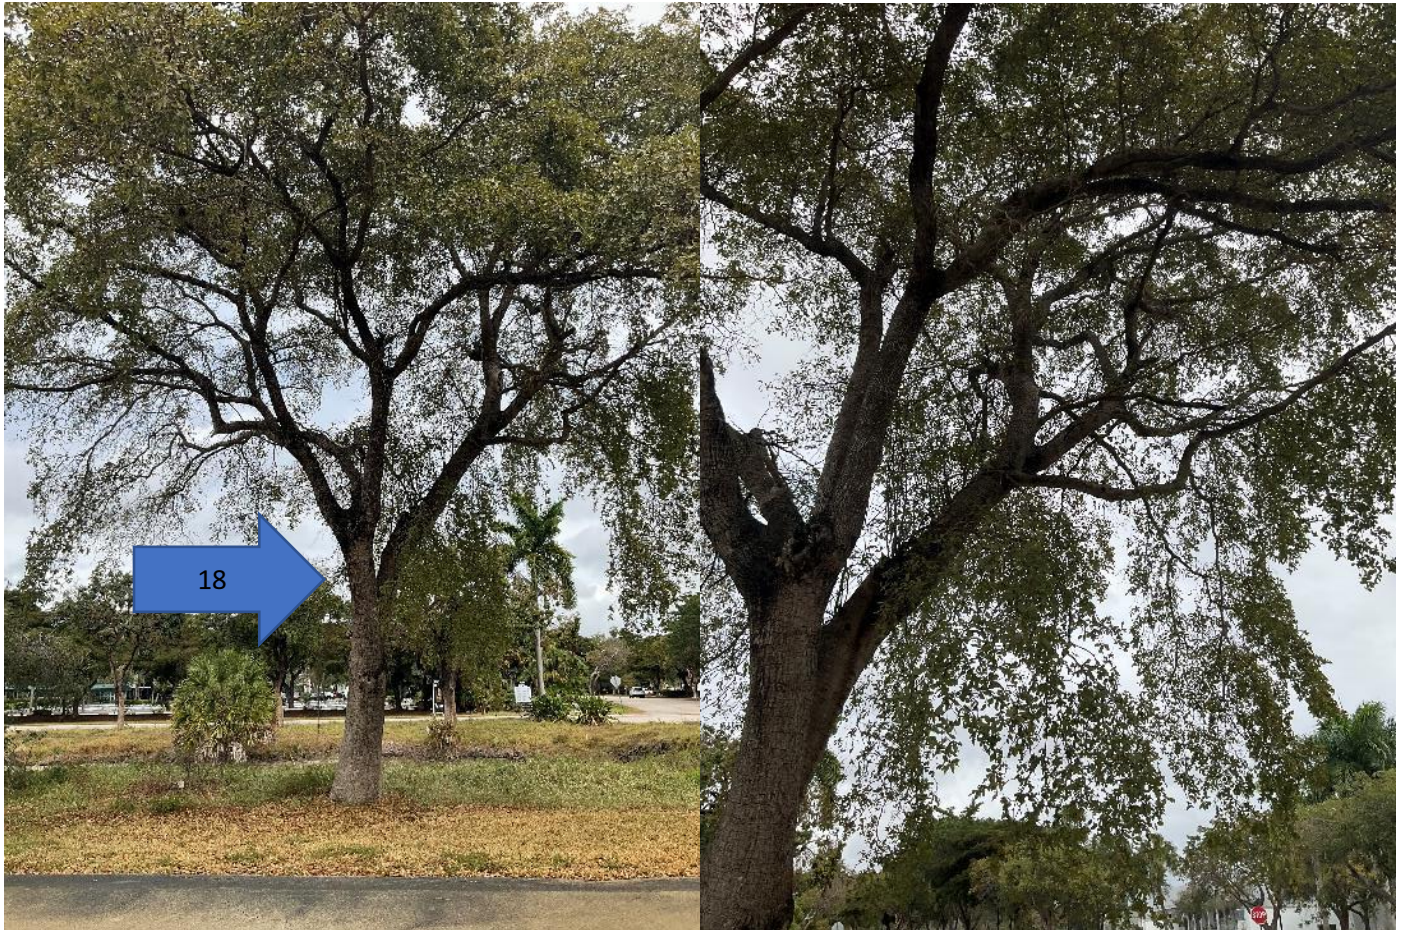
Tree 18

Black Olive (*Bucida buceras*), facing north. Note poor structure, canopy dieback, deadwood, visual evidence of decay, and water sprouts.

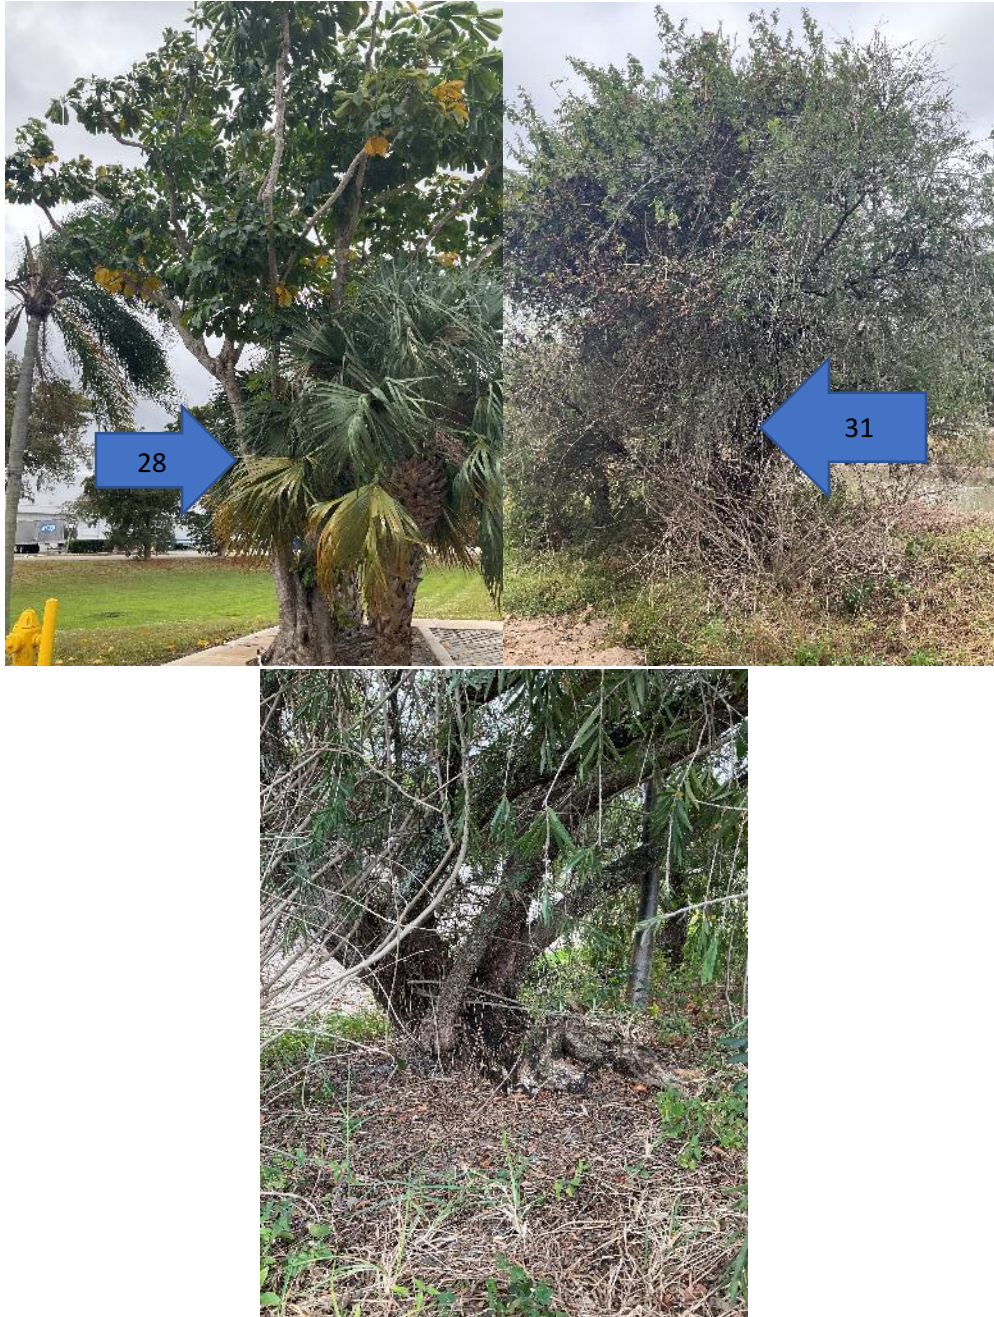
Trees 28 & 31

Umbrella Tree (*Heptapleurum actinophyllum*) Tree #28, and Bottlebrush (*Callistemon sp.*) Tree #31, facing west and north. Note Tree #28 is a Florida Invasive Species Council Category I Invasive, and Tree #31 has Poor structure, visual evidence of decay, and vines.

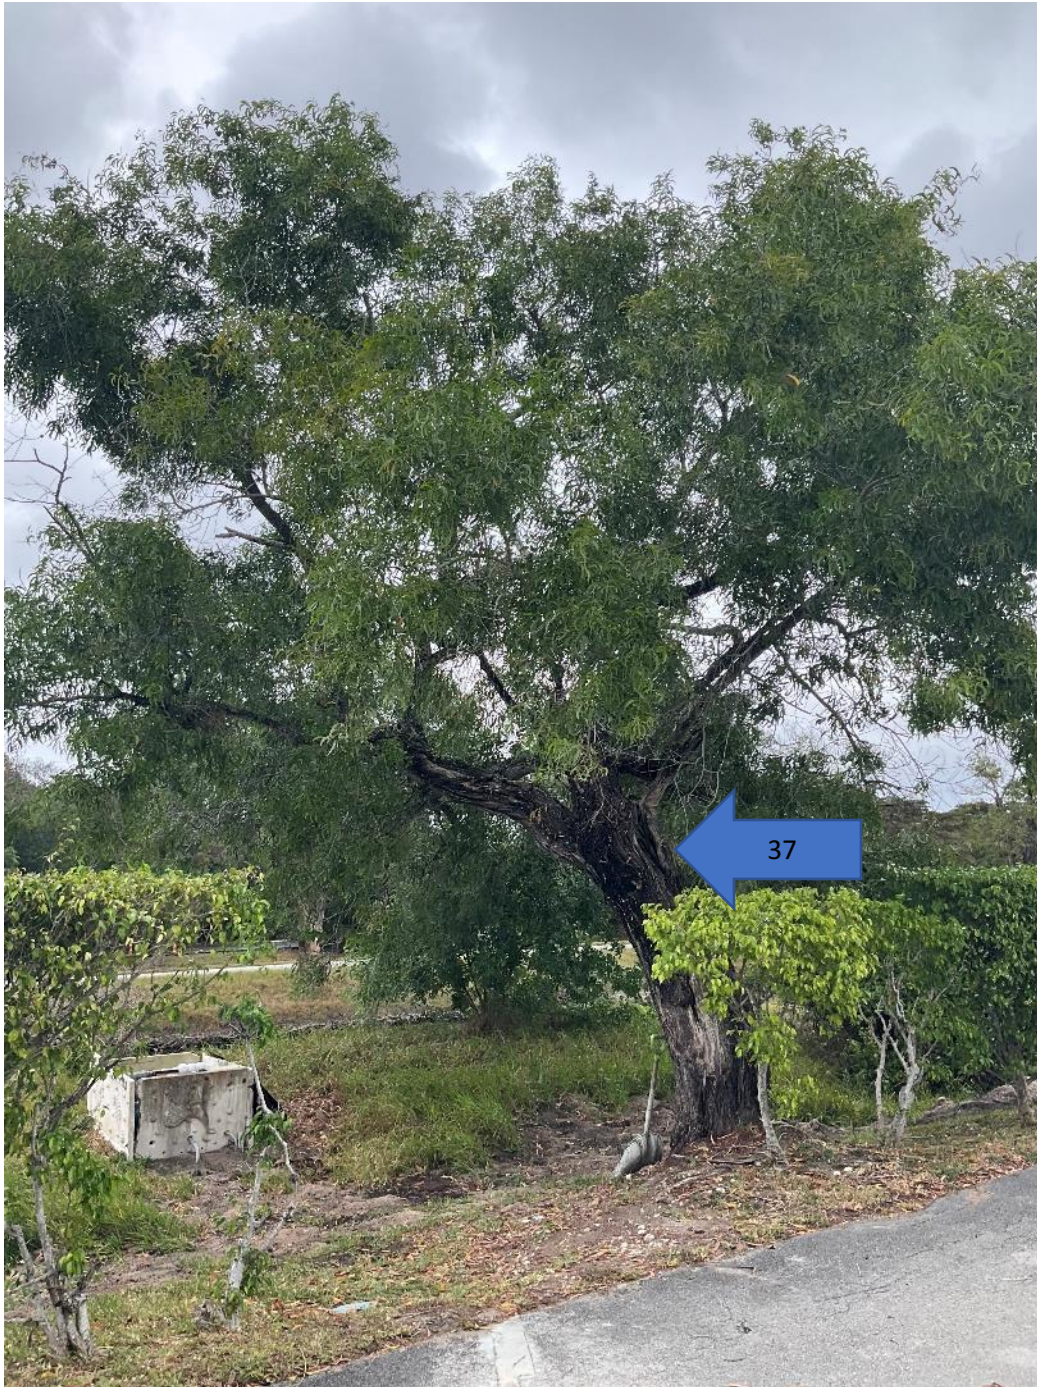
Tree 37

Earleaf Acacia (*Acacia auriculiformis*), facing north. Note tree is a Florida Invasive Species Council Category I Invasive.

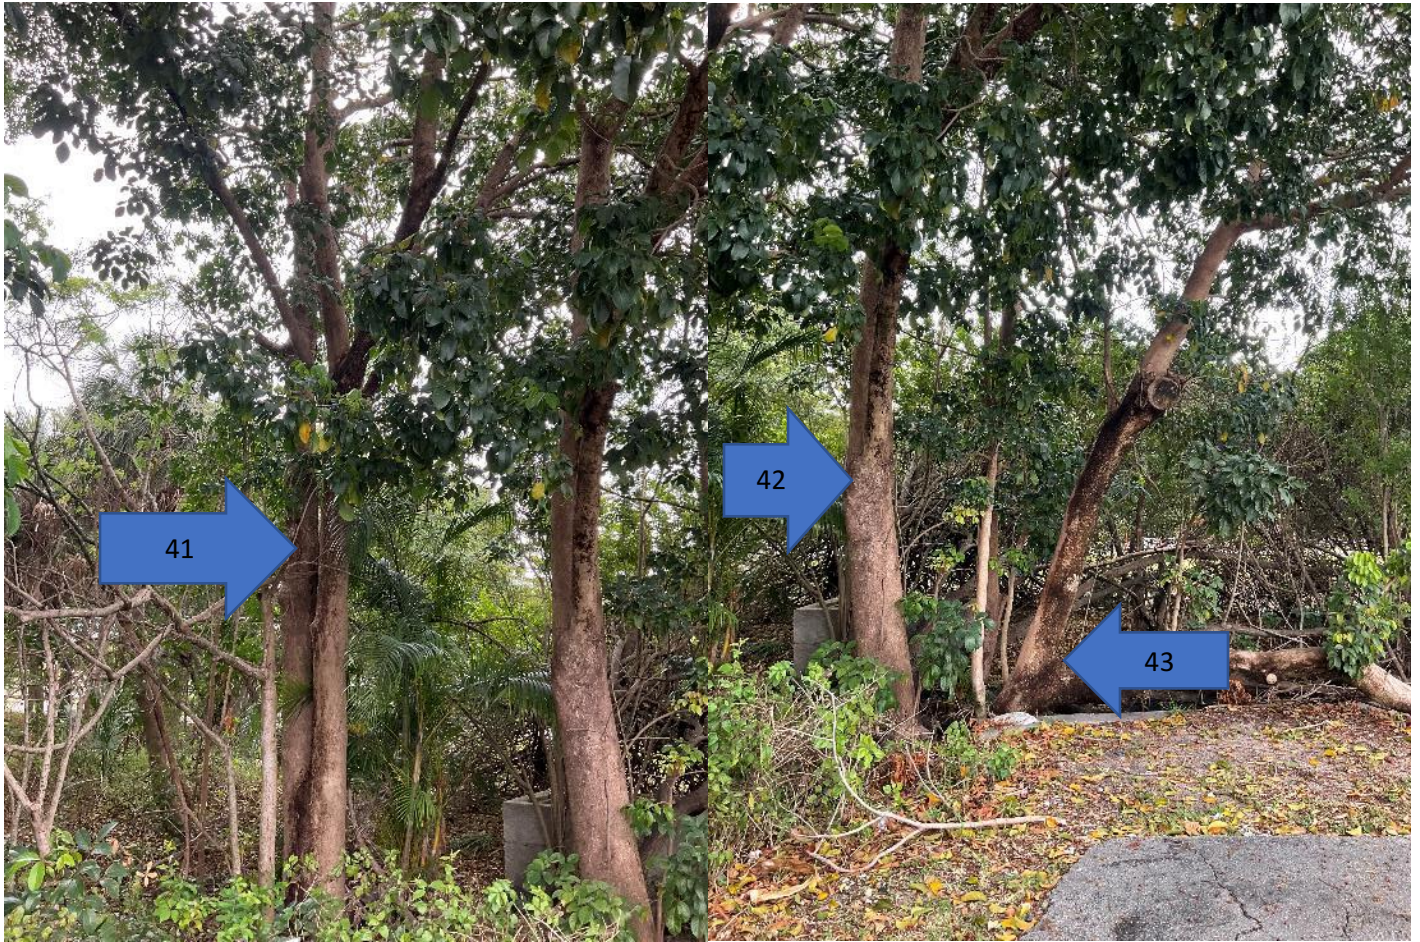
Trees 41, 42, & 43

Bishopwood trees (*Bischofia javanica*), facing north. Note all trees are Florida Invasive Species Council Category I Invasives.

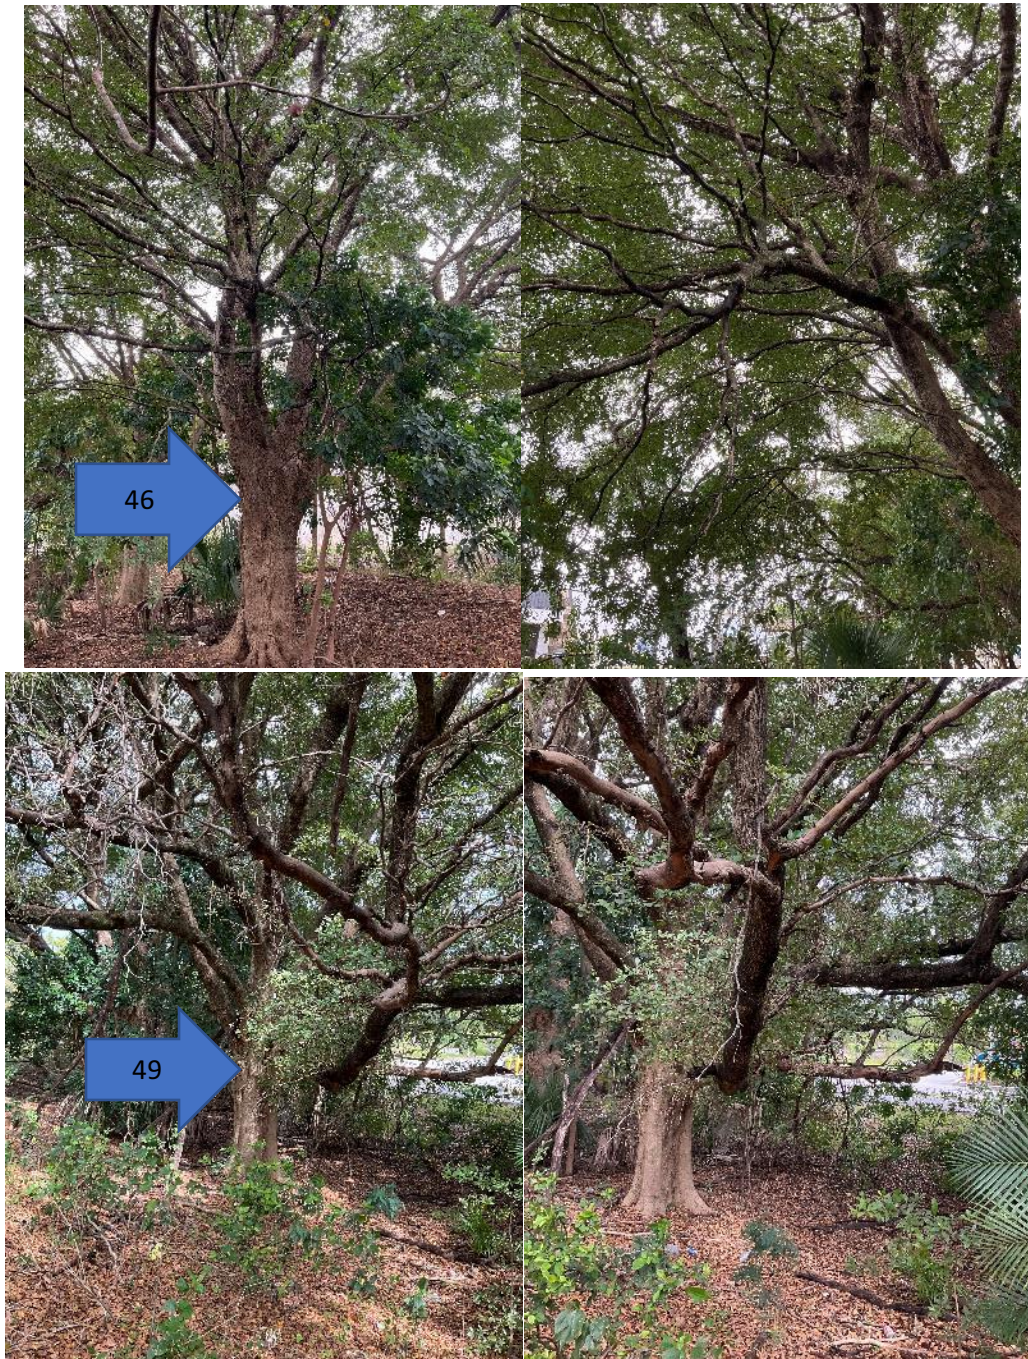
Trees 46 & 49

Black Olives (*Bucida buceras*), facing west. Note Poor structure, deadwood, visual evidence of decay for Tree #46, and poor structure, large diameter deadwood, visual evidence of decay, and canopy dieback for Tree #49.

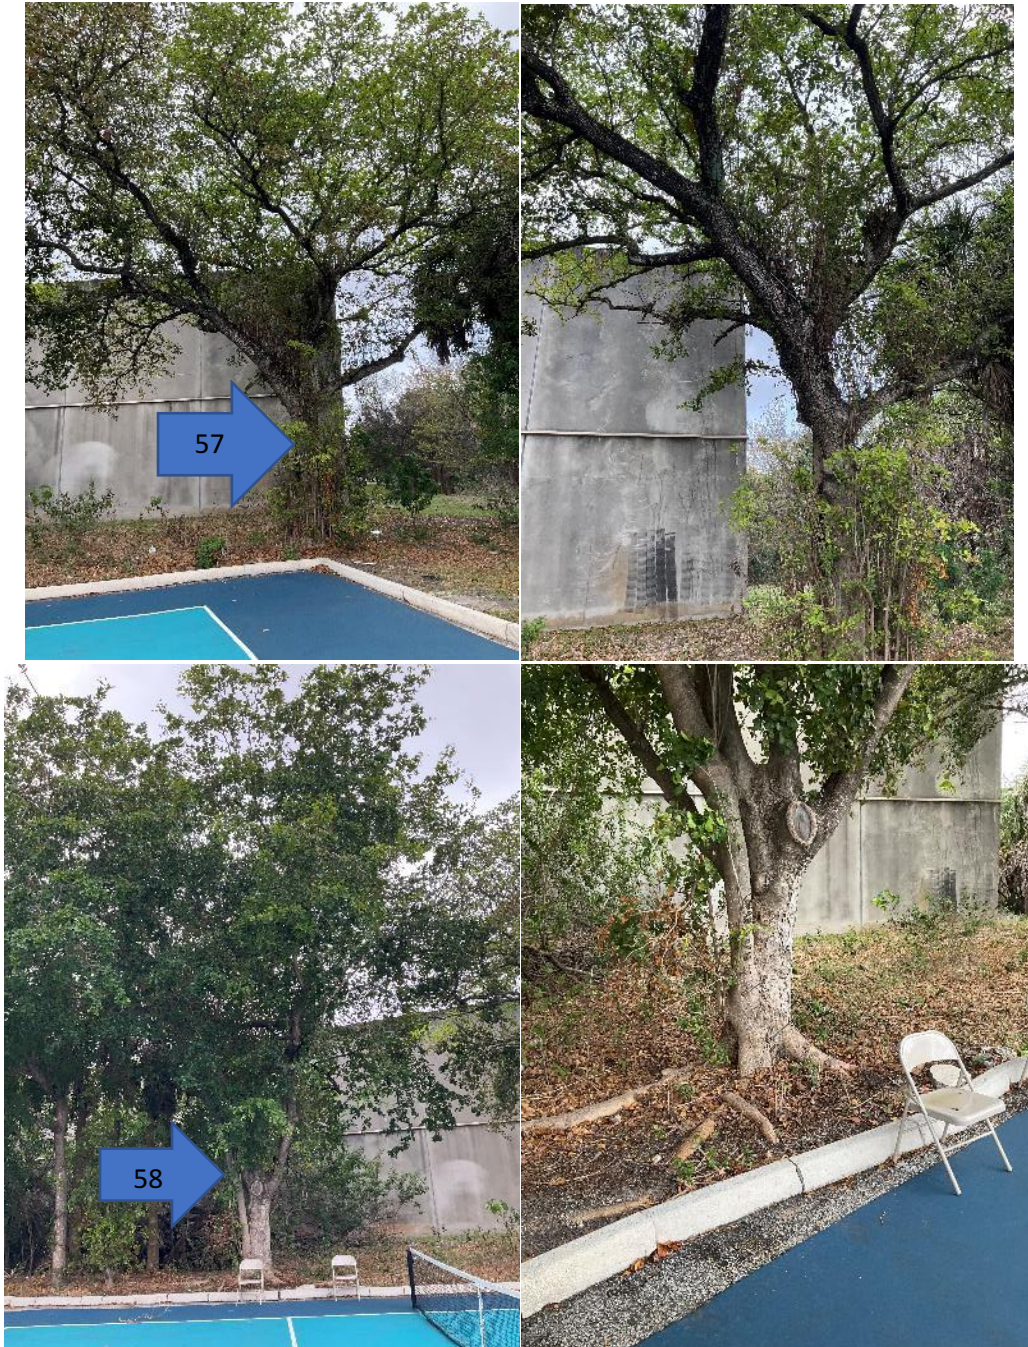
Trees 57 & 58

Black Olives (*Bucida buceras*), facing west. Note poor structure, water sprouts, chlorotic foliage for Tree #57, and poor structure, flush cuts, confined root space for Tree #58.

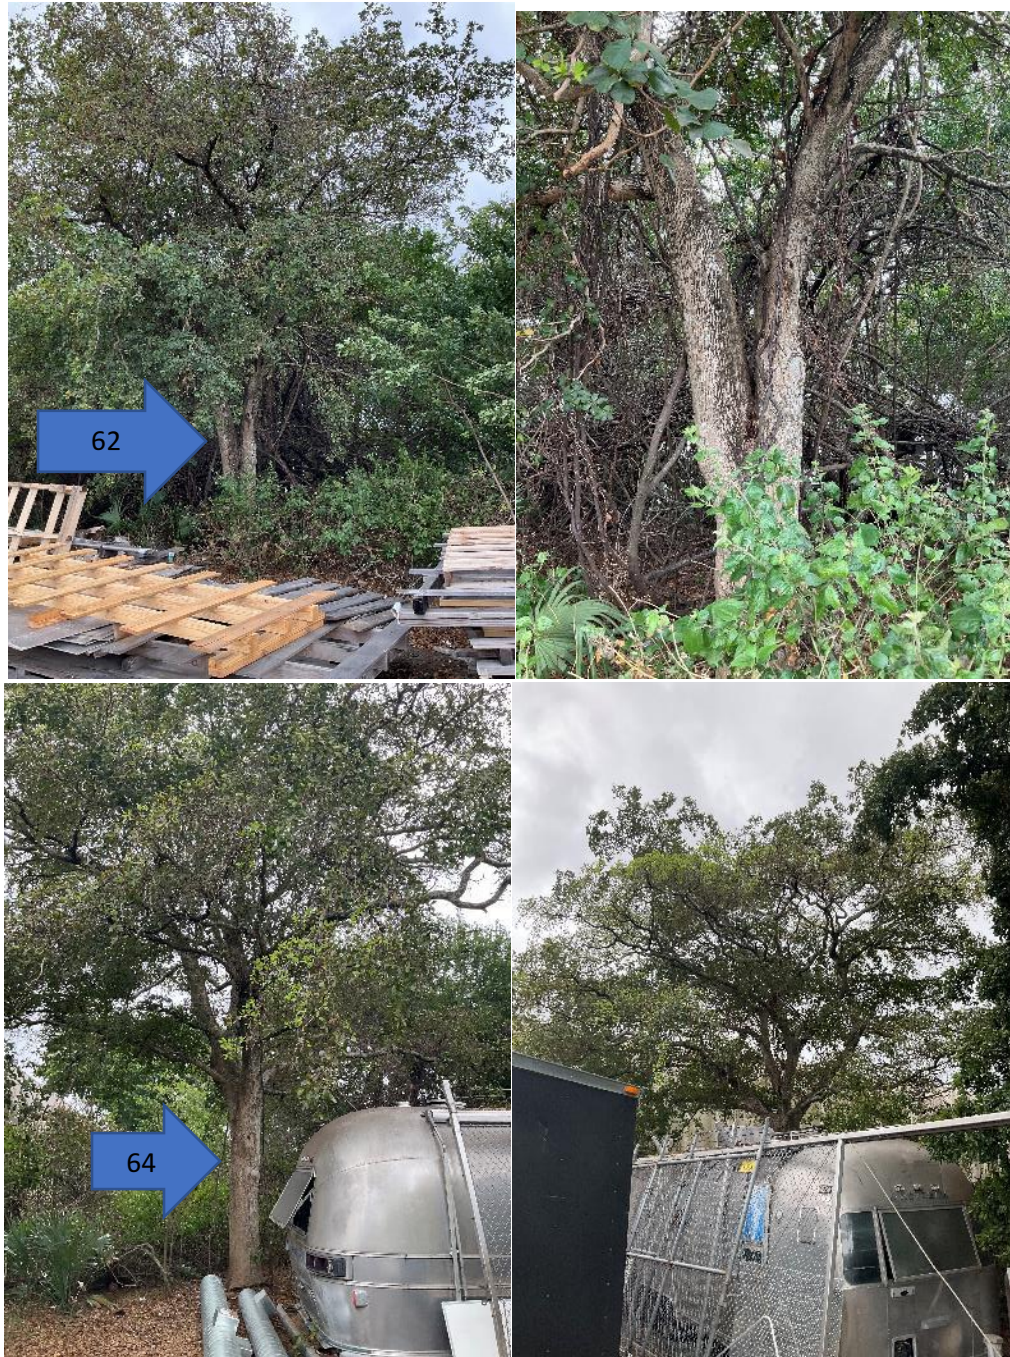
Trees 62 & 64

Black Olives (*Bucida buceras*), facing west. Note poor structure, flush cuts, deadwood, and vines for Tree #62, and poor structure, flush cuts, deadwood, and canopy dieback for Tree #64.

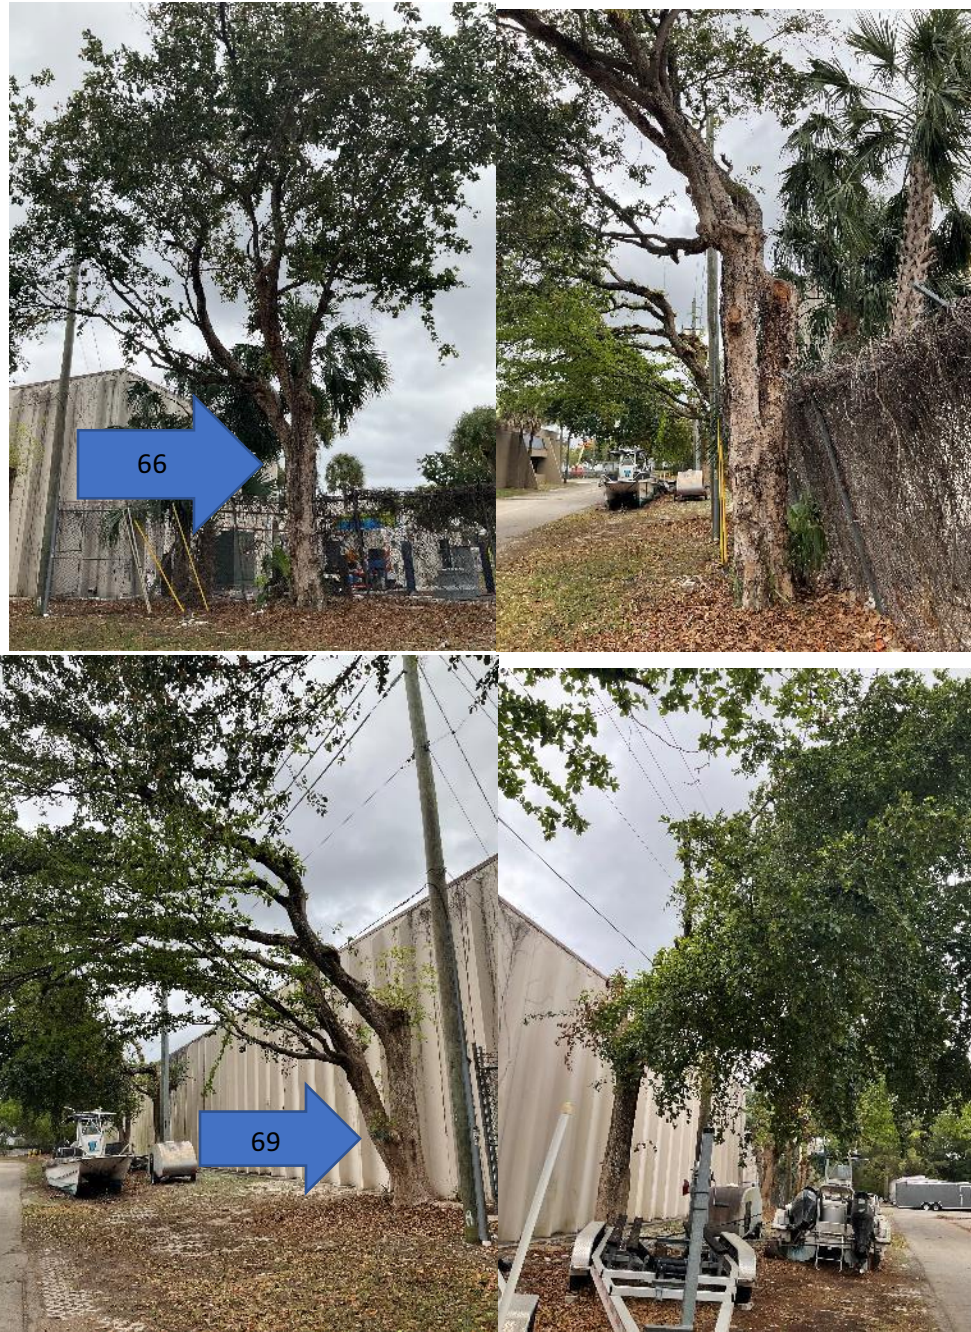
Trees 66 & 69

Black Olives (*Bucida buceras*), facing south. Note poor structure, unbalanced crown, severe utility pruning, bleeding cankers, and deadwood for Tree #66, and poor structure, unbalanced crown, severe utility pruning, canopy dieback for Tree #69.

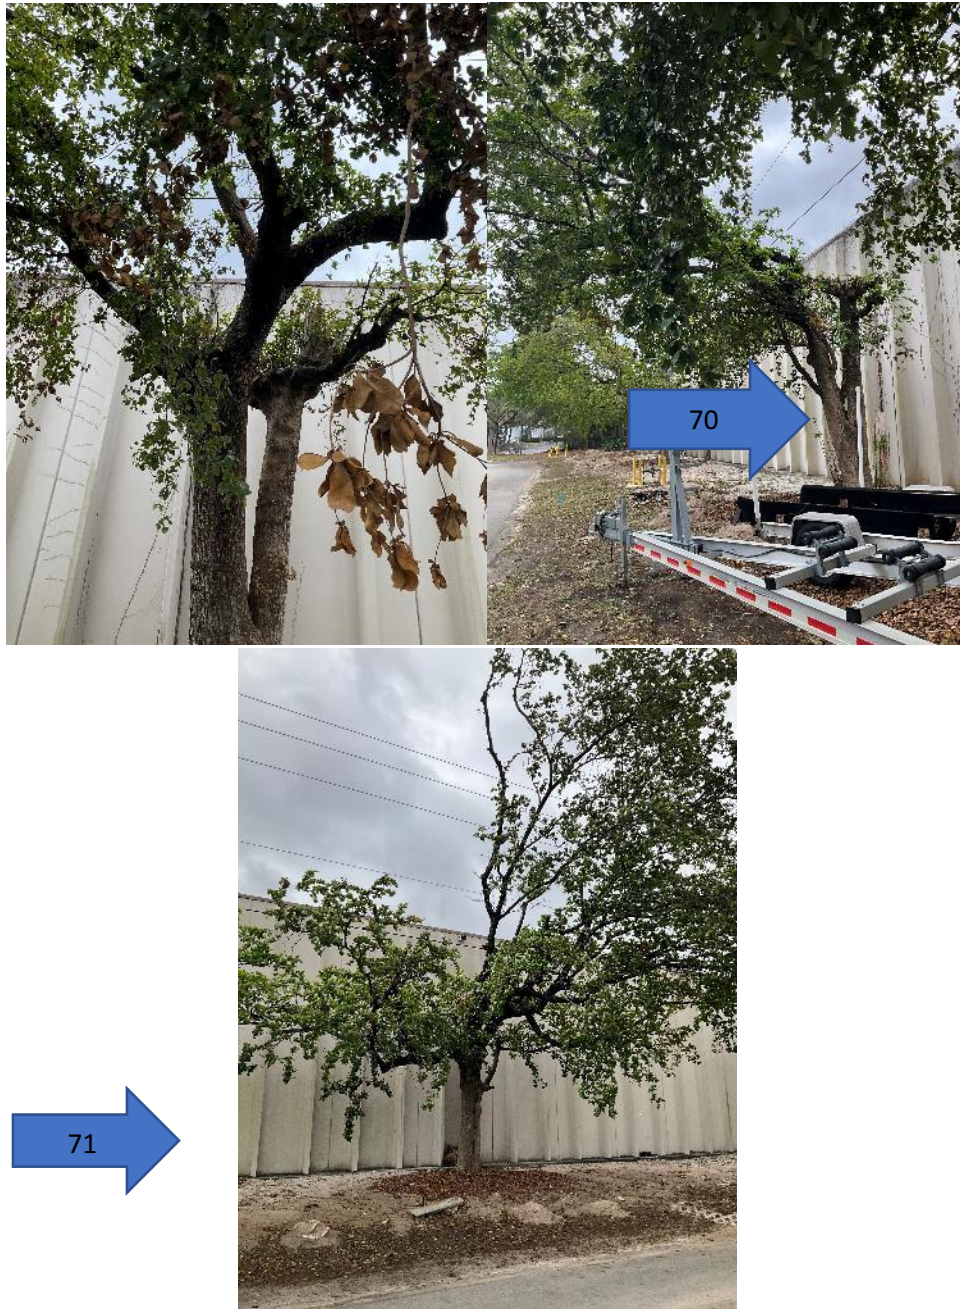
Trees 70 & 71

Black Olives (*Bucida buceras*), facing south. Note poor structure, unbalanced crown, severe utility pruning, and canopy dieback for Tree #70, and poor structure, unbalanced crown, severe utility pruning, and canopy dieback for Tree #71.

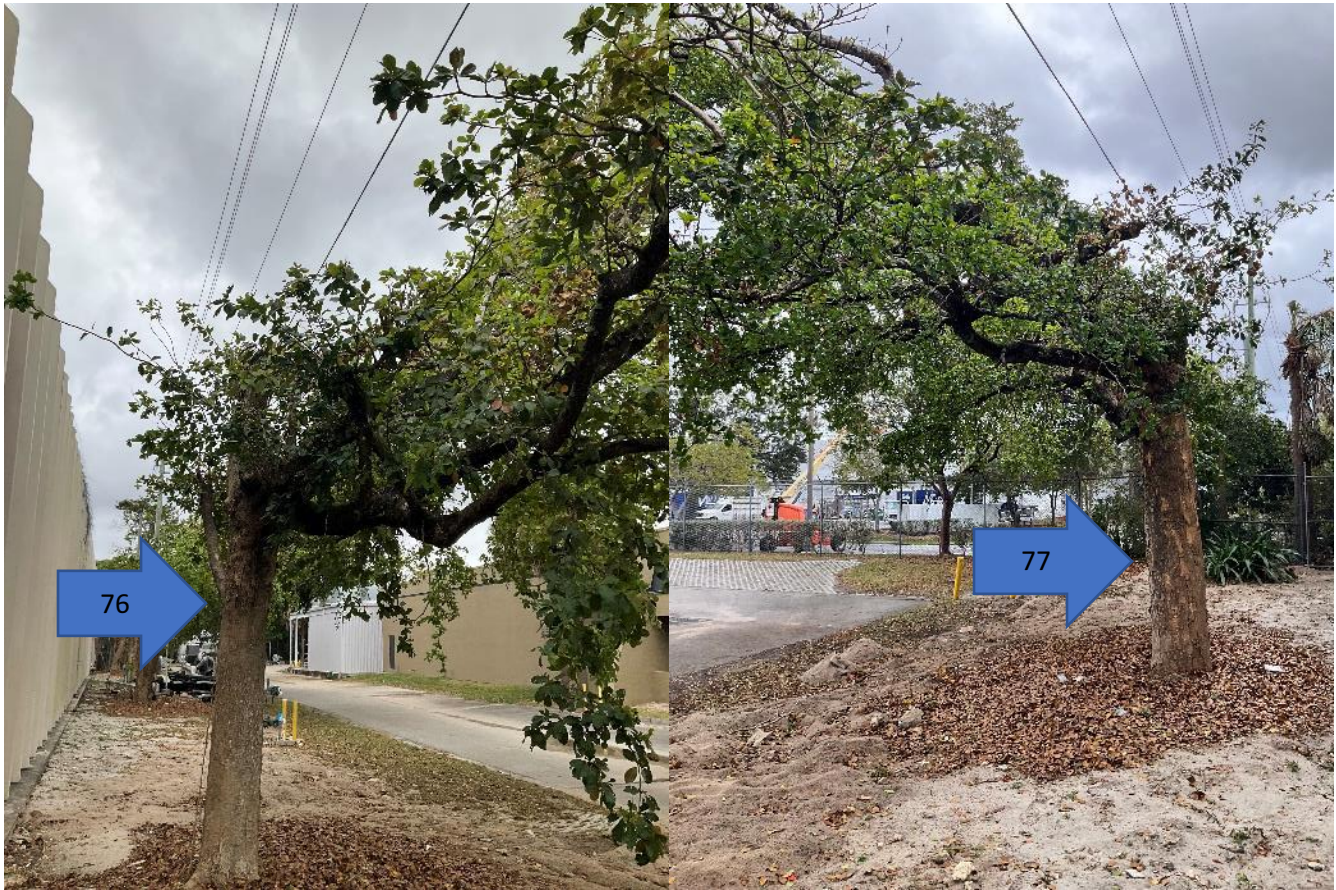
Tree 76 & 77

Black Olives (*Bucida buceras*), facing south. Note poor structure, unbalanced crown, severe utility pruning, and canopy dieback for Tree #76, and poor structure, unbalanced crown, severe utility pruning, and canopy dieback for Tree #77.

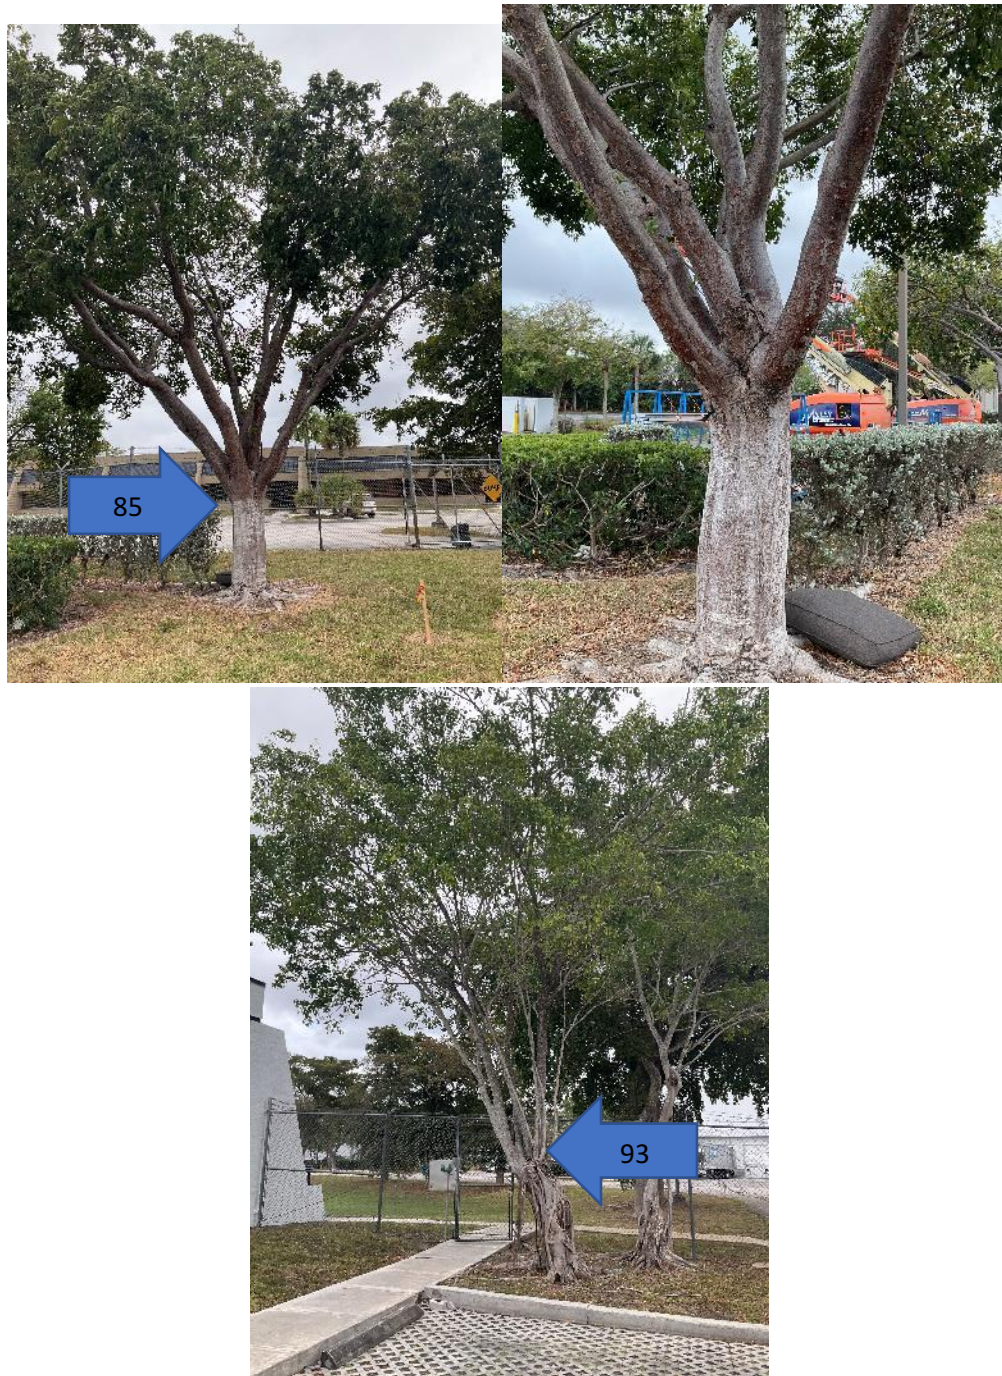
Trees 85 & 93

Gumbo Limbo (*Bursera simaruba*) Tree #85, and Weeping Fig (*Ficus benjamina*) Tree #93, facing north and east. Note poor structure, confined root space, and extensive visual evidence of decay for Tree #93.

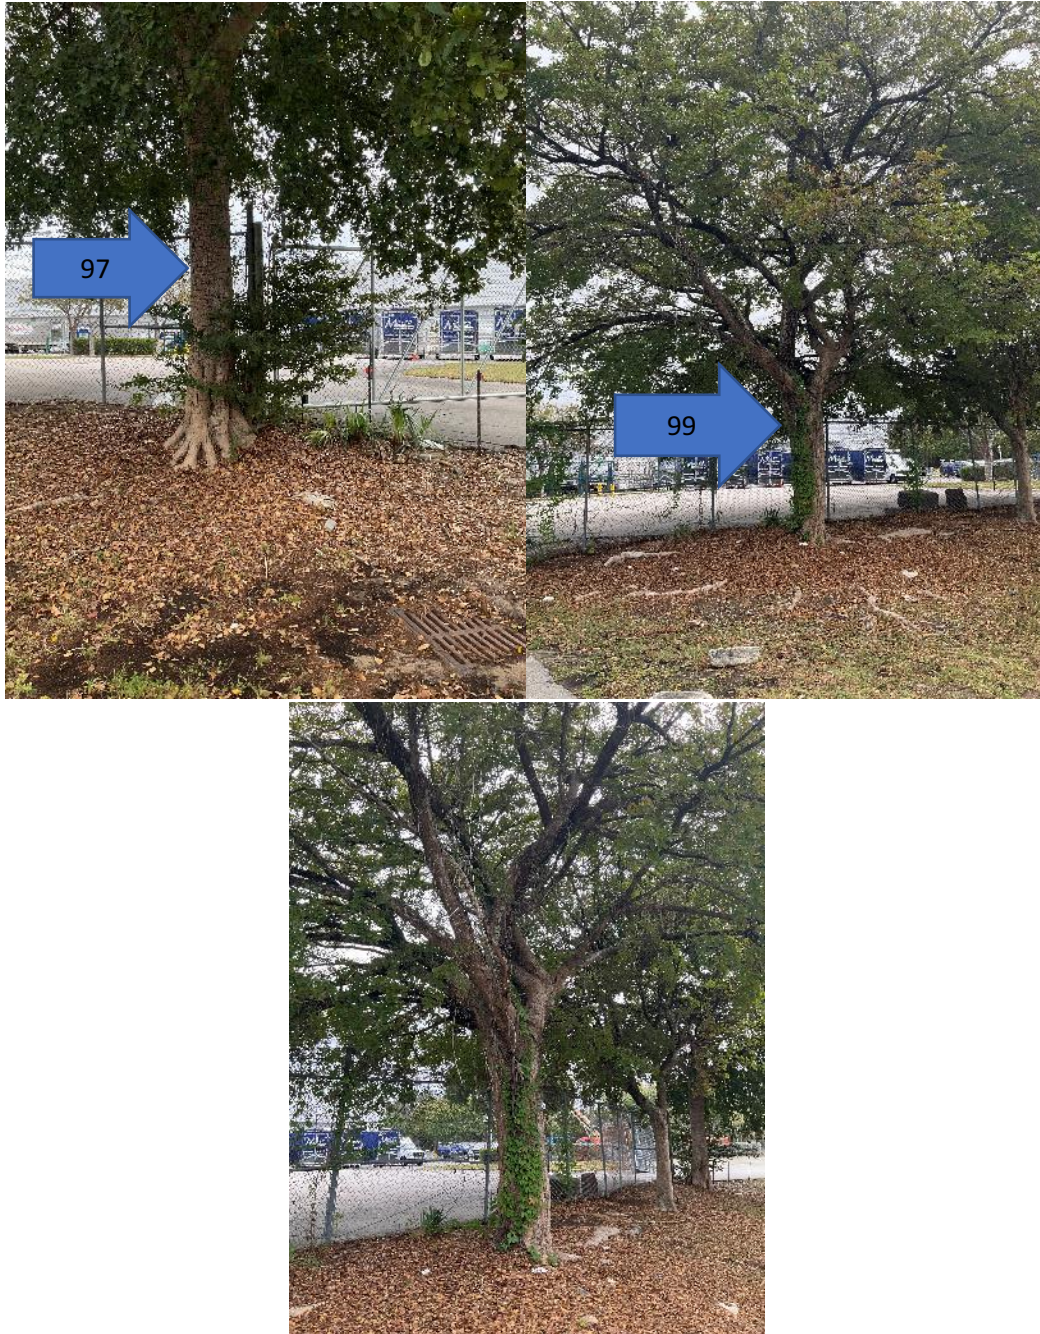
Trees 97 & 99

Black Olives (*Bucida buceras*) facing east. Note poor structure, confined root space, canopy crowding, insufficient rootball for relocation for Tree #97, and poor structure, vines, canopy dieback, confined root space, and deadwood for Tree #99.

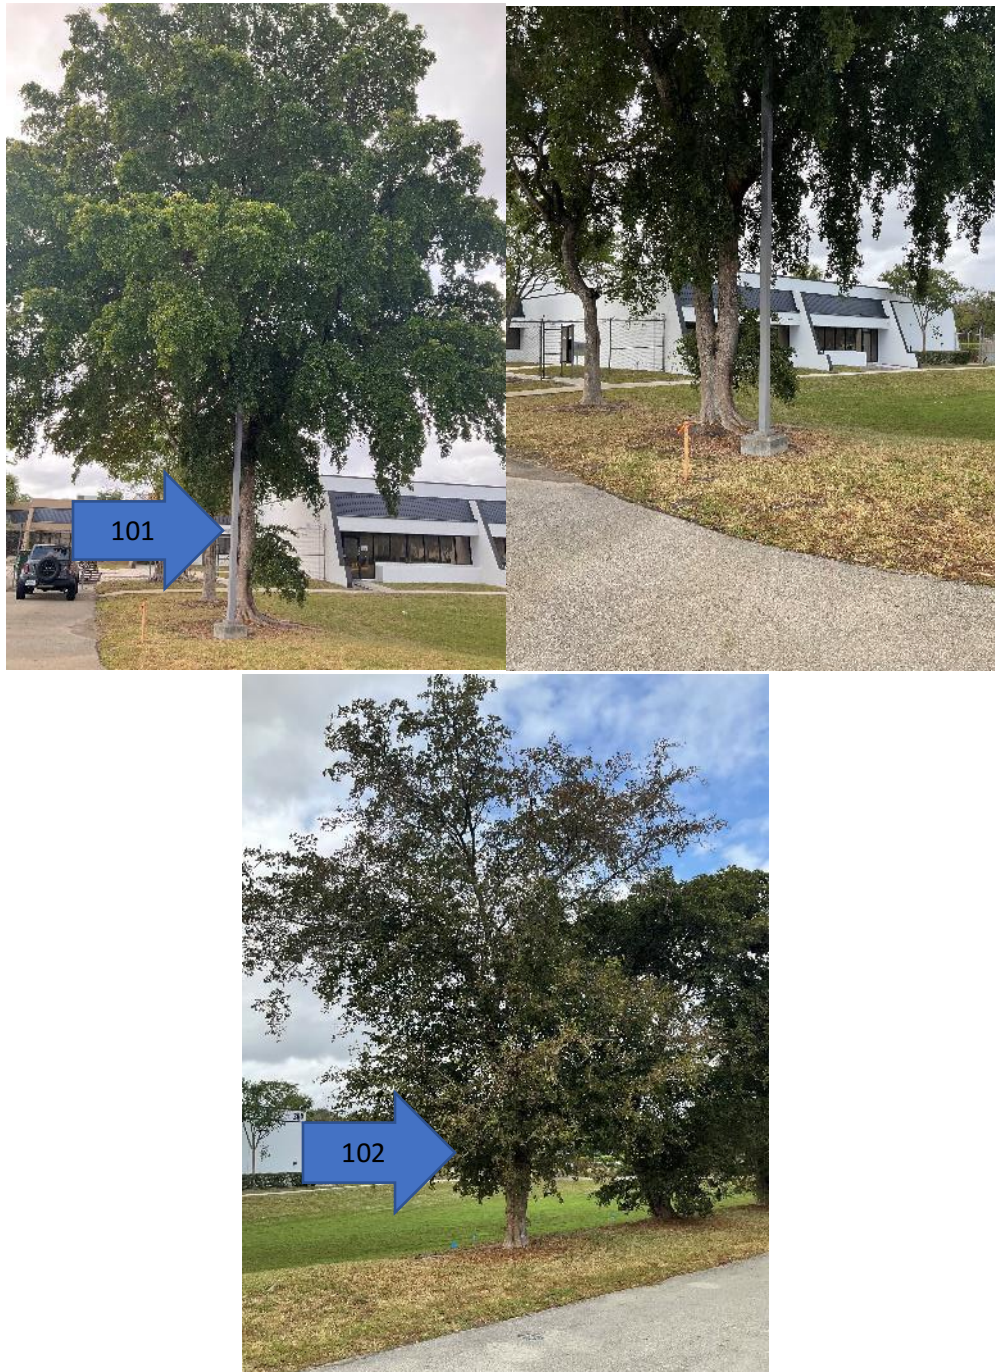
Trees 101 & 102

Black Olives (*Bucida buceras*) facing west. Note poor structure, girdling roots, and light pole conflict for Tree #101, and Poor structure, canopy crowding, flush cuts, and visual evidence of decay for Tree #102.
