Re: Arborist Findings at 200 Park Central Boulevard, Pompano Beach, FL

I visited the above-mentioned property on Saturday, February 4th, 2023 to evaluate +/- 121 trees, take photographs (Specimen sized trees only), perform relocation evaluations, calculate appraisal values (Rule 14-10 2020), and note any defects.

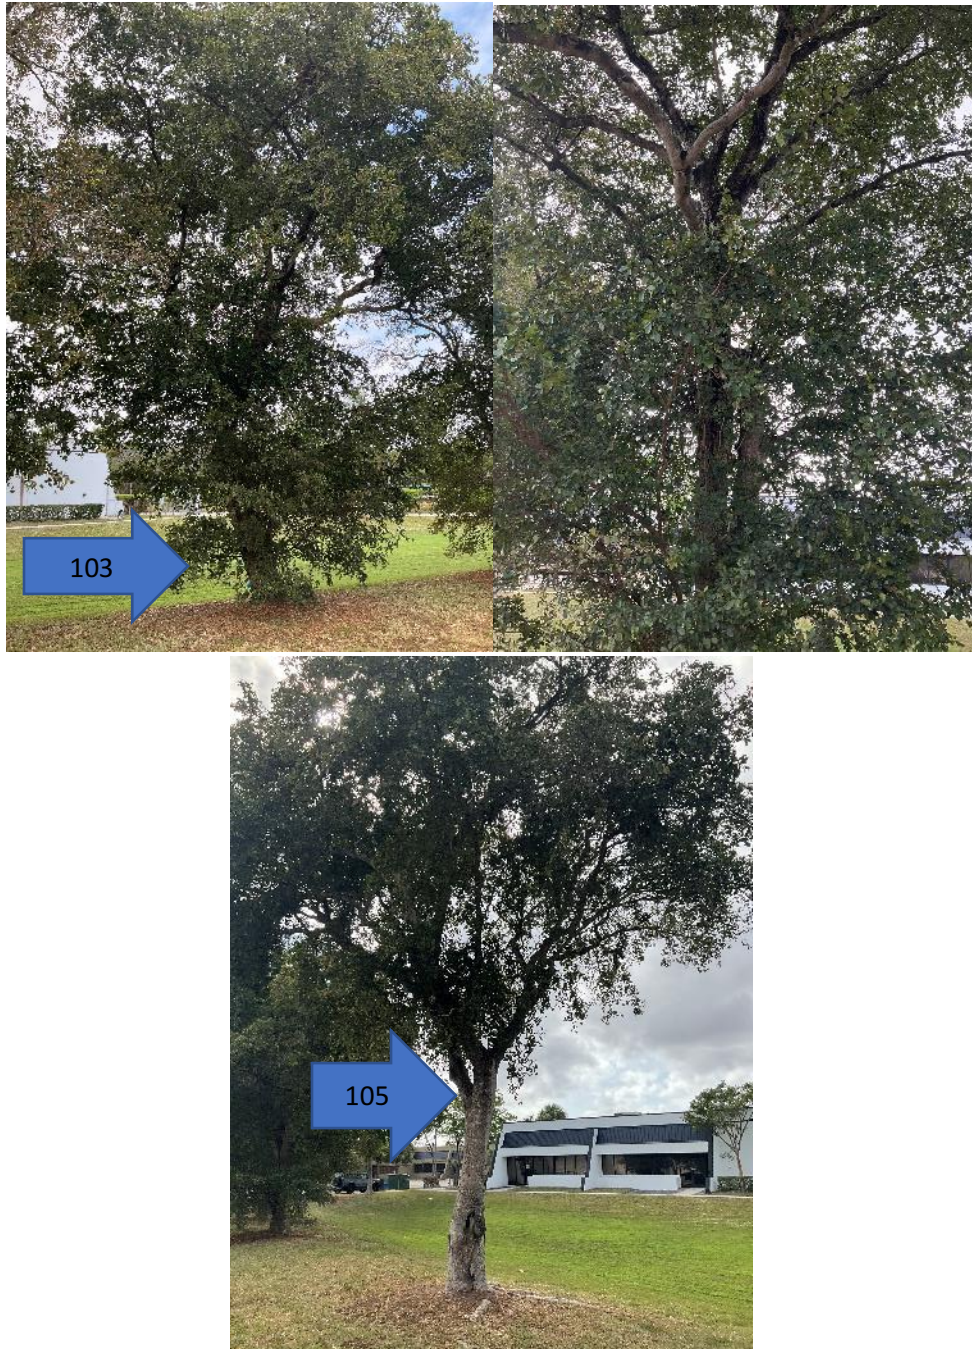
Trees 103 & 105

Black Olives (*Bucida buceras*) facing west. Note poor structure, canopy crowding, flush cuts, visual evidence of decay for Tree #103, and Poor structure, canopy crowding, flush cuts, visual evidence of decay, and over lifted canopy for Tree #105.
