Arborist Report

301 S Pompano Parkway
Pompano Beach

7/29/2021

Chevron Gas Station #10
301 S Pompano Parkway
Pompano Beach, FL 33069

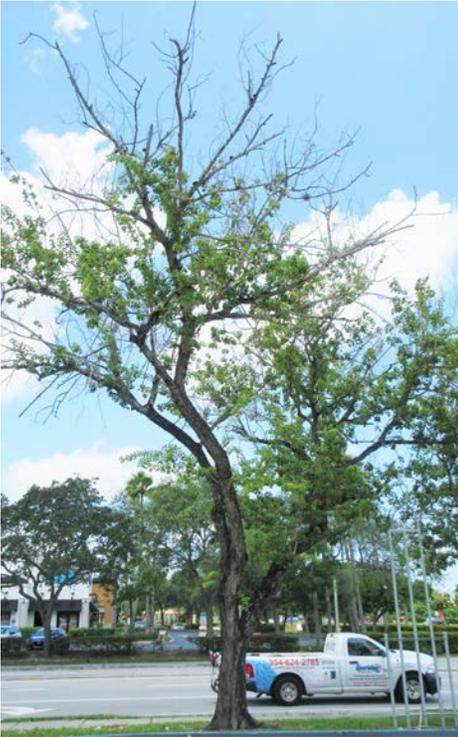
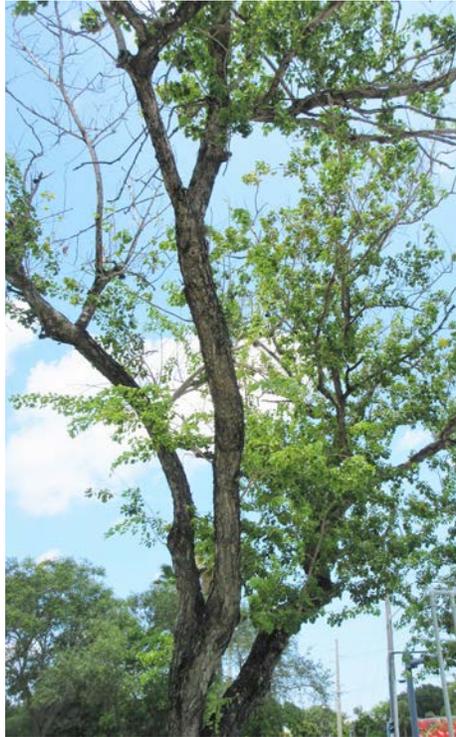
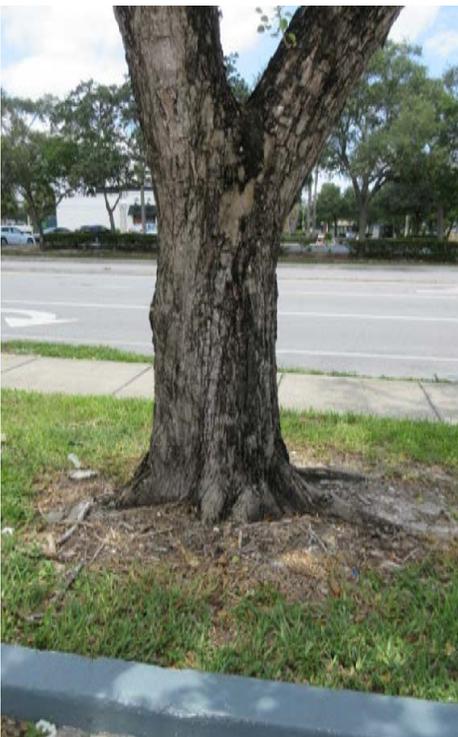
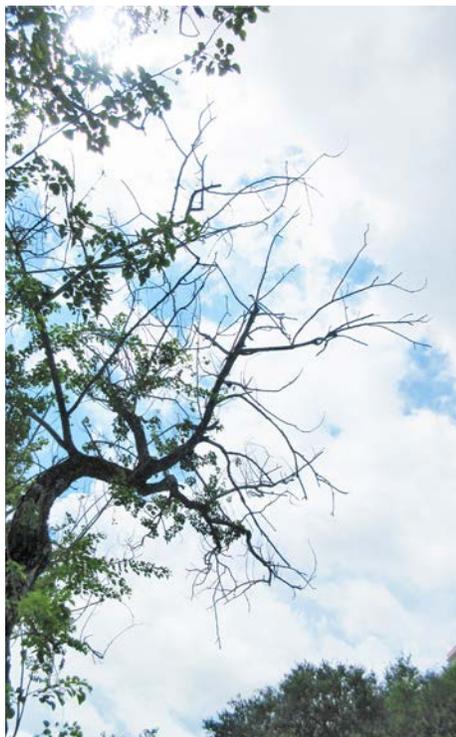
Condition -
Poor

Tree #8 is an Indian Rosewood located on the north side of the property. It is located approximately 42 inches from the existing curb. The tree is in poor condition. There is large deadwood with decay throughout the canopy. There is extensive dieback. The remaining canopy is sparse. The leaves are chlorotic. The failure of dead limbs presents a hazard to vehicles and pedestrians below the tree.

This species is listed as a Category II invasive plant according to the Florida Exotic Pest Plant Council's 2019 List of Invasive Plant Species. It is recommended that this tree be removed.

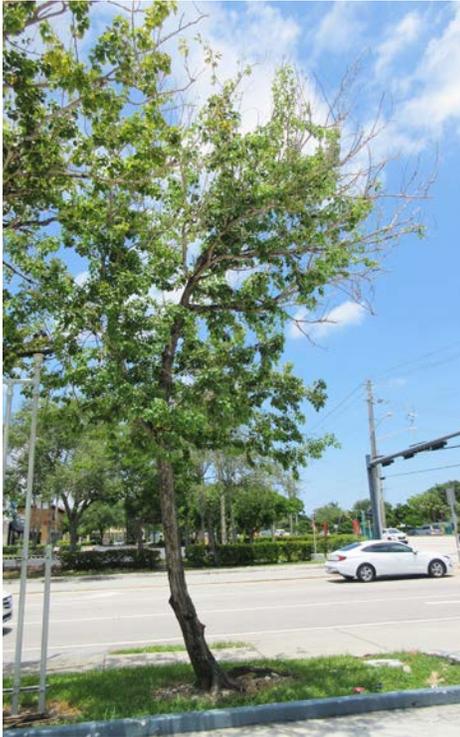
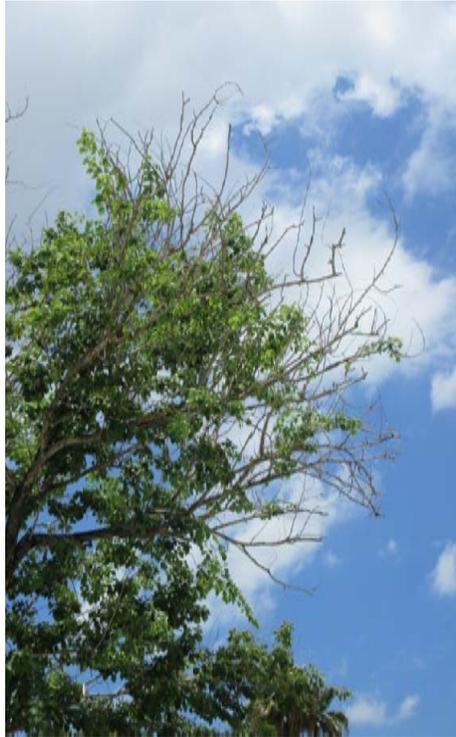
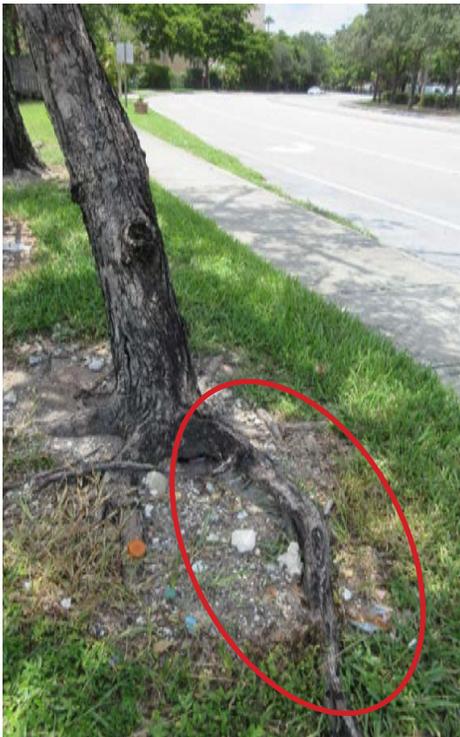
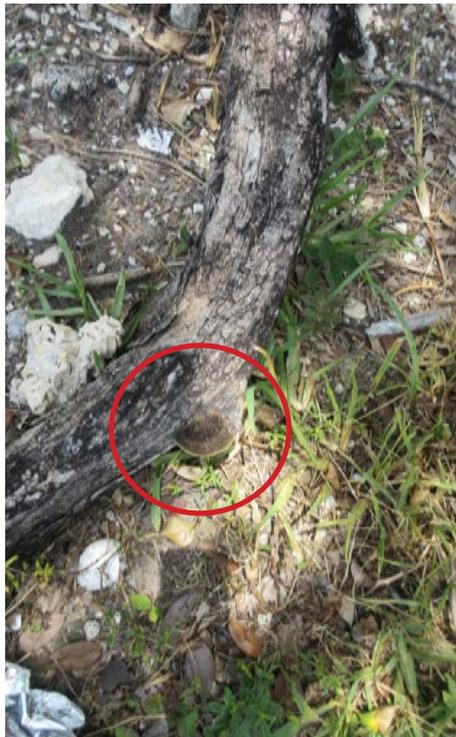
Condition -
Poor

Tree #9 is an Indian Rosewood located on the north side of the property. It is located approximately 42 inches from the existing curb. The tree is in poor condition. There is deadwood at the top of the canopy and dieback. The leaves are chlorotic. A large structural root has lifted out of the ground (circled in red, below left). There are decay conks growing on the root (circled in red, below right). The failure of the tree presents a hazard to vehicles and pedestrians below the tree.

This species is listed as a Category II invasive plant according to the Florida Exotic Pest Plant Council's 2019 List of Invasive Plant Species. It is recommended that this tree be removed.

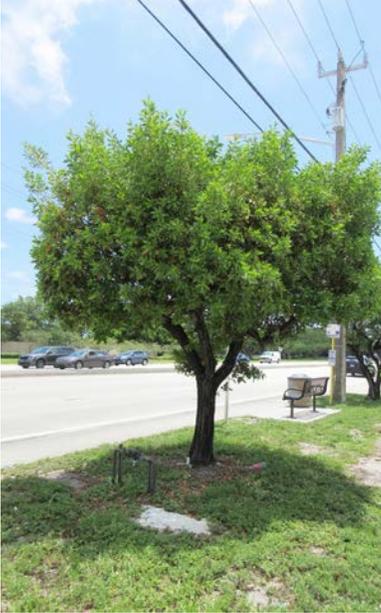
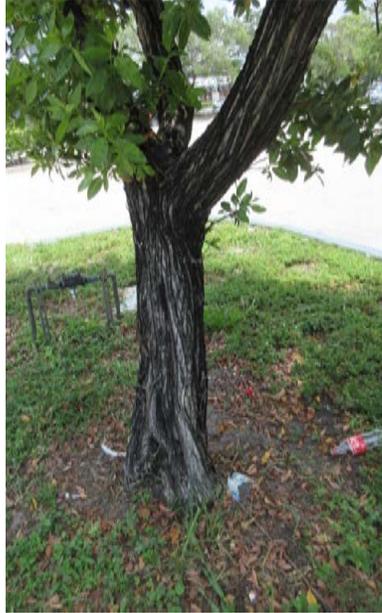
Condition -
Fair

Tree #10 is a Green Buttonwood located on the east side of the property. Overhead wires are above. It is in fair condition. It has been hatracked, presumably to maintain a small size and provide clearance for the overhead wires. New foliage is distorted and may be due to a mite infestation. This tree is to remain.

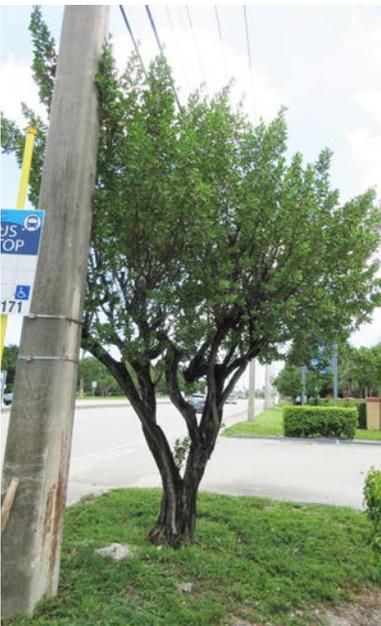
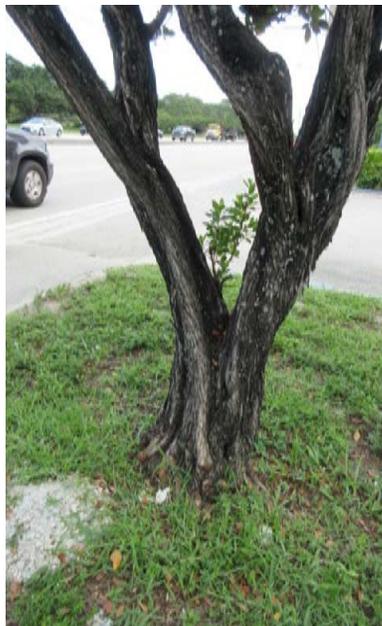
Condition -
Fair

Tree #11 is a Green Buttonwood located on the east side of the property. Overhead wires are above. It is in fair condition. It has been hatracked, presumably to maintain a small size and provide clearance for the overhead wires. This tree is to remain.
