## Tim Hodgins –ISA Certified Arborist FL-6128A

I, Tim Hodgins, (ISA certified arborist) was contracted, on 6/10/23 to make an Arborist Report at 3225 NE 6st Pompano Beach Fl 33062.

PZ23-1200003

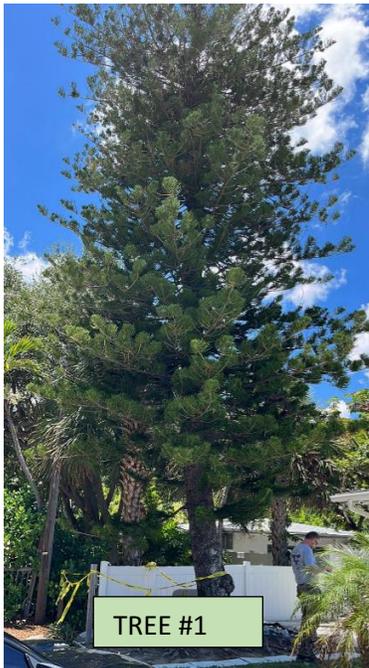
TREE #1

- 1- Norfolk Pine (*Araucaria heterophylla*) 24" DBH, 50' HT, 15' SPR Is nuisance specie.
- 2- Roebelenii Palm (*Phoenix roebelini*) Double 4"-4" DBH, 4'-3' HT, 6' SPR and is in fair.

ID	ID AS TREE SURVEYOR	Botanical name	Common name	DBH (INCH)	Spread (FT)	Height (FT)	Condition	Disposition	Reason	CRZ	TPZ
1	AS #1	<i>Araucaria heterophylla</i>	Norfolk Pine	24	15	50	Nuisance	Remove	Nuisance	N-A	N-A
2	NOT SHOWN	<i>Phoenix roebellini</i>	Robellini (double)	4-4	6	4-3	Good	Remove	Interfers with proposed construction	N-A	N-A
3	AS #2	<i>Adonidia merrillii</i>	Christmas Palm (double)	5-5	6	8-8	Good	Relocate	Interfers with proposed construction	2'	6x4'
4	AS #3	<i>Adonidia merrillii</i>	Christmas Palm (double)	5-5	6	8-8	Good	Relocate	Interfers with proposed construction	2'	6x4'
5	NOT SHOWN	<i>Phoenix roebellini</i>	Robellini (double)	4-4	8	8-4	Good	Remove	Interfers with proposed construction	N-A	N-A
6	AS #4	<i>Coco nucifera</i>	Coconut Tree Palm	12	20	20	Good	Remove	Interfers with proposed construction	N-A	N-A
7	NOT SHOWN	<i>Phoenix roebellini</i>	Robellini (double)	5-5	5	3	Good	Remove	Interfers with proposed construction	N-A	N-A

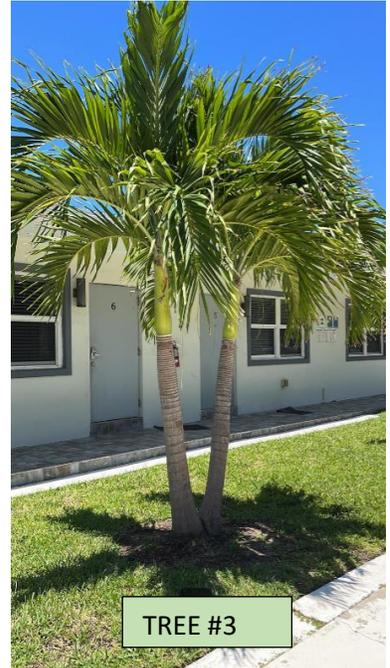
TREE #3

- 3- Christmas Palm (*Adonidia merrillii*) Double 5"-5" DBH, 8'-8' HT, 6' SPR and is in good condition.
- 4- Christmas Palm (*Adonidia merrillii*) Double 5"-5" DBH, 8'-8' HT, 6' SPR and is in good condition.
