# City of Pompano Beach Water Treatment Plant Building Hurricane Hardening Study – Final Technical Memorandum

June 30, 2016

**Tetra Tech  
450 N. Park Rd., Suite 502  
Hollywood, FL 33021**

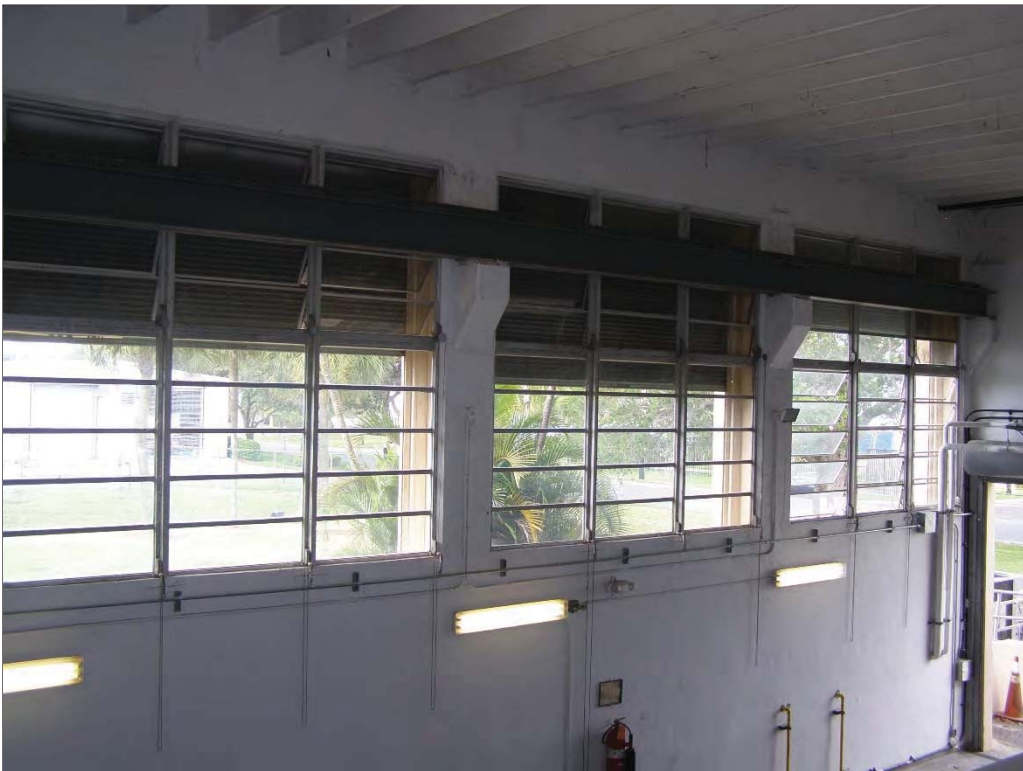
**Photo 4: Interior View of Windows**
