Rahim Vedaee

March 13, 2024
500 NW 12th Ave
Pompano Beach, FL

An Arborist Report/Appraisal was requested for the above referenced property regarding the condition of Live Oaks on site. See Below for a detailed report.

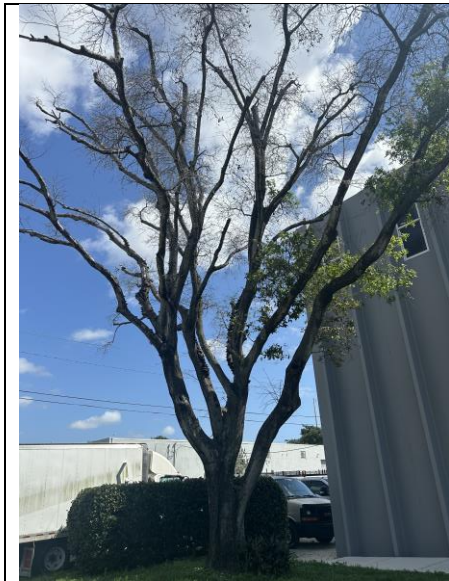
Tree #1 Live Oak (*Quercus Virginiana*) DBH 28", HT 25', SP 15', Cond Dead

This tree is on the Northwest side of the property. This tree is dead with Ganoderma visible on the stems.

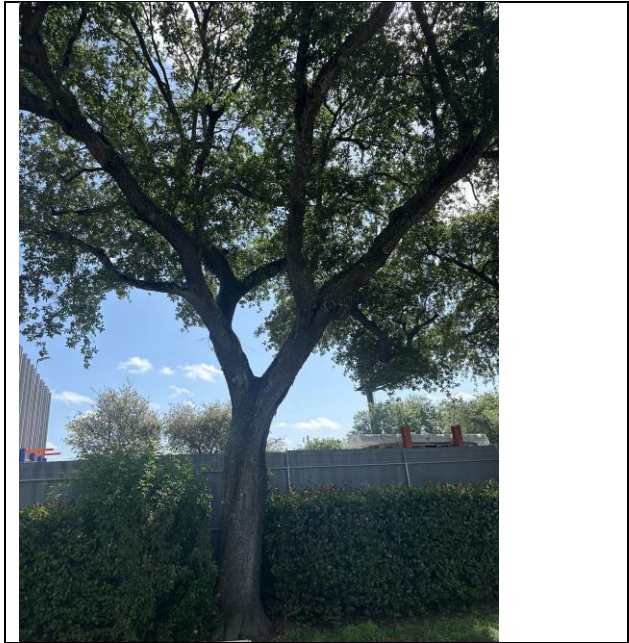
Tree #2 Live Oak (*Quercus Virginiana*) DBH 24", HT 28', SP 20', Cond 72% appraisal \$5,163

This tree is on the North side of the property. This tree has a dense canopy which appears to not have been pruned for a while with many cross, dead and rubbing branches. Some bark peeling was noticed. Stem bleeding was also visible this is an indication internal bacterial issues

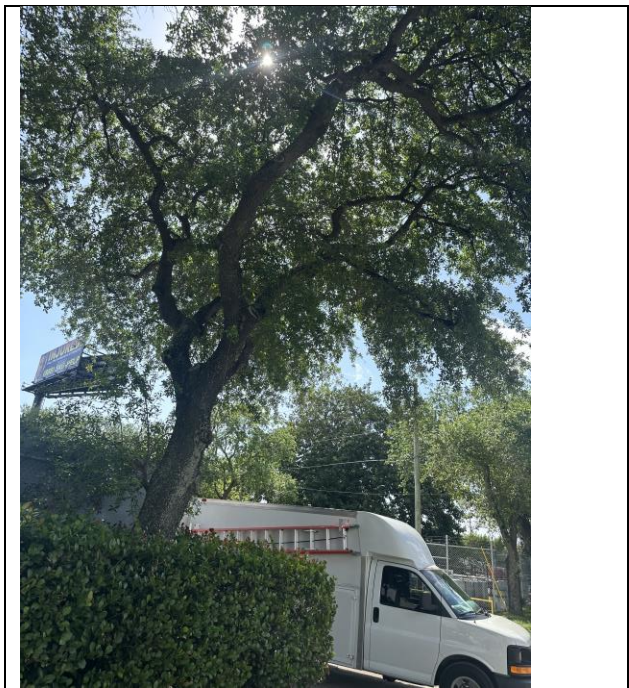
Tree #3 Live Oak (*Quercus Virginiana*) DBH 15", HT 28', SP 20', Cond 70% appraisal \$3,137.4
This tree is on the North side of the property. This tree has a dense canopy which appears to not have been pruned for a while with many cross, dead and fused branches.

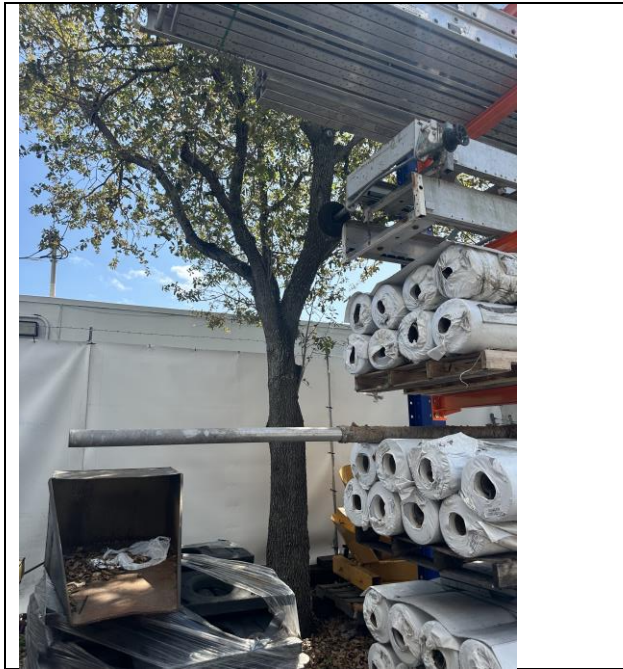
Tree #4 Live Oak (*Quercus Virginiana*) DBH 13", HT 25', SP 16', Cond 56% appraisal \$2,175.26
This tree is on the east side of the property in a small landscape planter about three feet in width. This tree has a spars canopy with chlorotic leaves. Materials are being stored on and around the tree root system. The tree appears to be stressed and is the cause for the spars canopy and nutritional deficiencies.

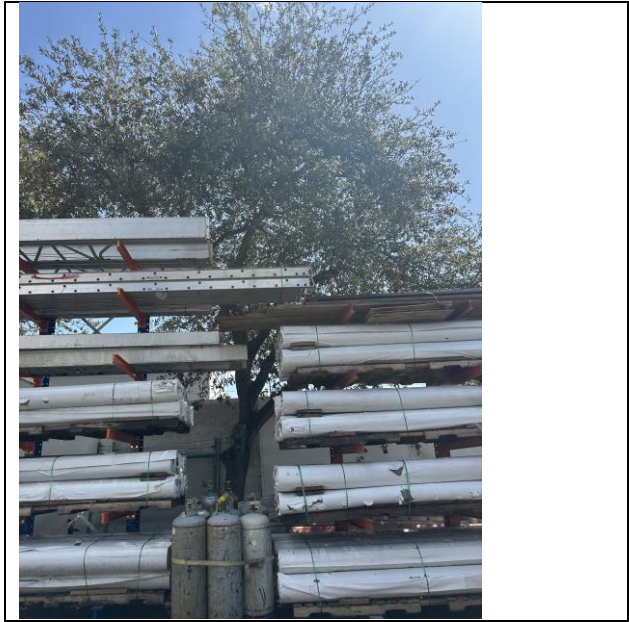
Tree #5 Live Oak (*Quercus Virginiana*) DBH 13", HT 25', SP 16', Cond 56% appraisal \$2,175.26
This tree is on the east side of the property in a small landscape planter about three feet in width. This tree has a spars canopy with majority of the trees canopy being concentrated on the east side. Materials are being stored on and around the tree root system.

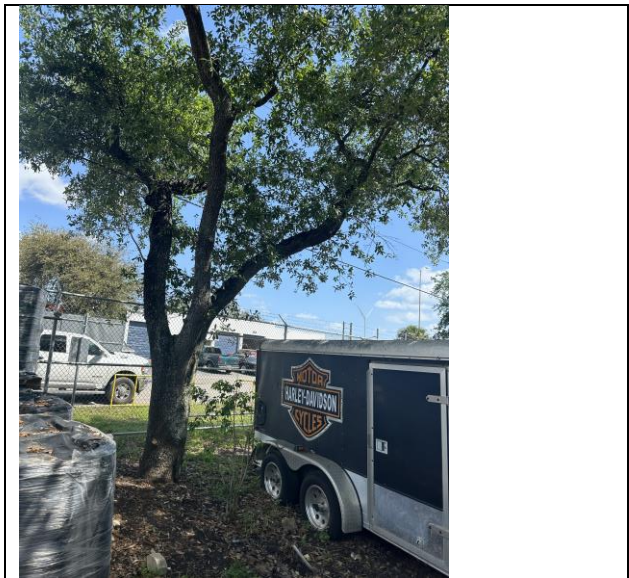
Tree #6 Live Oak (*Quercus Virginiana*) DBH 18", HT 25', SP 18', Cond 54% appraisal \$2,904.33

This tree is on the south side of the property. One portion of the tree has been hatracked due to the overhead powerline. Tree has codominant stems with a slight bark inclusion. Bark Inclusion occurs when two branches or stems of a tree grow too close together, this can result in cracked trunks and a broken limb. The trunks have fused together this is cause weak attachment and eventually one of these trunks will snap.

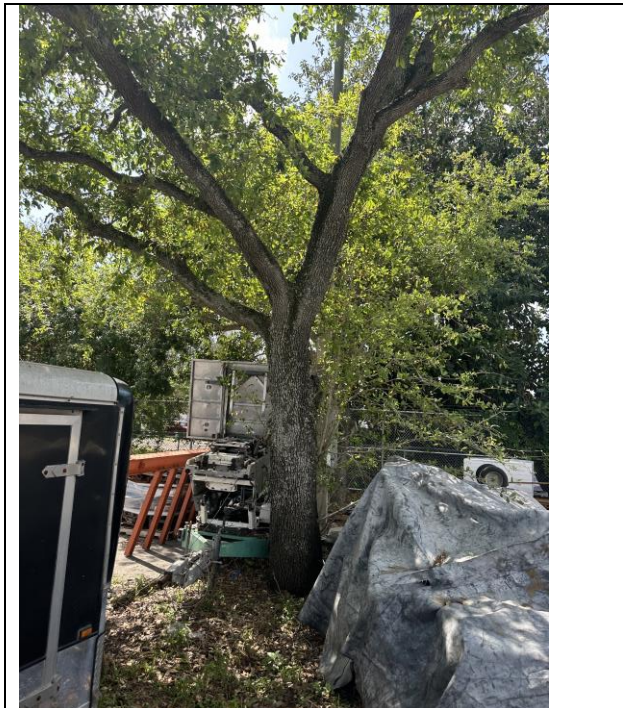
Tree #7 Live Oak (*Quercus Virginiana*) DBH 18", HT 25', SP 18', Cond 56% appraisal \$3,011.90

This tree is on the south side of the property. This tree has a lopsided canopy with all the canopy on the southside has been removed. Tree has codominant stems with a slight bark inclusion. Bark Inclusion occurs when two branches or stems of a tree grow too close together, this can result in cracked trunks and a broken limb. The trunks have fused together this is cause weak attachment and eventually one of these trunks will snap. Equipment has been stored on the tree root system. This could cause the tree stress and slowly decline.

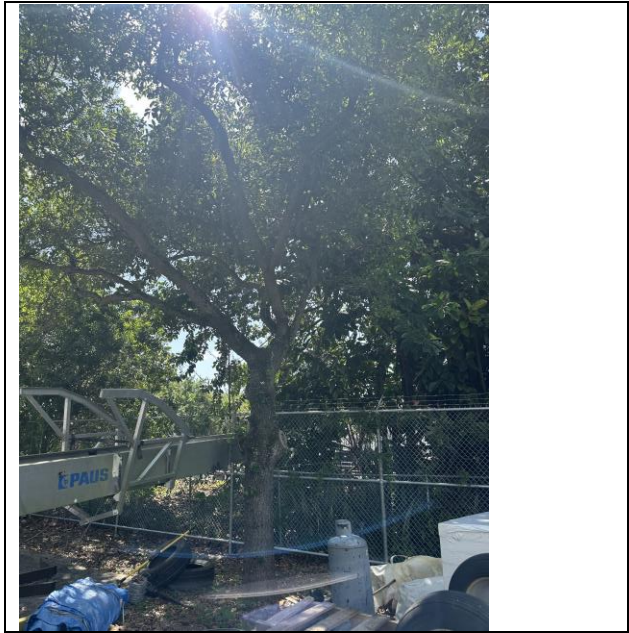
Tree #8 Live Oak (*Quercus Virginiana*) DBH 18", HT 25', SP 18', Cond 50% \$2,689.2

This tree is on the south side of the property. This tree has a lopsided canopy with all the canopy on the southside has been removed. This tree has a spar canopy with stunted growth. Equipment has been stored on the tree root system. This could cause the tree stress and slowly decline.

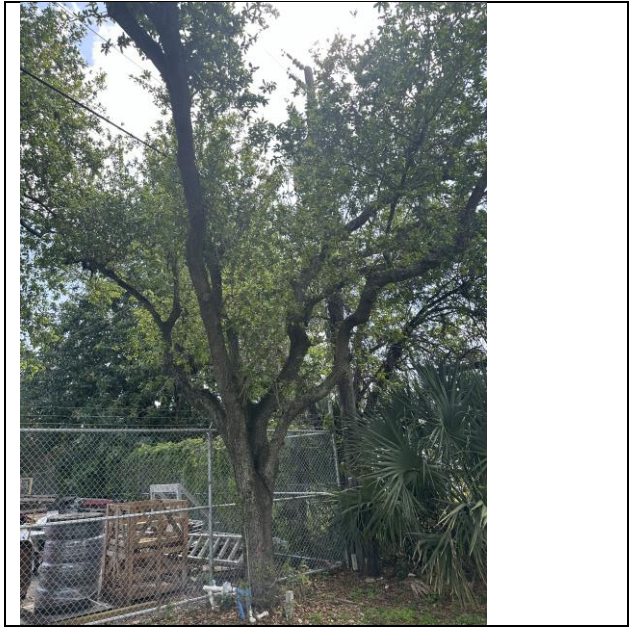
Tree #9 Live Oak (*Quercus Virginiana*) DBH 12", HT 25', SP 18', Cond 50% appraisal \$1,792.8
This tree is on the south side of the property. Tree has codominant stems with a slight bark inclusion. Bark Inclusion occurs when two branches or stems of a tree grow too close together, this can result in cracked trunks and a broken limb. Many dead, decayed and broken branches can be seen throughout the trees canopy.

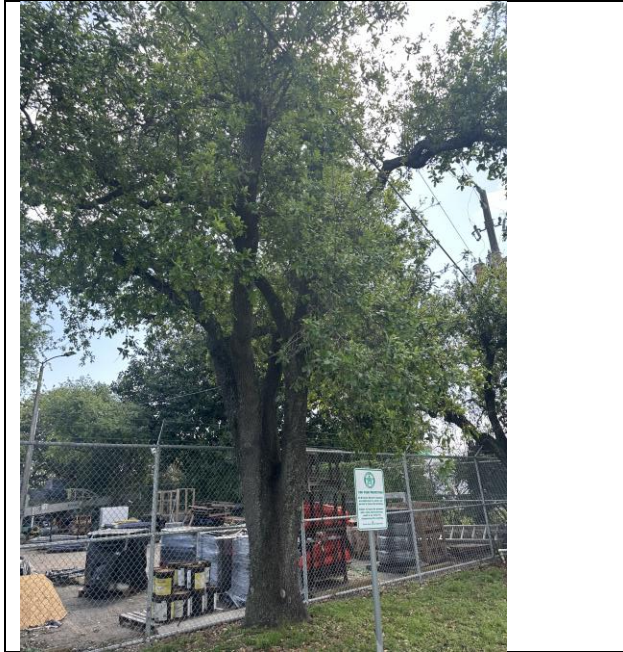
Tree #10 Live Oak (*Quercus Virginiana*) DBH 20", HT 25', SP 18', Cond 52% appraisal \$3,107.52

This tree is on the south side of the property. Tree has codominant stems with a slight bark inclusion. Bark Inclusion occurs when two branches or stems of a tree grow too close together, this can result in cracked trunks and a broken limb. Many dead, decayed and broken branches can be seen throughout the trees canopy.

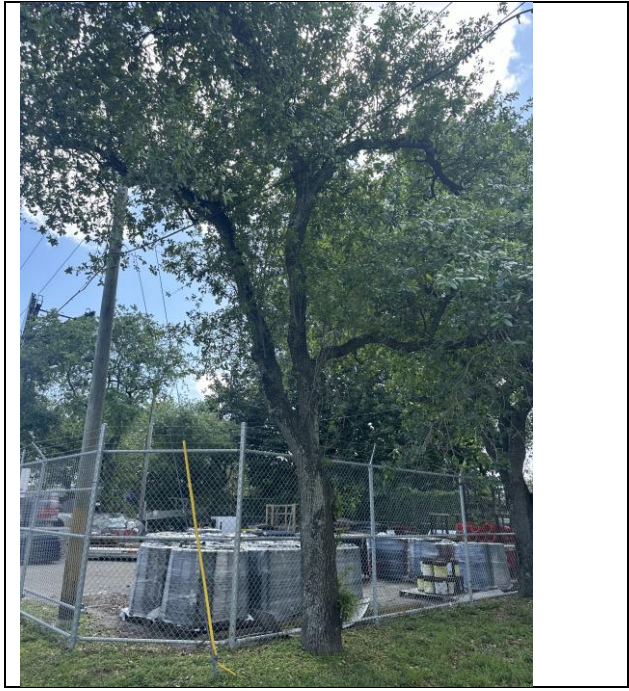
Tree #10 Live Oak (*Quercus Virginiana*)

Tree #11 Live Oak (*Quercus Virginiana*) DBH 12", HT 25', SP 18', Cond 50% appraisal \$1,792.8

This tree is on the southwest side of the property. This tree has a lopsided canopy growing into the powerlines. Many dead, decayed and broken branches can be seen throughout the trees canopy. Old pruning wounds were observed where the tree has failed to properly compartmentalize. This will allow disease rot and decay to set in.
