Re: Arboricultural Consulting Services for 324 Northwest 6th Street, Pompano Beach, Florida

I visited the above-mentioned property on Tuesday, May 16th, to evaluate +/- 24 trees, take photographs (Specimen sized trees only), calculate Rule 14-10 appraisal values, perform relocation evaluations, and note any defects.

PZ22-12000032
07/19/2023

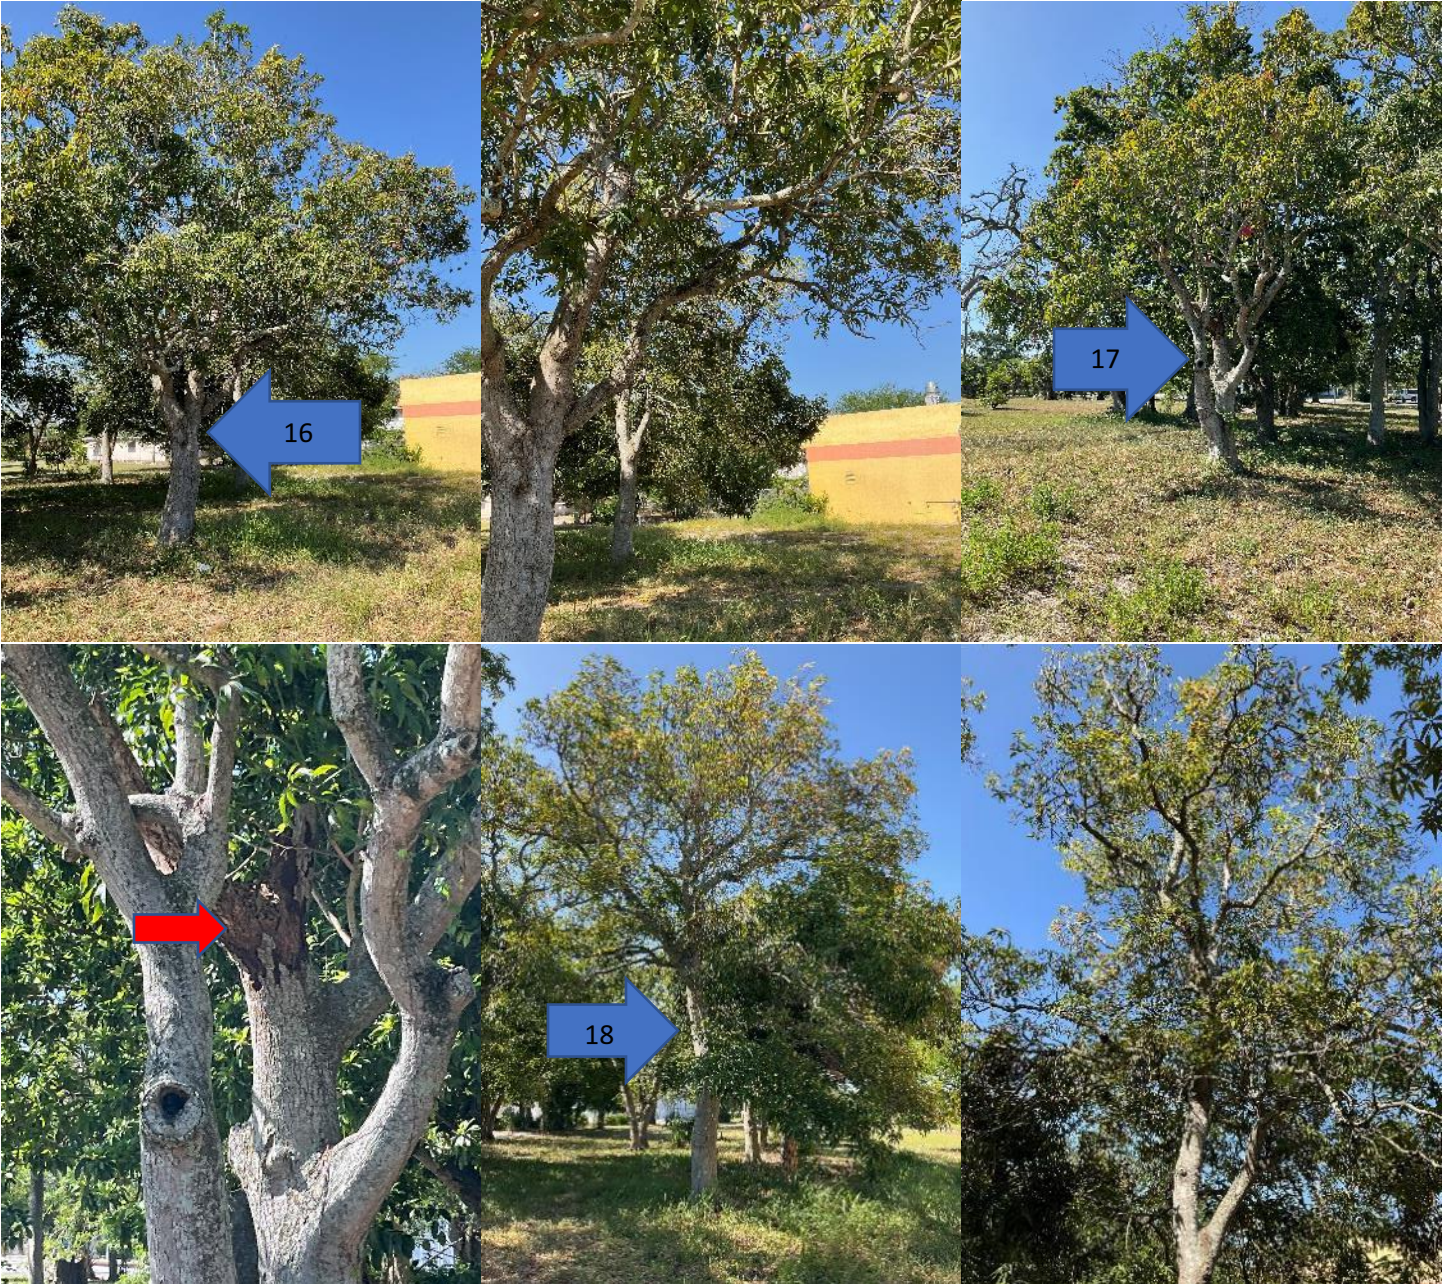
Trees 16, 17, & 18

Mango Trees (*Mangifera indica*), facing south and west. Note poor structure, deadwood, and canopy dieback for Tree #16, poor structure, deadwood, canopy dieback, visual evidence of decay (red arrow), and canopy crowding for Tree #17, and poor structure, canopy dieback, chlorotic foliage, and deadwood for Tree #18.

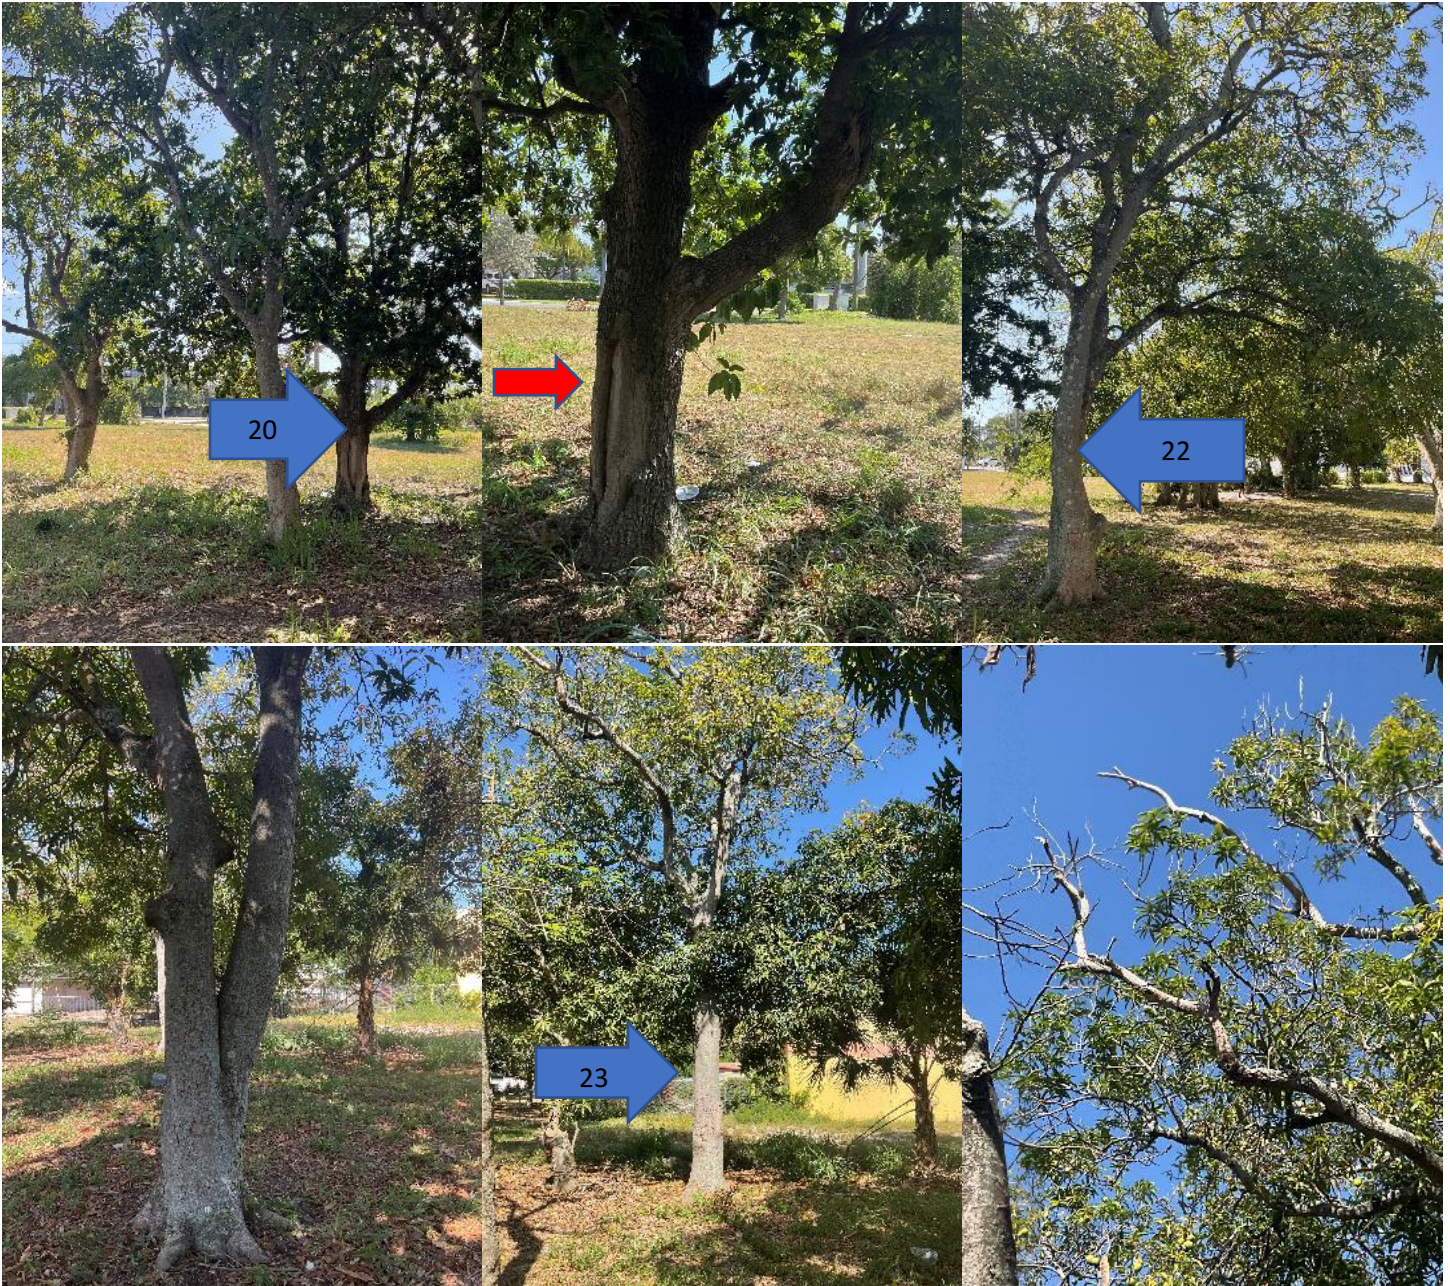
Trees 20, 22, & 23

Sapodilla (*Manilkara zapota*) Tree #20, and Mango Trees (*Mangifera indica*) Tree #'s 22 & 23 facing east, south, and west. Note visual evidence of decay, storm damage, large trunk wound (red arrow), and deadwood for Tree #20, poor structure, canopy dieback, storm damage, and canopy crowding for Tree #22, and poor structure, large diameter deadwood, and canopy dieback for Tree #23.
