Re: Arboricultural Consulting Services for Patagonia Project, 308 Northwest 7th Avenue, Pompano Beach, Florida

I visited the above-mentioned property on Monday, April 15th, to evaluate +/- 55 trees, take photographs (Specimen sized trees only), calculate Rule 14-10.057 (2020) appraisal values, perform relocation evaluations, and note any defects.

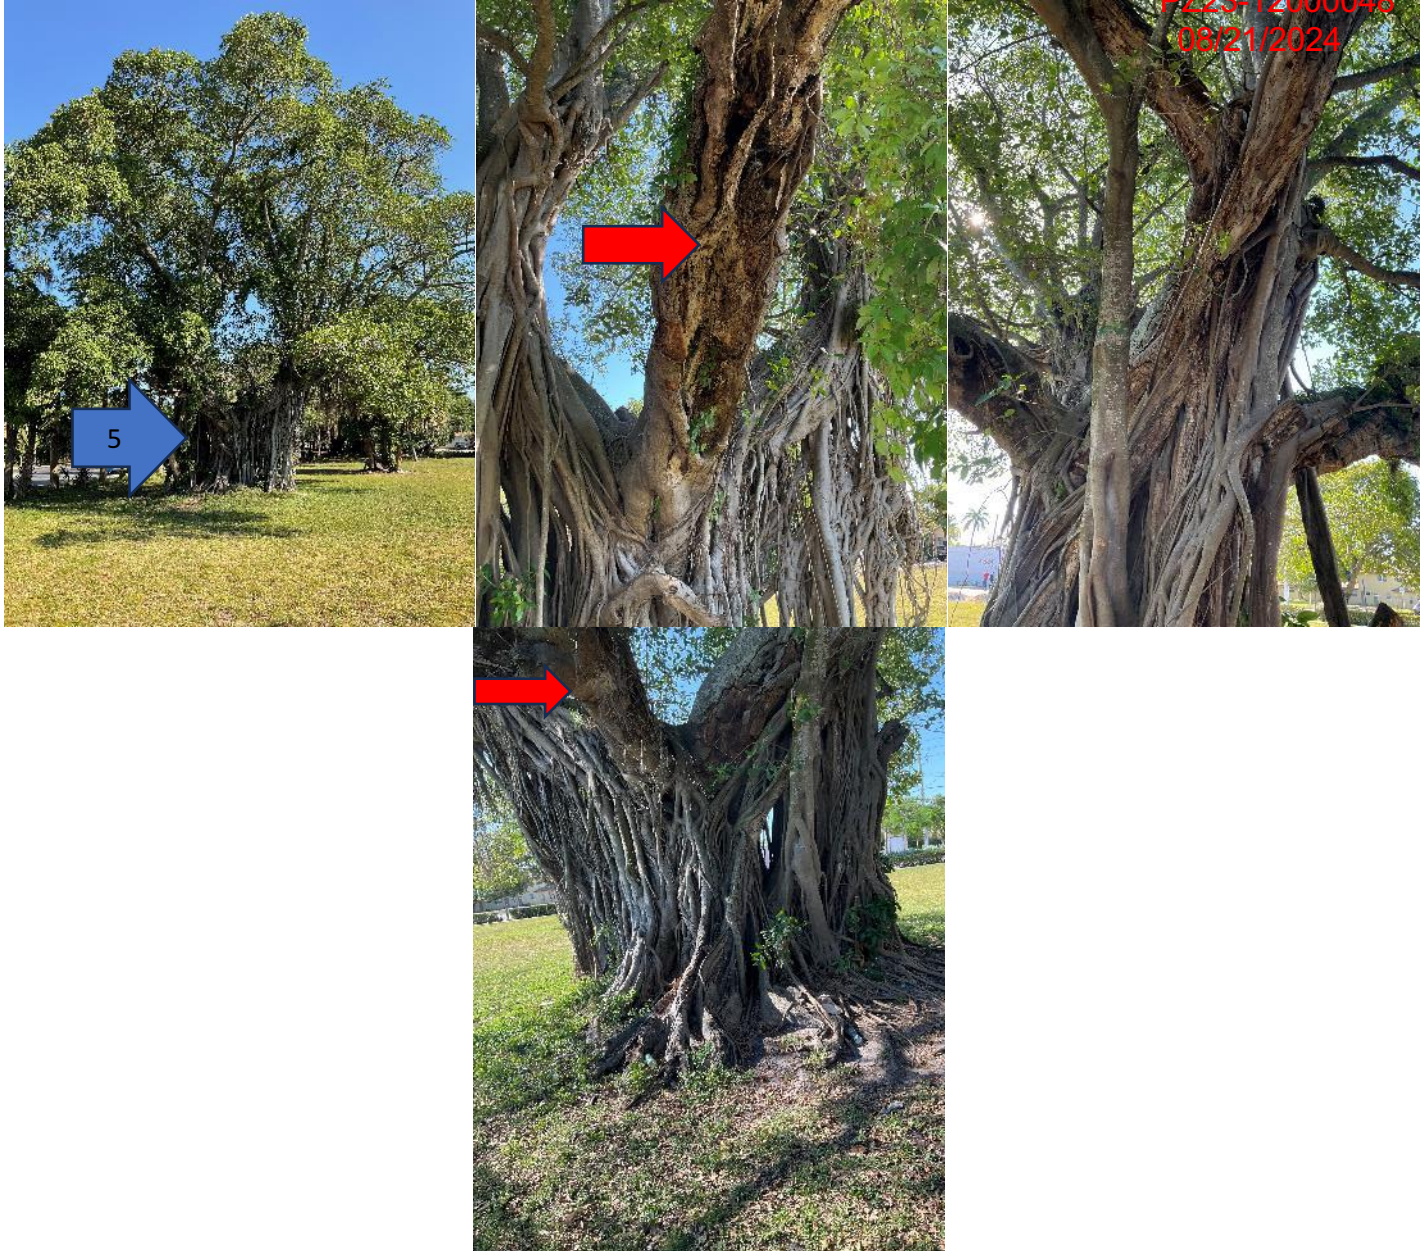
Tree Five

Strangler Fig (*Ficus aurea*), facing north. Note Poor structure, visual evidence of decay (red arrows), canopy dieback, and deadwood.

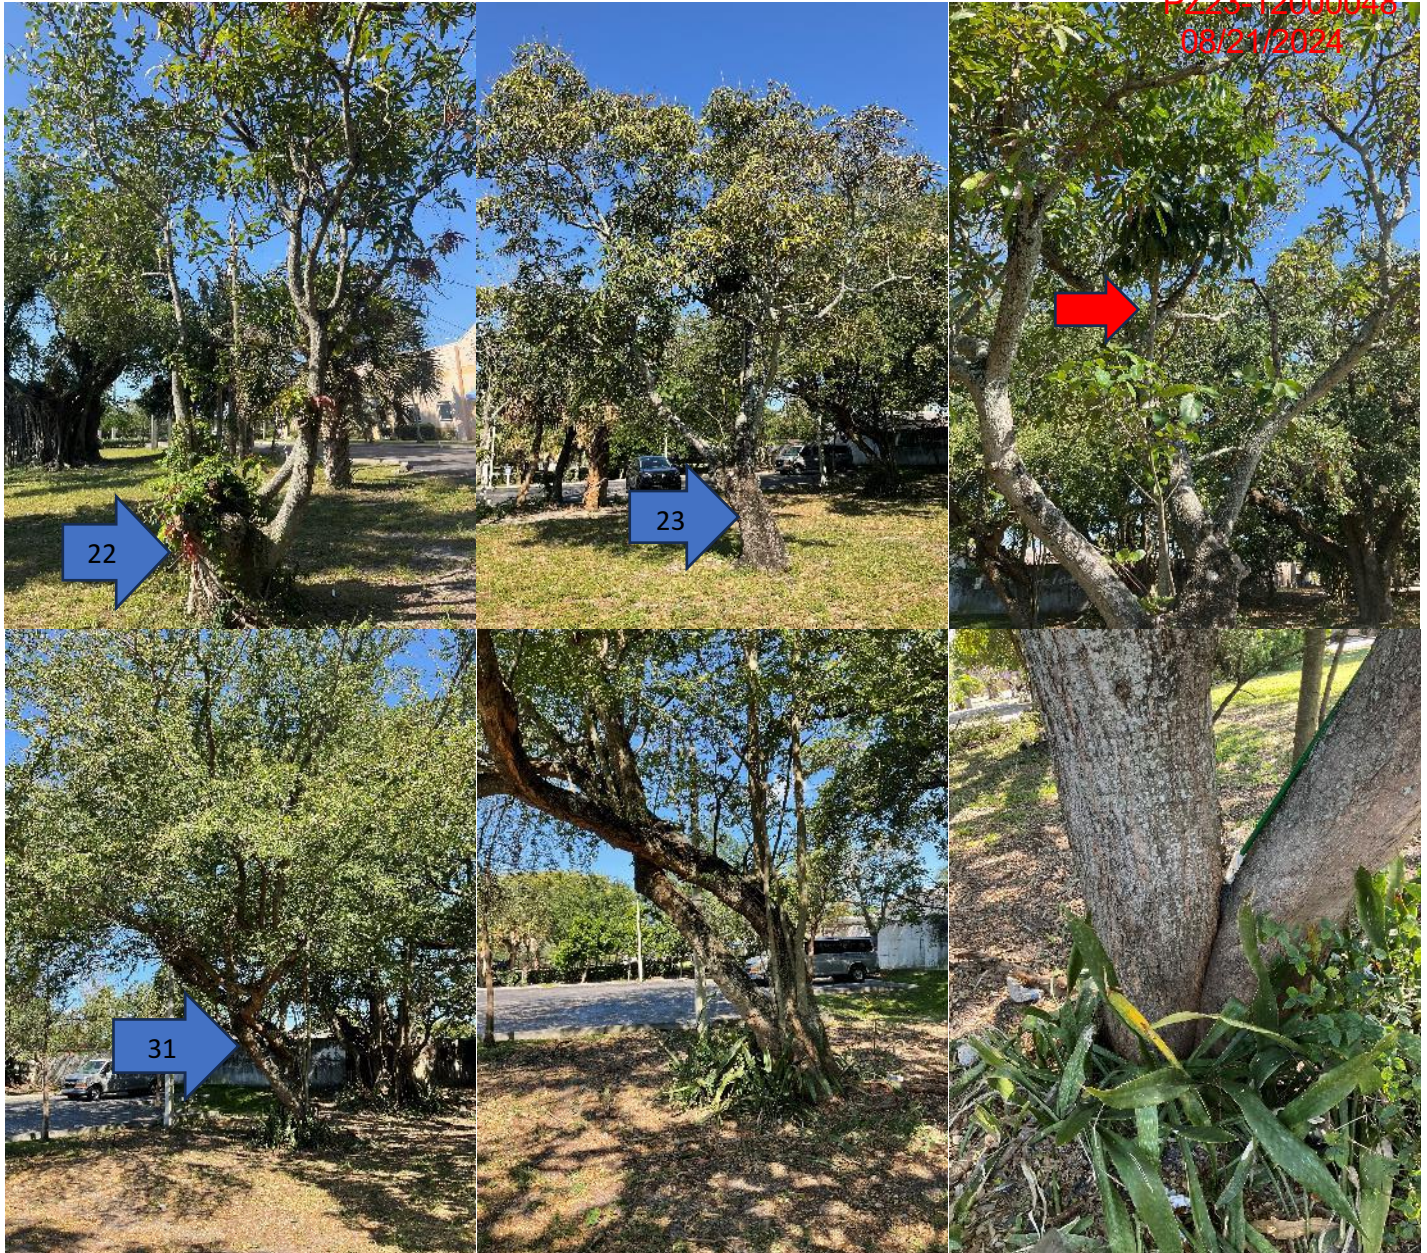
Trees 22, 23 & 31

Mangos (*Mangifera indica*) Tree #'s 22 & 23, and Manila Tamarind (*Pithecellobium dulce*) Tree # 31, facing south, north, and west. Note Poor structure, canopy dieback, Strangler Fig parasite, and visual evidence of decay for Tree # 22. Note poor structure, canopy dieback, leaf necrosis, and schefflera parasite (red arrow) for Tree # 23. Note poor structure, trunk lean, canopy crowding, and water sprouts for Tree # 31.

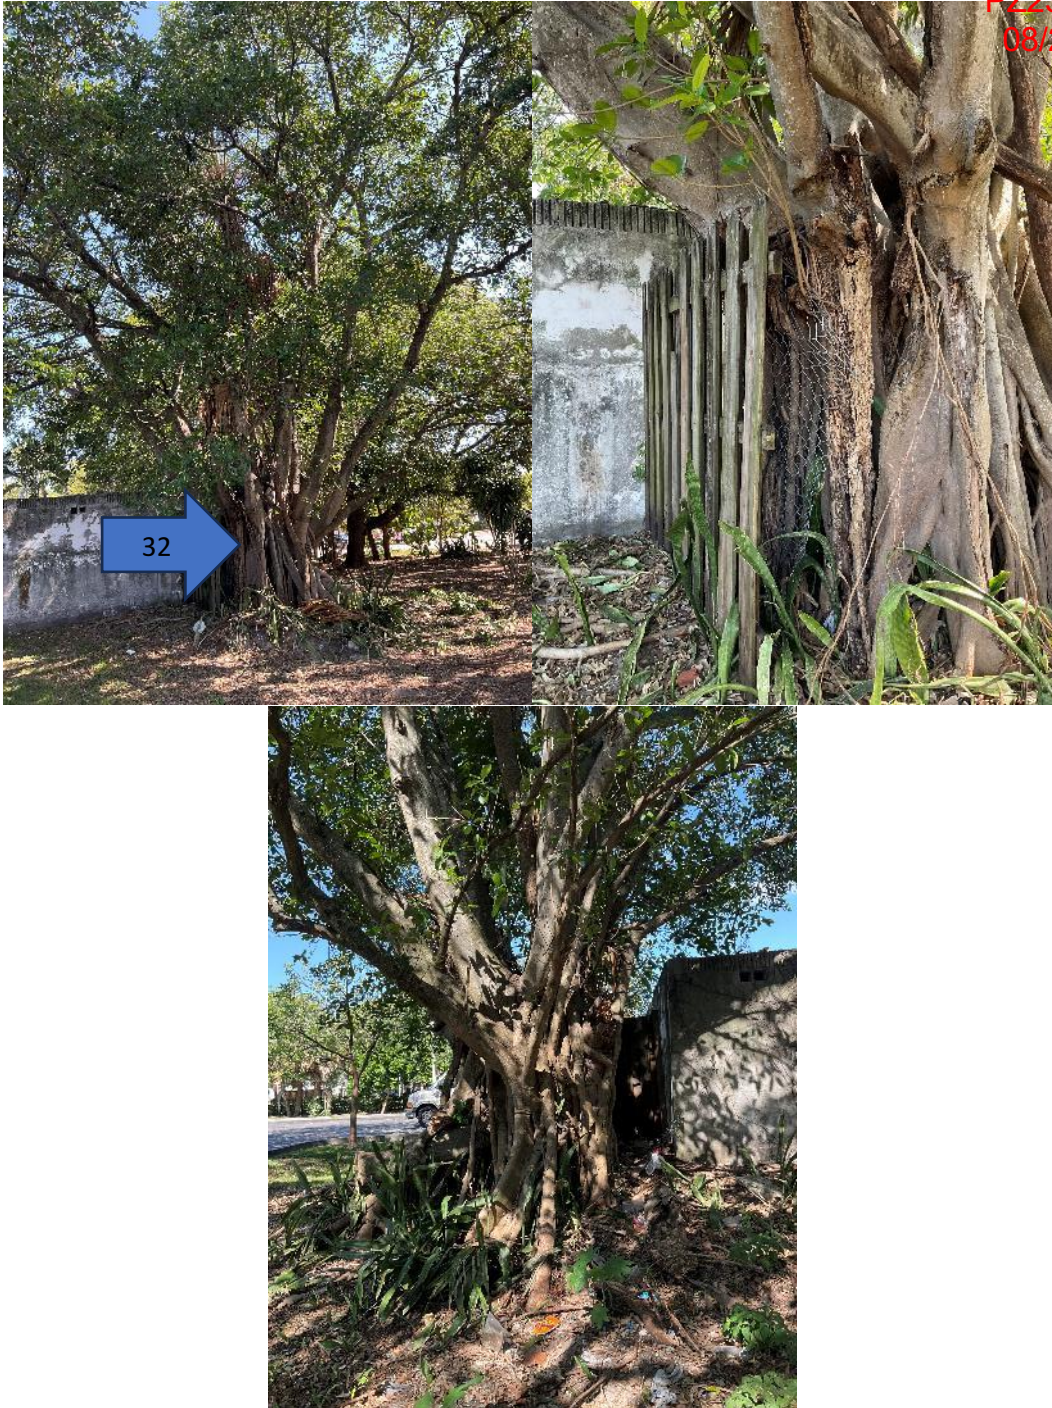
Tree 32

Strangler Fig (*Ficus aurea*), facing north. Note poor structure, severely confined root space, engulfed Sabal Palm, visual evidence of decay heading cuts, and canopy dieback.

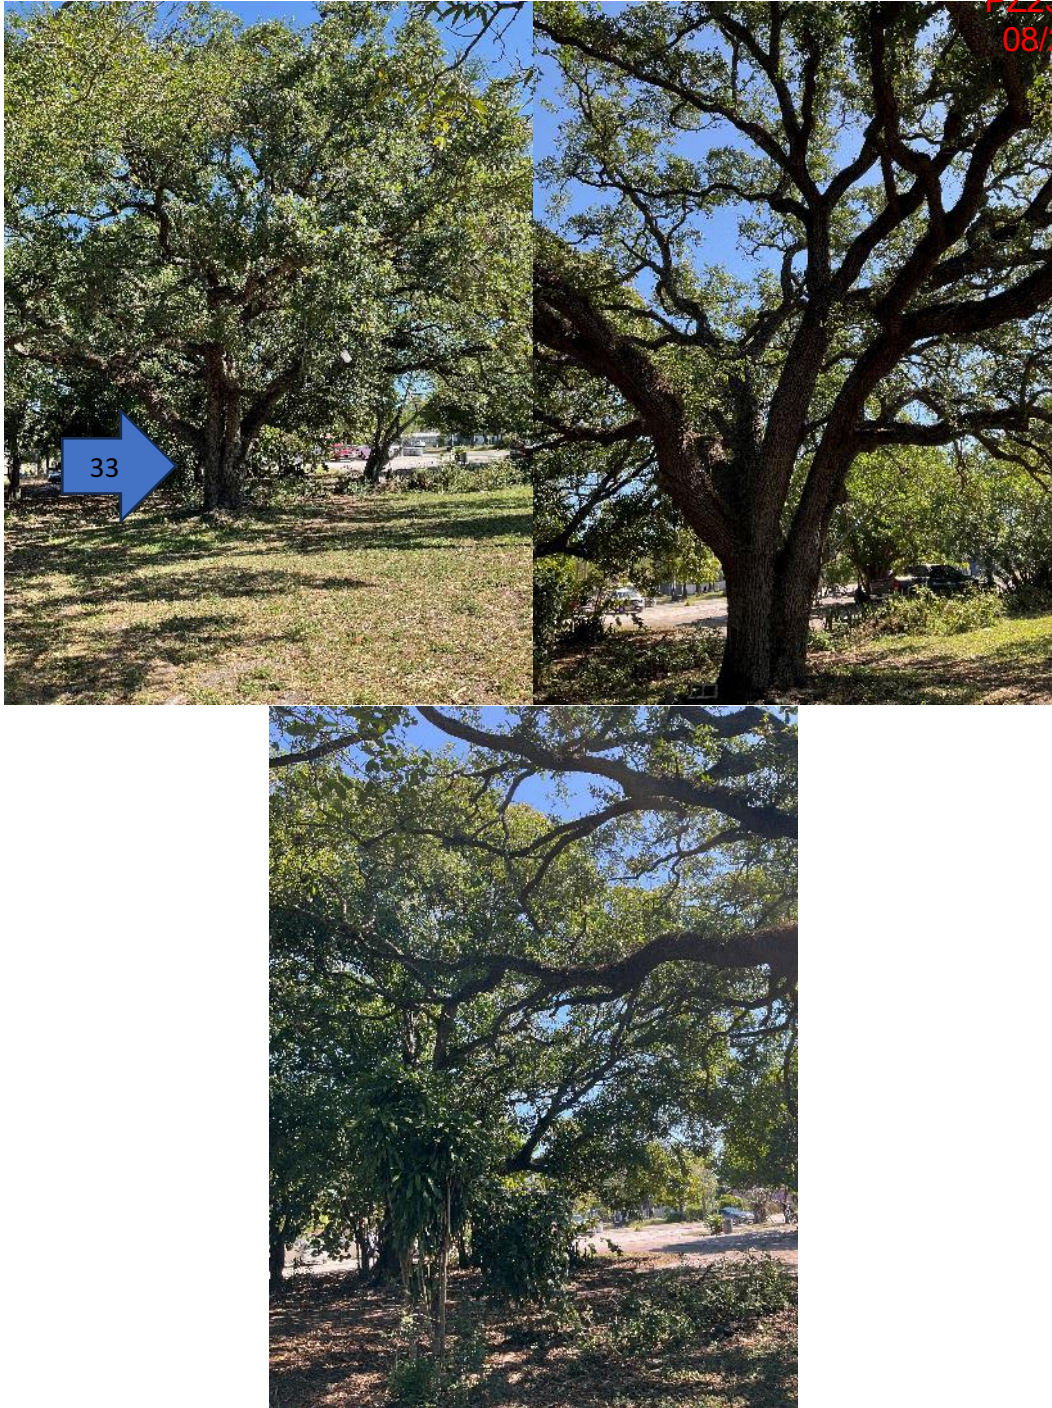
Tree 33

Live Oak (*Quercus virginiana*), facing north. Note poor structure, canopy dieback, deadwood, and canopy crowding.

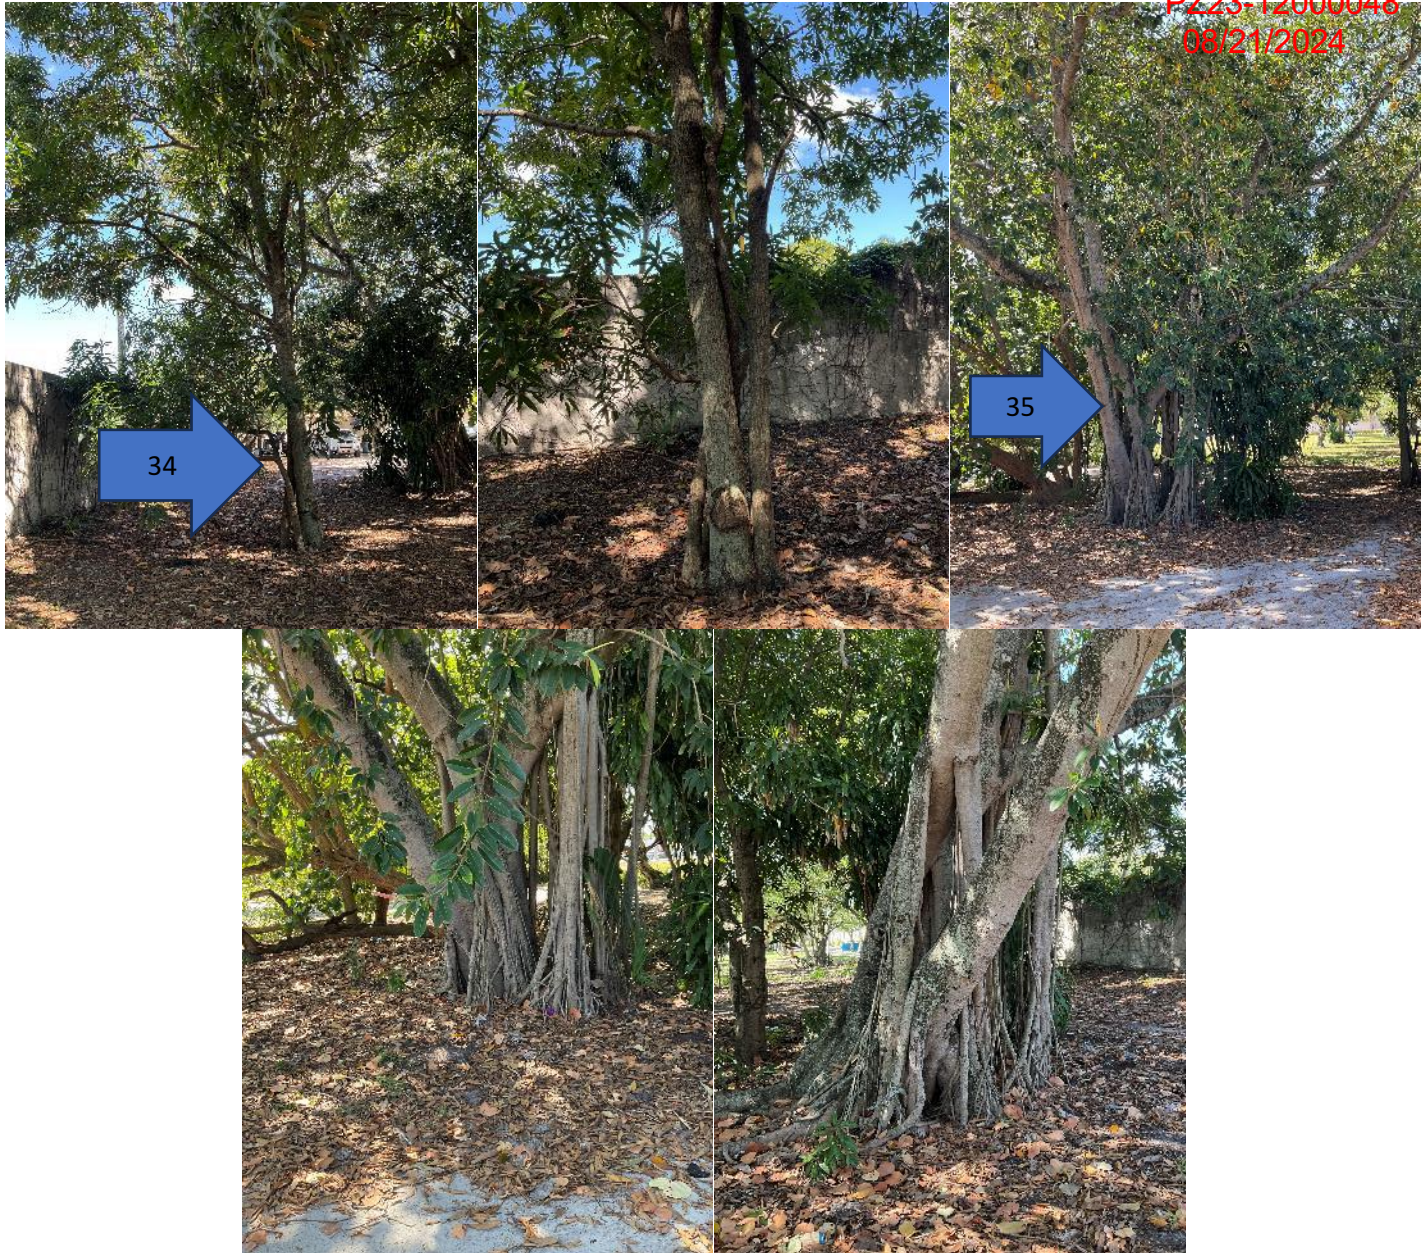
Trees 34 & 35

Mango (*Mangifera indica*) Tree # 34, and Rubber Tree (*Ficus elastica*) Tree # 35, facing west and south. Note poor structure, canopy crowding, canopy dieback for Tree # 34, and poor structure, canopy crowding, visual evidence of decay, and canopy dieback for Tree # 35.

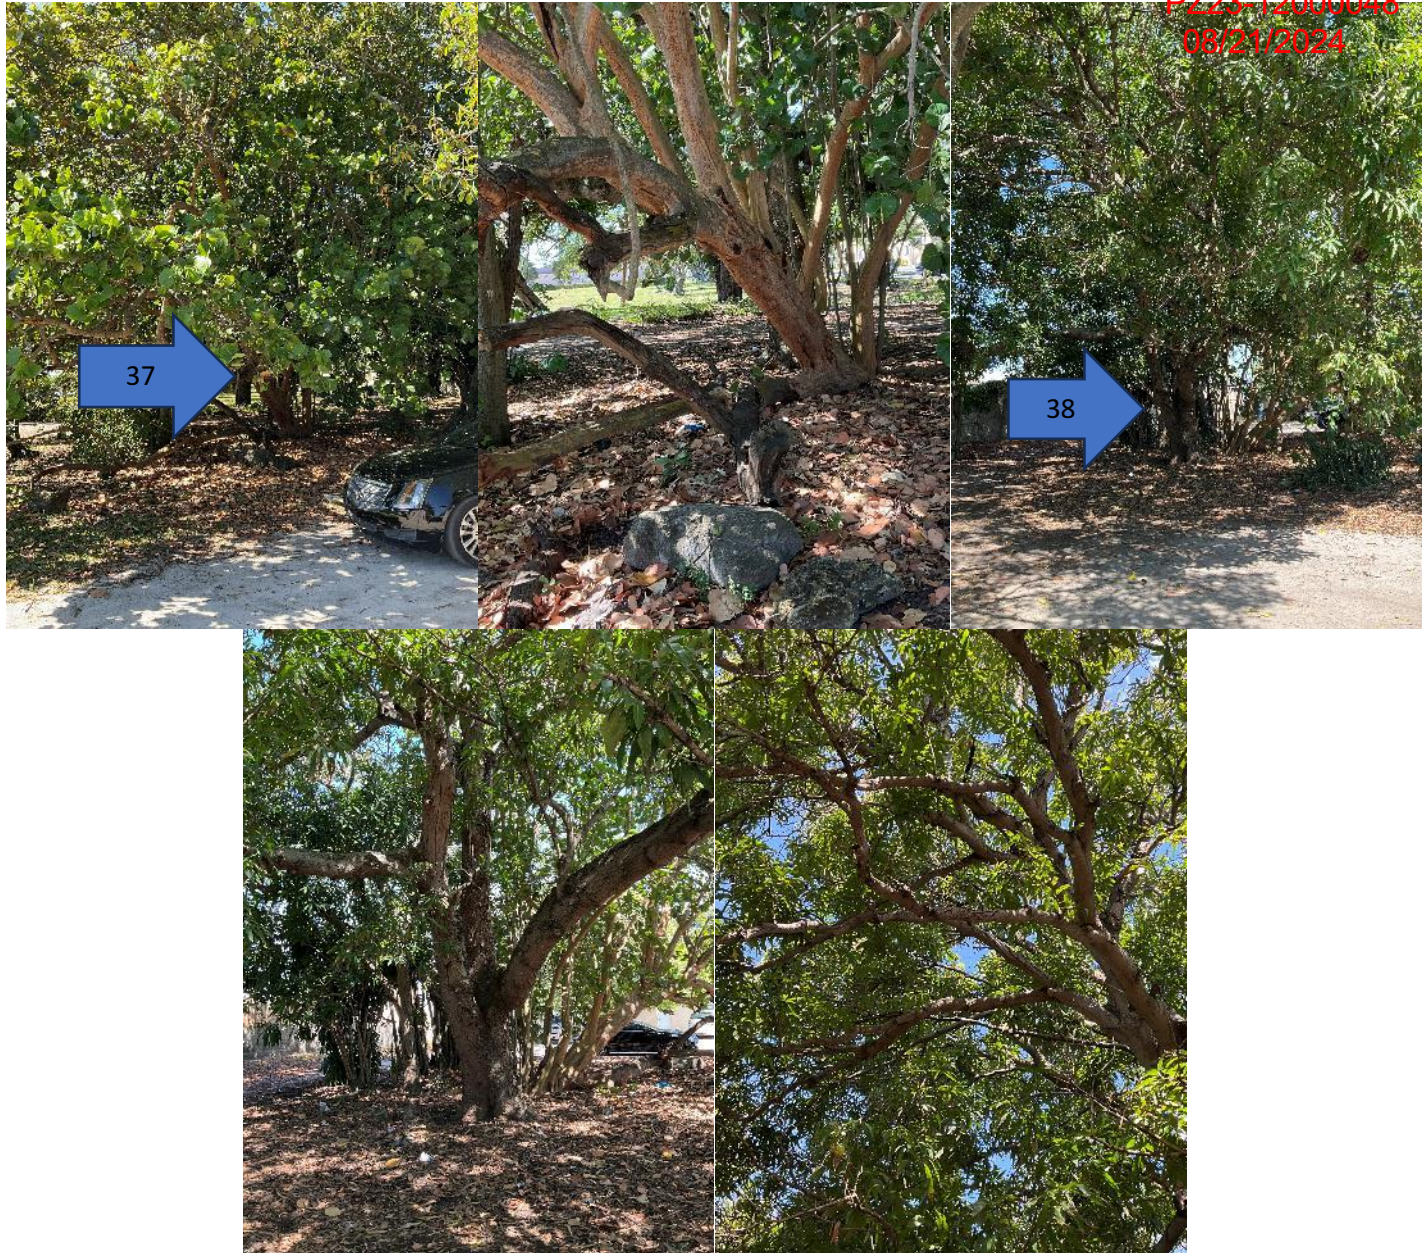
Trees 37 & 38

Seagrape (*Coccoloba uvifera*) Tree # 37, and Mango (*Mangifera indica*) Tree 3 38, facing south and north. Note poor structure, deadwood, trunk lean, canopy crowding, water sprouts, and visual evidence of decay for Tree # 37. Note Poor structure, canopy crowding, deadwood, and canopy dieback for Tree # 38.

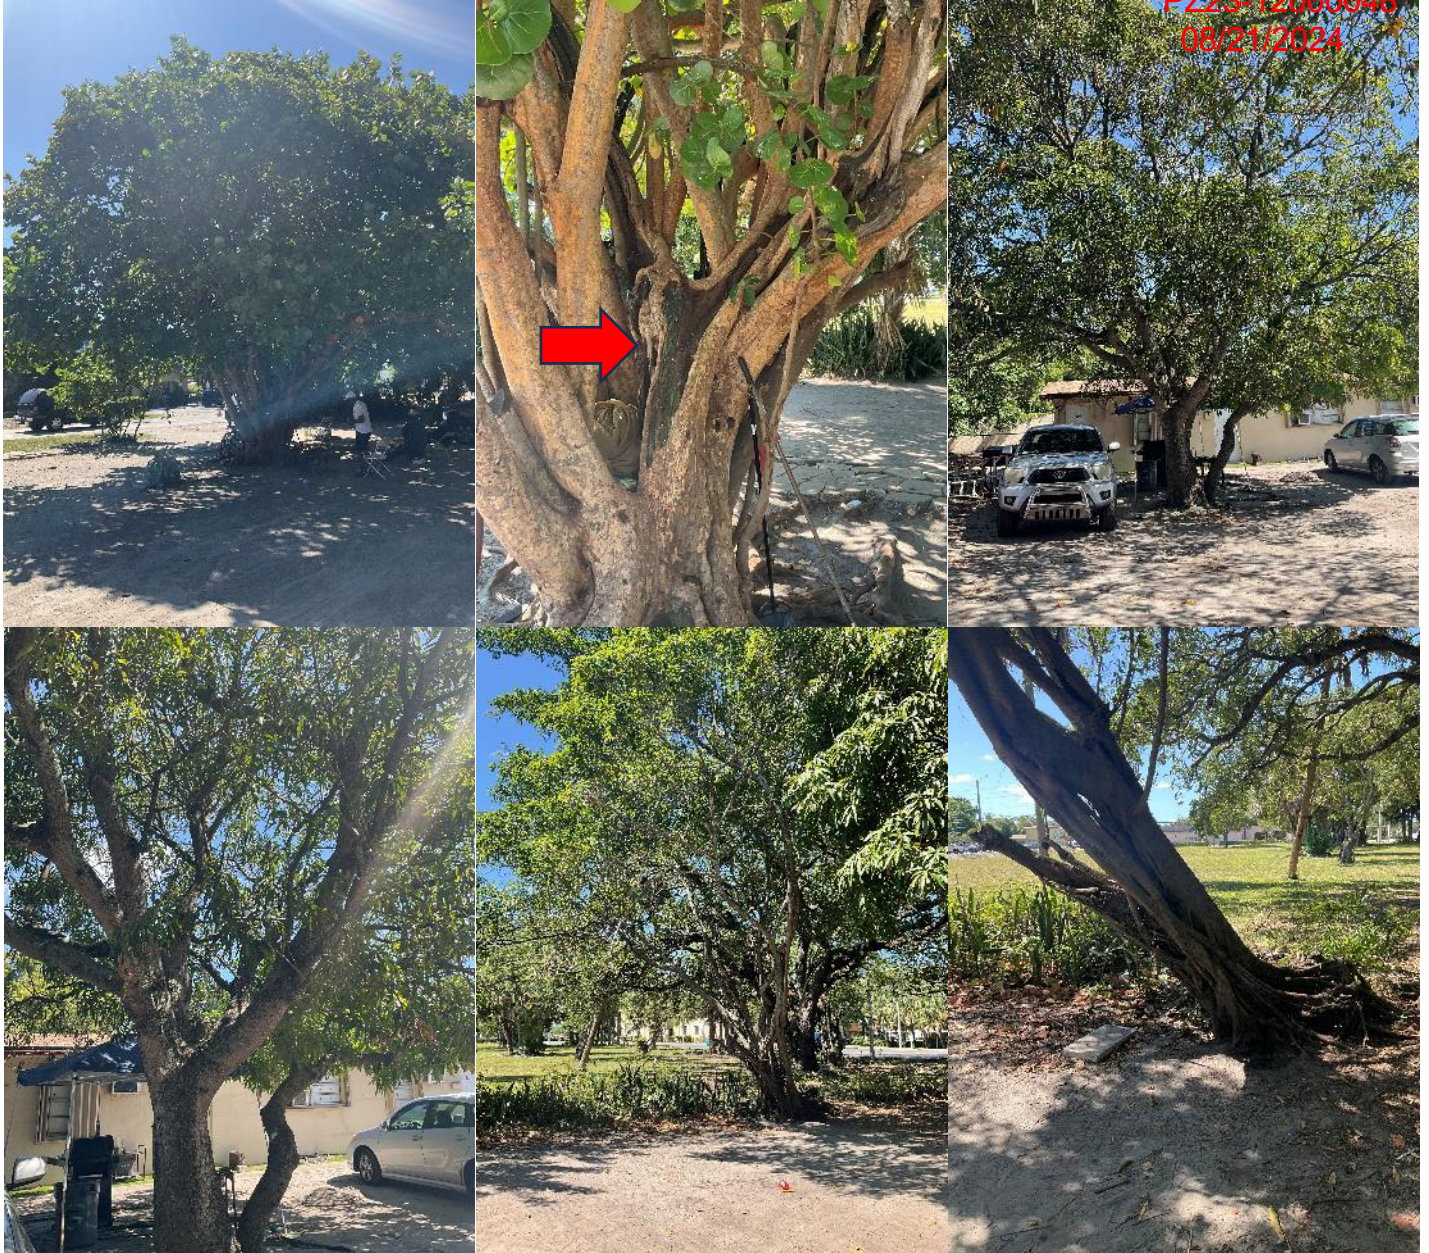
Trees 42, 43 & 44

Seagrape (*Coccoloba uvifera*) Tree # 42, Mango (*Mangifera indica*) Tree # 43, and Weeping Fig (*Ficus benjamina*) Tree # 44, facing east, north and south. Note Poor structure, deadwood, visual evidence of decay Red arrow), water sprouts for Tree # 42. Note poor structure, canopy dieback, deadwood, and leaf necrosis for Tree # 43, and tree partially toppled, uplifted root zone, and deadwood for Tree # 44.

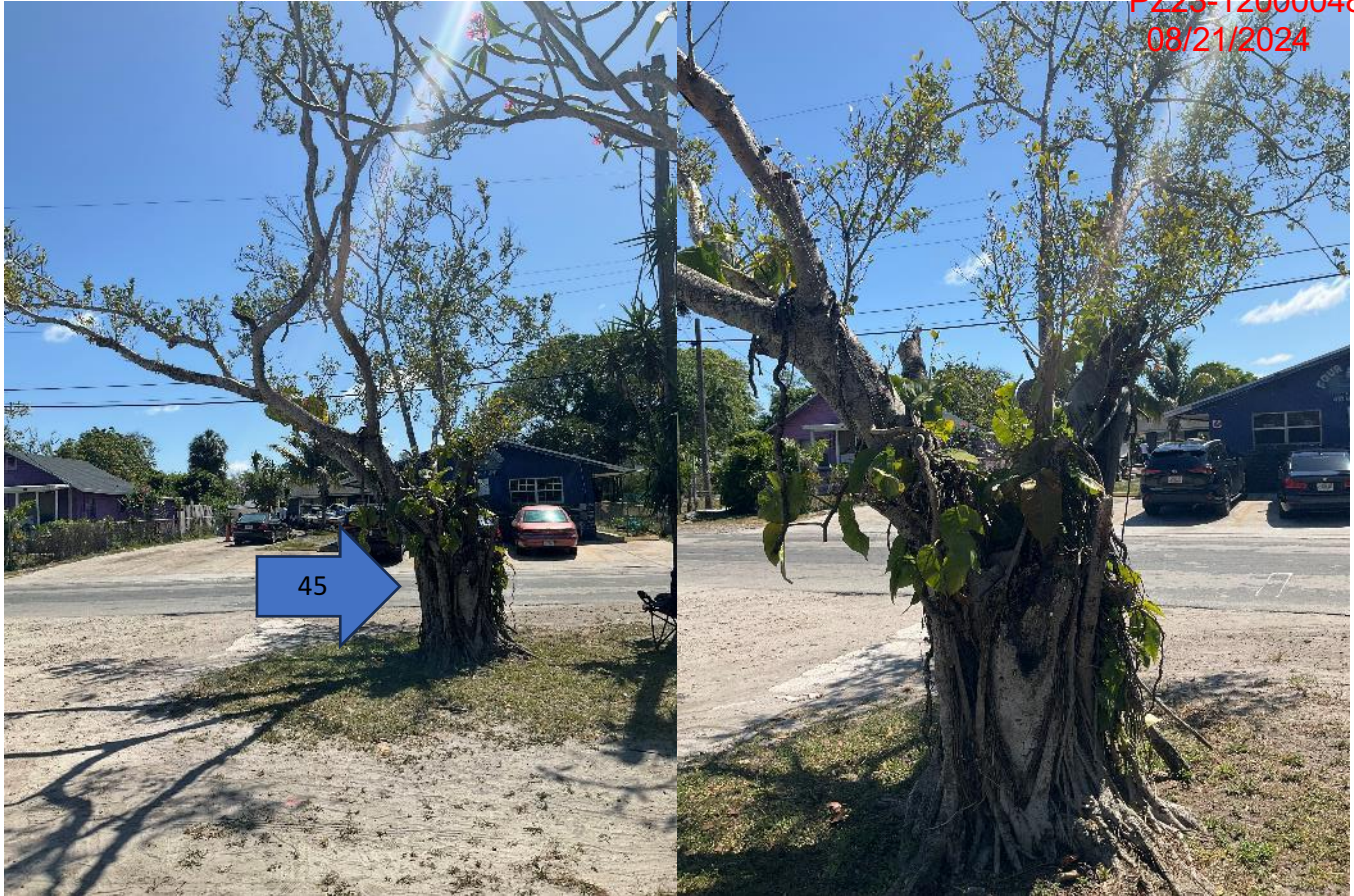
Tree 45

Weeping Fig (*Ficus benjamina*), facing east. Note poor structure, severe canopy dieback, and deadwood.

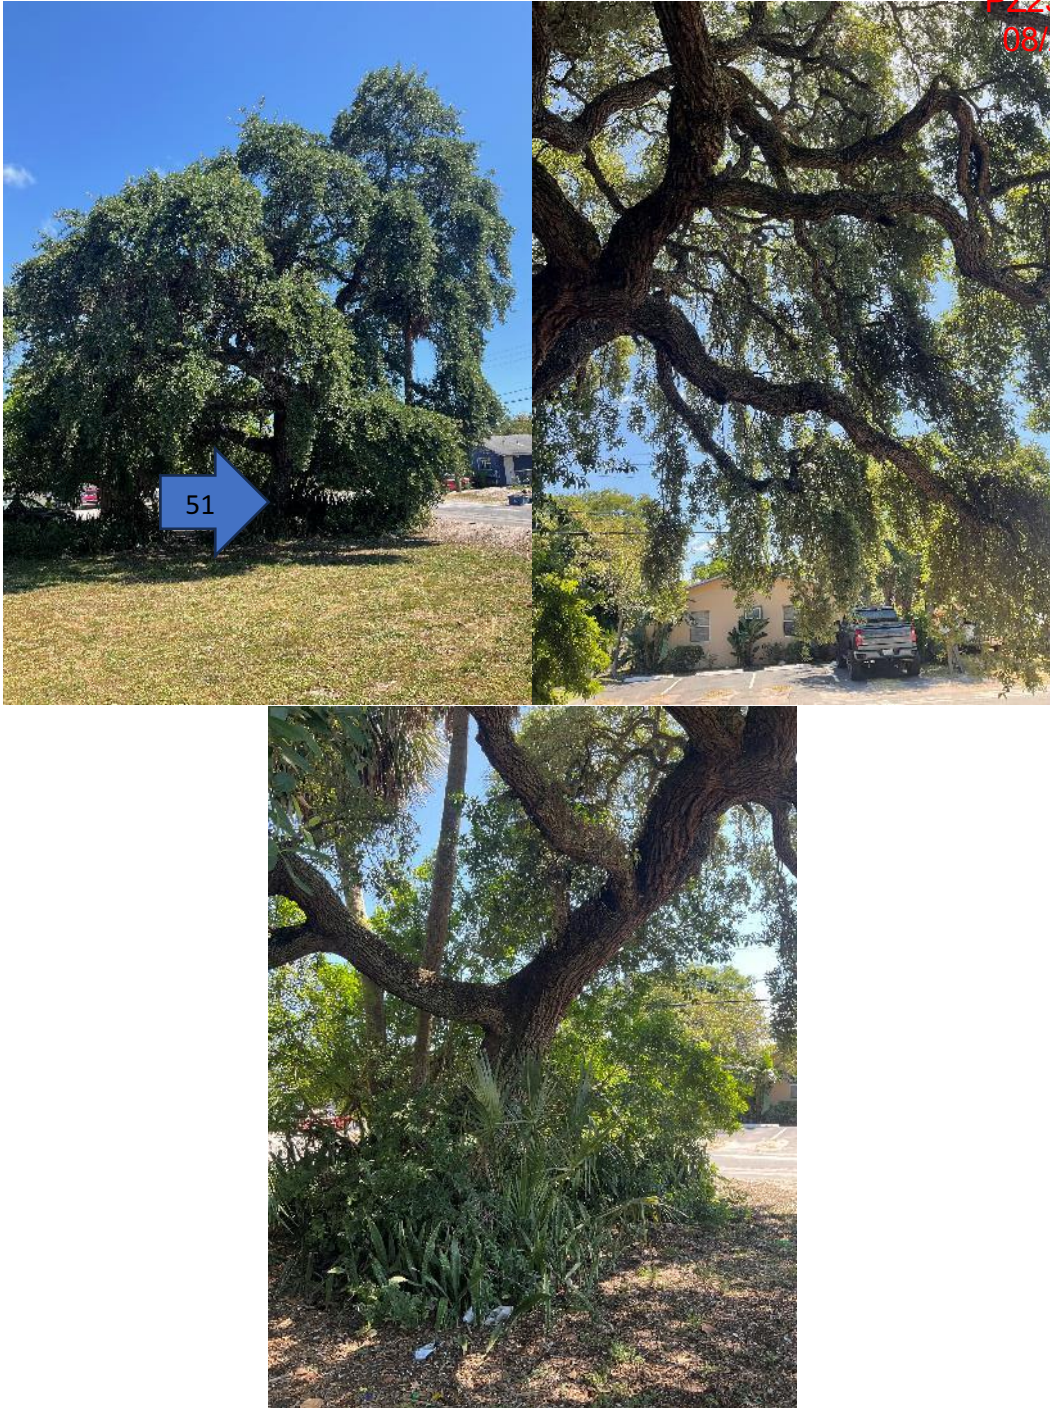
Tree 51

Live Oak (*Quercus virginiana*), facing east. Note poor structure, trunk lean, canopy dieback, and compacted root zone.

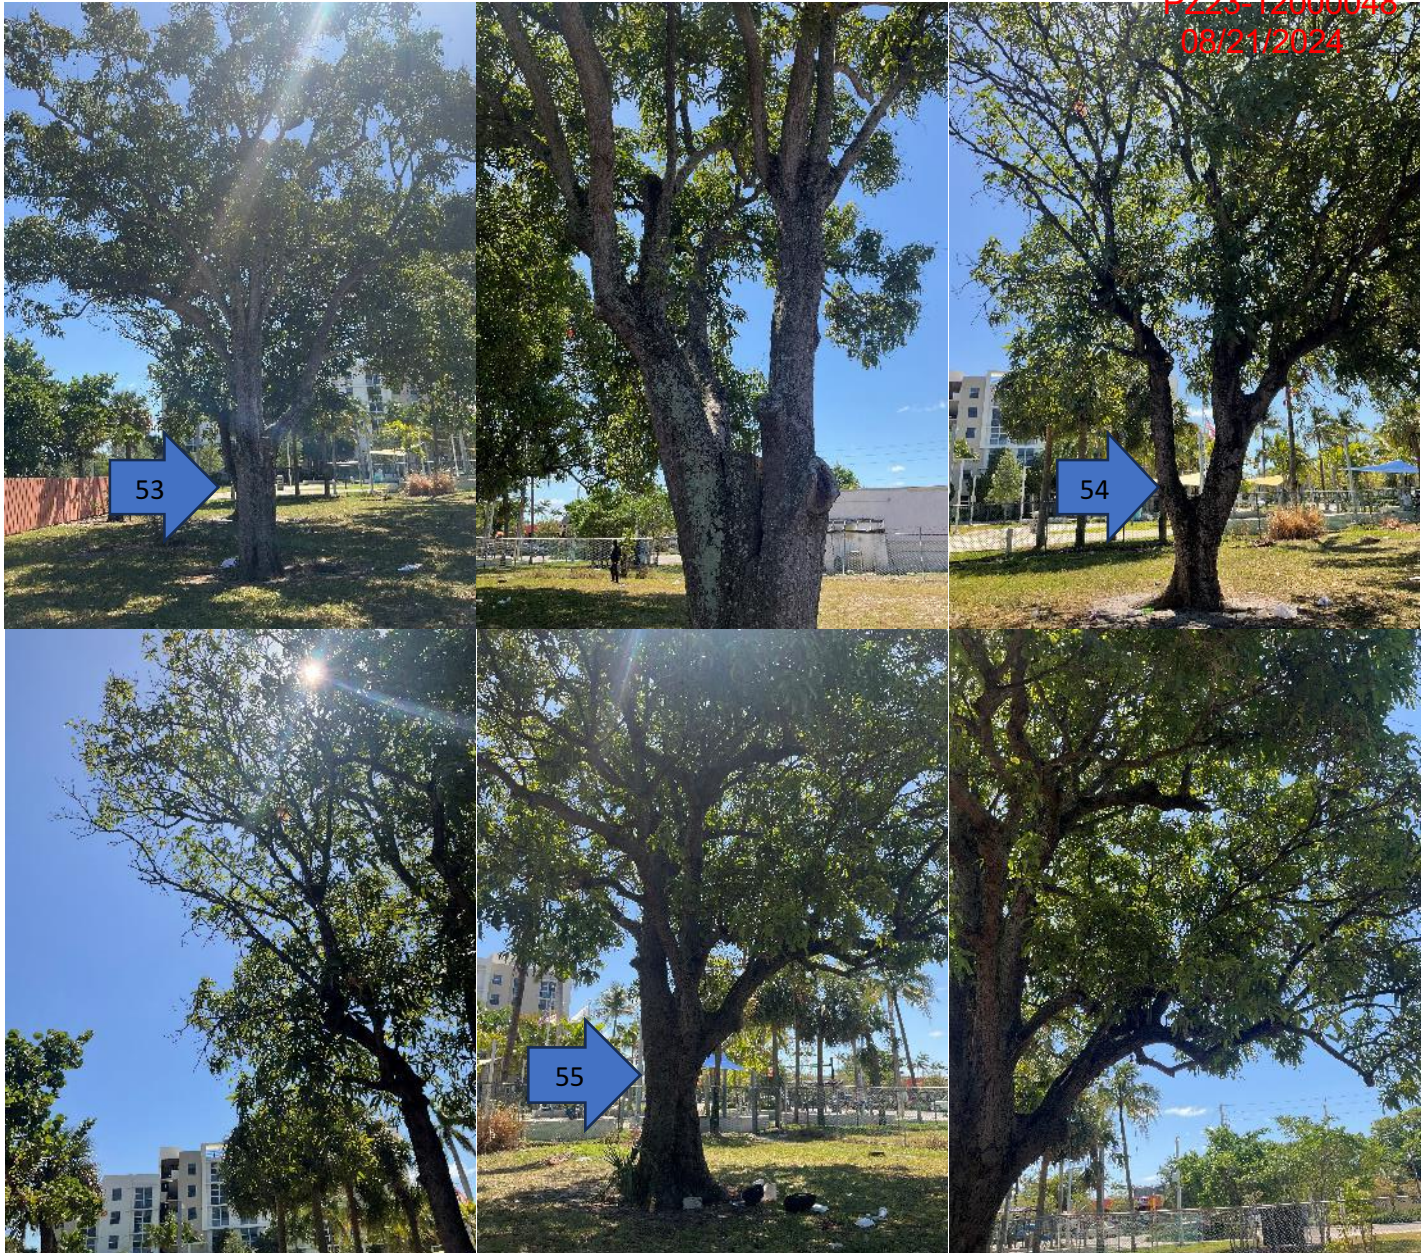
Mangos (*Mangifera indica*), facing east and south. Note poor structure, heading cuts, canopy dieback, and overlifted crown for Tree # 53. Note poor structure, canopy crowding, canopy dieback, overlifted crown, and deadwood for Tree # 54, and poor structure, canopy crowding, canopy dieback, overlifted crown, and deadwood for Tree # 55.
