# ARBORIST REPORT

200 N. Federal Hwy.  
Pompano Beach, Fl 33062

Treage LLC was contacted by George Akirtava of Elit Group to do a Certified Arborist Report/Tree Assessment at 200 N. Federal Hwy. in Pompano Beach, FL.

A site visit was conducted on November 16, 2022. A Level 2 visual inspection of all trees was conducted and documented with photographs. Measurements of DBH, height, and canopy were taken and recorded, and the condition and location of each tree was noted. Tree measurements were taken as follows: DBH was recorded with a metal Spencer ProTape; height and canopy were estimated from the ground; and overall condition was done by visual inspection.

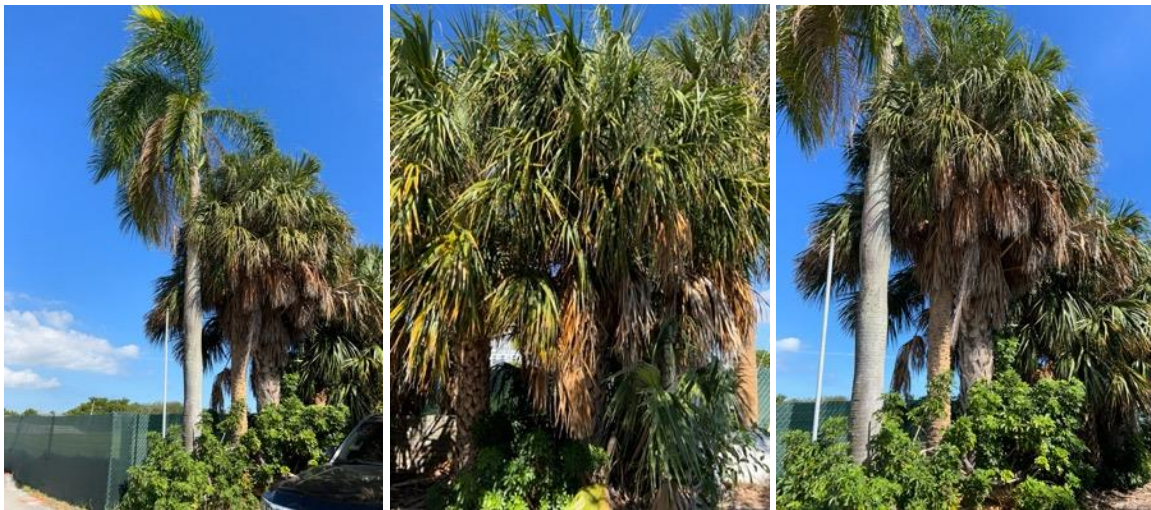
**Tree #1 – *Roystonea regia*, Royal Palm** – this tree is located in the northwest corner of the property adjacent to the parking lot and next to the ROW. It is crowded with minor chlorosis and a slightly undersized canopy. Overall, it is in fair condition and is proposed for removal.

**Tree #2 – *Sabal palmetto*, Sabal Palm** – this tree is located directly east of Tree #1. It is very crowded with a pronounced curve in the upper trunk due to the crowded conditions. It is in fair condition and is proposed for removal.

**Tree #3 – *Sabal palmetto*, Sabal Palm** – this tree is located directly east of Tree #2 on the northeast side of the property. It is very crowded and has live fronds only on one side of the trunk due to severe crowding. It is in poor condition and is proposed for removal.

**Tree #4 – *Sabal palmetto*, Sabal Palm** – this tree is located directly east of Tree #3. It is very crowded and overgrown but otherwise is in fair condition. This tree is proposed for removal.

**Tree #5 – *Sabal palmetto*, Sabal Palm** – this tree is located directly east of Tree #4. It is very crowded and overgrown but otherwise is in fair condition. It is proposed for removal.

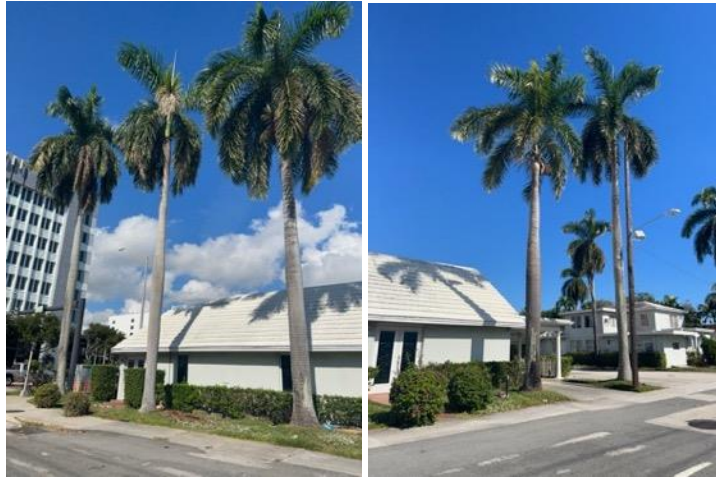
**Tree #14 – *Roystonea regia*, Royal Palm** – this tree is located on the south side of the property east of Trees #11-13 and just west of the concrete walkway to the covered porch area. It shows signs of minor chlorosis/nutrient deficiency, but otherwise is in good condition with no significant defects. It is proposed for removal.

**Tree #15 – *Roystonea regia*, Royal Palm** – this tree is located on the south side of the property east of the covered walkway to the covered porch area. It shows signs of very minor nutrient deficiency, but otherwise is in good condition with no significant defects. It is proposed for removal.

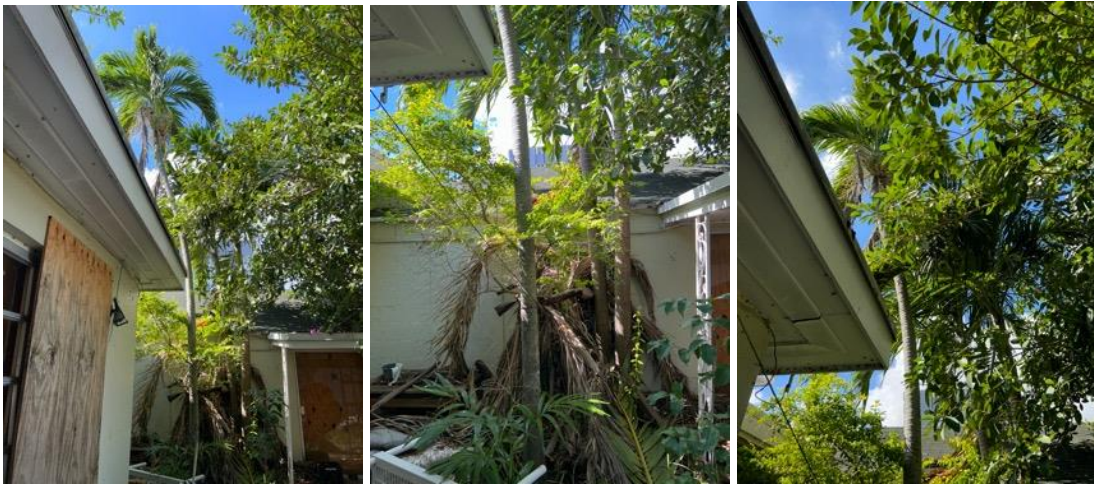
**Tree #18 – *Adonidia merrillii*, Christmas Palm** – this refers to a cluster of 3 palms located inside of a courtyard area on the east side of the existing back building. They are slightly crowded, but otherwise in fair to good condition. They are proposed for removal.

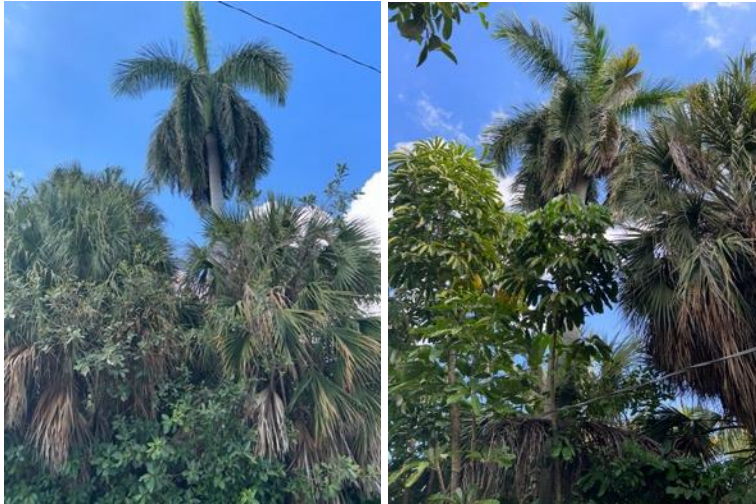
**Tree #20 – *Roystonea regia*, Royal Palm** – this tree is located in an overgrown cluster of vegetation on the east side of the property. It is very crowded and overgrown and could not be accessed due to its location within a fenced area. It shows signs of very minor nutrient deficiency. Overall it is in fair condition and is proposed for removal.

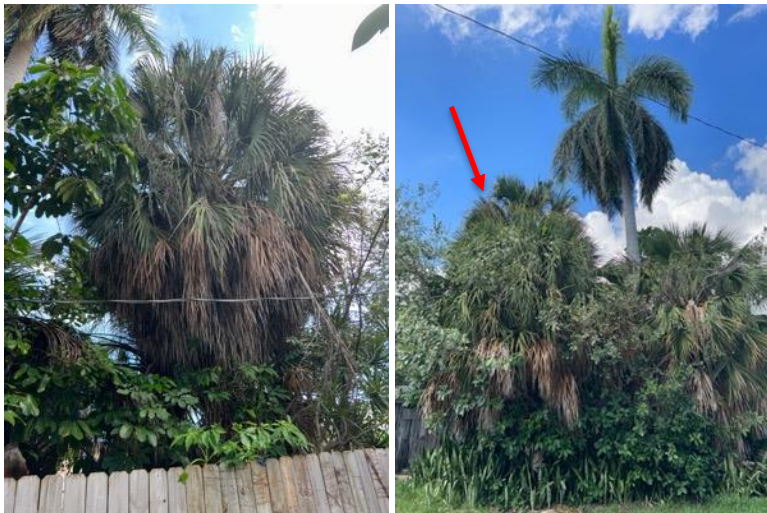
**Tree #21 – *Sabal palmetto*, Sabal Palm** – this tree is located on the south side of the overgrown cluster of vegetation on the east side of the property. It is very crowded and overgrown, and was inaccessible, but otherwise it is in good condition. It is proposed for removal.

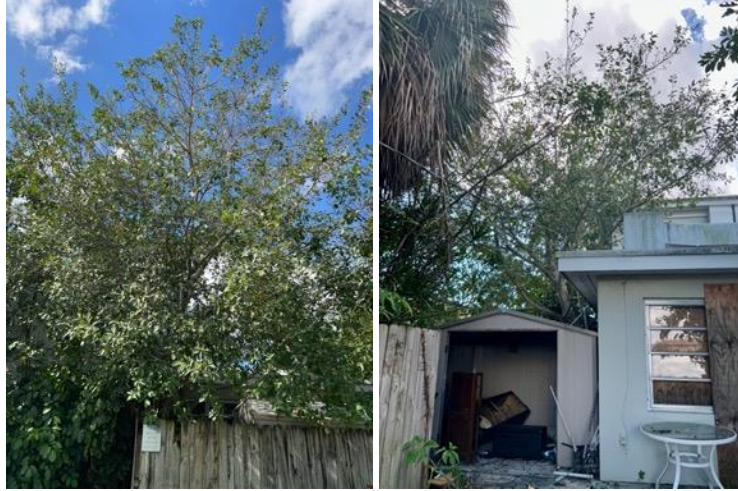
**Tree #22 – *Ficus aurea*, Strangler Fig** – this tree is located on the east side of the building on the east side of the property. It is inaccessible due to its location inside a fenced area. It appears to be crowded, overgrown and unmaintained with areas of slightly sparse foliage. Overall, it is in fair condition and will be removed.

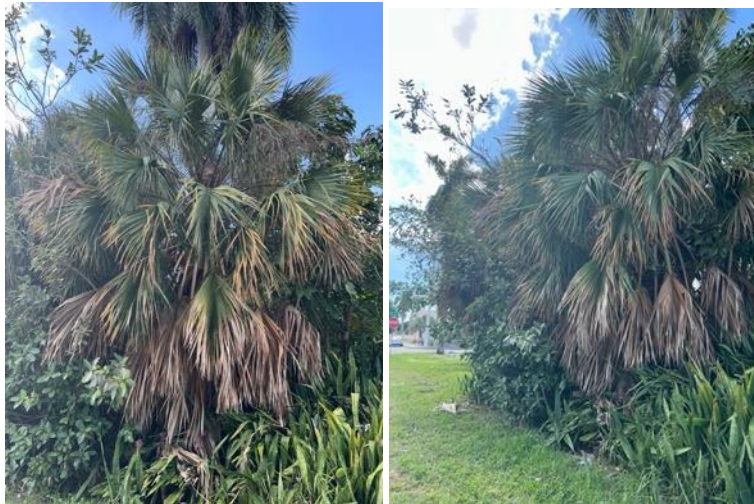
**Tree #23 – *Sabal palmetto*, Sabal Palm** – this tree is located on the north side of the overgrown cluster of vegetation on the east side of the property. It is very crowded, and overgrown. Overall it is in fair condition and is proposed for removal.

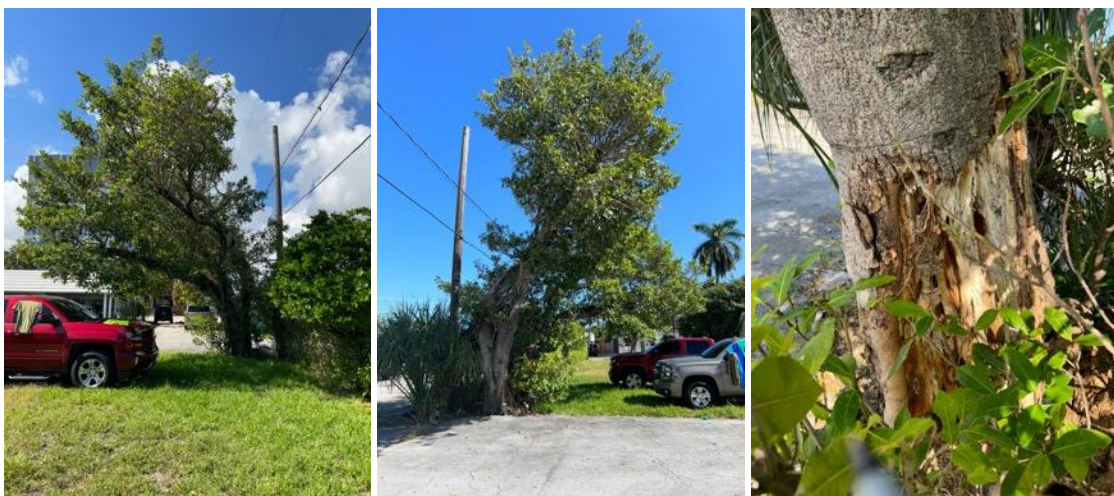
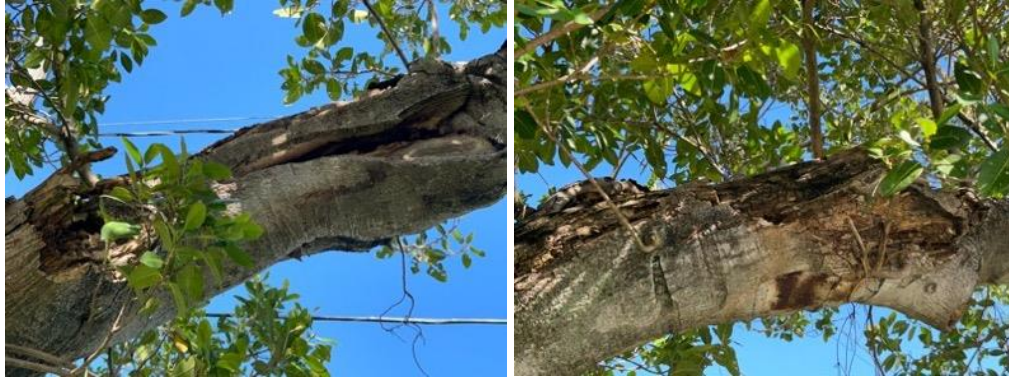
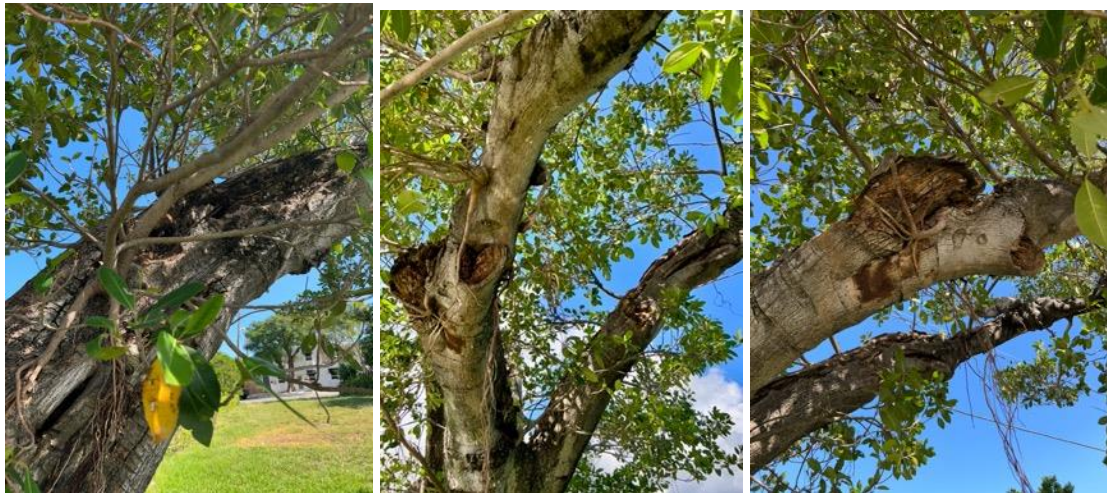
**Tree #25 – *Ficus aurea*, Strangler Fig** – this tree is located on the north side of the main parking lot near the entrance to the small parking lot (Lot 17, Block 5). It has extensive internal decay at the base of the trunk and in all remaining scaffold limbs. There is decayed wood, apparent termite damage, and fruiting fungal bodies present. Based on a Level 2 inspection and using the ISA Risk Rating matrix, this tree constitutes a high risk and there are no mitigation options that can reduce its risk to moderate or less; therefore, it is recommended for consideration for removal without a permit or mitigation per FS 163.045.

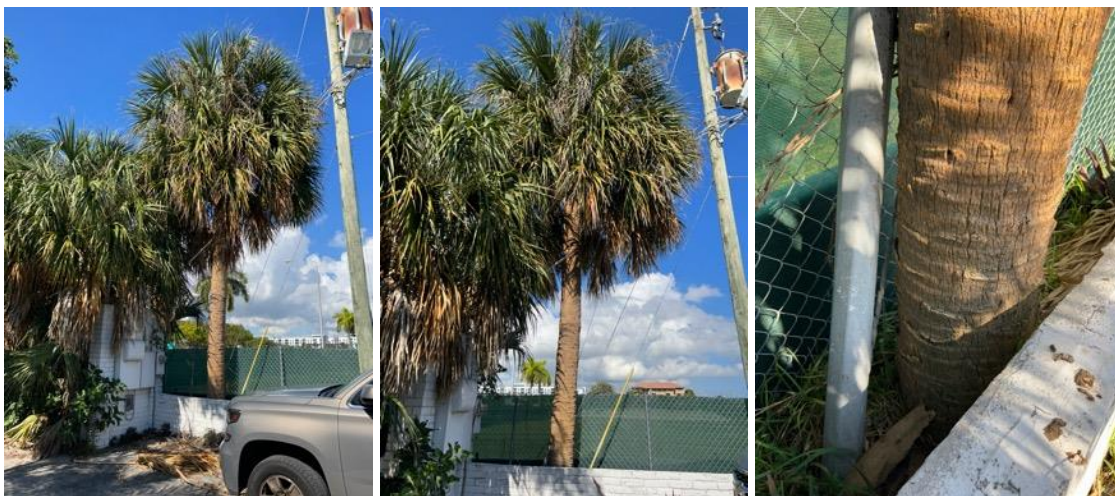
**Tree #26 – *Sabal palmetto*, Sabal Palm** – this tree is located just east of Trees #1-5 on the northeast side of the property/parking lot. It is somewhat crowded but otherwise is in good condition. It is proposed for removal.

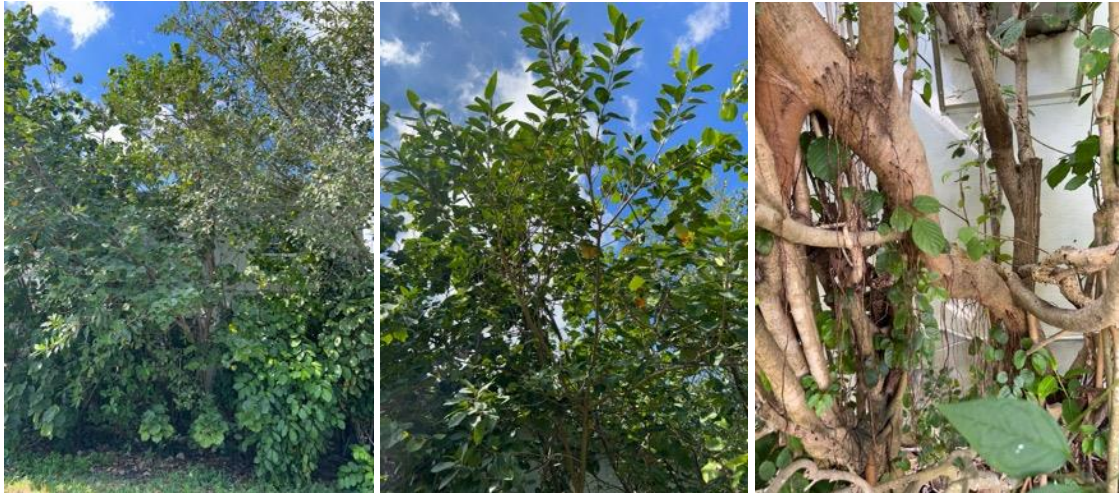
**Tree #28 – *Ficus aurea*, Strangler Fig** – this is a small volunteer that is growing in an overgrown cluster of Sea Hibiscus on the east side of the existing back building. It is crowded and leaning and has a weak growth habit/structure as a result. It is in poor condition and will be removed.

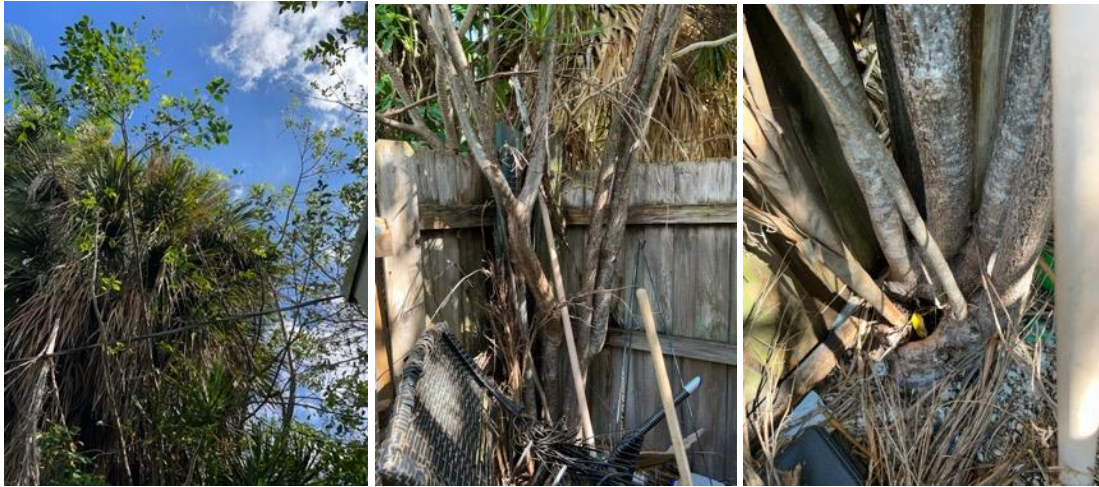
**Tree #29 – *Bursera simarouba*, Gumbo Limbo** – this tree is growing on the southwest corner of the cluster of overgrown vegetation on the east side of the existing back building; it is likely a volunteer. It is growing against a wooden fence and appears to have been trimmed multiple times near ground level so that it consists of multiple sprouts. There is a decay cavity near the base of the trunk. The canopy is small and sparse. Overall, this tree is in poor condition. It is proposed for removal.

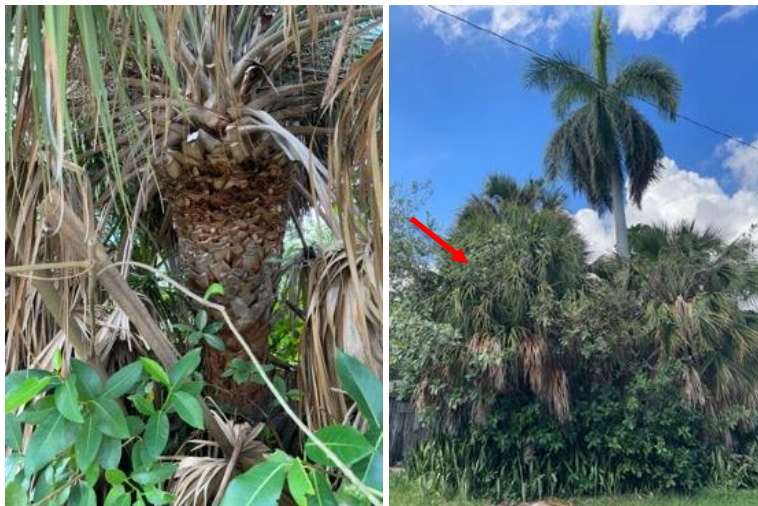
**Tree #30 – *Sabal palmetto*, Sabal Palm** – this tree is located directly in front of Tree #21 on the east side of the property. It is very crowded, overgrown with vines, and unmaintained. Overall, it is in fair condition and is proposed for removal.

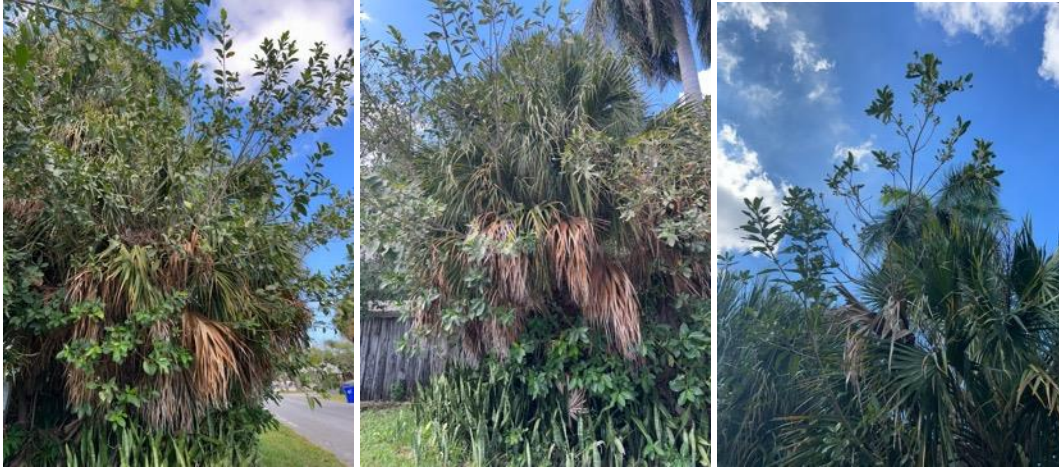
**Tree #31 – *Ficus aurea*, Strangler Fig** – there is at least one Strangler Fig growing in the middle of the overgrown cluster of vegetation containing Trees #20-21. It is very crowded, overgrown, inaccessible and difficult to see, but at least 3 individual trunks, each 2-3" DBH, were observed with minimal amounts of foliage visible as well. For the sake of this assessment, it is assumed that this is one tree. It is in poor condition and will be removed.
