City of Pompano Beach Water Treatment Plant Building Hurricane Hardening Study – Final Technical Memorandum

June 30, 2016

**City of Pompano Beach
Utilities Department
1205 NE 5th Ave
Pompano Beach, FL 33060**

**Tetra Tech
450 N. Park Rd., Suite 502
Hollywood, FL 33021**

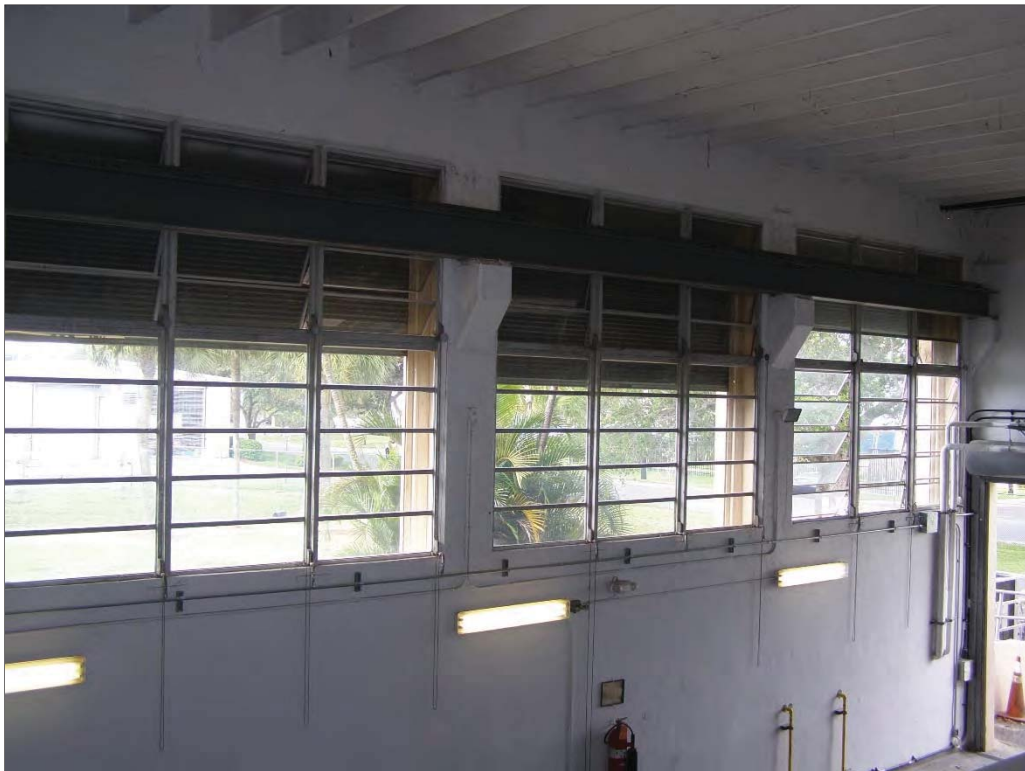
Photo 4: Interior View of Windows

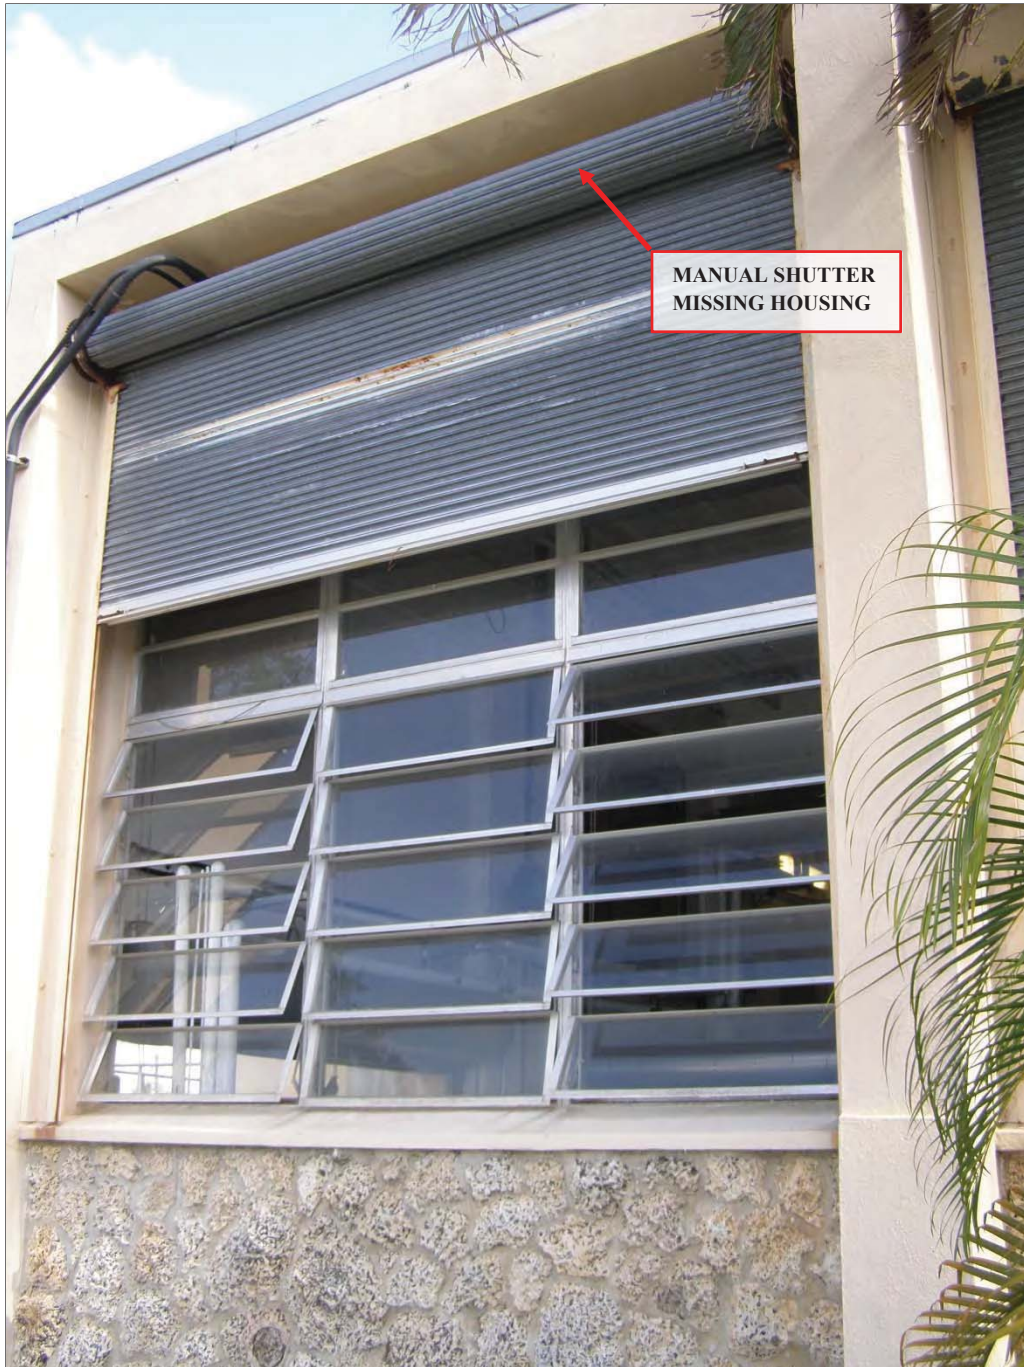
1. Six (6) approximately 12' x 12' operable window assemblies that are protected by manually operated roll down shutters doors mounted to the exterior of the building. The opening enclosures are original to the construction of the facility and provided ventilation to the HSP room.

Photo 5: Exterior View of Window and Shutter

1. Add #5 vertical reinforcement in grout filled cells at 48" o.c. to unreinforced CMU. ROM \$43,000.
2. Replace five (5) of six (6) approximately 12' x 12' operable window assemblies with HVHZ reinforced aluminum window frames and glazing rated for small and large missile impact and wind loads. Replace northern most 12'x12' window with HVHZ rated air intake fan and louver designed to meet code required for make-up air intake requirements and provide controlled ventilation of the HSP room. ROM \$60,000.

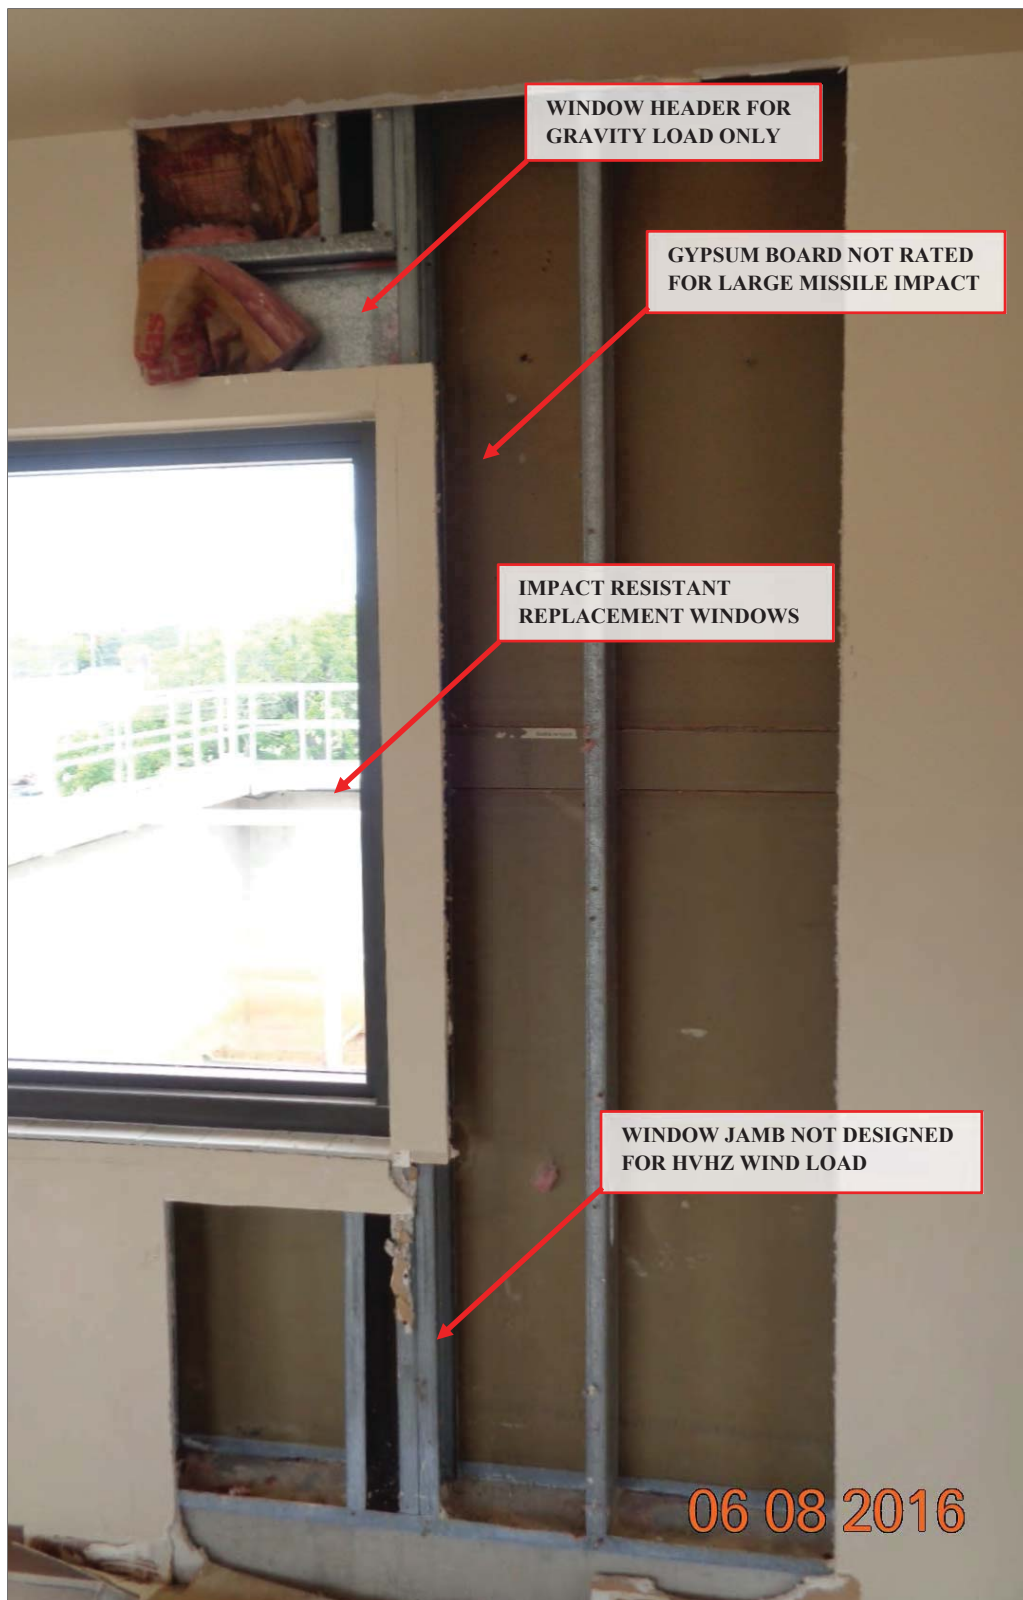
When the plant was expanded in 1983, the operation gallery was extended to the north but built with steel framing and metal stud cladding. Roof members are 8" deep wide flange beams with 1 ½" metal deck. Wall construction is 6" cold formed steel studs with stucco on metal lath over gypsum board. When analyzed for current wind loads, the structural framing and typical metal studs were verified as adequate. However, there are several deficiencies, including: metal roof deck attachment, metal stud construction/strength around large openings, lack of structural sheathing on the metal studs, and gypsum board attachment and wind/impact rating. Information regarding all three of these items is based on the record drawings and limited observation by removing sections of drywall from the building interior.

Photo 10: Filter Gallery Expansion - Stud Wall Assembly

1. Remove and replace metal stud wall assembly on Filter Operation Gallery addition with code compliant, engineered metal stud wall assembly. It is assumed that the recently replaced HVHZ rated windows can be reused. ROM \$75,000.

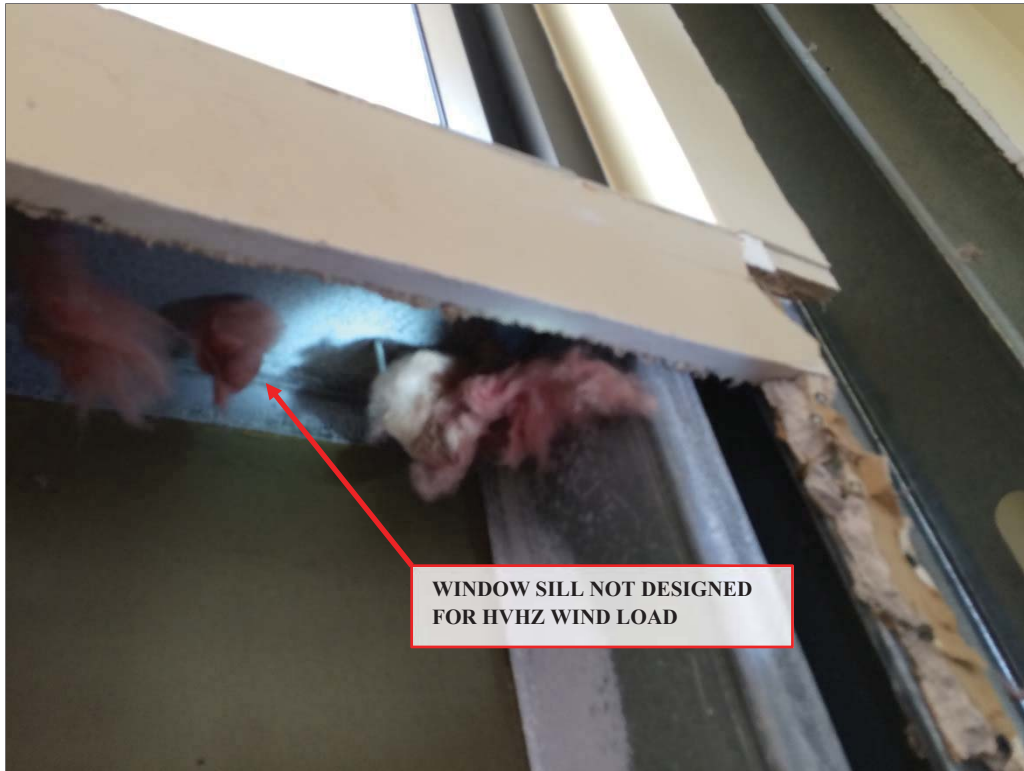
Photo 11: Filter Gallery Expansion - Window Sill Framing

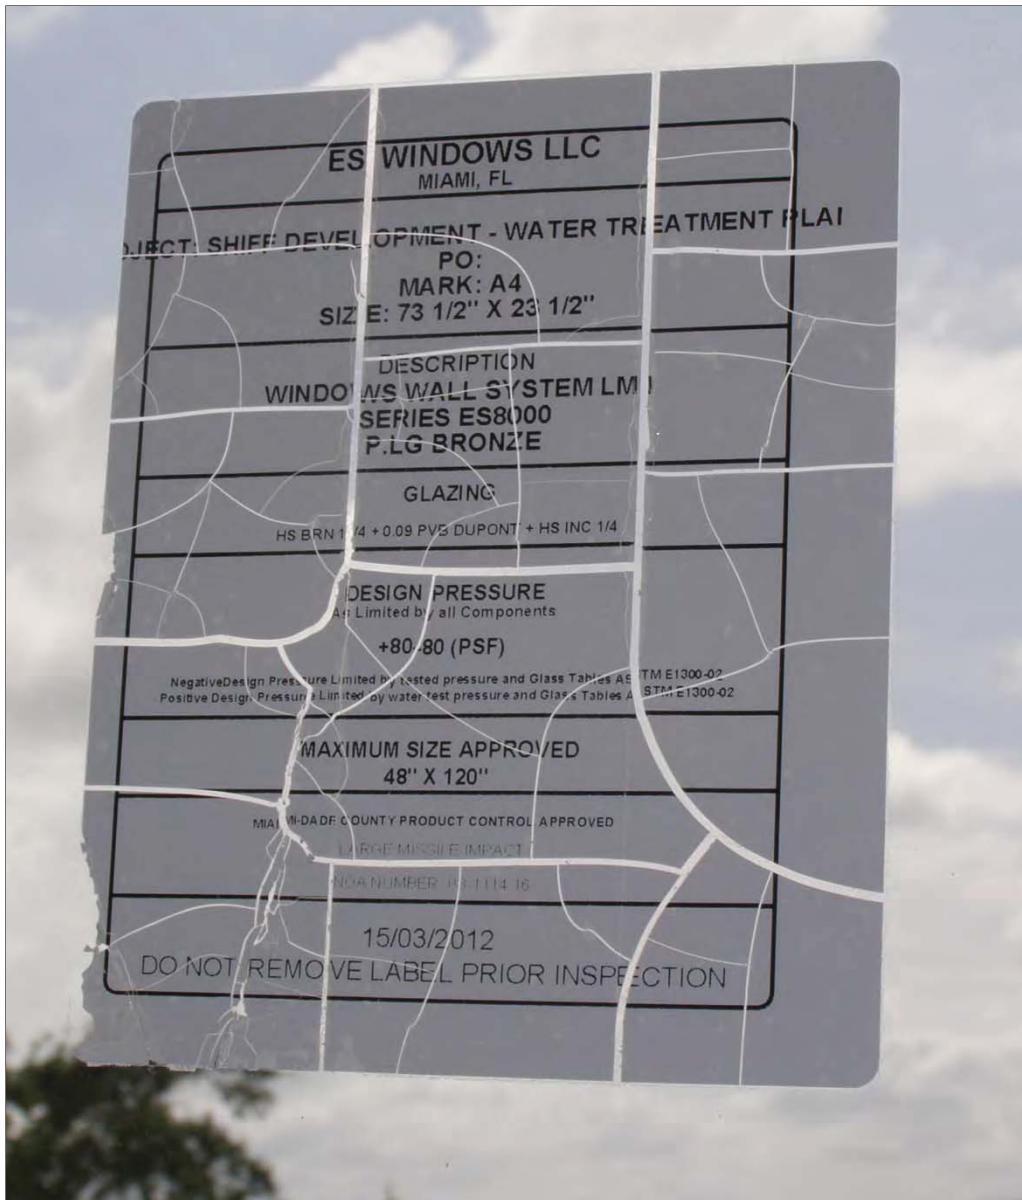
Photo 12: Replacement Window Information

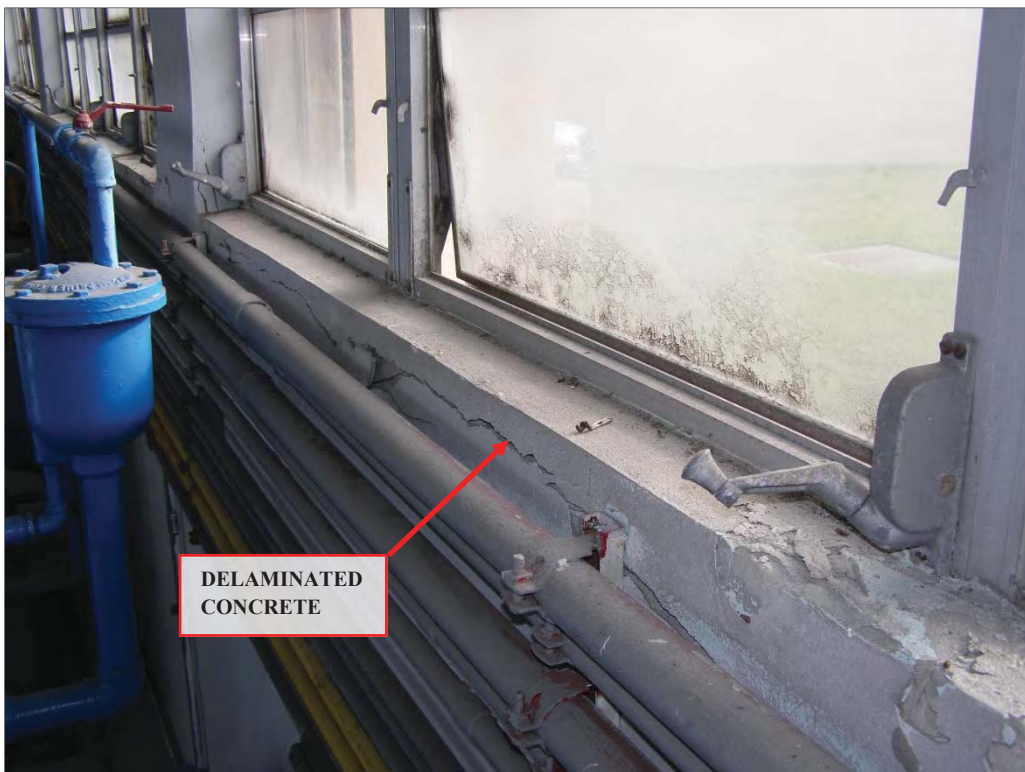
1. Seven (7) approximately 13' x 5' operable window assemblies that are protected by manually operated roll down shutters doors mounted to the exterior of the building. The openings are original to the construction of the facility and provide ventilation to the High Service Pump room. The windows are not currently operable, and water damage is evident where windows are stuck in the open position.

Photo 18: Window Sill Deterioration in Pump Room

2. Replace seven (7) approximately 13' x 5' operable window assemblies with HVHZ reinforced aluminum window frames and glazing rated for small and large missile impact and wind loads. Install louvers as required by mechanical for ventilation compliance. Remove roll shutters and repair exterior wall. ROM \$50,000.

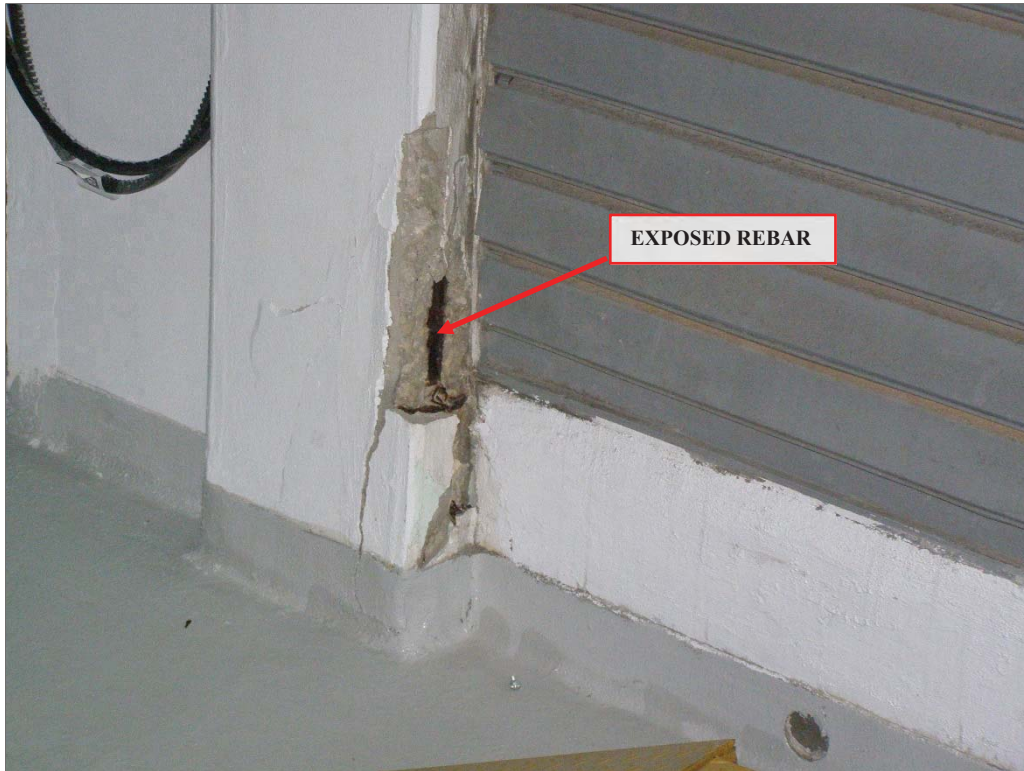
Photo 19: Column Damage in Generator Room

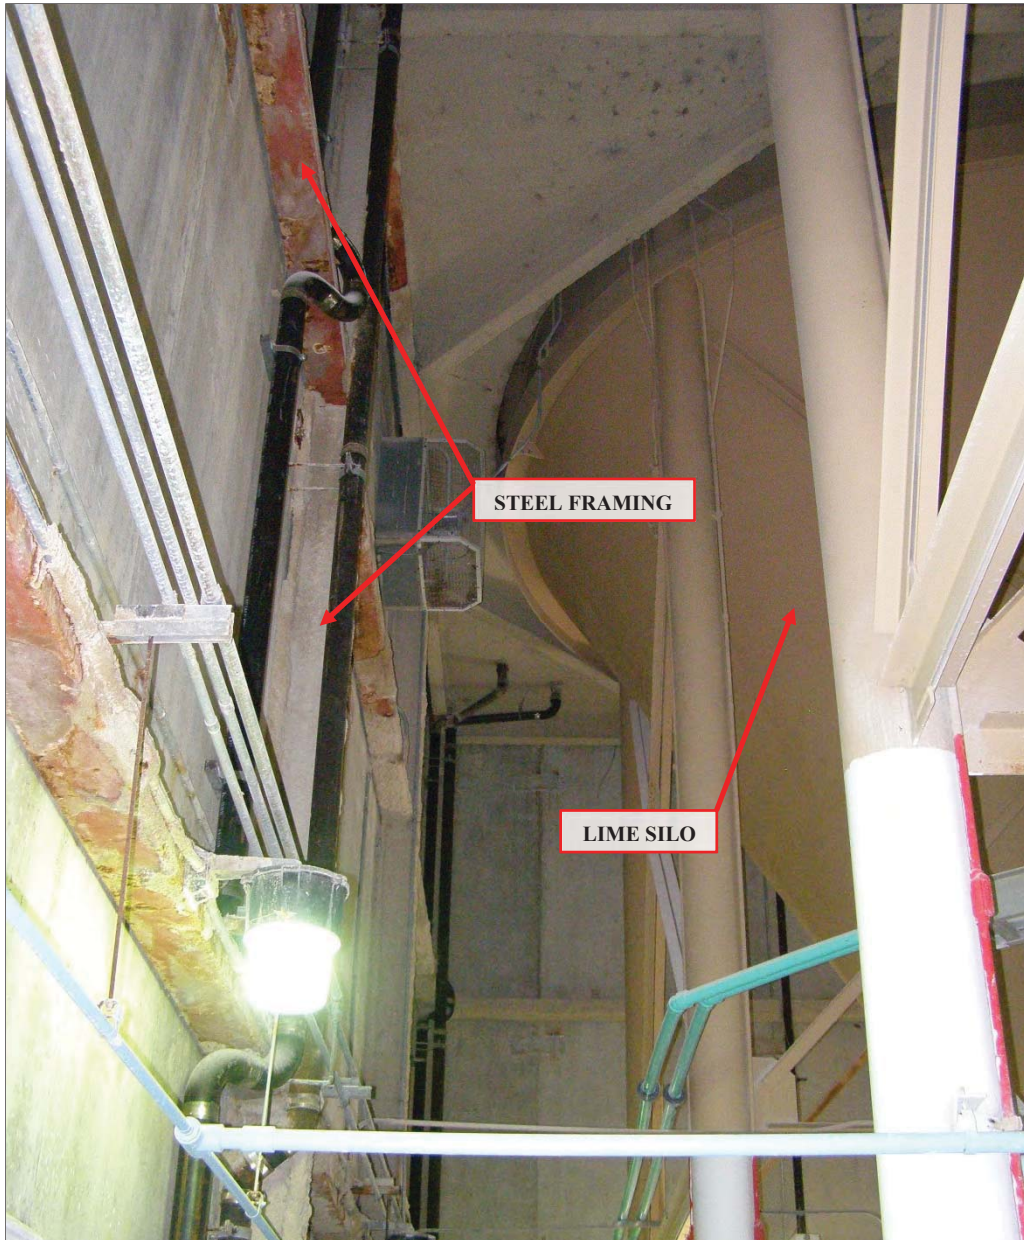
Building construction is primarily steel framing and exterior precast concrete wall panels that rest on top of the floor slab. The precast wall panel connections are detailed to transfer out-of-plane and in-plane loads only. Gravity loads from the roof and floor are carried by the steel framing. Roof framing over the shop and second floor is a combination of W-shape steel beams and H-series bar joists that support metal roof deck. The roof framing around the Lime silos is W-shape steel beams that act compositely with a 6" concrete slab. The second floor is a 6½" composite metal deck slab that is supported by a combination of CMU walls and W-shape beams. The concrete foundations are comprised of piers and stem walls on monolithically poured column and wall footings. Most structural members and components were observed to be in good condition overall, with the exception of some of the steel framing that has started corroding due to loss of sprayed-on fire protection.

Photo 25: Steel Framing with Corrosion and Loss of Fire Protection

1. Clean steel framing that is corroded and respray with fire protection. ROM \$8,000.
2. Retrofit metal deck attachment over shop area and 2nd floor by adding mechanical fasteners. Roofing replacement would be required for this retrofit. ROM \$50,000.

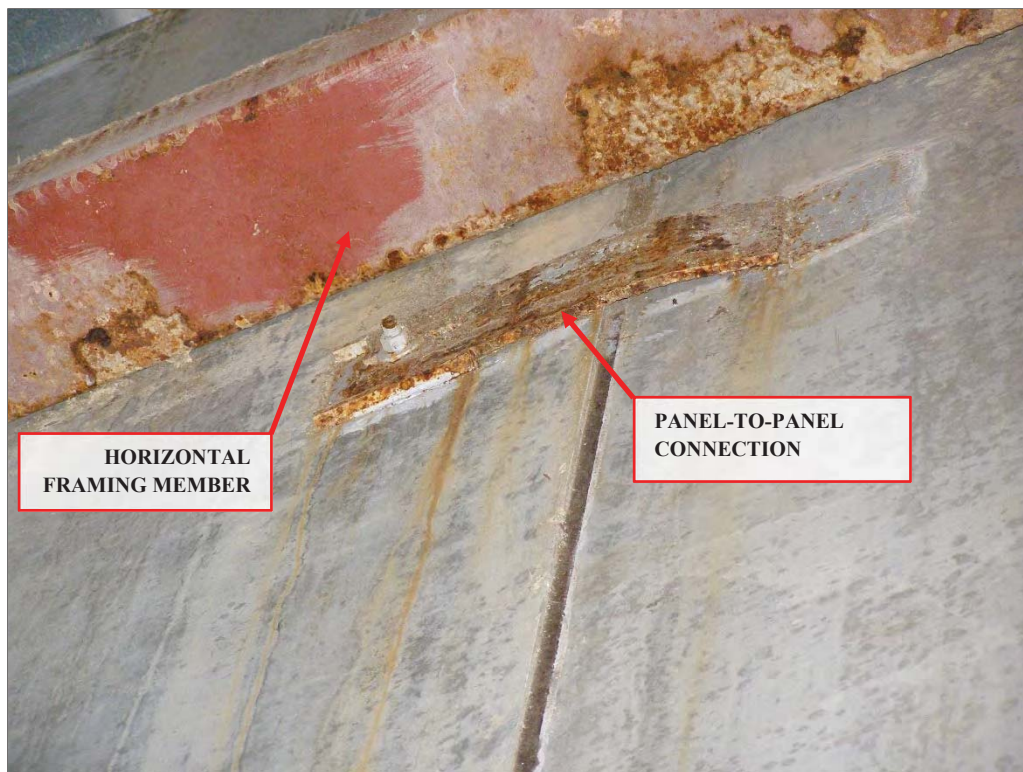
Photo 26: Steel Framing and Connection Corrosion

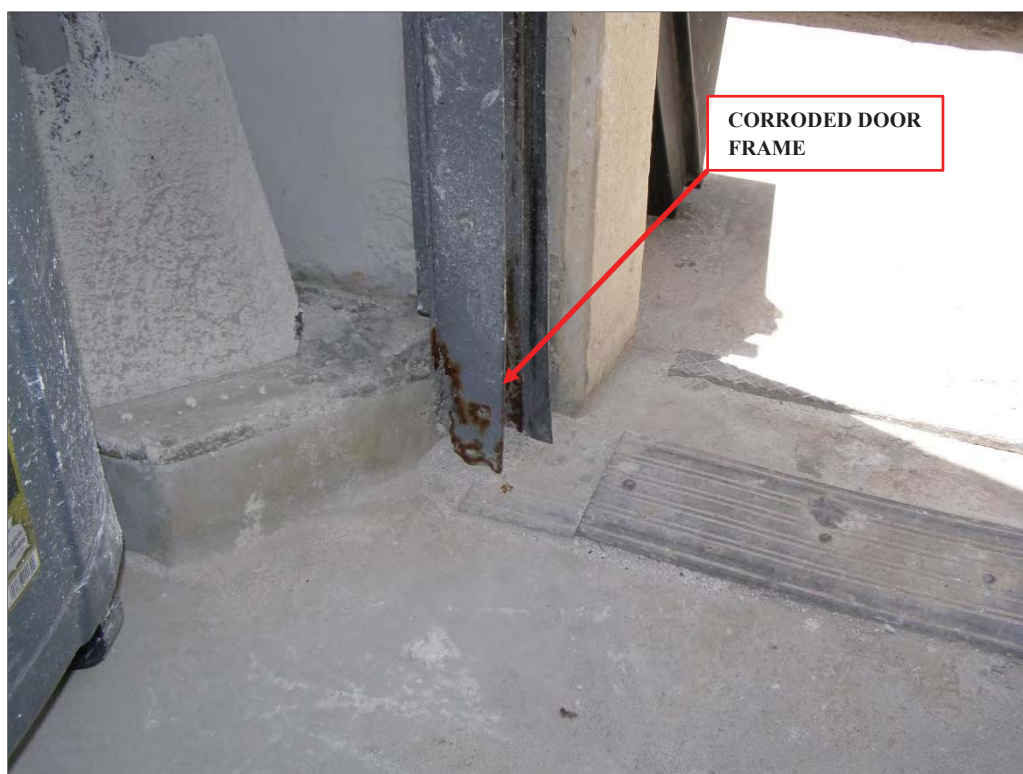
2. One (1) 10' x 14' and two (2) 12' x 9' manually operated overhead coil door provide service access to the Shop Area and the Lime Feed areas. The doors appears to be original to the construction of the facility and are showing advanced corrosion around the base of the tracks.

Photo 27: Overhead Door Frame Corrosion

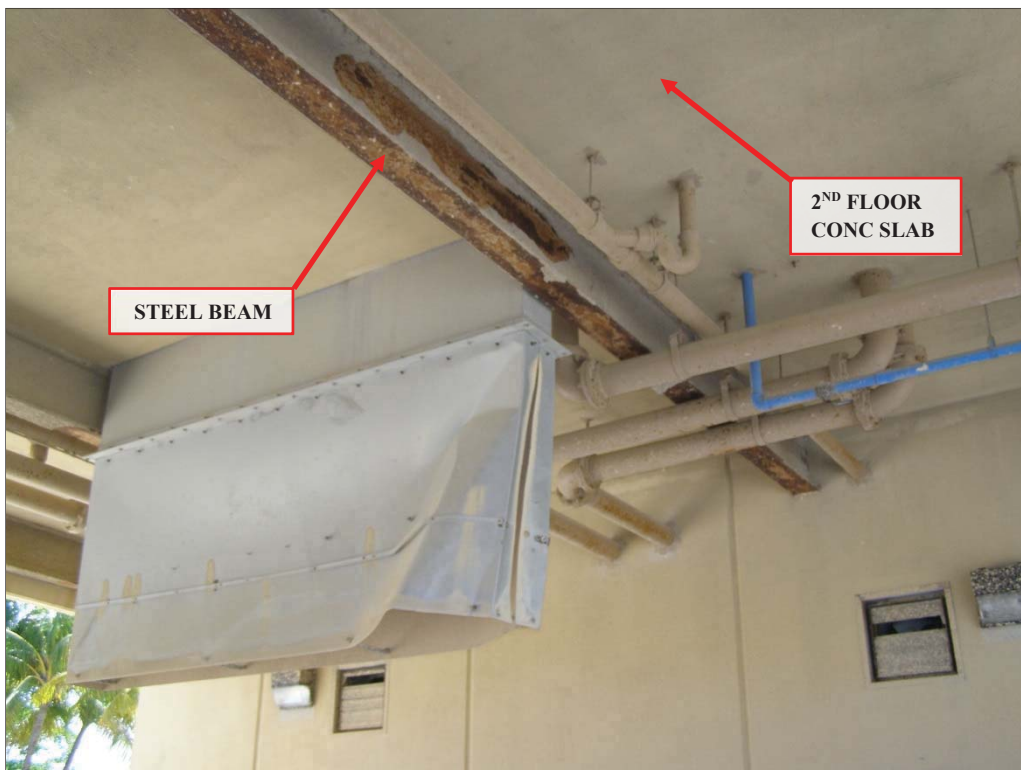
Building construction is steel framing with precast concrete wall panels. The precast wall panel connections are detailed to transfer out-of-plane and in-plane loads only. Gravity loads from the roof and floor are carried by the steel framing. Roof framing is a combination of W-shape steel beams and H-series bar joists that support metal roof deck. The second floor is an 8" concrete slab that acts compositely with the W-shape floor framing. The concrete foundations are mostly isolated column footings with some continuous wall footings to support the precast panels that extend to the ground level. Most structural members and components were observed to be in good condition overall, with the exception of some of the second floor steel framing that has started corroding due to loss of sprayed-on fire protection.

Photo 29: 2nd Floor Framing Corrosion

1. Clean steel framing that is corroded and respray with fire protection. ROM \$8,000.
2. Retrofit metal deck attachment by adding mechanical fasteners. Roofing replacement would be required for this retrofit. ROM \$42,000.
