Pre-Renovation Report of Building Material Survey, Sampling and Evaluation of Asbestos-Containing Materials

Denny's

2671 North Federal Highway

October 26, 2018

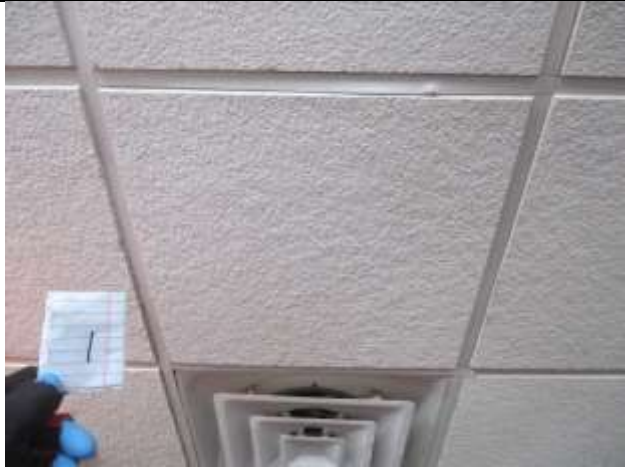
**HA 1- White 2' x 2' ACT
with Rough Finish**

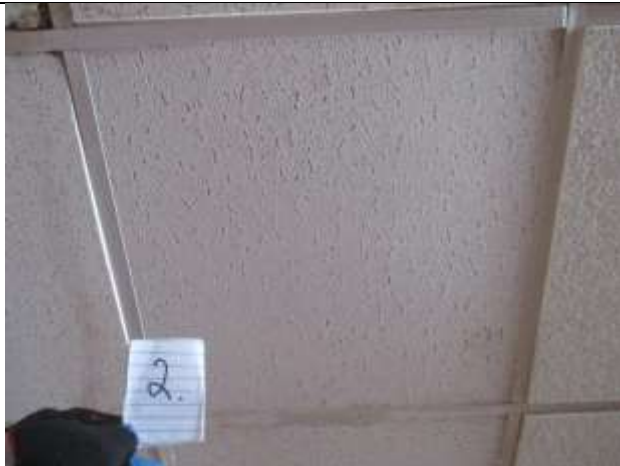
**HA 2- White 2' x 2' ACT
with Waves Pattern**

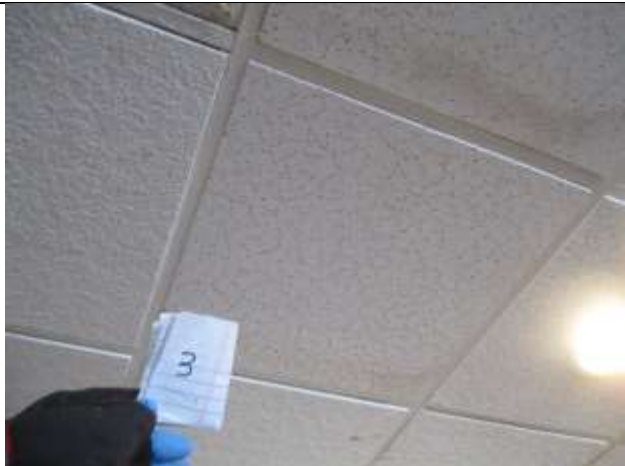
**HA 3- White 2' x 2' ACT
with Dot/Gash Pattern**

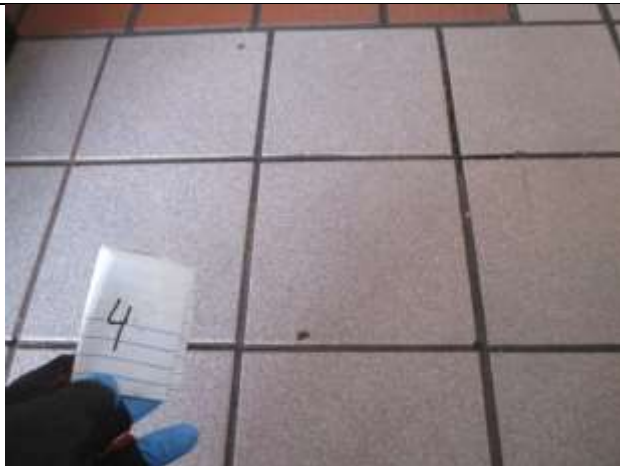
**HA 4- Gray 8' x 8' Ceramic Floor Tile
and Grout**

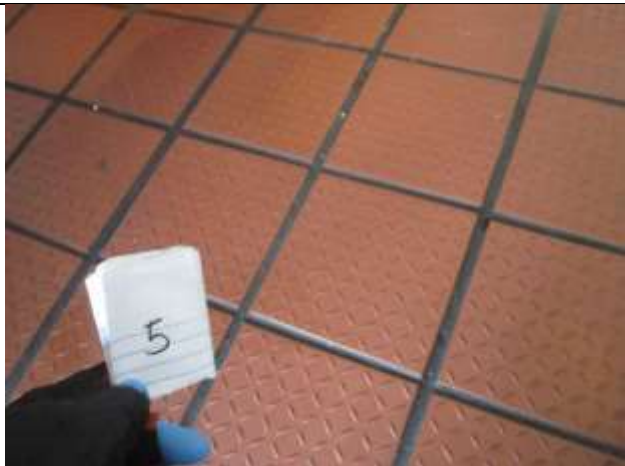
**HA 5- Orange 4' x 4' Ceramic Floor Tile
and Grout**

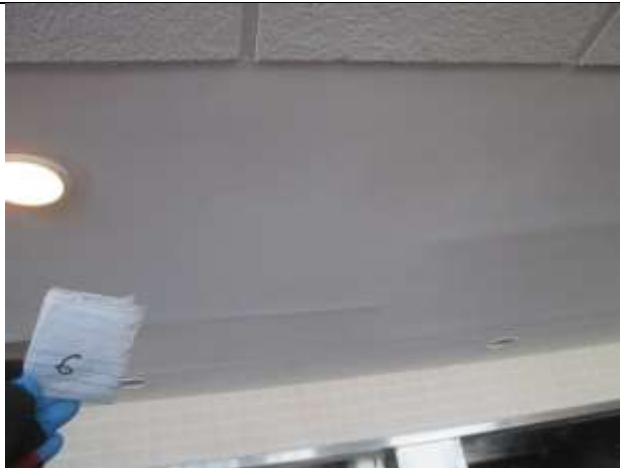
Homogenous Area (HA) Material	Location	Percentage/ Type	Material Condition/ Friability	Approximate Quantity	Category
HA 6: Drywall System Ceilings	Throughout Dining Room, Bathrooms, and Back Area	Drywall: ND Joint Compound: 0.25% Chrysotile*	Fair/ Friable	950 SF	OSHA (non-ACM)
HA 7: Drywall System Walls	Throughout the Interior	Drywall: ND Joint Compound: 0.50% Chrysotile*	Fair/ Friable	Throughout	OSHA (non-ACM)
HA 29: White Mastic on Air-Conditioning Units	Northwest Area Units on Flat Roof	ND-8% Chrysotile	Fair/ Non-Friable	30 SF	Category II NESHAPs
HA 30: Black Mastic on Air-Conditioning Units	Northwest Area Units on Flat Roof	ND-10% Chrysotile	Fair/ Non-Friable	20 SF	Category II NESHAPs
Inaccessible Black Duct Mastic	Above Drywall System Ceilings	Presumed	Unknown	Unknown	Category II NESHAPs

HA 6- Drywall System Ceilings

- **Occupational Safety and Health Administration (OSHA):** The results of the initial laboratory analysis for the friable drywall system walls and ceiling joint compound layer using the visual estimation method of quantification identified <1% chrysotile asbestos in the joint compound of five (5) samples. In accordance with Environmental Protection Agency (EPA) recommendations, the samples were then analyzed using the point count method of quantification. The results of the point count analysis were that the samples were <1% chrysotile asbestos. As such, the EPA does not consider these materials to be ACM. However, OSHA regulations pertaining to asbestos personnel exposure still apply to materials that contain <1% asbestos.

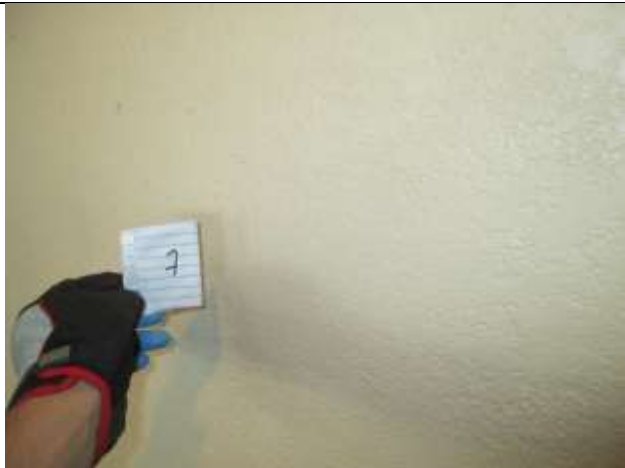
HA 7- Drywall System Walls

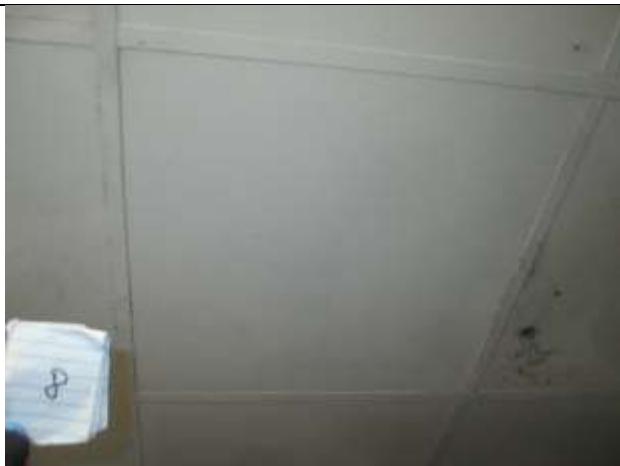
HA 8- White 2' x 2' Gypsum ACT

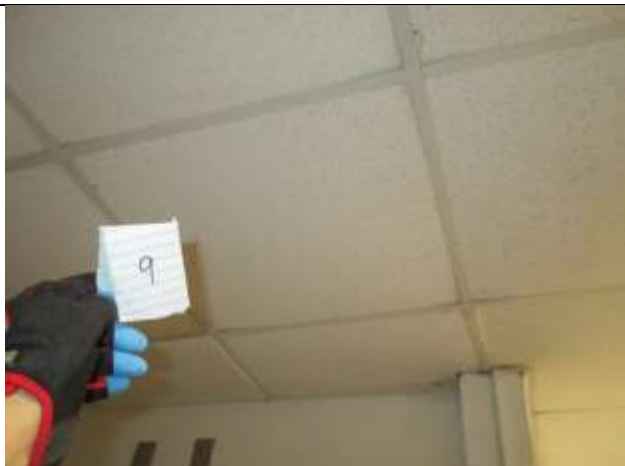
**HA 9- White 2' x 2' ACT
with Dot Pattern**

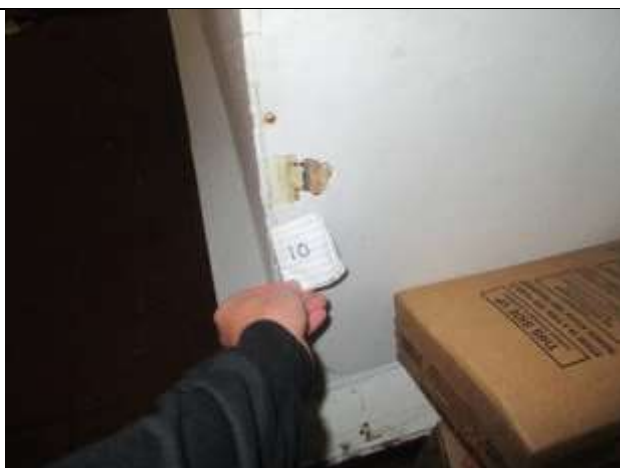
HA 10- Fiberglass Rigid Wall Panel and Glue

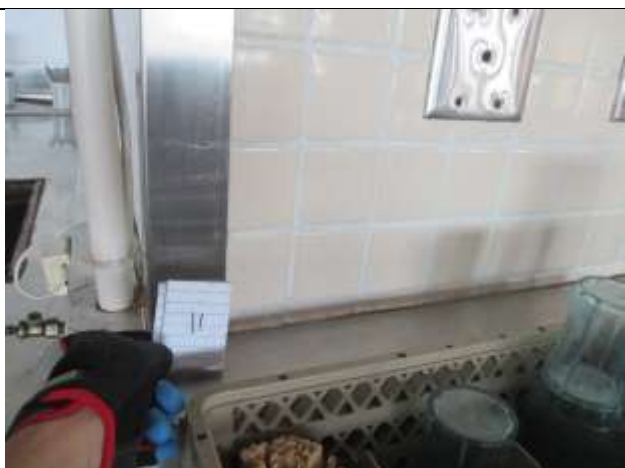
HA 11- Beige 3' x 3' Ceramic Wall Tile and Glue

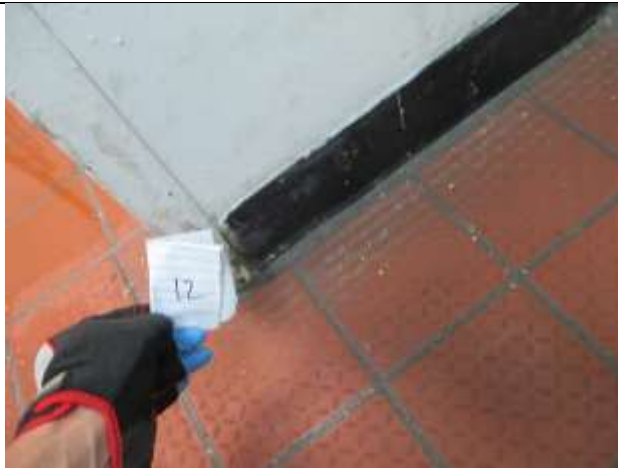
HA 12- Black 4" Vinyl Floor Cove and Mastic

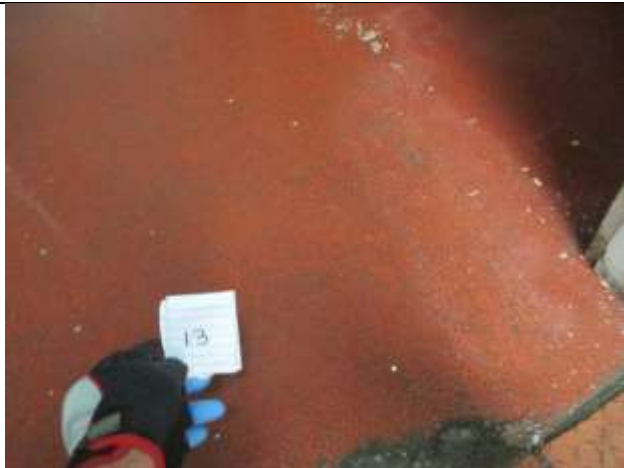
HA 13- Red Rolled Sheet Flooring and Glue

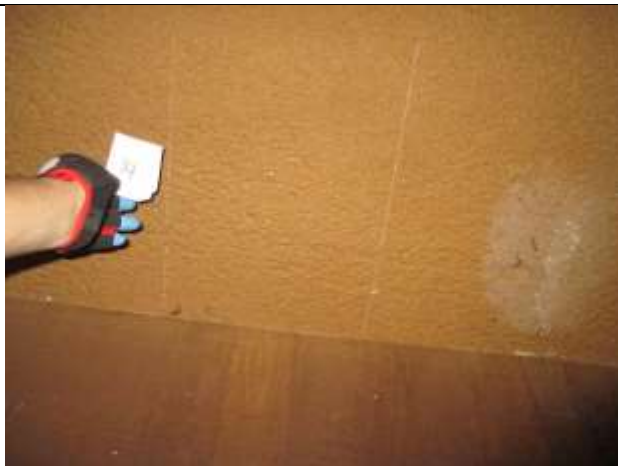
HA 14- Tan 1' x 1" ACT Above Plenum

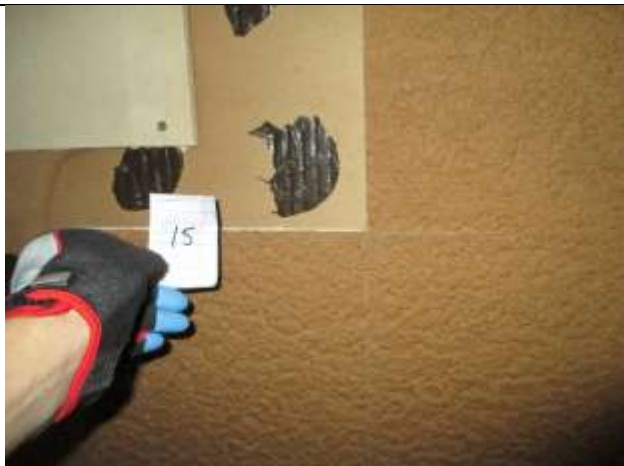
HA 15- Brown Mastic Above Plenum

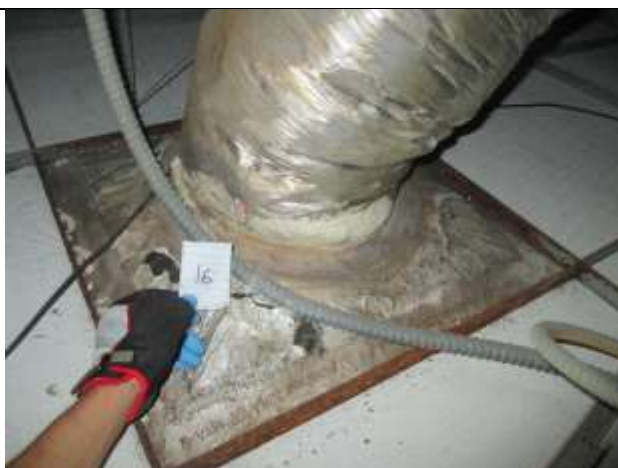
HA 16- White Mastic at Air-Conditioner Vent

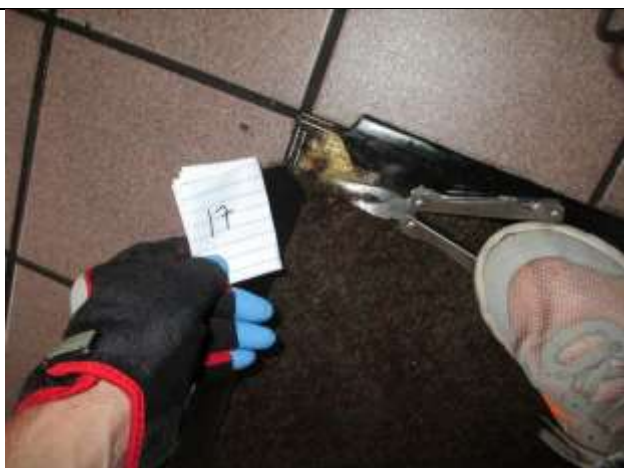
HA 17- Yellow Carpet Glue

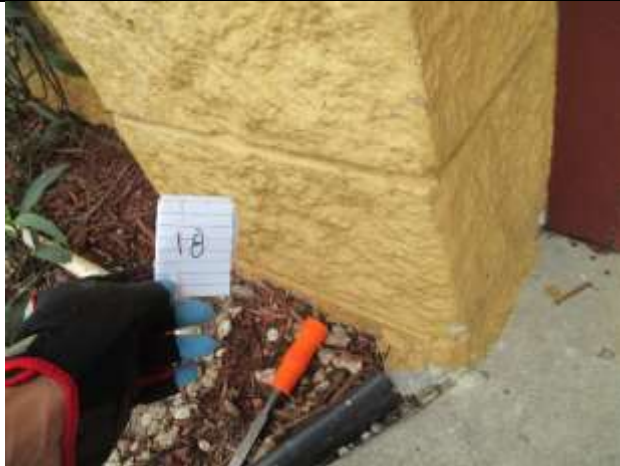
HA 18- Exterior Stucco

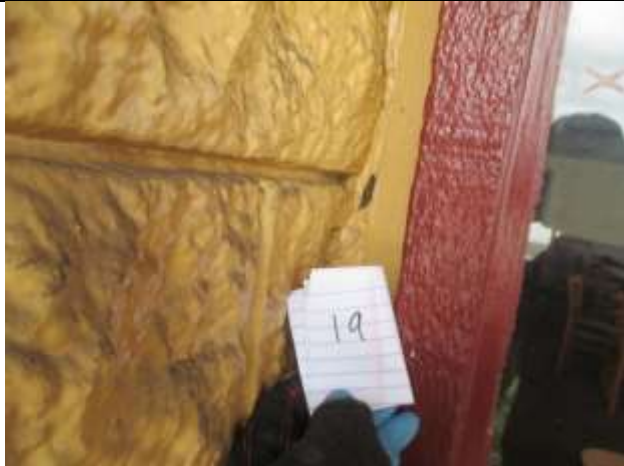
HA 19- Exterior Door Caulk

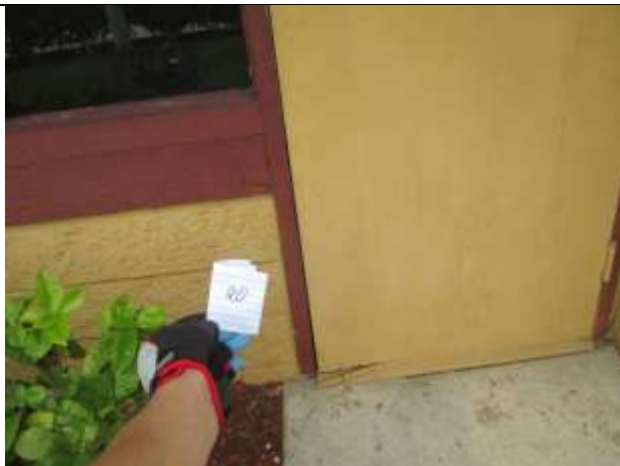
HA 20- Exterior Window Caulk

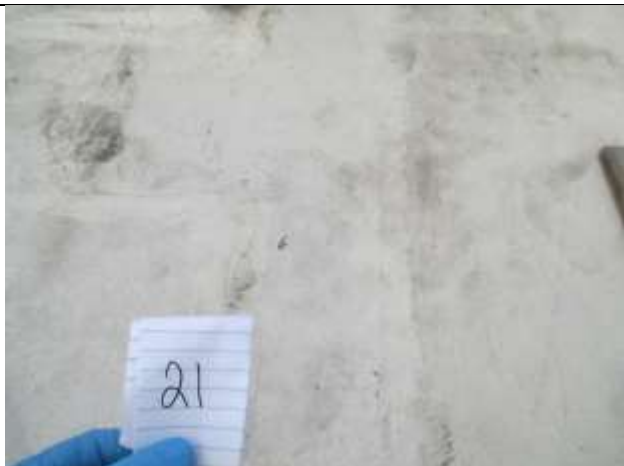
**HA 21- Built-Up Bituminous Roofing Material
at Membrane**

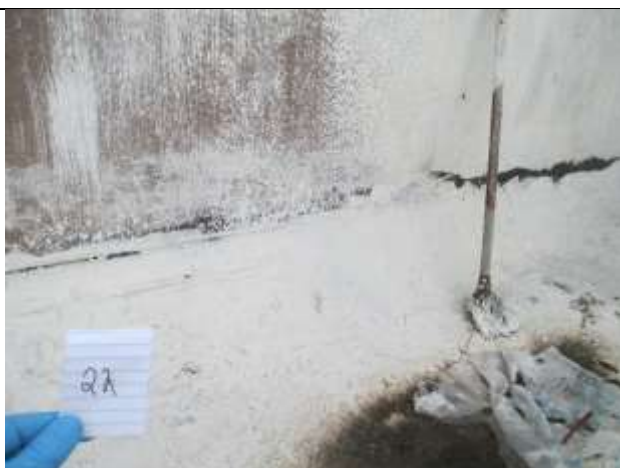
**HA 22- Built-Up Bituminous Roofing Material
at Flashing**

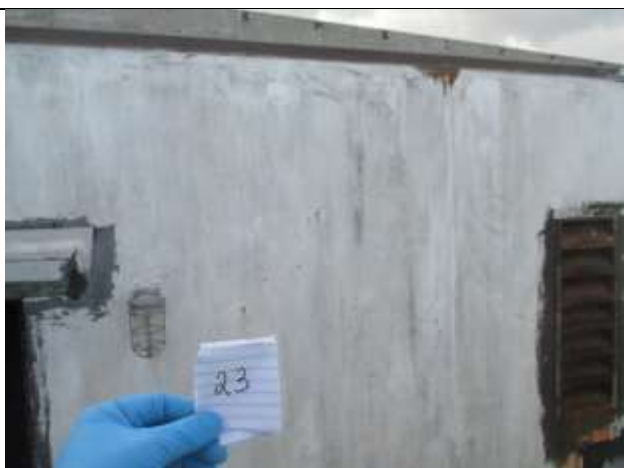
HA 23- Plaster at Parapet Walls

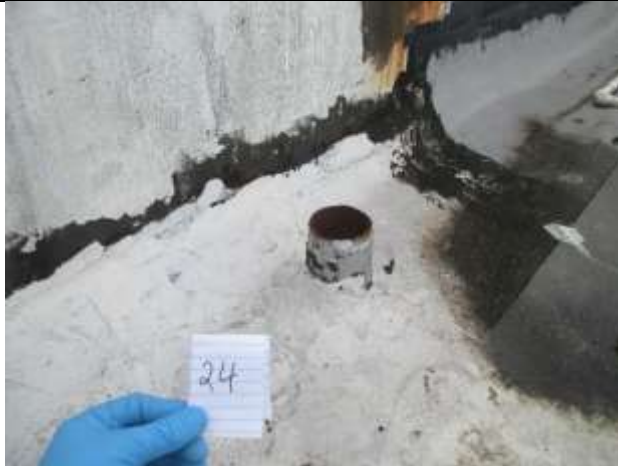
**HA 24- Built-Up Bituminous Roofing Material
at Deck Penetrations**

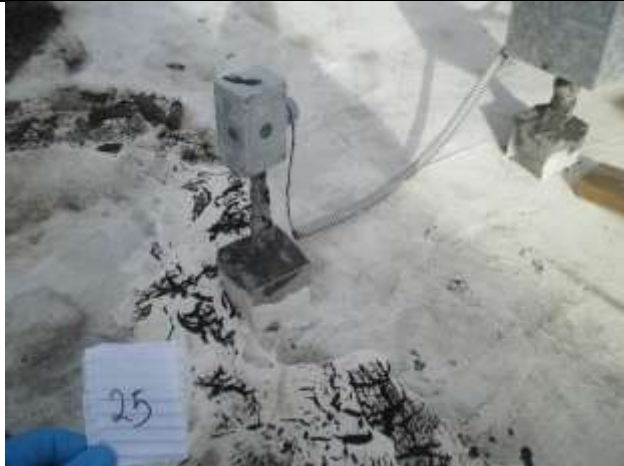
HA 25- Pitch Pan Mastic

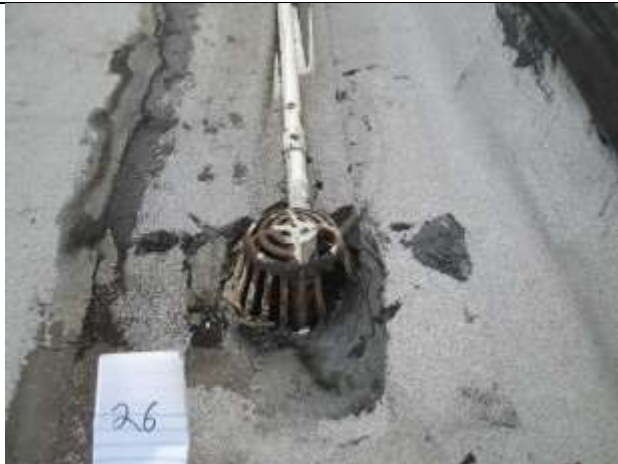
**HA 26- Built-Up Bituminous Roofing Material
at Drains**

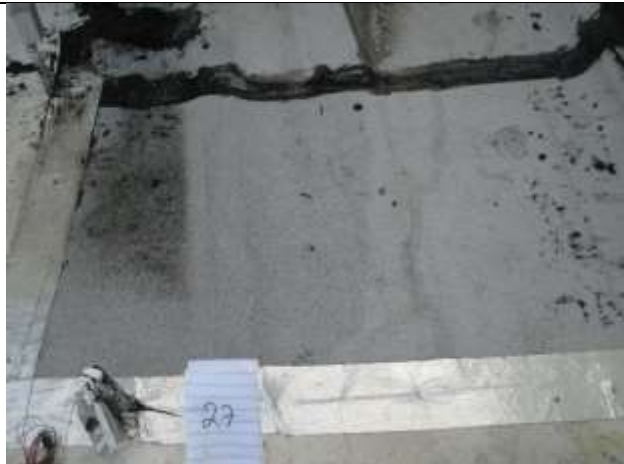
**HA 27- Built-Up Bituminous Roofing Material
Patch**

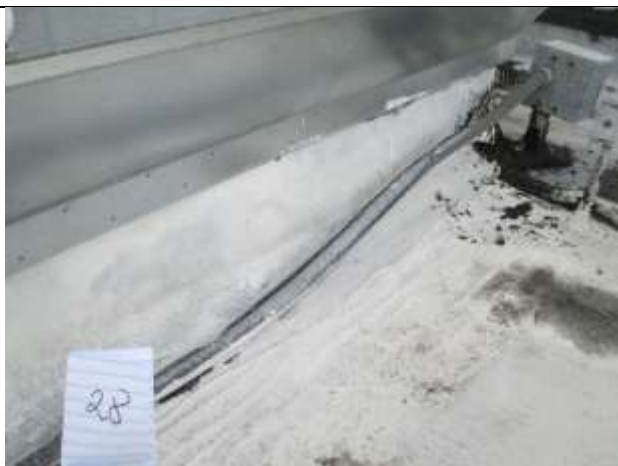
**HA 28- Built-Up Bituminous Roofing Material
at Vent Curbs**

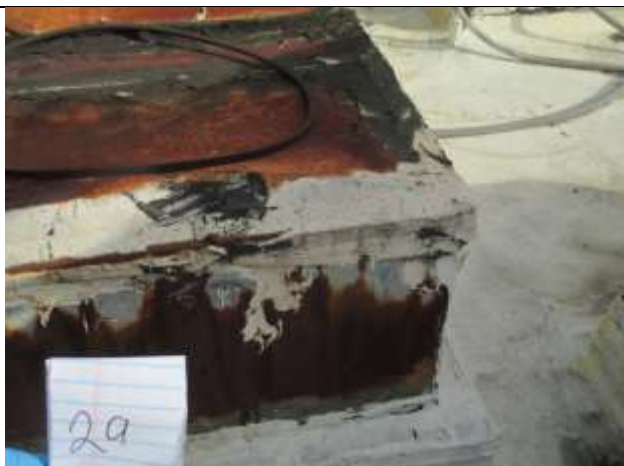
**HA 29- White Mastic on Air-Conditioning Unit
Asbestos Containing Material**

- **Category I:** Category I nonfriable ACM refers to asbestos-containing packing, gaskets, resilient floor coverings, and asphalt roofing products.
- **Category II:** Category II nonfriable ACM refers to any material that is not classified under Category I.
 - Renovation Activities: There is no regulatory guideline that requires removal of Category II nonfriable ACM unless they will be disturbed during renovation or demolition activities. If the Category II nonfriable ACM is to be impacted or removed, the removal must be conducted by a Florida Licensed Asbestos Abatement Contractor, with prior notification to the appropriate County and the State of Florida agencies.

Category II nonfriable ACM that will remain in place during demolition must be kept wet during demolition activities, segregated from the waste stream and disposed of in a Class I landfill capable of accepting such material. The demolition crew must abide by OSHA regulations pertaining to asbestos exposure. The owner should consider removal prior to demolition as this may be more cost-effective than complying with OSHA regulations, the costs associated with segregating the waste stream and the additional disposal costs.

Prior to the removal or in-place wet demolition of Category II nonfriable material, notification to the appropriate County and the State of Florida agencies is required.

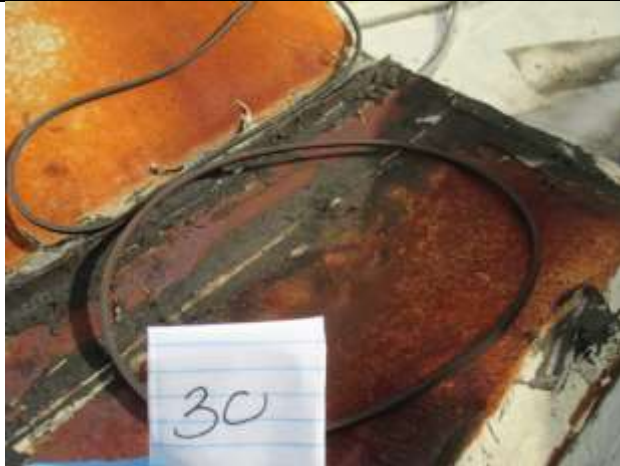
HA 30- Black Mastic on Air-Conditioning Unit
Asbestos Containing Material

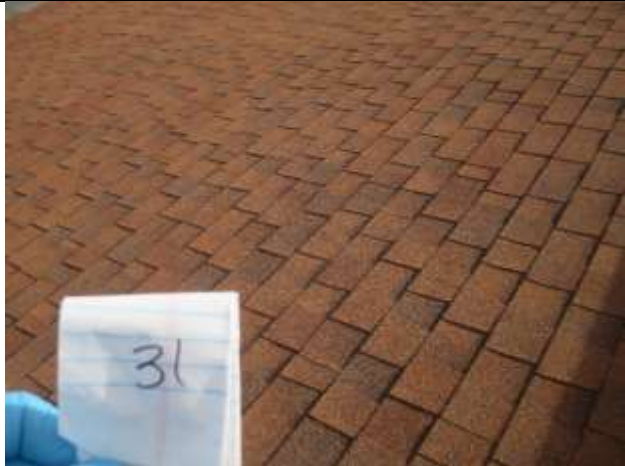
HA 31- Shingles at Roof Sides

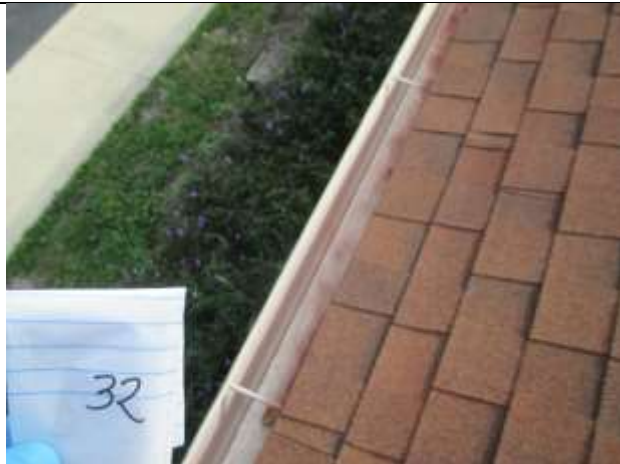
HA 32- Shingles at Side Roof Edges

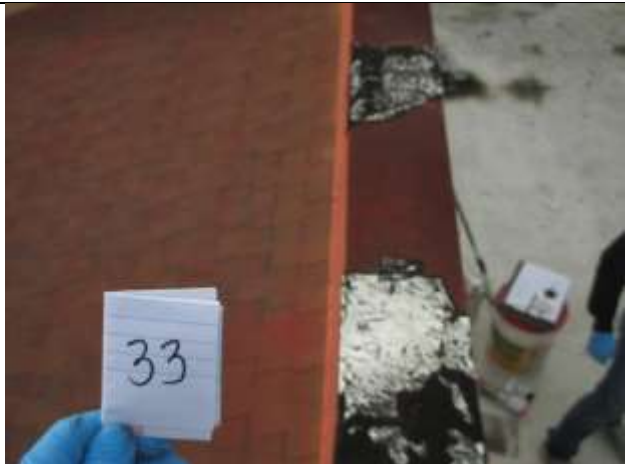
HA 33- Black Mastic at Top of
Parapet Wall

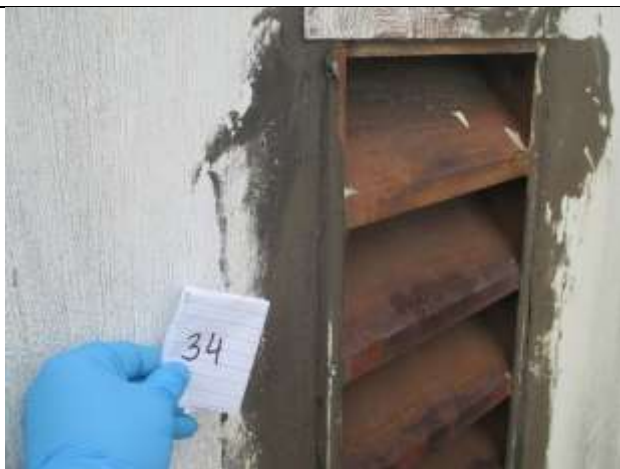
HA 34- Black Mastic at Louvers

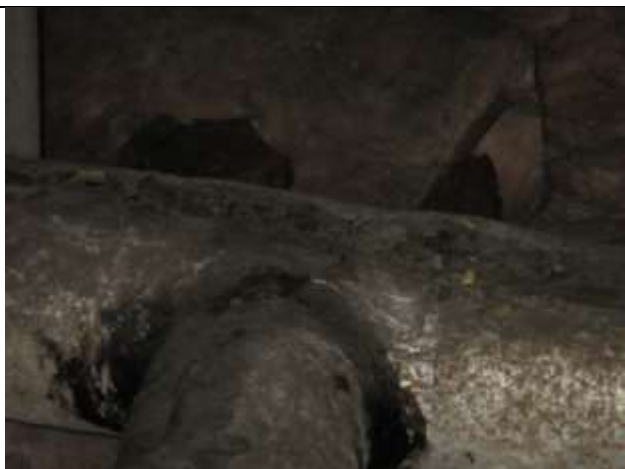
Black Mastic Above Drywall System Ceiling
Assumed Asbestos Containing Material
