PZ25-12000027

## Arboriculture Tree Report

### Lots 930,931,932 & 933, Collier City

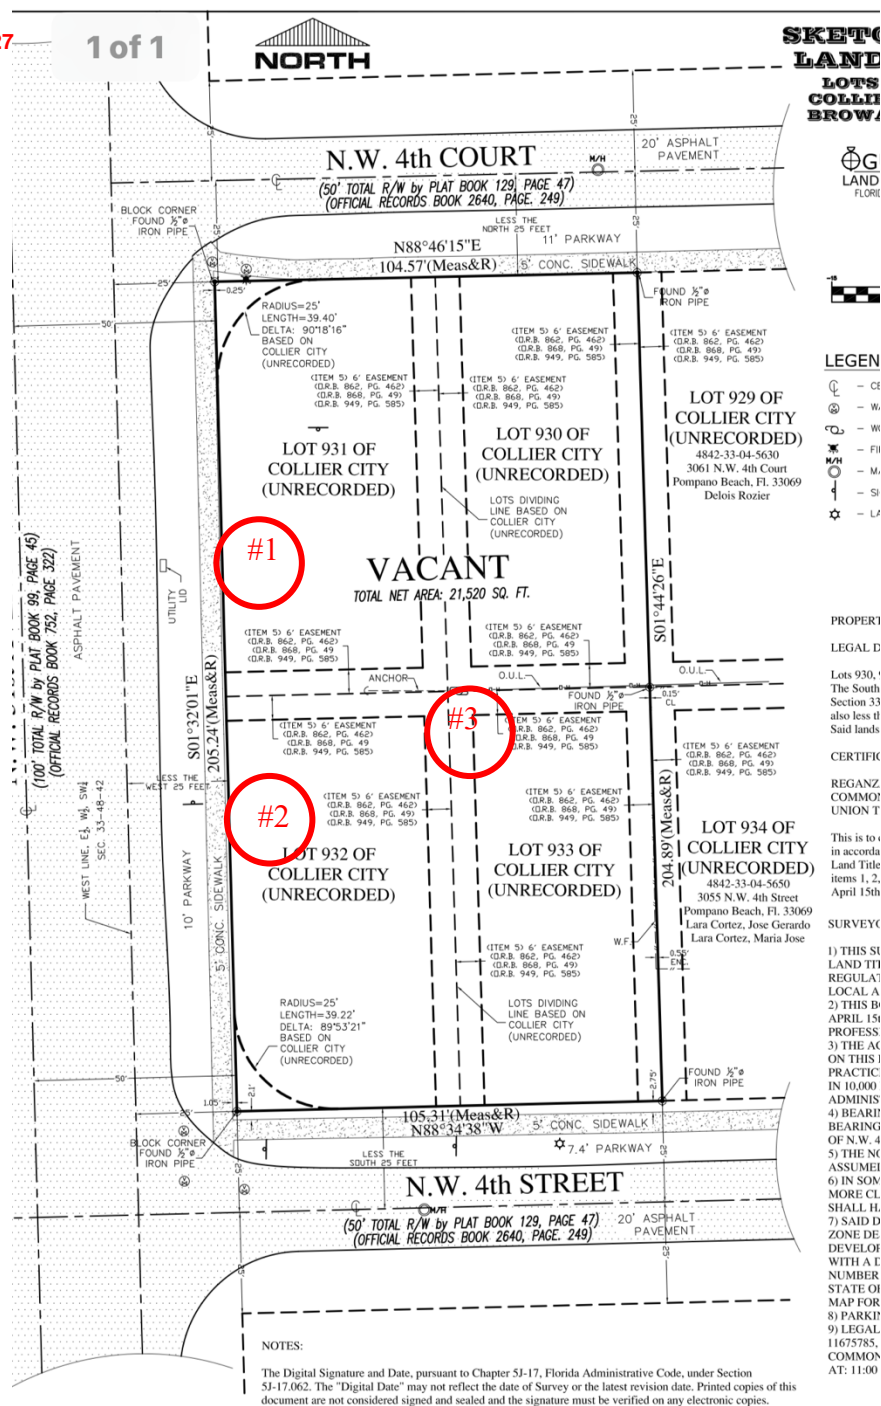
Please see survey with tree locations, excel spreadsheet and pictures below. All trees accessible have been tagged with numbers that correspond with report and survey.
