TREE RELOCATION PLAN FOR PALM AIRE CLUBHOUSE PROJECT

PZ23-12000017

03/05/2025

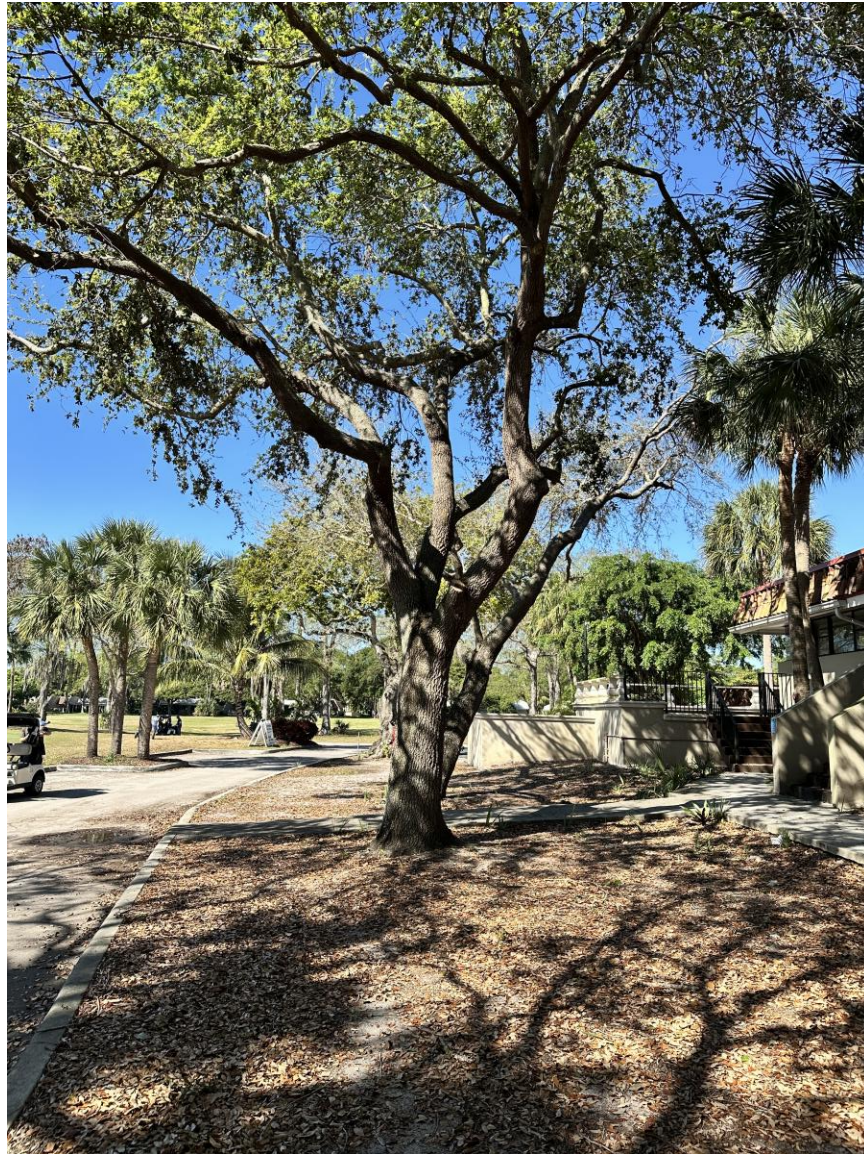
Tree Number 159

Looking north at Live Oak, the curbing on the west side of the tree should be far enough away to perform root pruning immediately inside of the back of the curbing. It is recommended to utilize a pneumatic air tool to excavate the soil and then utilize clean, sharp hand tools that can include a hand saw and loppers for pruning the exposed roots.

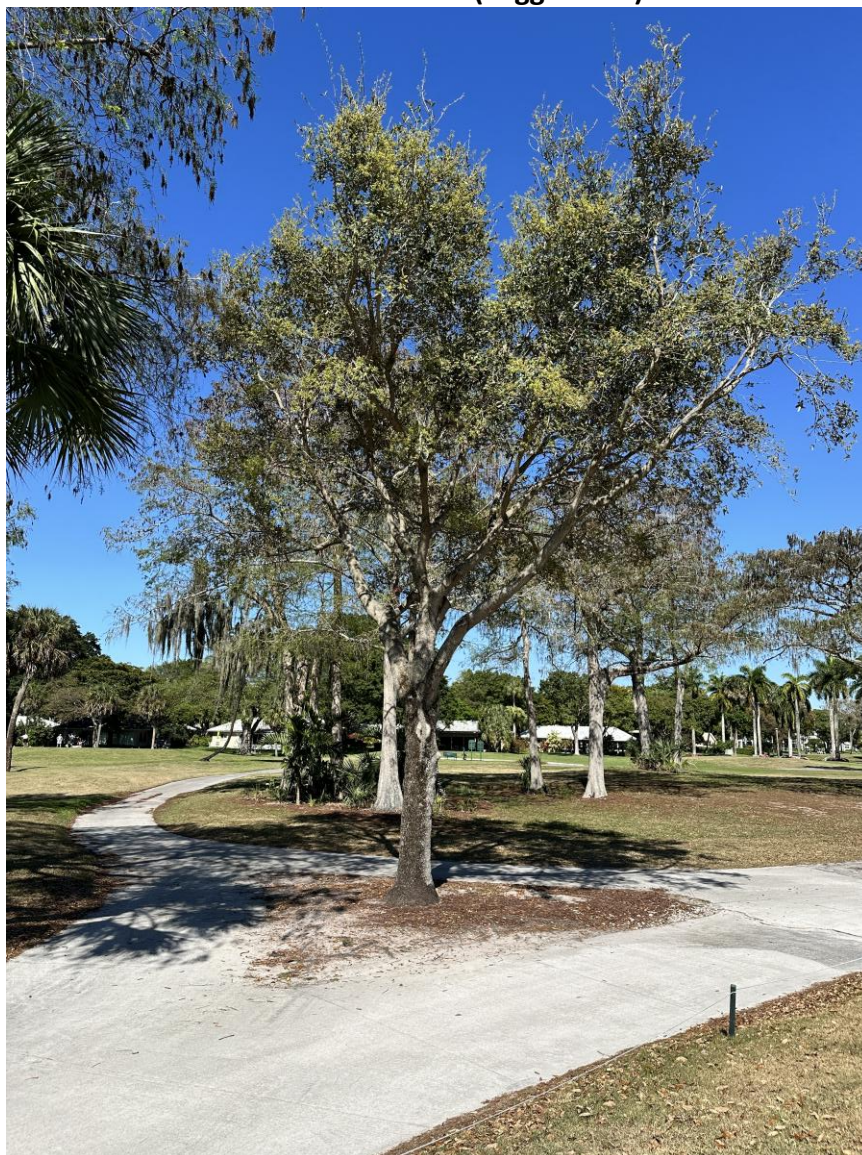
Tree Number 170 (Tagged 171)

Looking north at Live Oak. Our inspection found that this tree has good health and structure being suitable for a relocation effort. The tree is 30 feet tall with an average canopy spread of 25 feet. The diameter of the trunk was measured at dbh. The diameter was 18 inches. The trees health condition rating was 65% at the time of our inspection. The tree has surface root damage and is confined on all sides by cart path. The root ball radius should be 72 inches or immediately within the confines of the cart path. The use of a pneumatic air tool is recommended to remove the soil along the edge of the cart path to expose the roots for pruning. Inspection by the Consulting Arborist is recommended at this time to verify the roots before pruning. No crown pruning is necessary during the preparation period of this tree.

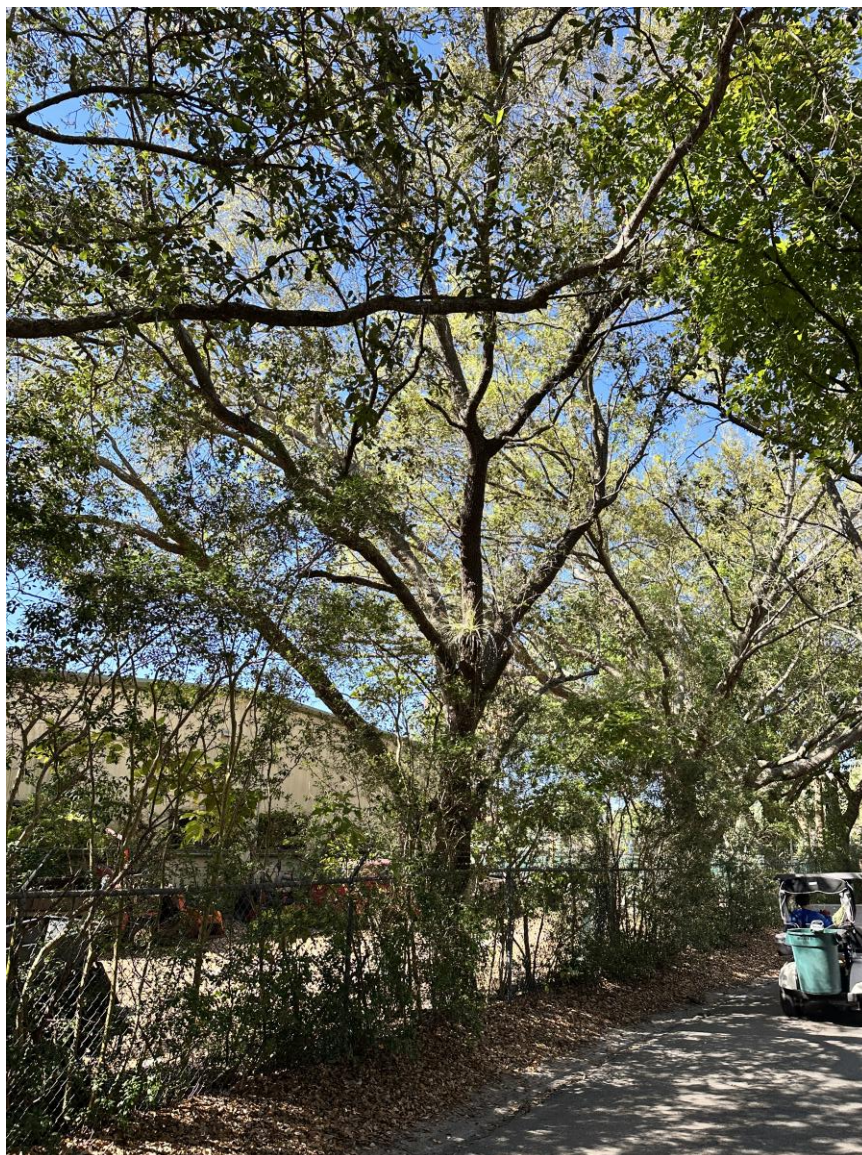
Tree Number 267

View looking northwest at Live Oak, *Quercus virginiana*. Our inspection found that this tree has good health and structure being suitable for a relocation effort. The tree is 40 feet tall with an average canopy spread of 35 feet. The diameter of the trunk was measured three feet above ground level, immediately beneath the branching. The diameter was 23 inches. The tree's health condition rating was 60% at the time of our inspection. The tree has dieback of twigs and small limbs with minor trunk damage. The canopy is suppressed on the east and south sides. A small portion of the east and west sides of the root system has been impeded by existing asphalt. The root ball radius should be 92 inches. The use of a pneumatic air tool is recommended to remove the soil along the edge of the asphalt to expose the roots for pruning. Inspection by the Consulting Arborist is recommended at this time to verify the roots before pruning. No crown pruning is necessary during the preparation period of this tree.
