TREE RELOCATION PLAN FOR PALM AIRE CLUBHOUSE PROJECT

PZ23-12000017

06-25-2025

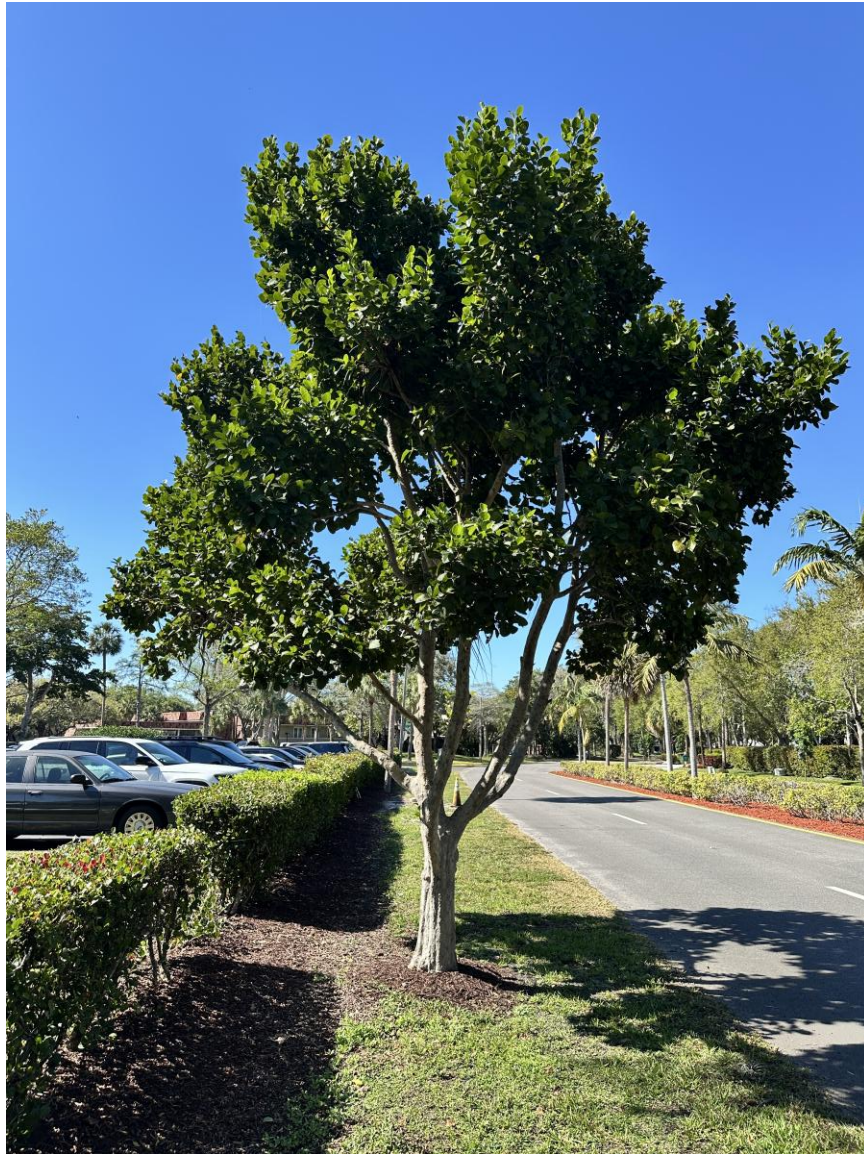
Tree Number 42

View looking north at a Pigeon Plum, *Coccoloba diversifolia*. Our inspection found that this tree has good health and structure being suitable for a relocation effort. The tree is 25 feet tall with an average canopy spread of 20 feet. The diameter of the trunk was measured at three feet above ground level immediately beneath the branching. The diameter was 10 inches. The trees health condition rating was 70% at the time of our inspection. The root ball radius should be 50 inches. No crown pruning is necessary during the preparation period of this tree.

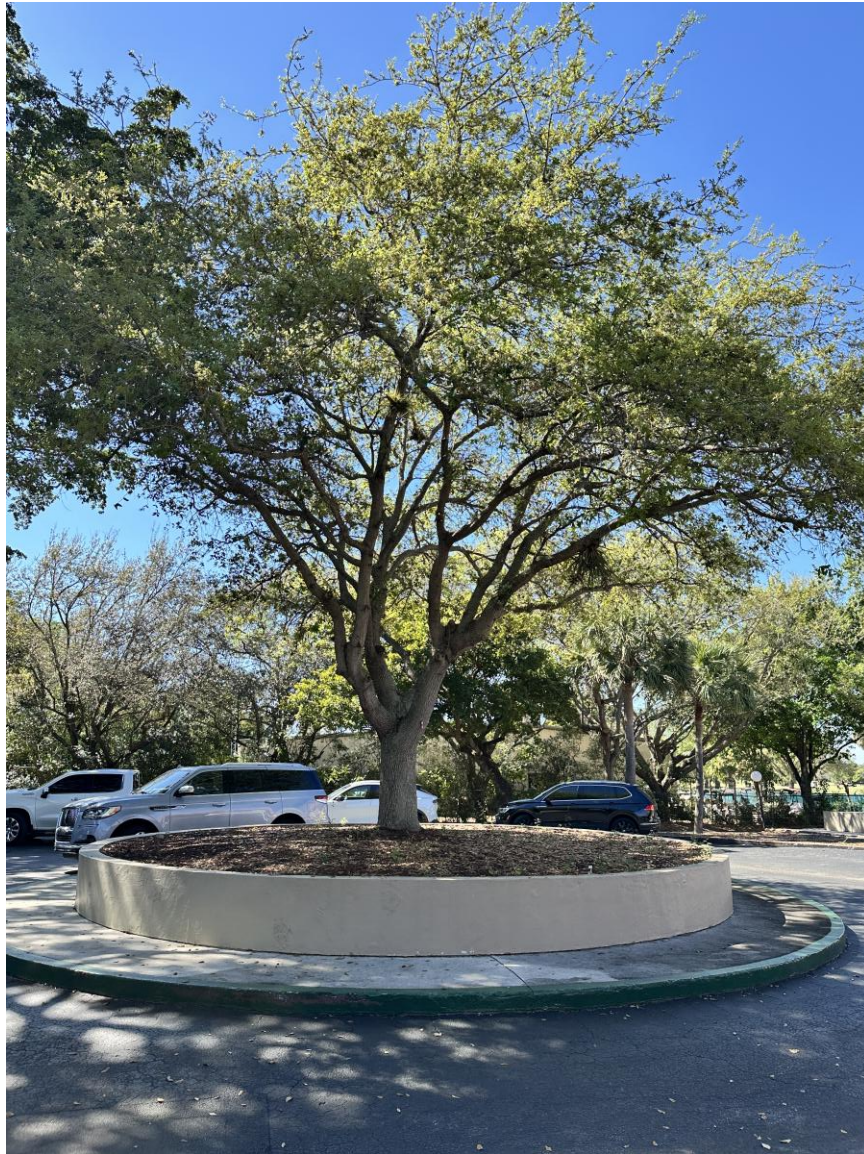
Tree Number 84

View looking west at a Live Oak, *Quercus virginiana*. Our inspection found that this tree has good health and vitality being suitable for a relocation effort. The tree is 35 feet tall with an average canopy spread of 40 feet. The diameter of the trunk was measured at 54 inches above ground level (dbh). The diameter was 20 inches. The tree's health condition rating was 65% at the time of our inspection. The tree has three codominant trunks that formed 66 inches above the ground level and minor stem girdling roots were observed. The tree has been growing within an above ground planter confining the root system. The root ball radius should be 80 inches. No crown pruning is necessary during the preparation period of this tree. It is recommended that the planter walls be removed, and the root ball be shaved or reduced in size with either a pneumatic air tool or by washing the root ball with water to achieve the final radius. This would preserve the maximum number of roots. Inspections by the Consulting Arborist shall occur during this process to provide timely feedback.

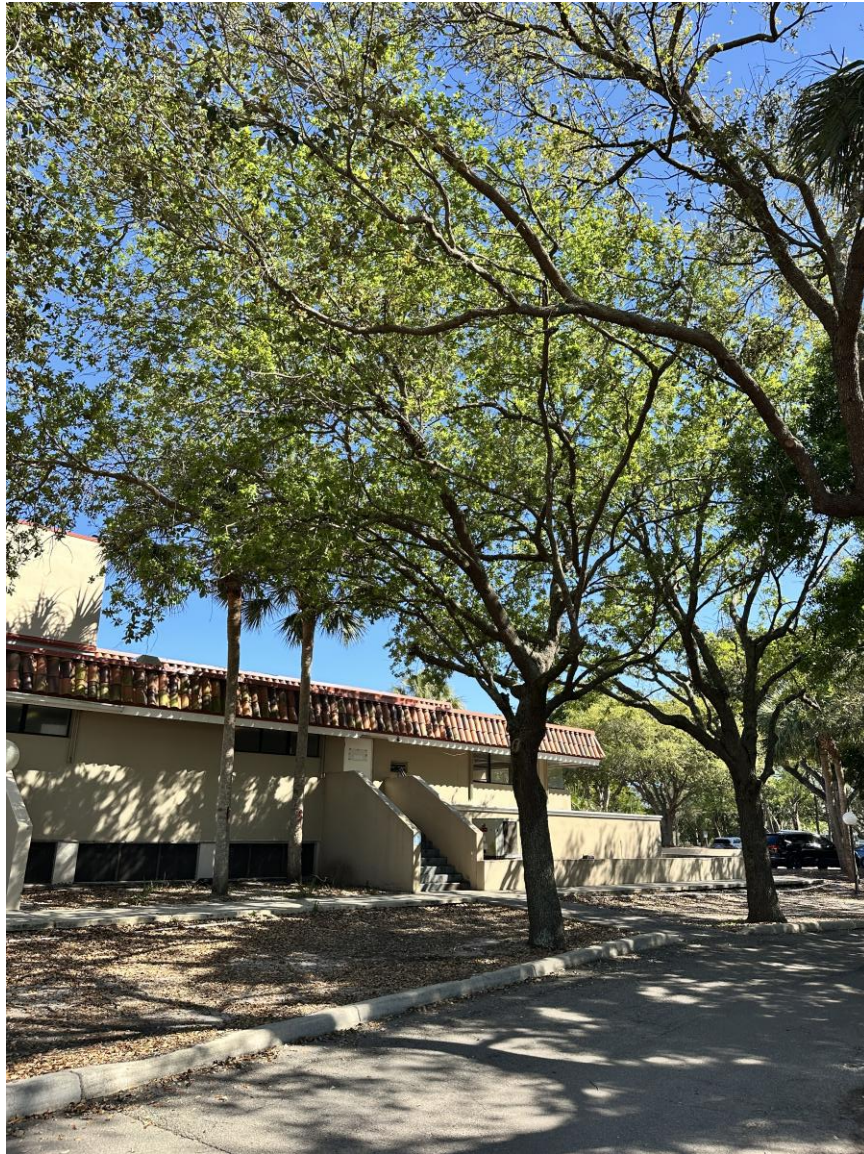
Tree Number 158

View looking southeast at Live Oak, *Quercus virginiana*. Our inspection found that this tree has good health and structure being suitable for a relocation effort. The tree is 45 feet tall with an average canopy spread of 30 feet. The trees' canopy on the south side is suppressed by the adjacent tree. The diameter of the trunk was measured at dbh. The diameter was 20 inches. The trees health condition rating was 65% at the time of our inspection. The tree has bark inclusions, dieback and minor surface root damage. The west side of the root system has been impeded by an existing curb and asphalt cart path and the south side of the tree has an existing sidewalk. The root ball radius should be 80 inches. This will require the removal of the curbing, asphalt cart path and sidewalk by hand. The materials may be broken with pneumatic jackhammers or the like, however no mechanized equipment shall be utilized within nine feet of the tree's trunk. No crown pruning is necessary during the preparation period of this tree.

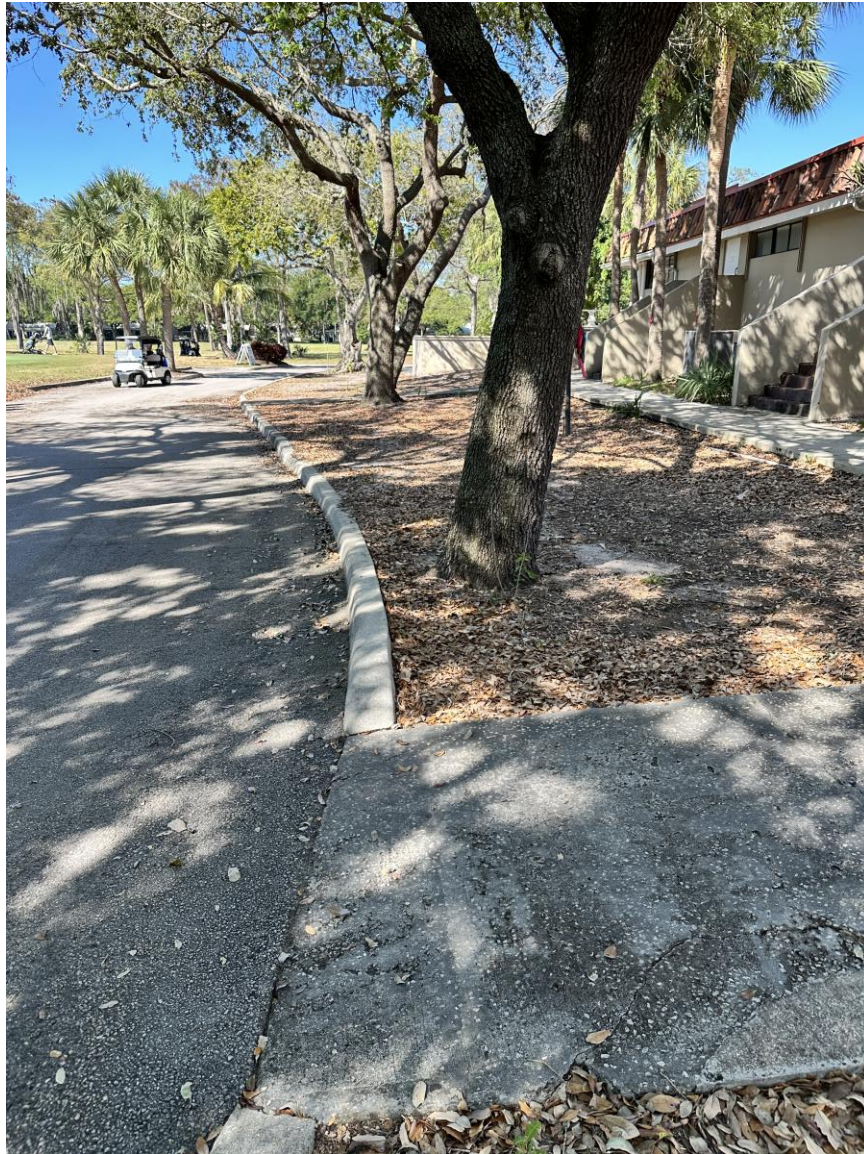
Tree Number 158

View looking north at curbing, cart path and sidewalk. Inspection by the Consulting Arborist after removal of this infrastructure is recommended to review root system and assess continued viability of a relocation effort.

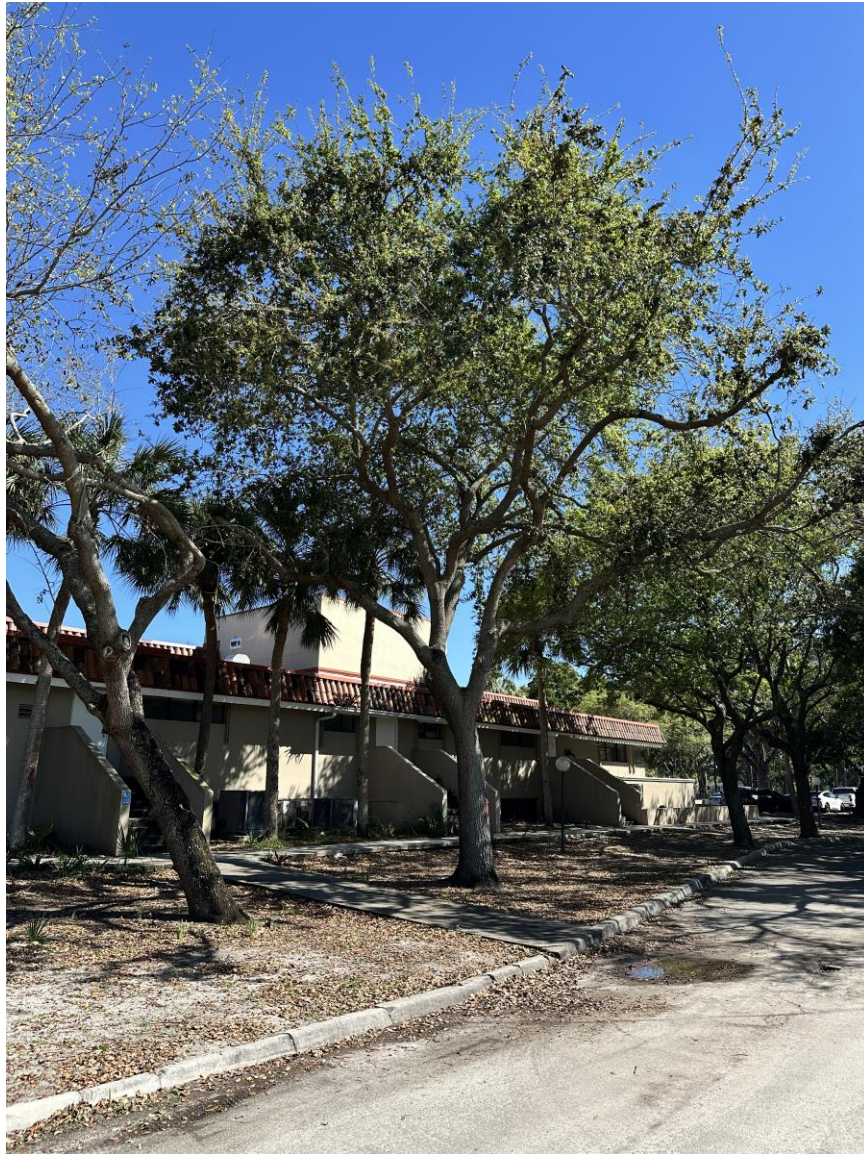
Tree Number 159

View looking southeast at Live Oak, *Quercus virginiana*. Our inspection found that this tree has good health and structure being suitable for a relocation effort. The tree is 45 feet tall with an average canopy spread of 40 feet. The diameter of the trunk was measured at dbh. The diameter was 24 inches. The trees health condition rating was 70% at the time of our inspection. The tree has minor dieback of twigs and small limbs. The north side of the root system has been impeded by an existing sidewalk, see photo below. The root ball radius should be 96 inches. No crown pruning is necessary during the preparation period of this tree.

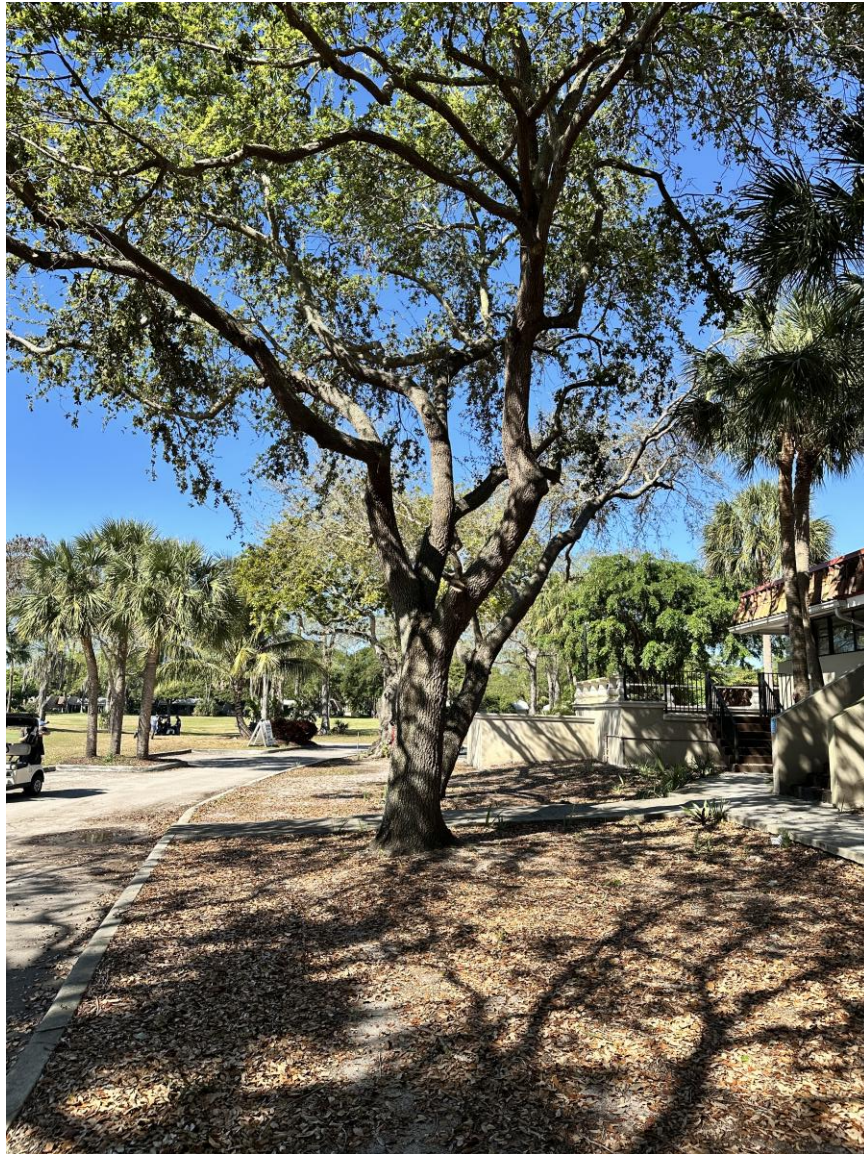
Tree Number 159

Looking north at Live Oak, the curbing on the west side of the tree should be far enough away to perform root pruning immediately inside the back of the curbing. It is recommended to utilize a pneumatic air tool to excavate the soil and then utilize clean, sharp hand tools that can include a hand saw and loppers for pruning the exposed roots.

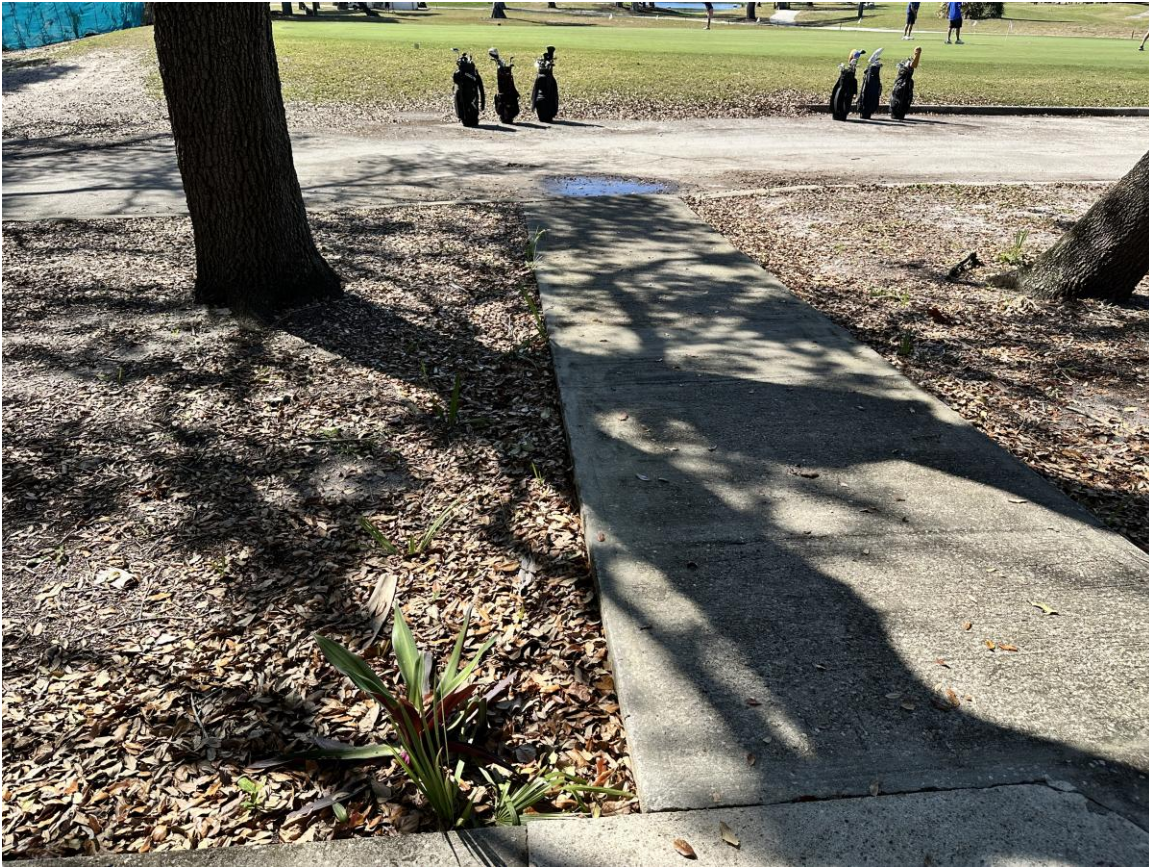
Tree Number 159

Looking west at the existing sidewalk. The removal of the sidewalk shall be by hand. The materials may be broken with pneumatic jackhammers or the like, however no mechanized equipment shall be utilized to remove the debris from beneath the tree.

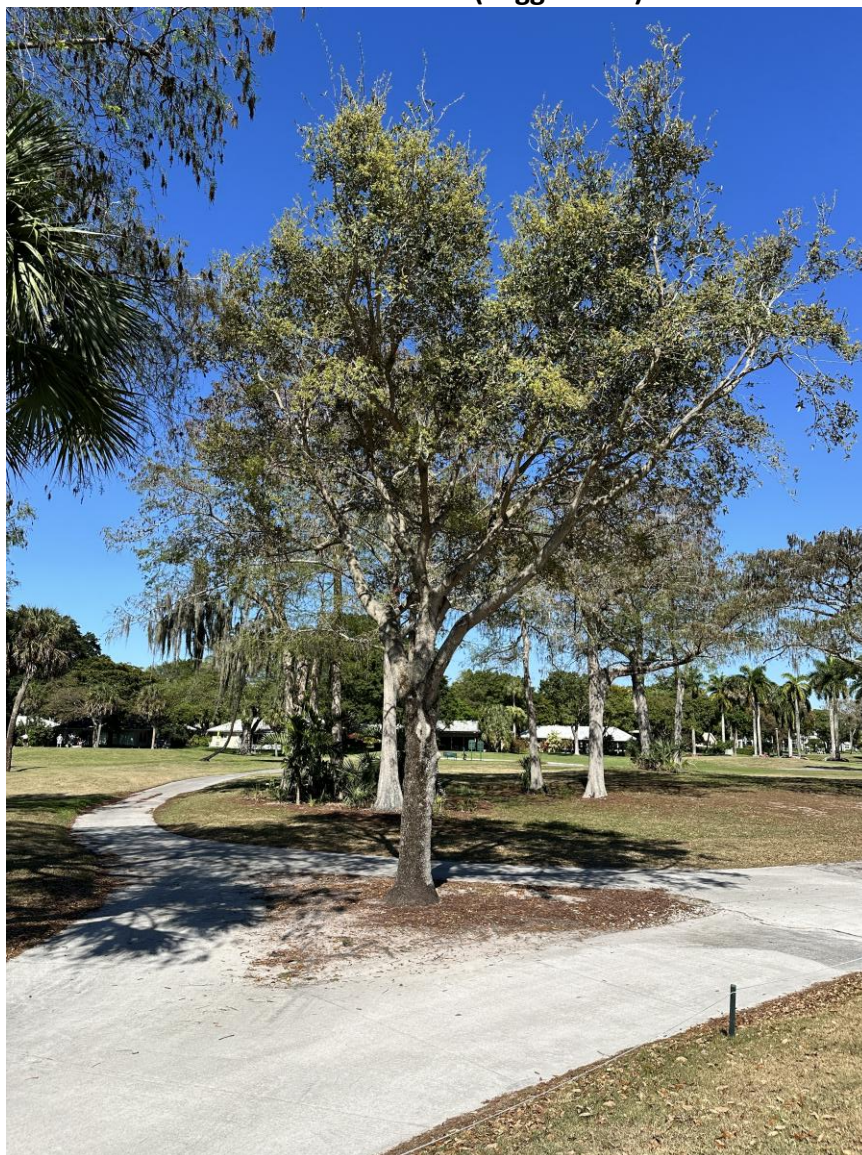
Tree Number 170 (Tagged 171)

Looking north at Live Oak. Our inspection found that this tree has good health and structure being suitable for a relocation effort. The tree is 30 feet tall with an average canopy spread of 25 feet. The diameter of the trunk was measured at dbh. The diameter was 18 inches. The trees health condition rating was 65% at the time of our inspection. The tree has surface root damage and is confined on all sides by cart path. The root ball radius should be 72 inches or immediately within the confines of the cart path. The use of a pneumatic air tool is recommended to remove the soil along the edge of the cart path to expose the roots for pruning. Inspection by the Consulting Arborist is recommended at this time to verify the roots before pruning. No crown pruning is necessary during the preparation period of this tree.

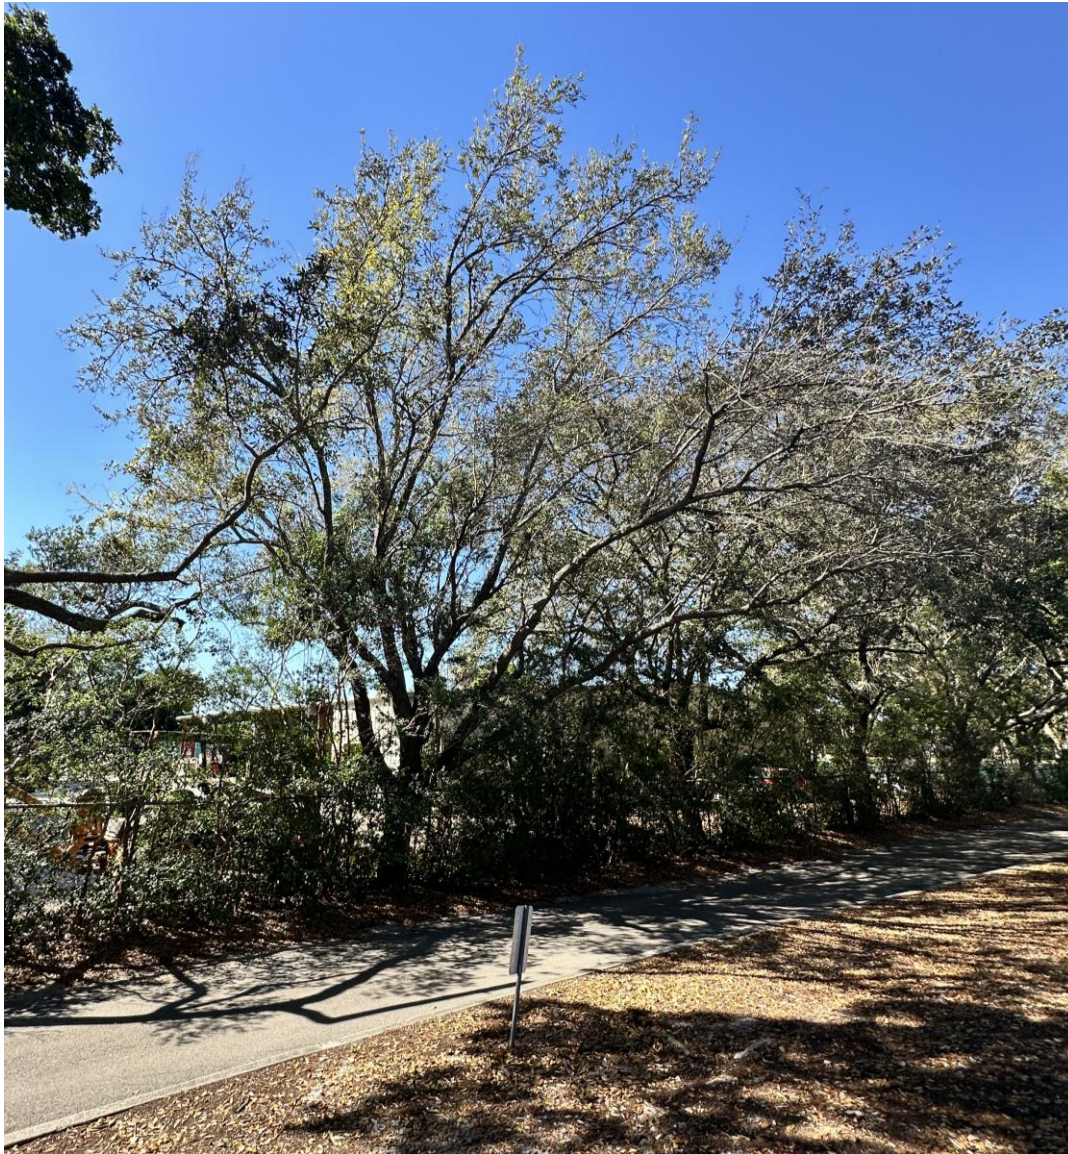
Tree Number 265

View looking west at Live Oak, *Quercus virginiana*. Our inspection found that this tree has good health and structure being suitable for a relocation effort. The tree is 30 feet tall with an average canopy spread of 30 feet. The diameter of the trunk was measured at dbh. The diameter was 20 inches. The trees health condition rating was 65% at the time of our inspection. The tree has minor dieback of twigs and small limbs. A small portion of the east side of the root system has been impeded by an existing asphalt cart path. The root ball radius should be 80 inches. Crown reduction on the east side of the tree reducing two to three-inch diameter limbs six to eight feet in length from the ends of the branches This will improve canopy balance. Maximum eight pruning cuts are needed.

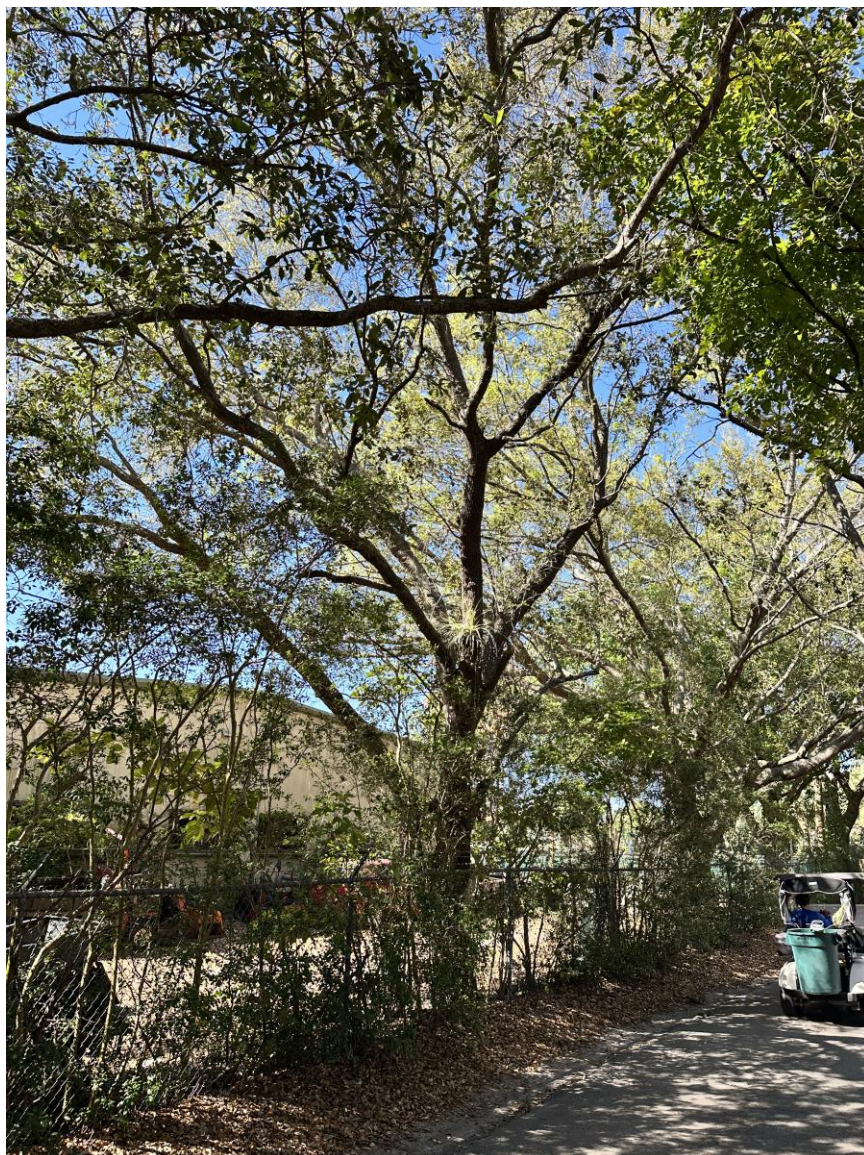
Tree Number 267

View looking northwest at Live Oak, *Quercus virginiana*. Our inspection found that this tree has good health and structure being suitable for a relocation effort. The tree is 40 feet tall with an average canopy spread of 35 feet. The diameter of the trunk was measured three feet above ground level, immediately beneath the branching. The diameter was 23 inches. The tree's health condition rating was 60% at the time of our inspection. The tree has dieback of twigs and small limbs with minor trunk damage. The canopy is suppressed on the east and south sides. A small portion of the east and west sides of the root system has been impeded by existing asphalt. The root ball radius should be 92 inches. The use of a pneumatic air tool is recommended to remove the soil along the edge of the asphalt to expose the roots for pruning. Inspection by the Consulting Arborist is recommended at this time to verify the roots before pruning. No crown pruning is necessary during the preparation period of this tree.

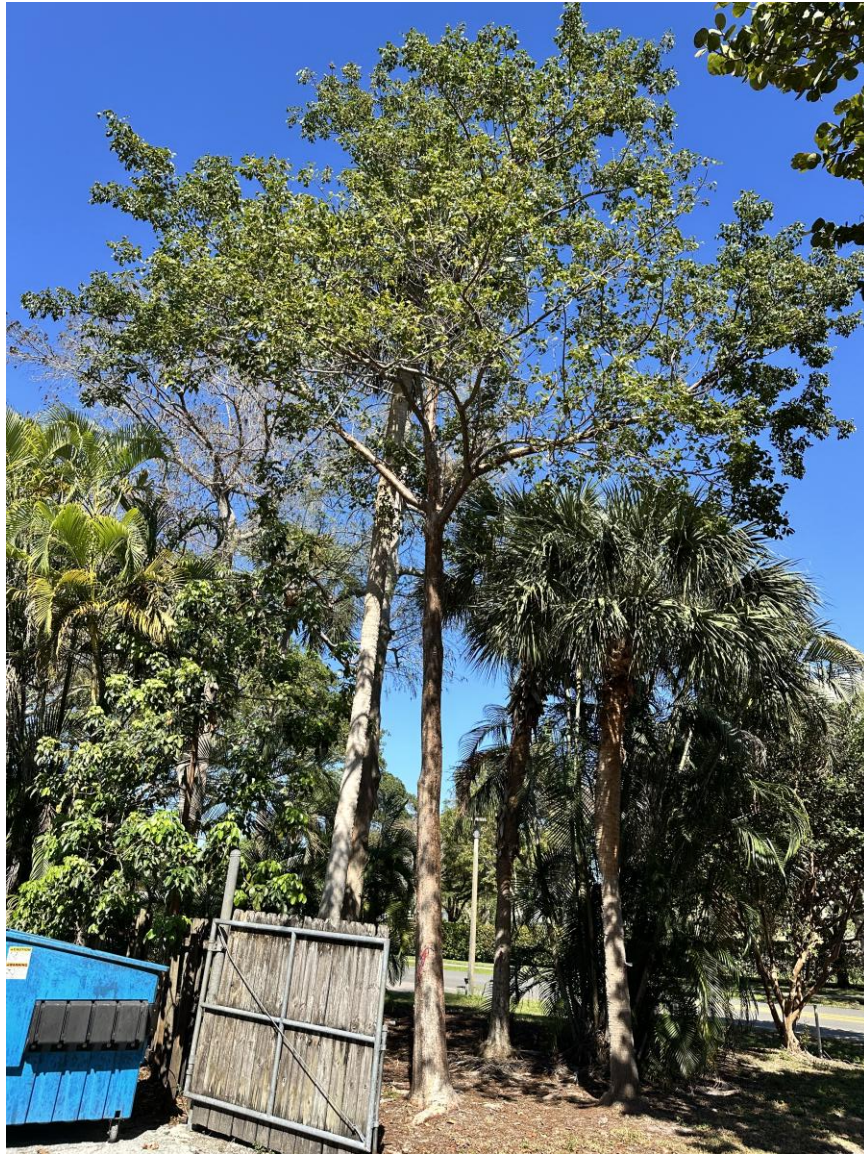
Tree Number 3011

Looking northeast at Gumbo Limbo, *Bursera simaruba*. Our inspection found that this tree has good health and structure being suitable for a relocation effort. The tree is 30 feet tall with an average canopy spread of 25 feet. The diameter of the trunk was measured at dbh. The diameter was 12 inches. The trees health condition rating was 60% at the time of our inspection. The root ball radius should be 60 inches. No crown pruning is necessary during the preparation period of this tree.
