Enclosed please find the updated Certified Arborist Report/Tree Assessment for the property located at 200 N. Federal Hwy. in Pompano Beach, FL conducted on November 16, 2022.

ARBORIST REPORT

200 N. Federal Hwy.
Pompano Beach, Fl 33062

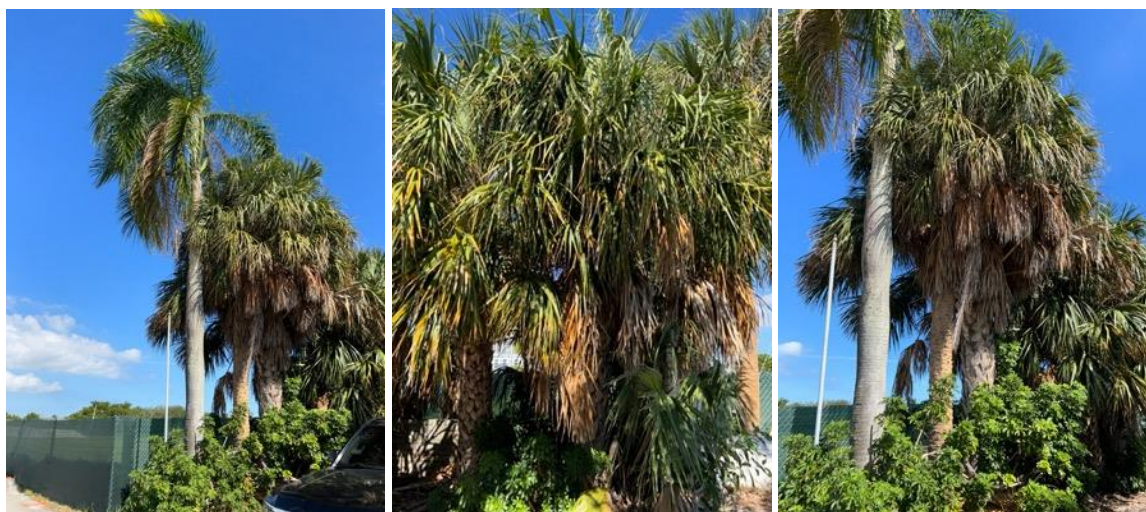
Tree #1 – *Roystonea regia*, Royal Palm – this tree is located in the northwest corner of the property adjacent to the parking lot and next to the ROW. It is crowded with minor chlorosis and a slightly undersized canopy. Overall, it is in fair condition and is proposed for removal.

Tree #2 – *Sabal palmetto*, Sabal Palm – this tree is located directly east of Tree #1. It is very crowded with a pronounced curve in the upper trunk due to the crowded conditions. It is in fair condition and is proposed for removal.

Tree #3 – *Sabal palmetto*, Sabal Palm – this tree is located directly east of Tree #2 on the northeast side of the property. It is very crowded and has live fronds only on one side of the trunk due to severe crowding. It is in poor condition and is proposed for removal.

Tree #4 – *Sabal palmetto*, Sabal Palm – this tree is located directly east of Tree #3. It is very crowded and overgrown but otherwise is in fair condition. This tree is proposed for removal.

Tree #5 – *Sabal palmetto*, Sabal Palm – this tree is located directly east of Tree #4. It is very crowded and overgrown but otherwise is in fair condition. It is proposed for removal.

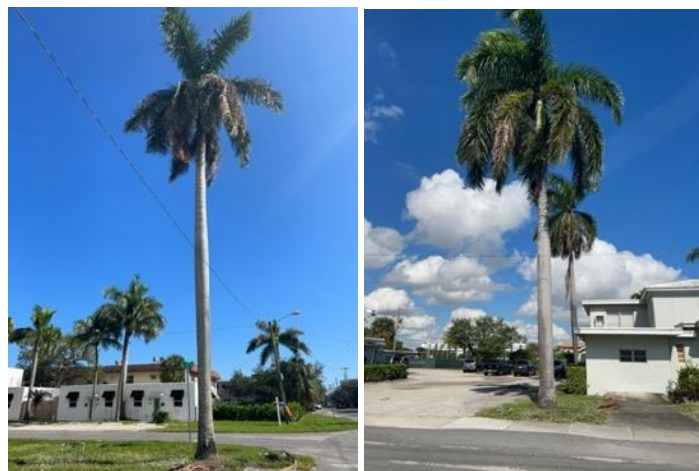
Tree #17 – *Roystonea regia*, Royal Palm – this tree is located on the south side of the property just east of the entrance to the asphalt parking lot. It is in good condition with no significant defects. It is proposed for removal.

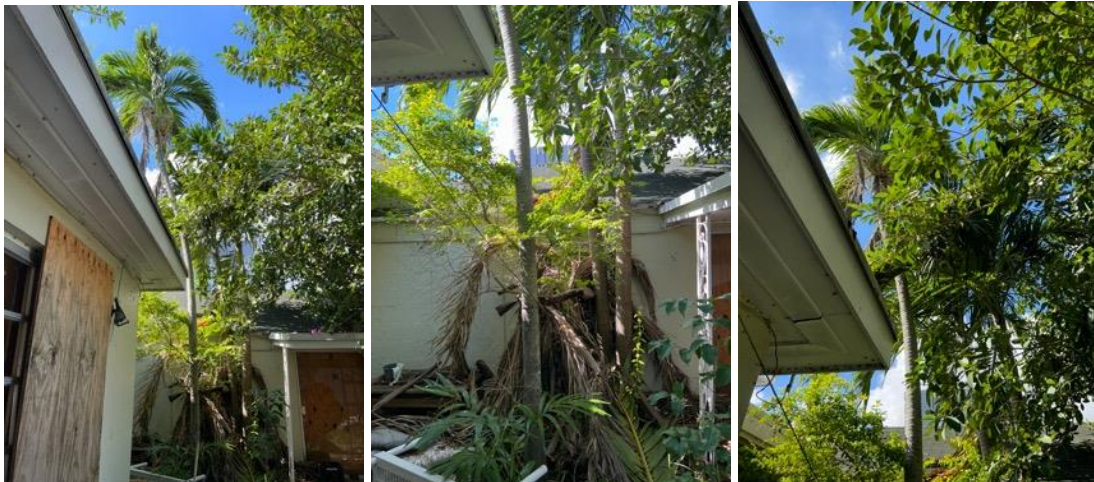
Tree #18 – *Adonidia merrillii*, Christmas Palm – this refers to a cluster of 3 palms located inside of a courtyard area on the east side of the existing back building. They are slightly crowded, but otherwise in fair to good condition. They are proposed for removal.

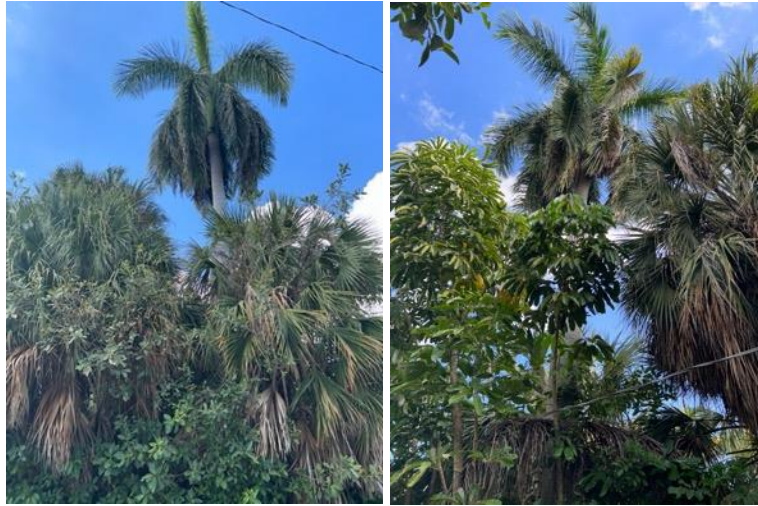
Tree #20 – *Roystonea regia*, Royal Palm – this tree is located in an overgrown cluster of vegetation on the east side of the property. It is very crowded and overgrown and could not be accessed due to its location within a fenced area. It shows signs of very minor nutrient deficiency. Overall it is in fair condition and is proposed for removal.

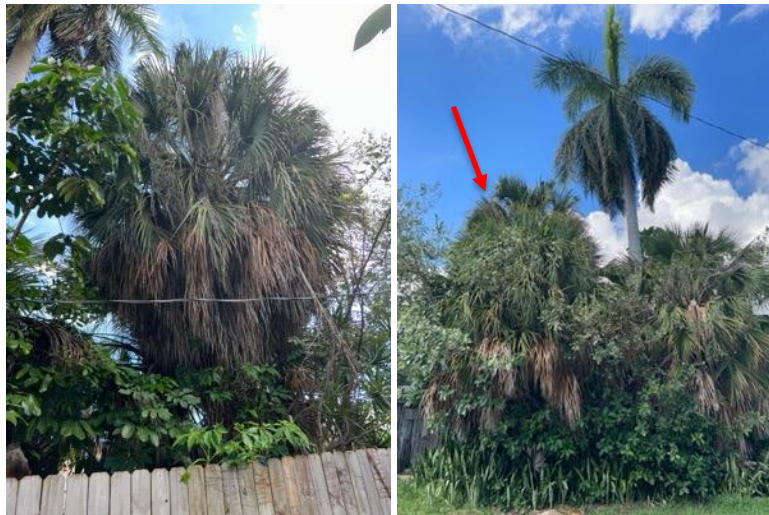
Tree #21 – *Sabal palmetto*, Sabal Palm – this tree is located on the south side of the overgrown cluster of vegetation on the east side of the property. It is very crowded and overgrown, and was inaccessible, but otherwise it is in good condition. It is proposed for removal.

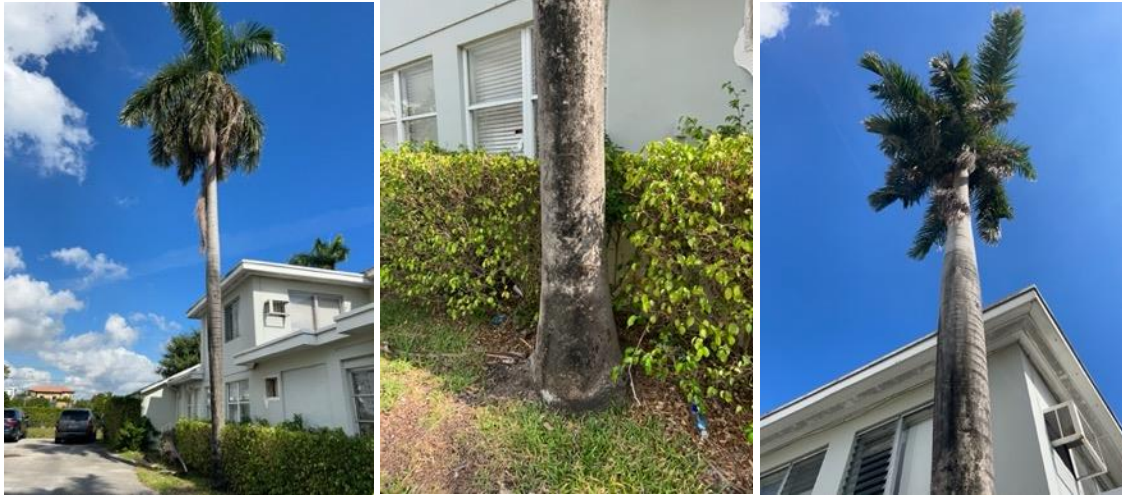
Tree #24 – *Roystonea regia*, Royal Palm – this tree is located on the west side of the back building that is on the east side of the property. It is growing within 5.5' of the existing building. It shows very minor signs of nutrient deficiency and is in overall good condition.

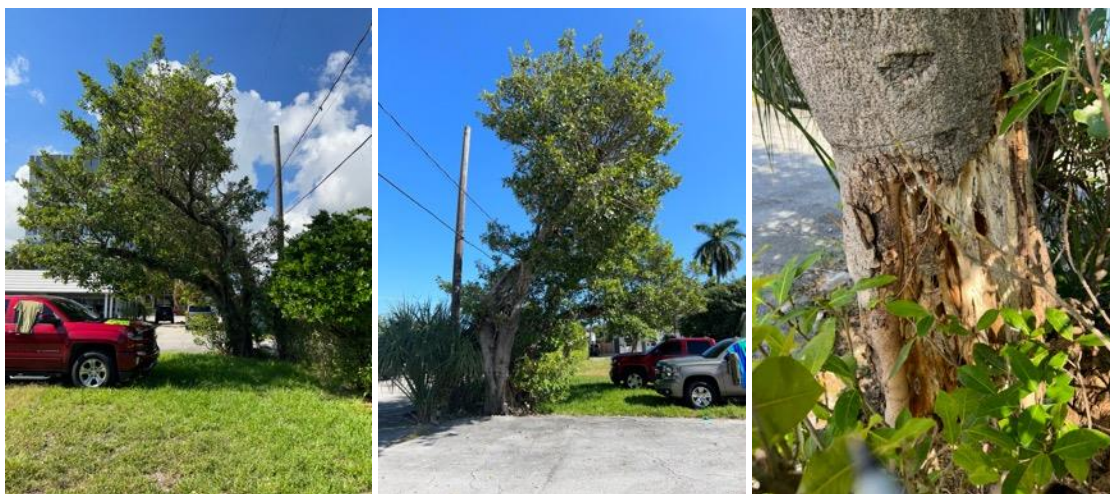
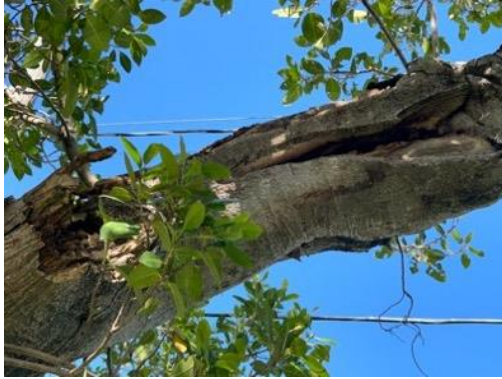
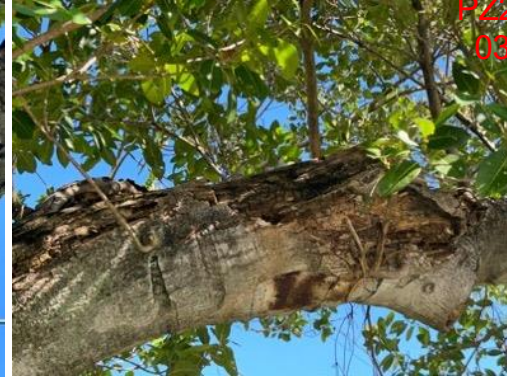
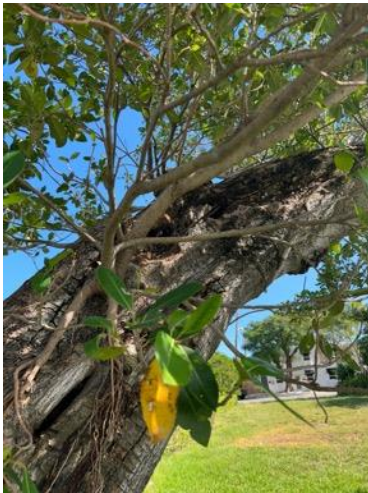
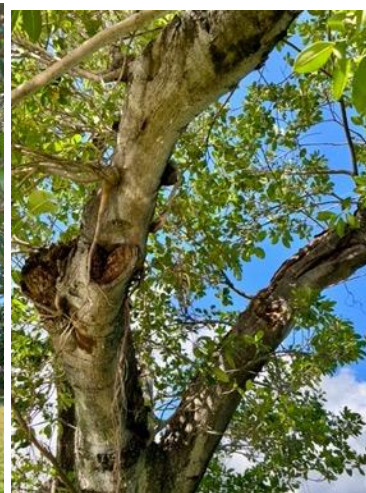
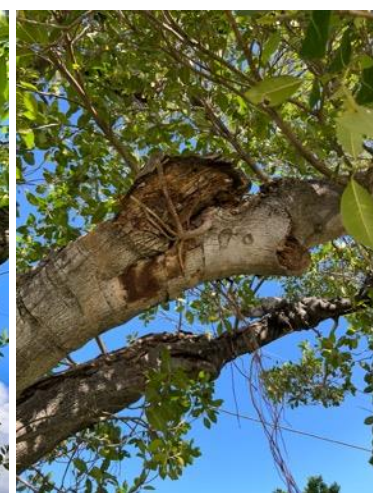
25	<i>Ficus aurea</i>	Strangler Fig	36	30	30	Poor/Hazard	Remove	6750		Severe decay
26	<i>Sabal palmetto</i>	Sabal Palm	13.8	30	12	Good	Remove	350		
27	<i>Bursera simarouba</i>	Gumbo Limbo	4.8	20	12	Fair	Remove		5	
28	<i>Ficus aurea</i>	Strangler Fig	3.6	12	8	Poor	Remove		4	Volunteer
29	<i>Bursera simarouba</i>	Gumbo Limbo	10	20	10	Poor	Remove		10	Likely volunteer
30	<i>Sabal palmetto</i>	Sabal Palm	~16	20	15	Fair	Remove	262.50		
31	<i>Ficus aurea</i>	Strangler Fig	~2+2+2	18	16	Poor	Remove		6	Volunteer
32	<i>Bursera simarouba</i>	Gumbo Limbo	4+2	20	12	Fair	Remove		6	Likely volunteer

Tree #25 – *Ficus aurea*, Strangler Fig – this tree is located on the north side of the main parking lot near the entrance to the small parking lot (Lot 17, Block 5). It has extensive internal decay at the base of the trunk and in all remaining scaffold limbs. There is decayed wood, apparent termite damage, and fruiting fungal bodies present. Based on a Level 2 inspection and using the ISA Risk Rating matrix, this tree constitutes a high risk and there are no mitigation options that can reduce its risk to moderate or less; therefore, it is recommended for consideration for removal without a permit or mitigation per FS 163.045.

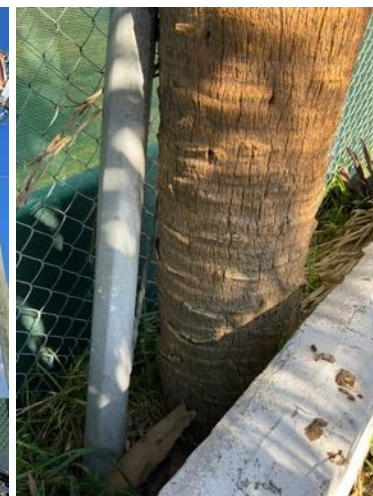
Tree #26 – *Sabal palmetto*, Sabal Palm – this tree is located just east of Trees #1-5 on the northeast side of the property/parking lot. It is somewhat crowded but otherwise is in good condition. It is proposed for removal.

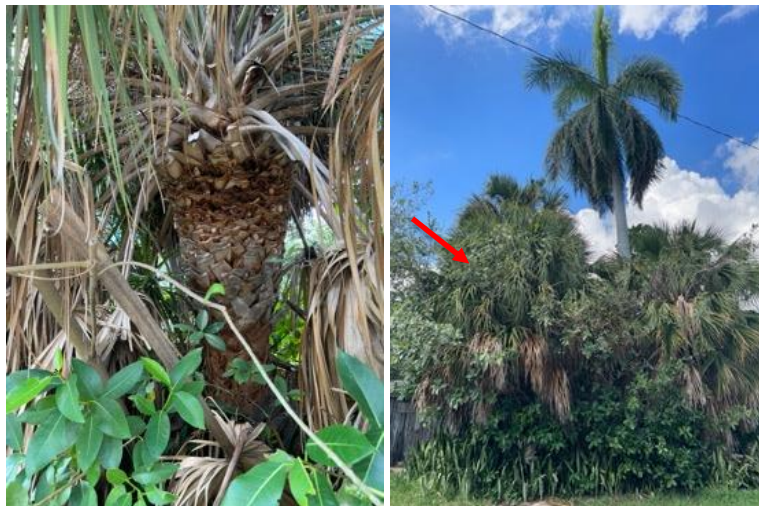
Tree #30 – *Sabal palmetto*, Sabal Palm – this tree is located directly in front of Tree #21 on the east side of the property. It is very crowded, overgrown with vines, and unmaintained. Overall, it is in fair condition and is proposed for removal.

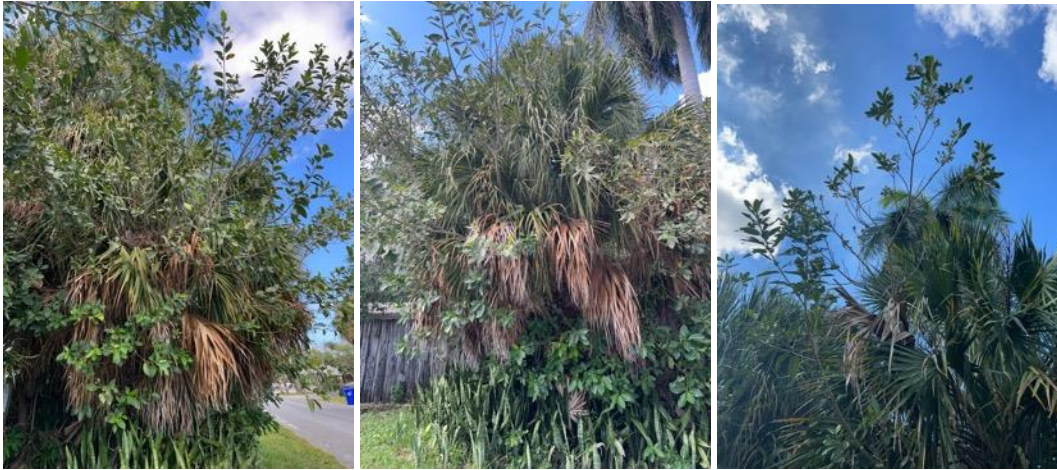
Tree #31 – *Ficus aurea*, Strangler Fig – there is at least one Strangler Fig growing in the middle of the overgrown cluster of vegetation containing Trees #20-21. It is very crowded, overgrown, inaccessible and difficult to see, but at least 3 individual trunks, each 2-3" DBH, were observed with minimal amounts of foliage visible as well. For the sake of this assessment, it is assumed that this is one tree. It is in poor condition and will be removed.
