ECS Project No. 55:6977

Reference: Results for Tree Inventory and Appraisal, JBW Memorial Center (Pompano Pickle), 217 Northeast 3rd Street and 200 Northeast 4th Street, Pompano Beach, Broward County, Florida

1.0 POMPANO PROTECTED TREE APPRAISAL

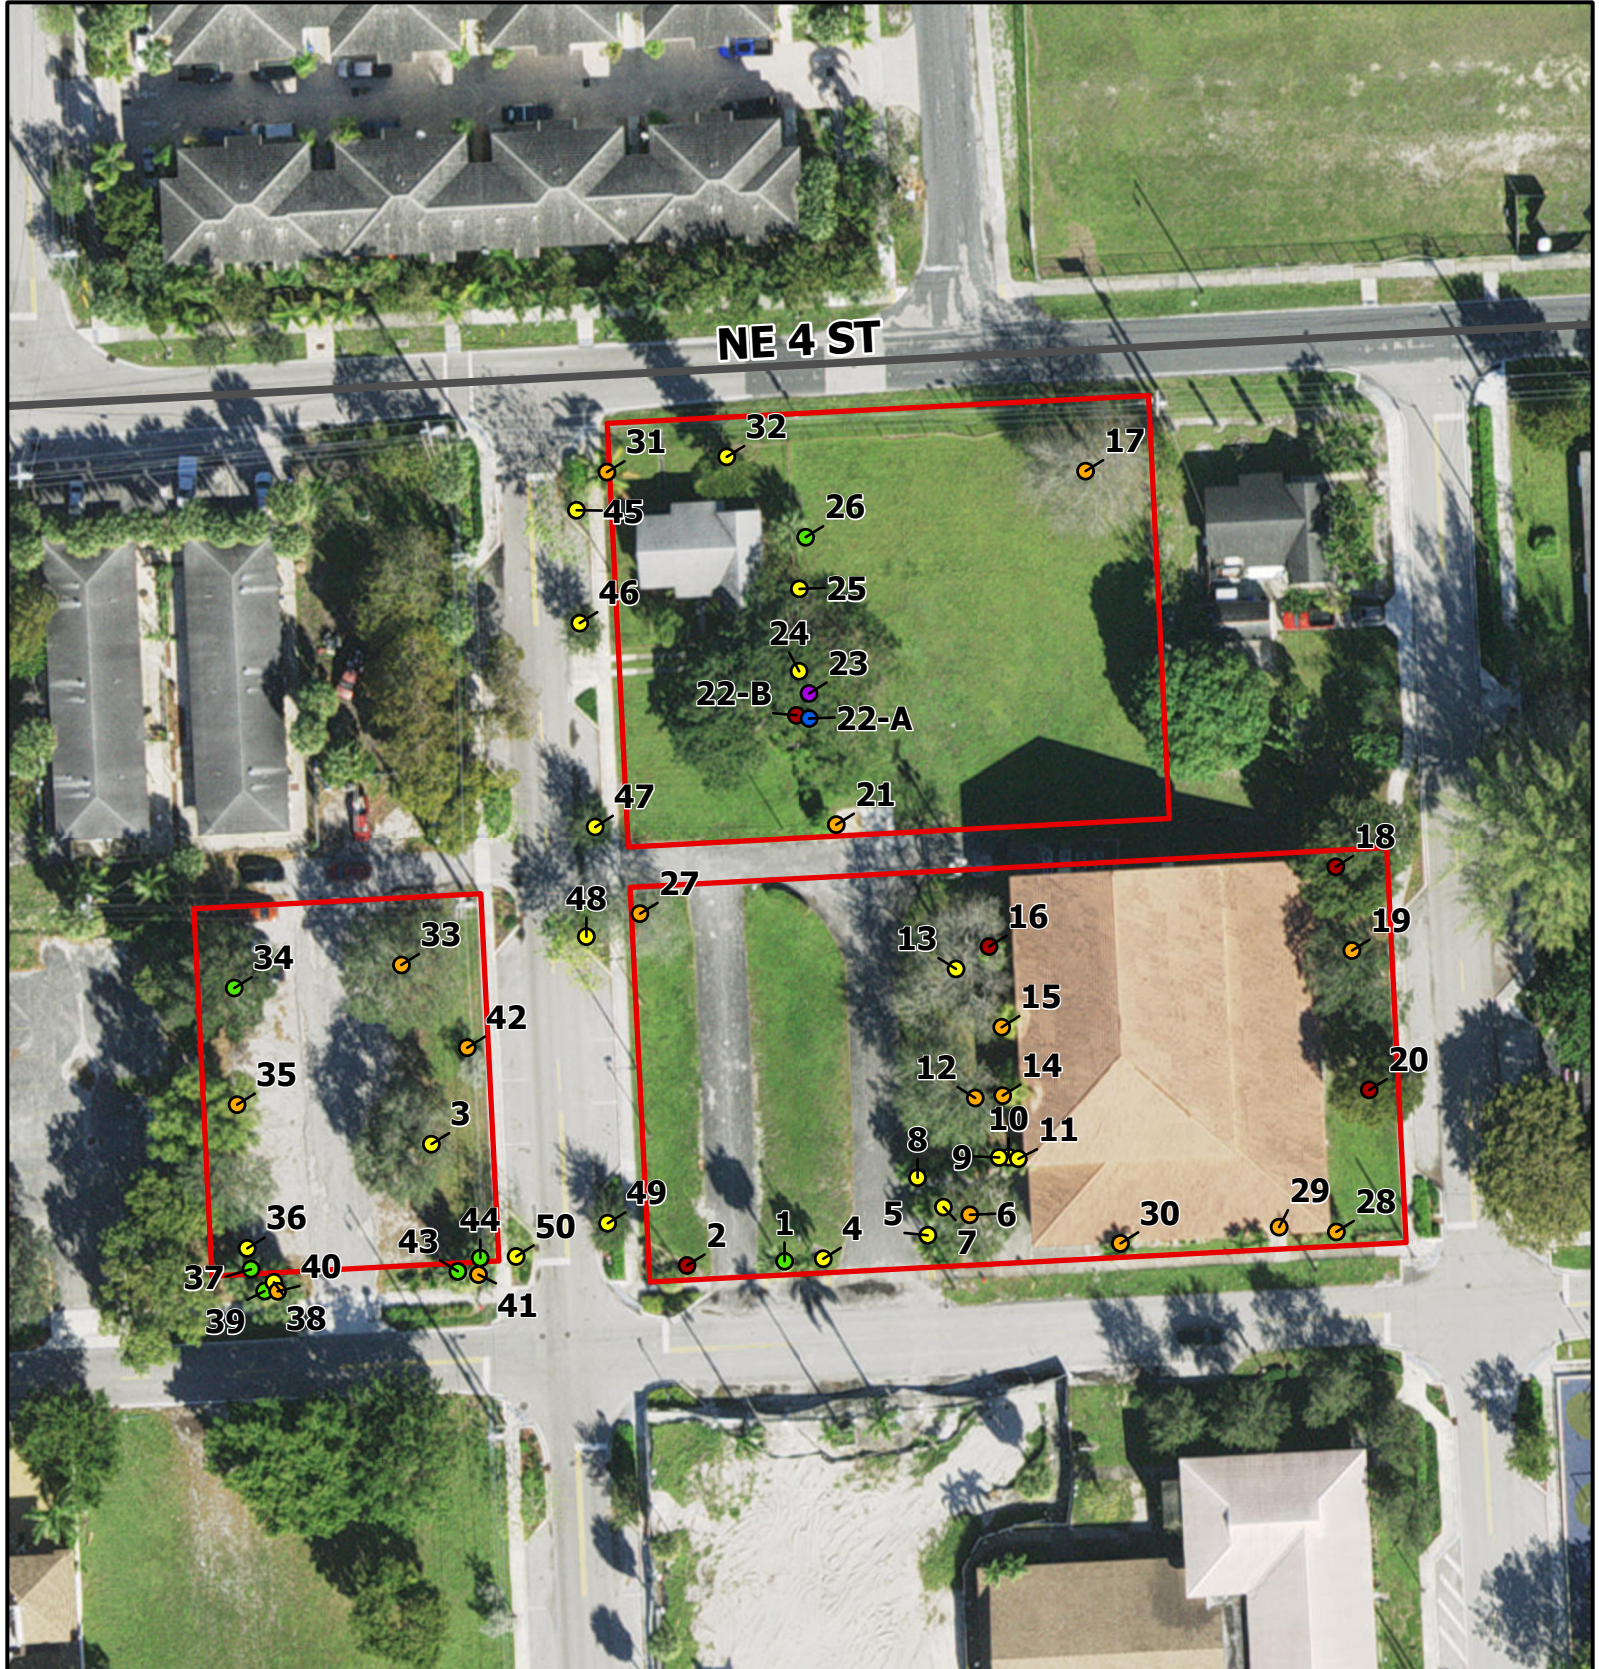
Tree Inventory & Health Condition Map
JBW Memorial Center Site
 217 NE 3rd St & 200 NE 4th St,
 Pompano Beach, FL, 33067
 Office 55: Project 6977

During the Arborist assessment, a total of 21 protected trees and 24 palm trees were reviewed, with six (6) trees/shrubs being invasive or dead. The health condition of each tree and palm were assessed using the Limited Visual Assessment (LVA) method, to determine arboricultural conditions. More specifically, wind damage, rot, included bark, diseased and canopy dieback. The inches inventoried that require mitigation totals approximately 729 inches.

Out of the 21 trees and 24 palms reviewed, all were given a good, fair, poor or very poor rating and associated condition rating (0.1 to 0.8 index rating).

In addition, ECS identified one (1) healthy specimen Live oak (21"dbh) and one (1) healthy specimen Sabal palm (19"dbh), equating to a total of 40 inches. If the protected trees cannot be replaced or relocated, the replacement cost (mitigation) for the protected trees and palms is estimated to be a total of approximately \$36,901.06.

Table 1 - Tree Appraisal Pompano Pickle 2-21-25							
Tree ID	Species	DBH (Inches)	Tree-Palm Height (feet)	Health Condition	Health Condition Index	Health Issues/Notes	Mitigation Fee
1	Cabbage Palm (<i>Sabal palmetto</i>)	8	20	Good	0.8		\$350.00
2	Cabbage Palm (<i>Sabal palmetto</i>)	7	20	Very Poor	0.3	Cracks or Splits in the Trunk Insect Infestation (Boring insects, frass, or beetle holes) Mechanical Damage (From mowers, vehicles, or improper pruning)	\$131.25
3	Laurel oak (<i>Quercus Hemisphaerica</i>)	17	15	Fair	0.6		\$1,115.63
4	Christmas Palm (<i>Adonidia merrillii</i>)	9	10	Fair	0.7	Cracks or Splits in the Trunk Excessive Leaning	\$112.00
5	Christmas Palm (<i>Adonidia merrillii</i>)	8	8	Fair	0.6	Cracks or Splits in the Trunk Excessive Leaning	\$76.80
6	Live Oak (<i>Quercus virginiana</i>)	17	20	Poor	0.4	Dead or Dying Branches Excessive Leaning	\$1,768.00
7	Christmas Palm (<i>Adonidia merrillii</i>)	8	8	Fair	0.6	Cracks or Splits in the Trunk Excessive Leaning	\$76.80

All trees to remain and trees to be relocated will be pruned in accordance with American National Standard (ANSI) A300 Pruning Standards.

All trees to remain within work limits will have tree barricades, based on the vegetation protection criteria, and county approval should be obtained prior to demolition, clearing and site work. No construction traffic, cutting, filling, staging trenching, or root compaction within a tree barricade. Barriers will be erected around trees to remain with 4-inch DBH and greater.
