Reference: Results for Tree Inventory and Appraisal, JBW Memorial Center (Pompano Pickle), 217 Northeast 3rd Street and 200 Northeast 4th Street, Pompano Beach, Broward County, Florida

## 1.0 POMPANO PROTECTED TREE APPRAISAL

Tree Inventory and Appraisal

**Table 1 - Tree Appraisal Pompano Pickle 10-2-24**

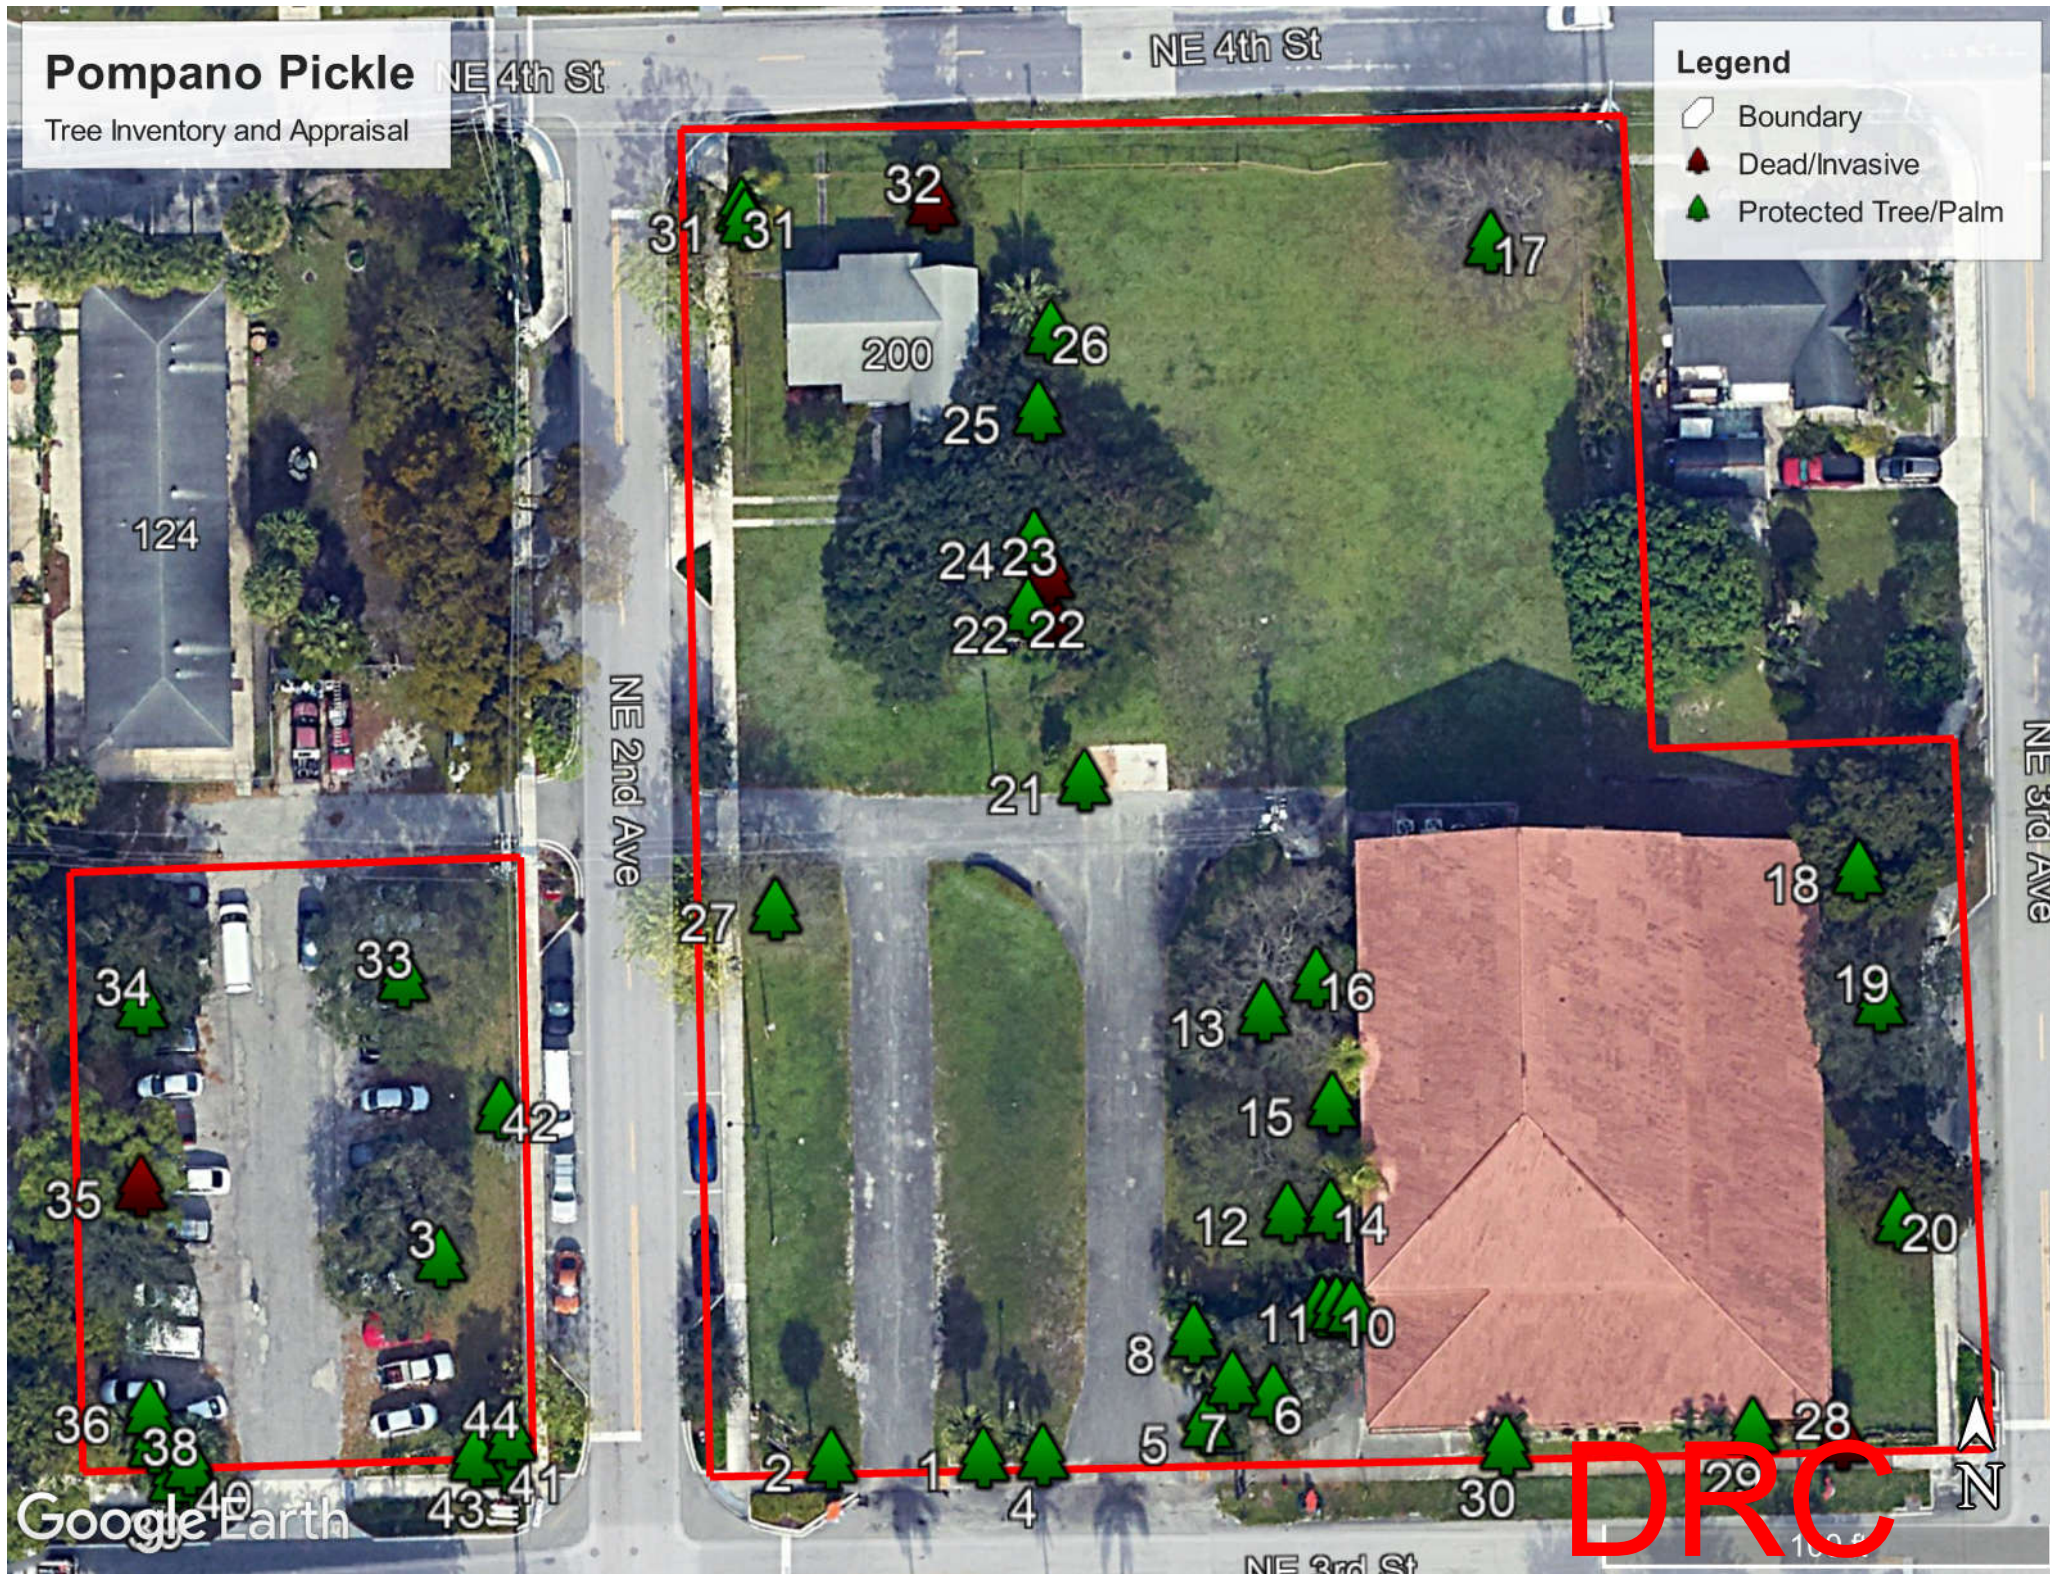
During the Arborist assessment, a total of 15 protected trees and 24 palm trees were reviewed, with five (5) trees/shrubs being invasive or dead. The health conditions were assessed using the Limited Visual Assessment (LVA) method, to determine arboricultural conditions. More specifically, wind damage, rot, included bark, diseased and canopy dieback.

Out of the 15 trees and 24 palms reviewed, all were given a good, fair, poor or very poor rating and calculated the condition rating (0.1 to 0.8 index rating).

In addition, ECS identified one (1) healthy specimen Live oak (21"dbh) and one (1) healthy specimen Sabal palm (19"dbh), equating to a total of 40 inches. If the protected trees cannot be replaced or relocated in the replacement cost (mitigation) for the protected trees and palms is estimated to be a total of approximately \$31,990.10.

All trees to remain and trees to be relocated will be pruned in accordance with American National Standard (ANSI) A300 Pruning Standards.

All trees to remain within work limits will have tree barricades, based on the vegetation protection criteria, and county approval should be obtained prior to demolition, clearing and site work. No construction traffic, cutting, filling, staging trenching, or root compaction within a tree barricade. Barriers will be erected around trees to remain with 4-inch DBH and greater.
