ATLAS SAFETY & SECURITY DESIGN, INC.

RE: Oldcastle Coastal Facility – 1200 NW 18th St., Pompano Beach, CPTED/Security Public Safety Plan

The following review is part of the required submission to have CPTED security drawing plan, and a security narrative explaining the specifications and locations of any specific security features or recommendations.

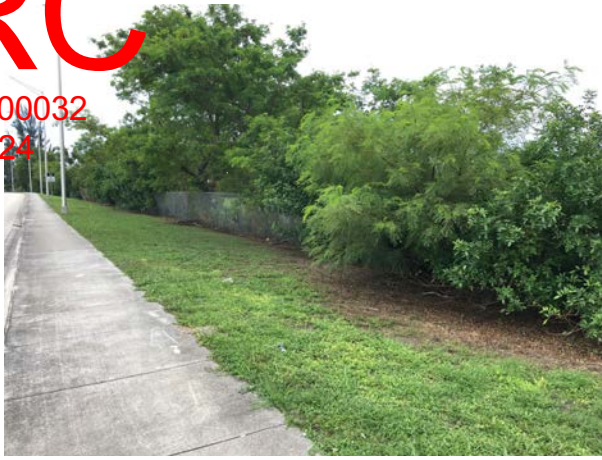
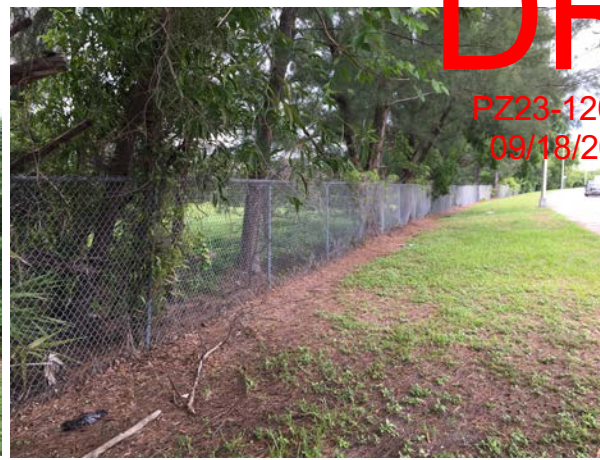
The west boundary on Andrews Avenue is chain link fencing and overgrown shrubs and non-native Australian Pine.

Territorial Reinforcement /Boundary definition – Fencing and Plantings – The existing six-foot high chain link fencing requires extensive repair and maintenance on the north, south, and east sides. Plantings should be maintained to be no higher than the fence line and the boundaries. Tree canopies should be maintained clear under 8 feet, with a trunk six inches in diameter or greater. If new saplings are planted, do not mutilate them to comply with the canopy requirement until they are mature trees with a six inch diameter trunk or greater, and if the tree canopies are blocking the field of vision.

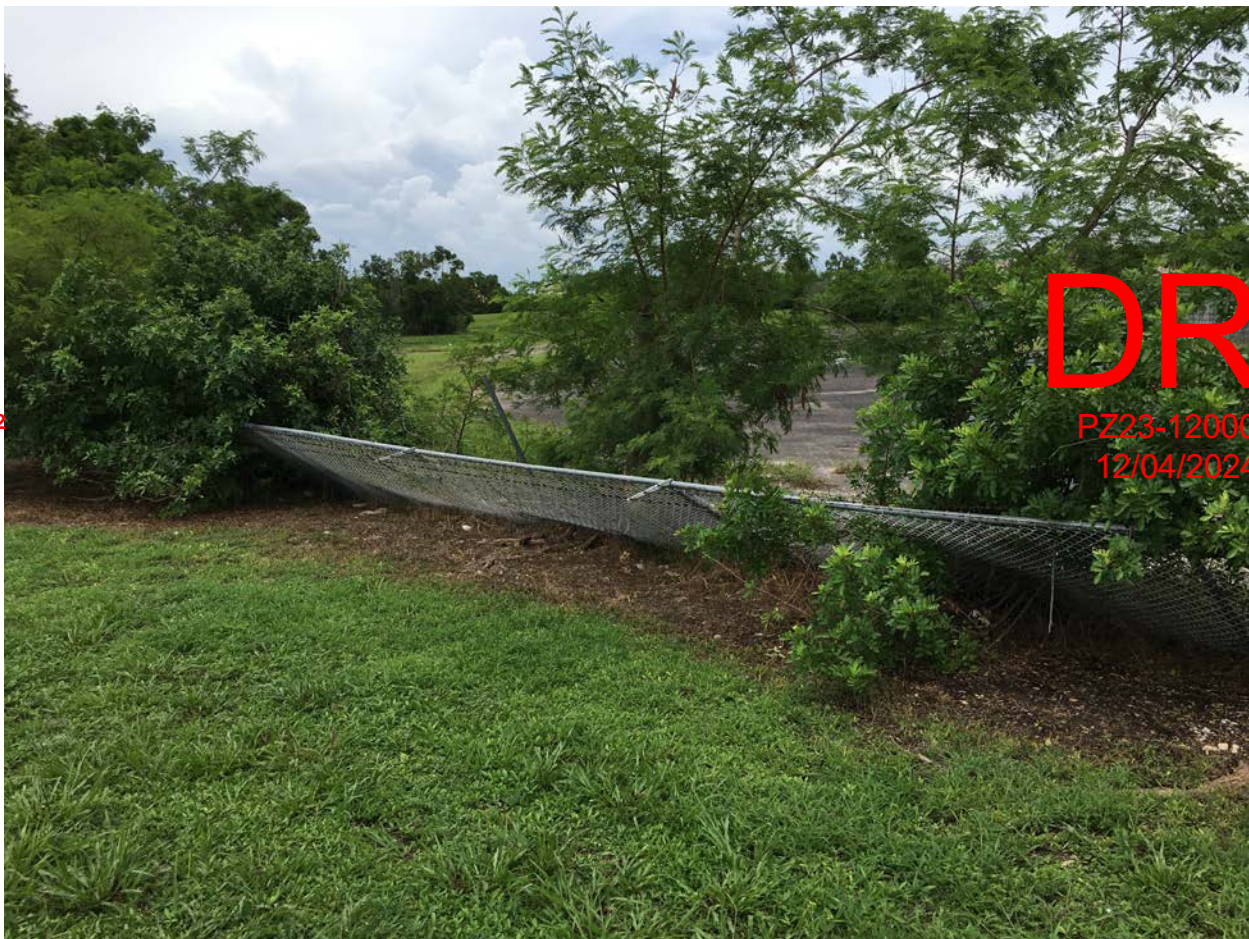
The West Boundary has sections of the chain link fence that are damaged and lying down.

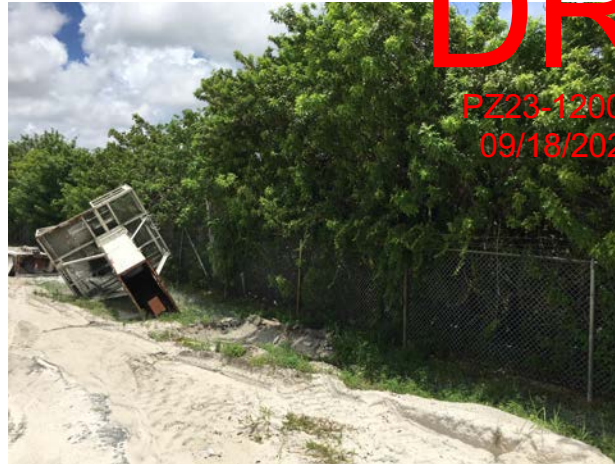
The East boundary is six-foot chain link with overgrown shrub.

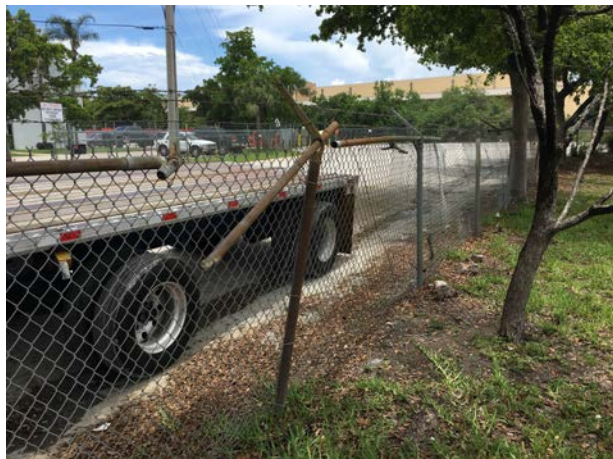
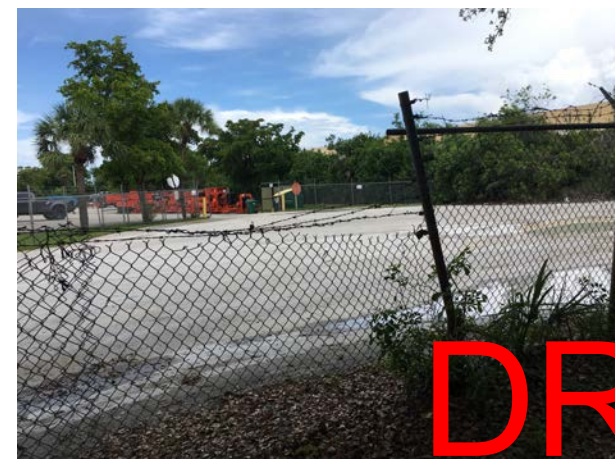
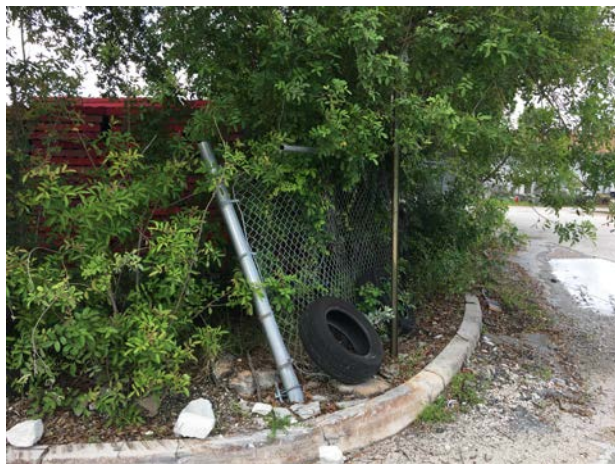
The North boundary is presently the primary access and egress points to the plant on NW 18th Street. There are two gates openings. Both gates are left open and have been damaged and non-operational. The barbed wire on the top of the chain link fencing has been damaged and not consistent.

The north boundary fencing is heavily damaged.

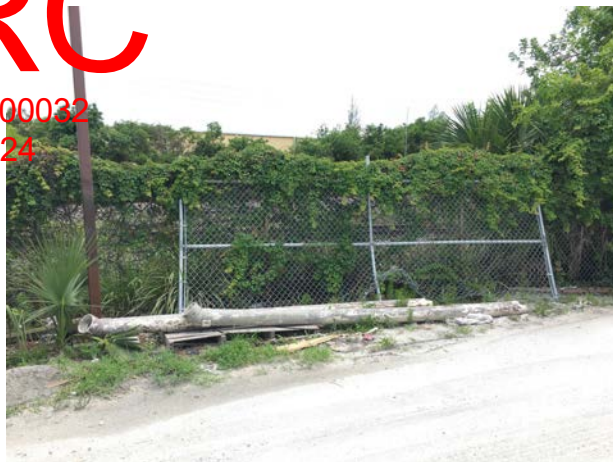
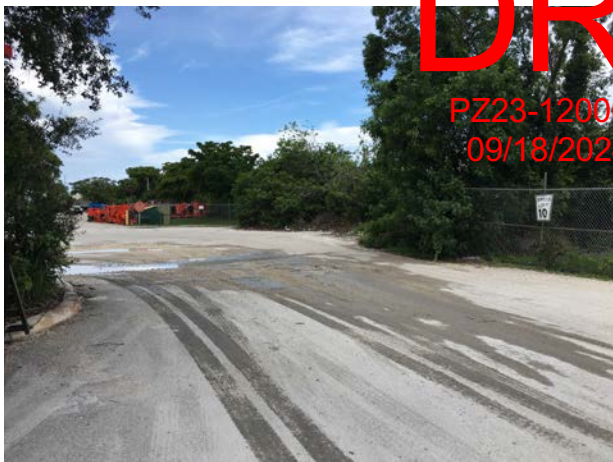
The northeast gate has been knocked off the tracks and lays against the east perimeter fence. The open access allows trucks with aggregate product to enter in the site, but also has no barriers to keep trespassers out.

The approach onto the site will remain open because of the volume of traffic by trucks and rigs picking up and dropping off product, While the gates remain open during plant operations, there is the capability to secure the site and close the manually operated gates when there are holidays.

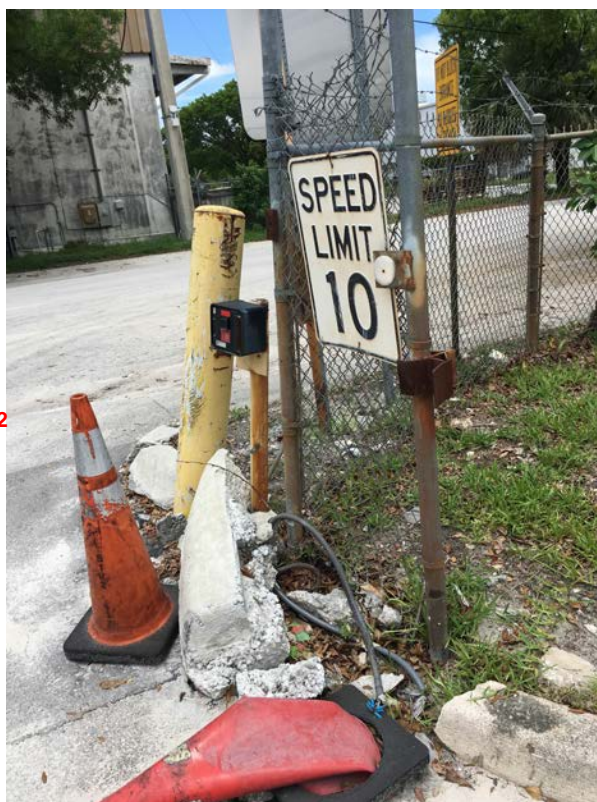
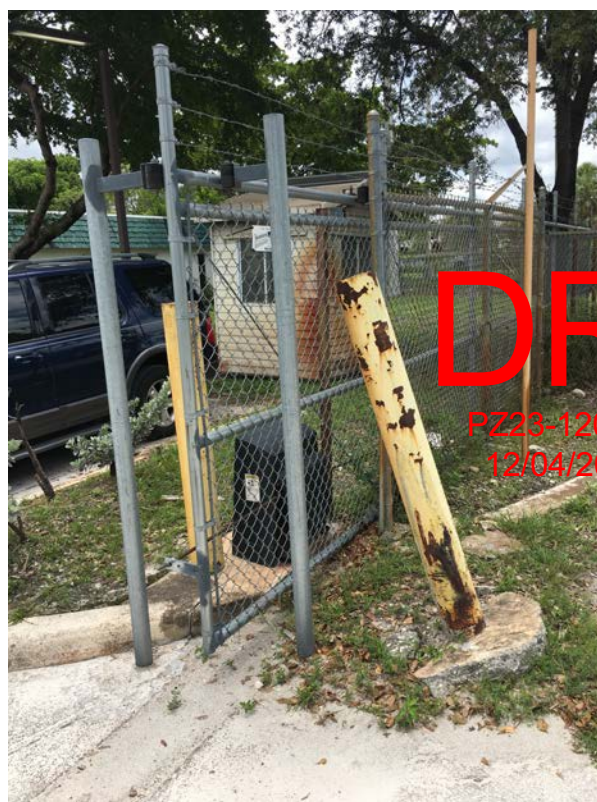
The Northwest gate is the primary entrance for administration, employee vehicles. The gate is non-functional and is in disrepair.

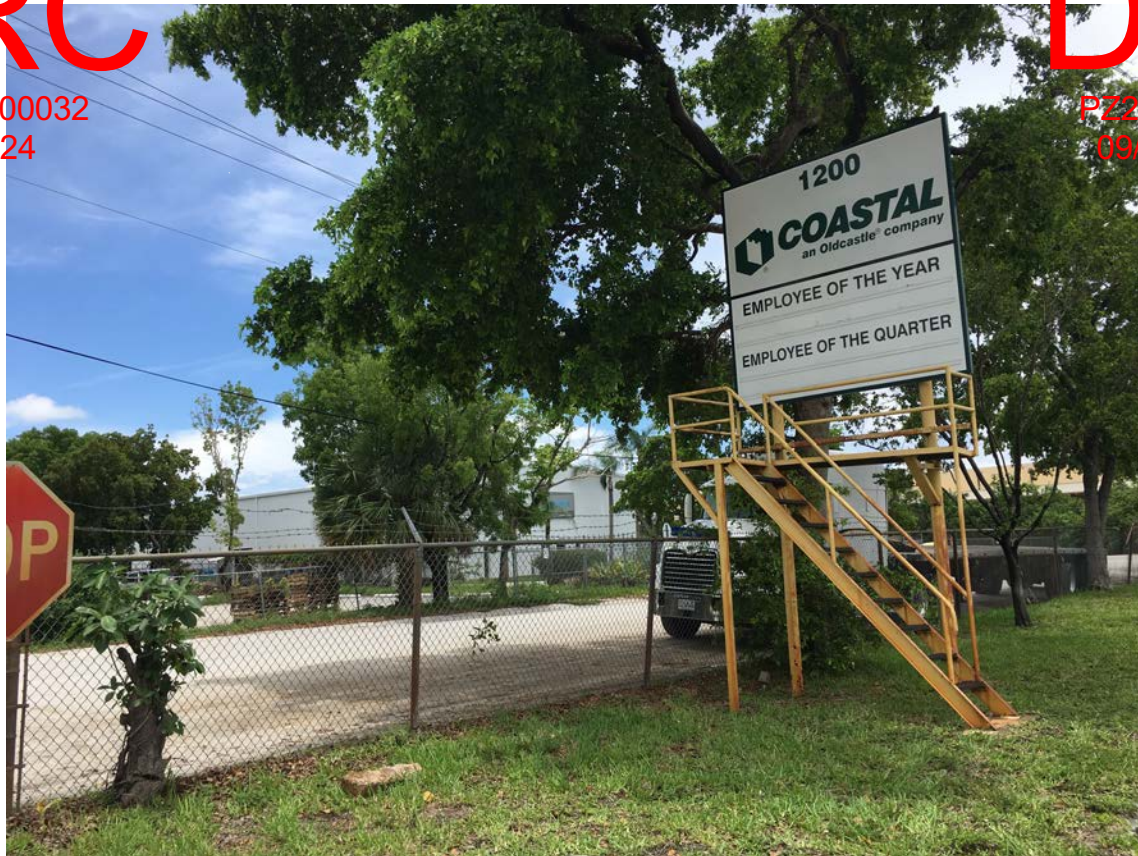
The north boundary on NW 18th Street has the marquee sign for the plant. It is difficult to see from the main road, Andrews Avenue.

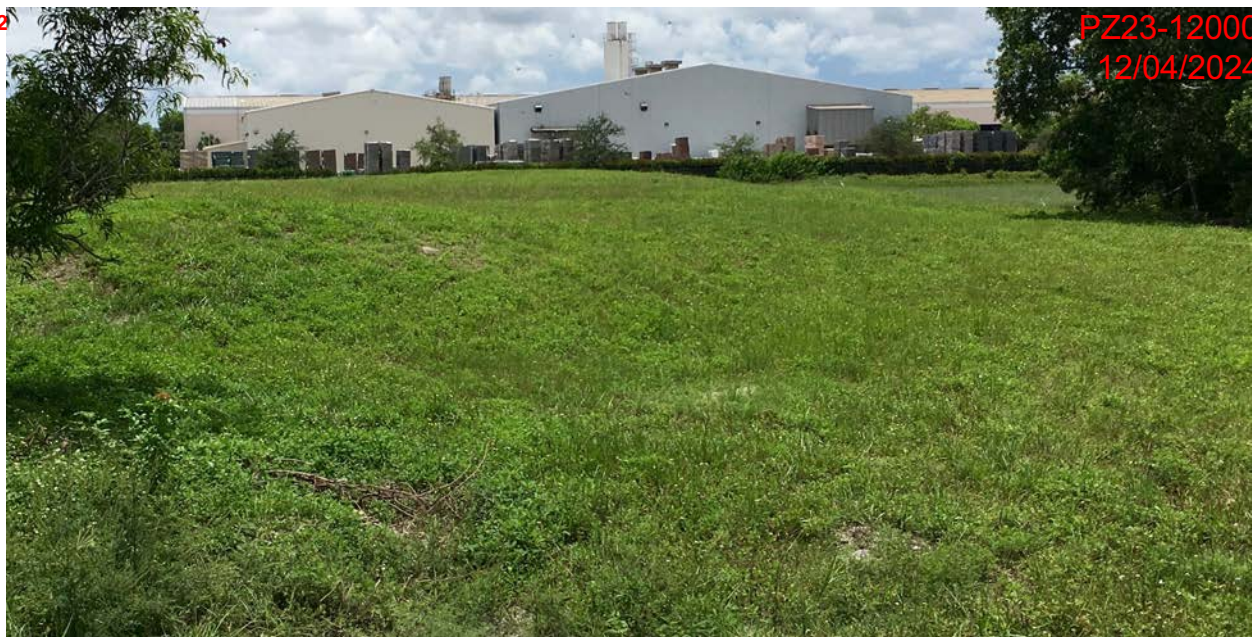
The South boundary is open real estate between the Bonsal Plant and the Oldcastle Distribution Center.

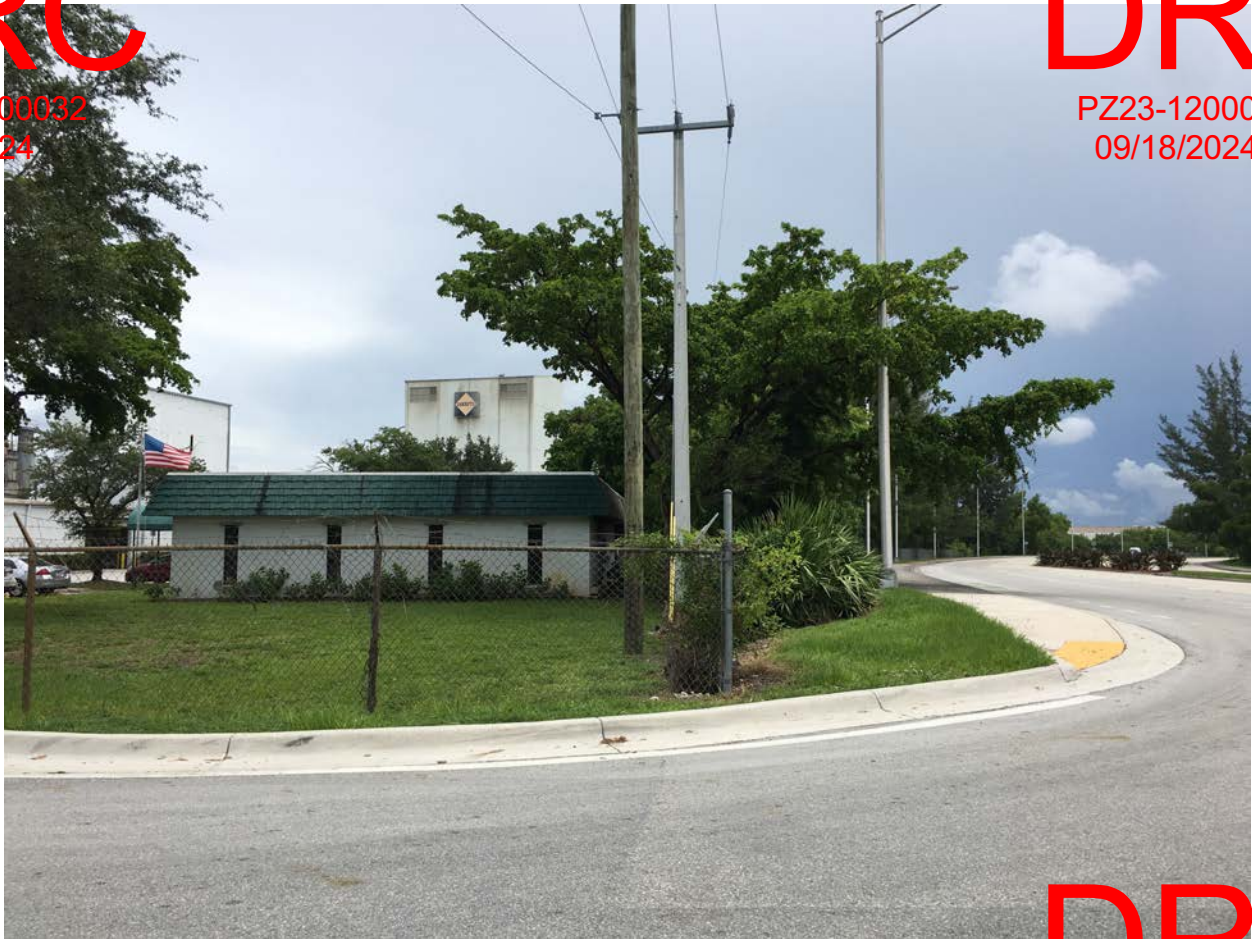
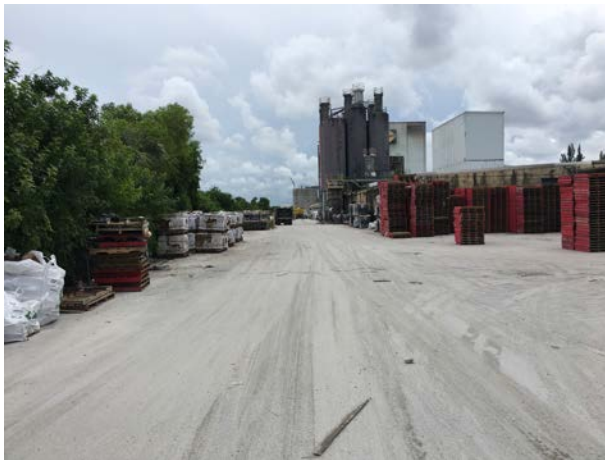
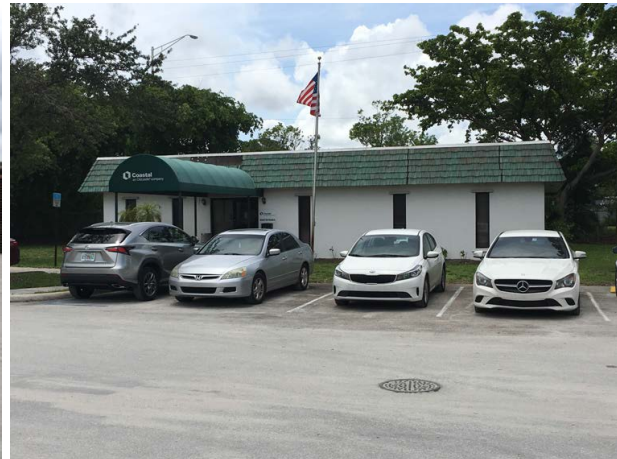
There are no controls for vehicles once trucks turn on 18^h Street. There are no barriers controlling access to the parking lot and site on the north side.

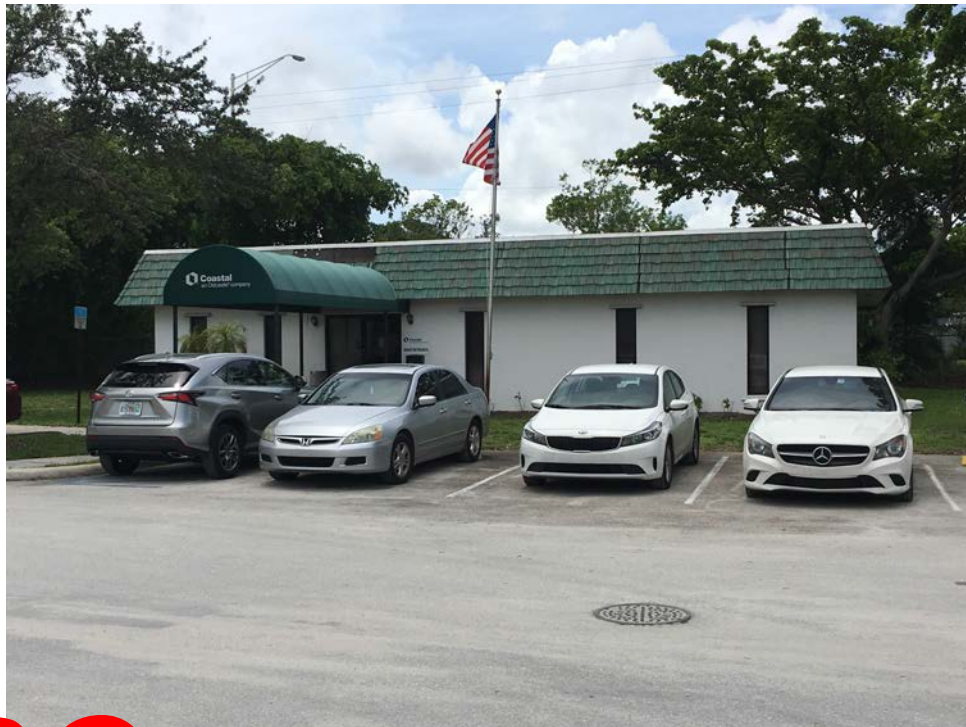
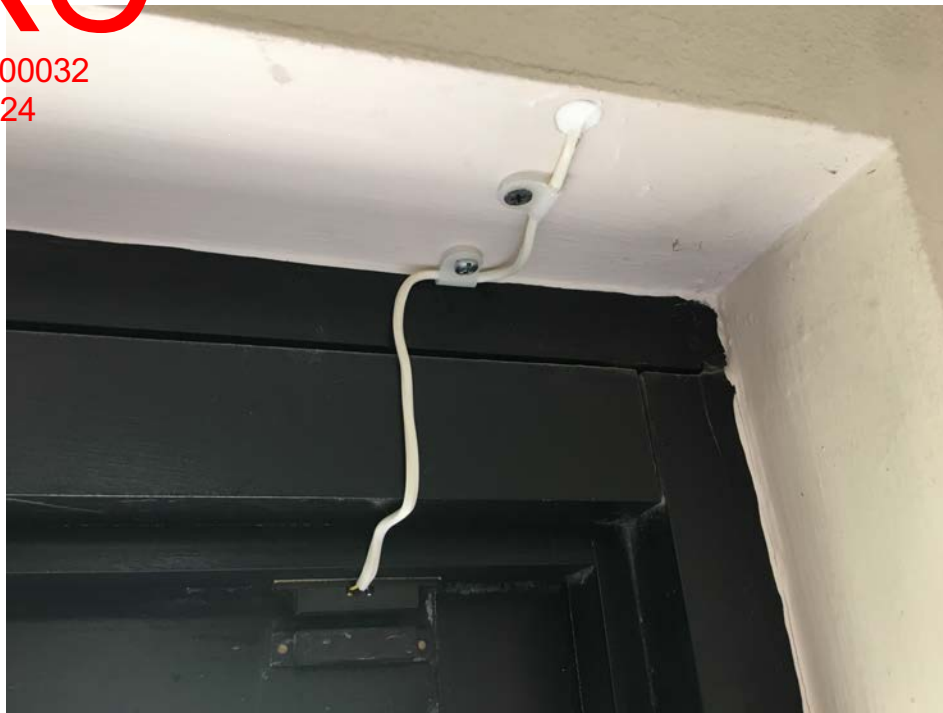
The business office entrance faces east and the north side of the site.

The office has a make shift security system that is monitored but needs to be updated. There is no exterior light along the east side of the business office.

Facility access control – The existing admin office building has a security burglar alarm system, with intrusion detection devices (motion sensors), and have the doors alarmed with door position switches (DPS). It is recommended that the existing building doors get rewired in a professional manner with no wires exposed, and if wires cannot be brought through the door frames, then have the wiring in security conduit. Since the factory plant is operating 24/7 their doors will be left open during operating hours, however the continual presence of staff should discourage and opportunity for criminal activity. The Alarm Company is Tyco/ADT and their service can be easily expanded to include the interior space protection alarms, the door position switches, and the proposed video surveillance system and video monitoring for the site.

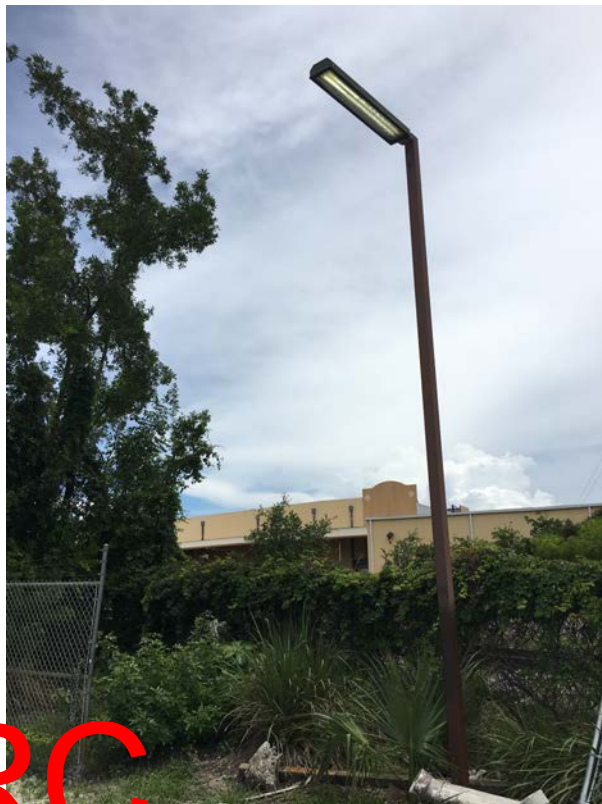
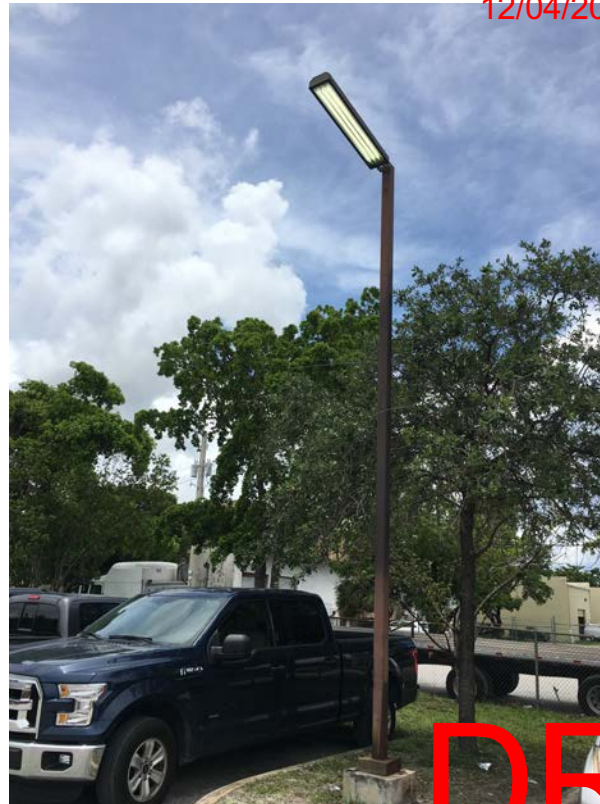
There are several large floodlights on 20-foot light poles positioned randomly in the parking areas to accomplish nighttime lighting. There are floodlights along the warehouse buildings, but the lighting is sporadic, and not up to contemporary lighting standards.

The pole lighting actually uses florescent tubes, and was turned on during daylight hours.

Perimeter Lighting – The proposed photometric lighting plan will provide adequate lighting for the site and parking areas, without the effects of light trespass or light pollution. On the west and south vehicle entrances light levels are a minimum of 1 footcandle (FC) or greater. The storage yard generally has at least ½ footcandle minimum average coverage. The plant and office buildings will have exterior lighting that illuminate the building exterior in the hours of darkness. It will be important to view any illegitimate activity on the site and around the buildings. Therefore, lighting should be uniform and consistent on the stock and pallet areas with enough lighting to be able to observe movement by any potential trespassers. The exterior showroom areas should have a minimum of ½ FC of lighting to facilitate pedestrian movement and support video surveillance. The plant's renovated lighting is adequate on the east, west and north sides. However, where the silo's are located on the south side, additional luminaires will be added, as there are vehicles parked, stock pallets, and heavy machinery that should be observable.

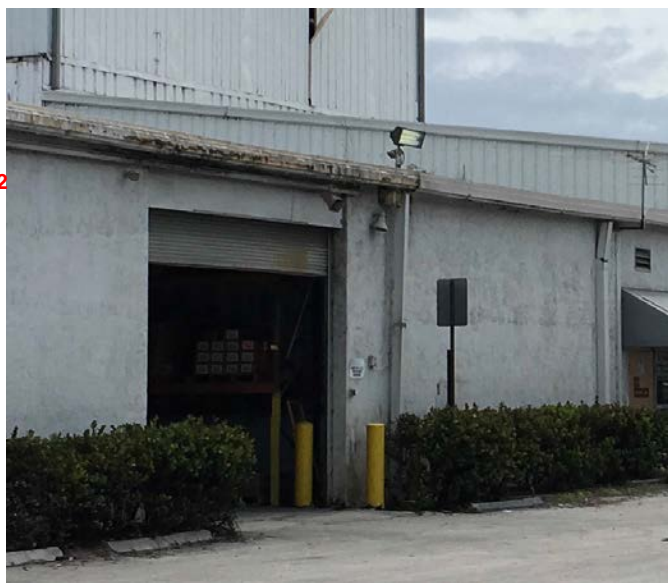
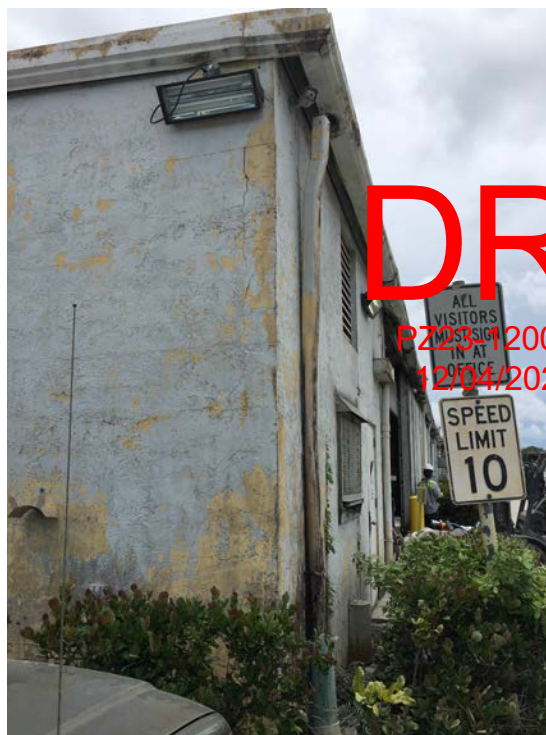
The exterior lighting using florescent tubes as the light source was inefficient and not effective to evenly light the site and building exterior.

Building exterior lighting – The newly renovated and retrofitted lighting plan is providing adequate illuminate to the exterior of the buildings, the stock areas, the exterior yard area, and vehicular entrances for good visibility and accountability. Additional lighting is needed on all sides of the plant, and the three vehicle entrances to complete the lighting goals.

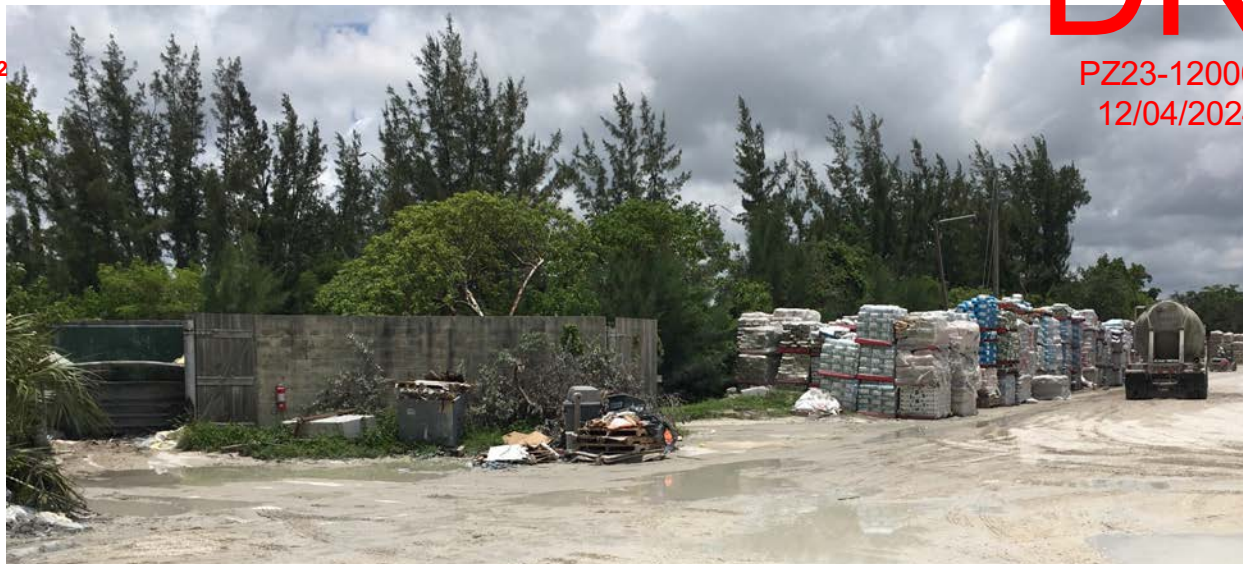
The exterior dumpster area is located in the south part of the yard area across from the Plant. The screening needs to be in working order, and lockable, and the area cleaned up. The dumpster is not set down on a concrete pad. There is no drainage capacity. The wooden gates and shielding are damaged and does not close properly. There is no locking capability to prevent outsiders from outside persons dumping trash.

There appears to be some dumping just adjacent to the dumpster. In the new site plan the dumpster will be designed to have compliant surrounding shielding and be secured.

The new proposed dumpster area should be on a concrete pad that can withstand picking up and dropping down by a garbage truck. There should be bollards/bumpers to prevent the truck from hitting the dumpster enclosure. The dumpster should be shielded on three sides with a screening that complies with zoning regulations. Swing gates that are locked should be used to protect the dumpster from illegal or unwanted dumpster diving or dumping. The front screening should be raised so that a person in the dumpster area can be observed from the outside. The gates should be lockable so they can be secured when not being used. If there is any trespassing in the exterior site areas, the person will stand out and be observed and challenged.

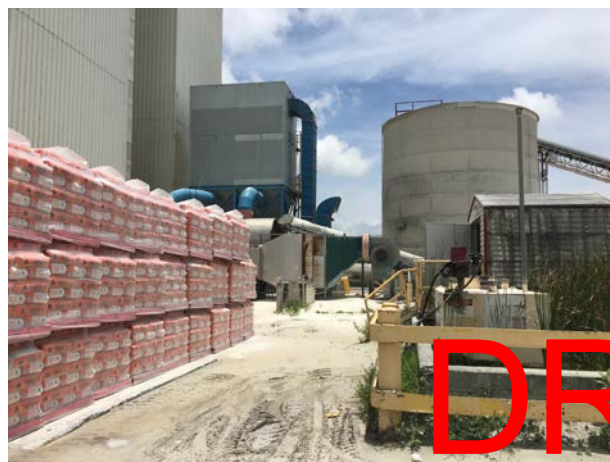
Tools and equipment is an attractive asset that need to be protected.

Tools and machinery must be protected from loss, theft, pilferage, or vandalism.
