ATLAS SAFETY & SECURITY DESIGN, INC.

RE: Oldcastle Coastal Facility – 1200 NW 18th St., Pompano Beach, CPTED/Security Public Safety Plan

I have been contracted to review the drawings for security and Crime Prevention Through Environmental Design (CPTED) features in the proposed Oldcastle Bonsal Facility site plan update that is being considered for permitting by the City of Pompano Beach.

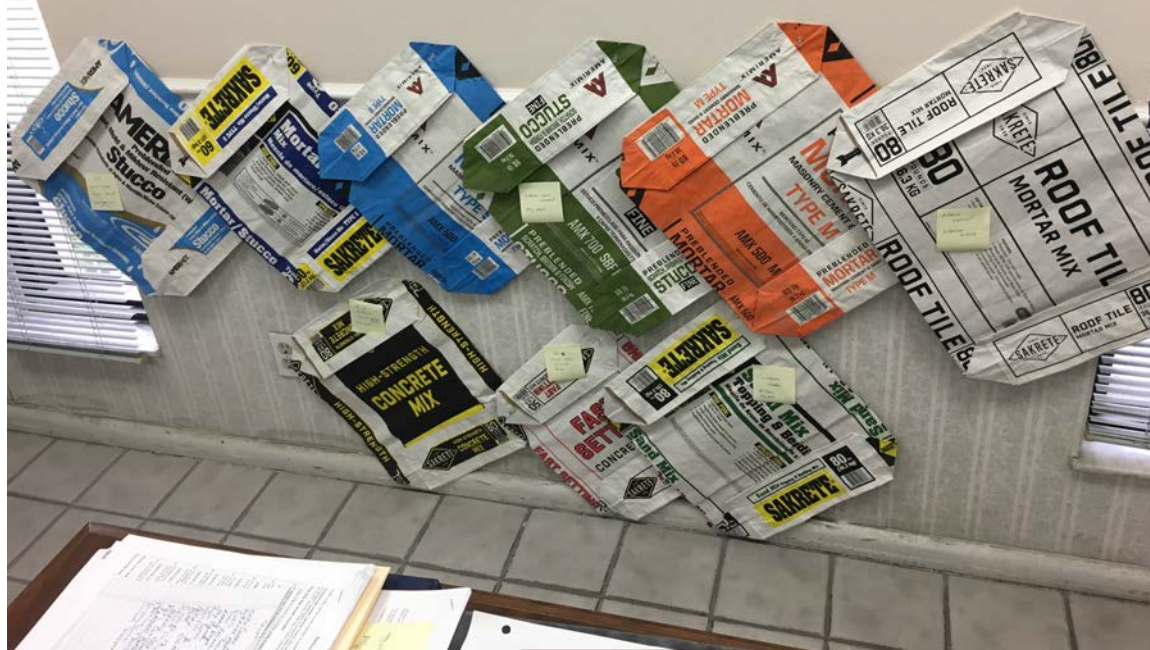
The types of products that are made at made at the Oldcastle Bonsal Plant.

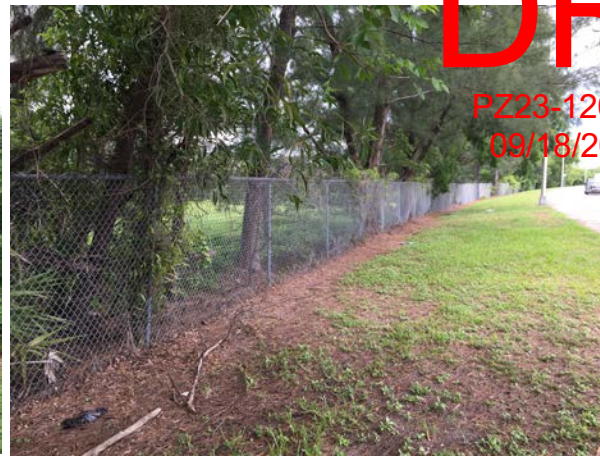
Existing territorial reinforcement of the Oldcastle Bonsal property is achieved on the West boundary with a six-foot high chain link fence with overgrown shrubs along Andrews Avenue. The North boundary is a six-foot high chain link fence, with two gate openings. The East boundary is a six-foot high chain link fence along the FEC railroad tracks. The south boundary is presently open just grass and trees.

The west boundary on Andrews Avenue is chain link fencing and overgrown shrubs and non-native Australian Pine.

The west border definition will be improved with an attractive picket metal code compliant fencing with plantings, and a vehicle gate. It is recommended that as the site is improved to accommodate a sidewalk connection, and new monumental sign, and additional stripping at the entrance of onto Andrews Avenue will be added to direct the heavy trucks and rigs.

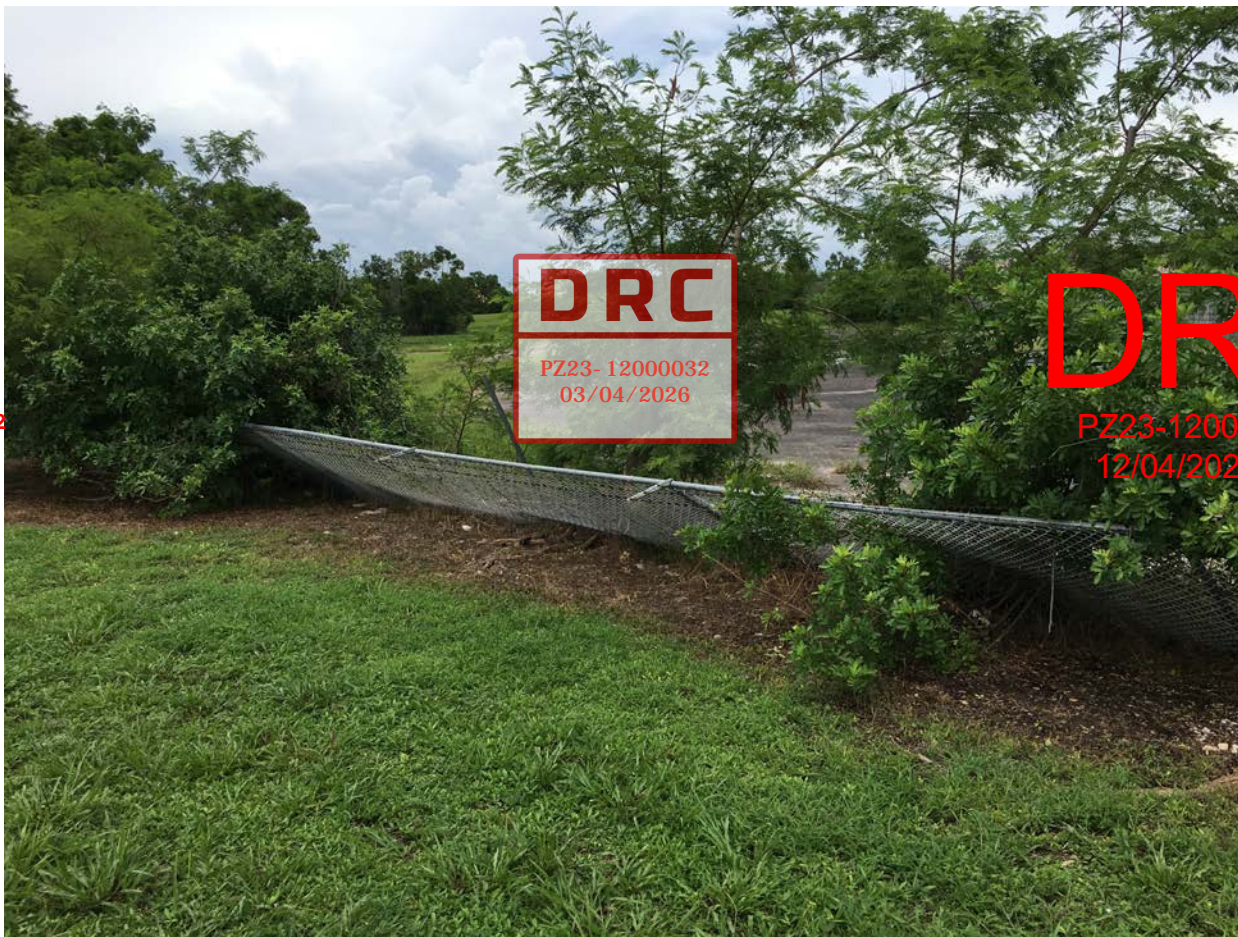
The West Boundary has sections of the chain link fence that are damaged and lying down.

Territorial Reinforcement /Boundary definition – Fencing and Plantings – The existing six-foot high chain link fencing requires extensive repair and maintenance on the north, south, and east sides. Plantings should be maintained to be no higher than the fence line and the boundaries. Tree canopies should be maintained clear under 8 feet, with a trunk six inches in diameter or greater. If new saplings are planted, do not mutilate them to comply with the canopy requirement until they are mature trees with a six inch diameter trunk or greater, and if the tree canopies are blocking the field of vision.

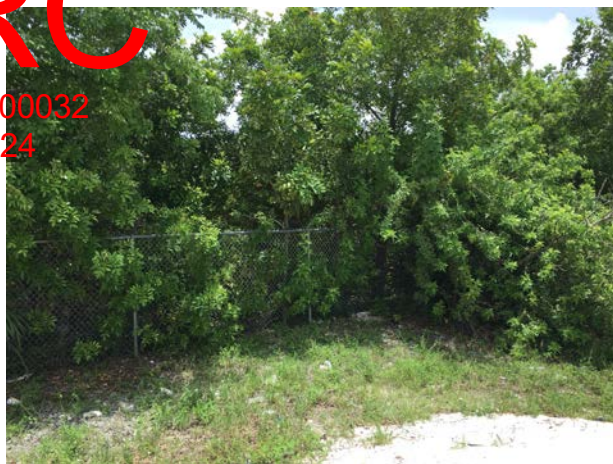
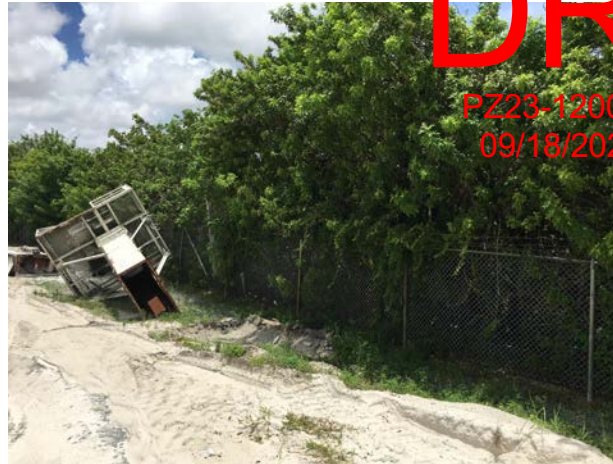
The East boundary is six-foot chain link with overgrown shrub.

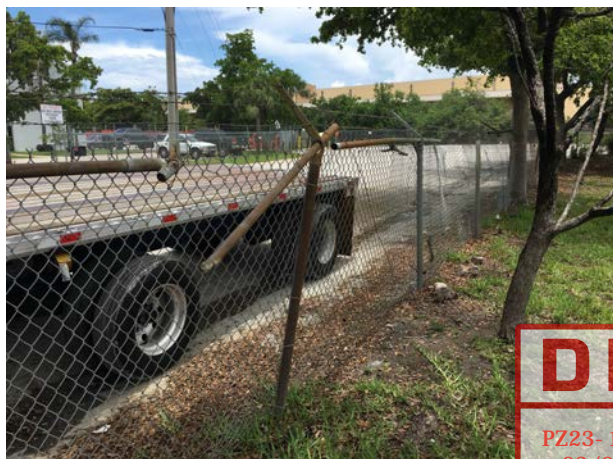
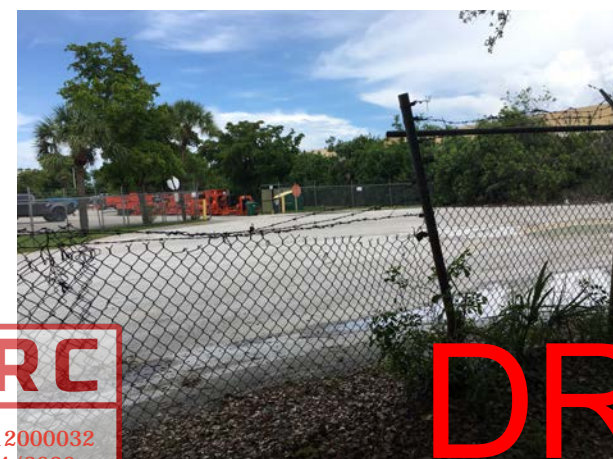
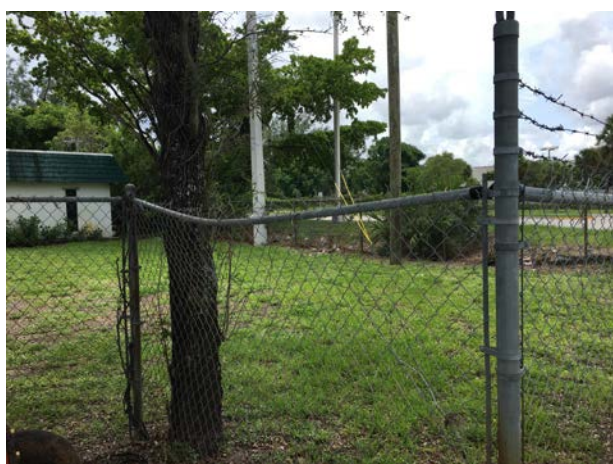
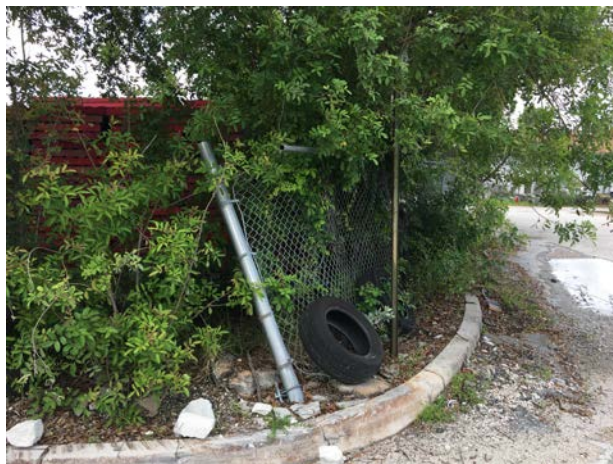
The North boundary is presently the primary access and egress points to the plant on NW 18th Street. There are two gates openings. Both gates are left open and have been damaged and non-operational. The barbed wire on the top of the chain link fencing has been damaged and not consistent.

The north boundary fencing is heavily damaged.

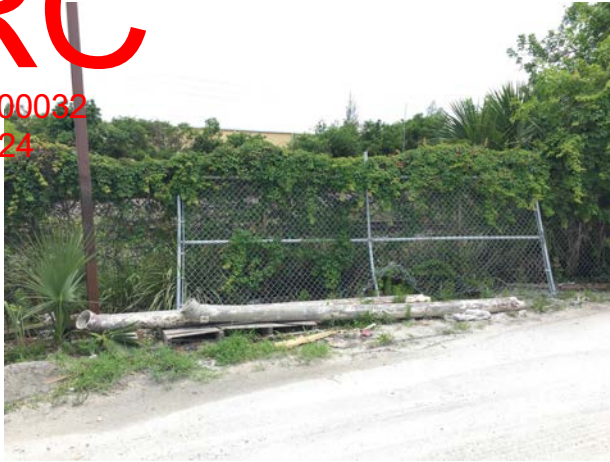
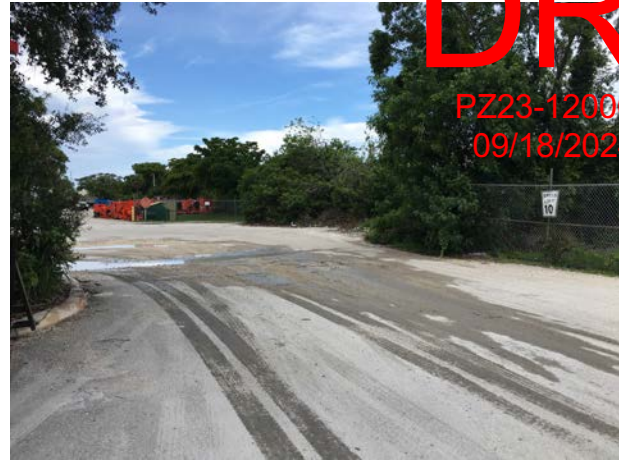
The northeast gate has been knocked off the tracks and lays against the east perimeter fence. The open access allows trucks with aggregate product to enter in the site, but also has no barriers to keep trespassers out.

The approach onto the site will remain open because of the volume of traffic by trucks and rigs picking up and dropping off product, While the gates remain open during plant operations, there is the capability to secure the site and close the manually operated gates when there are holidays.

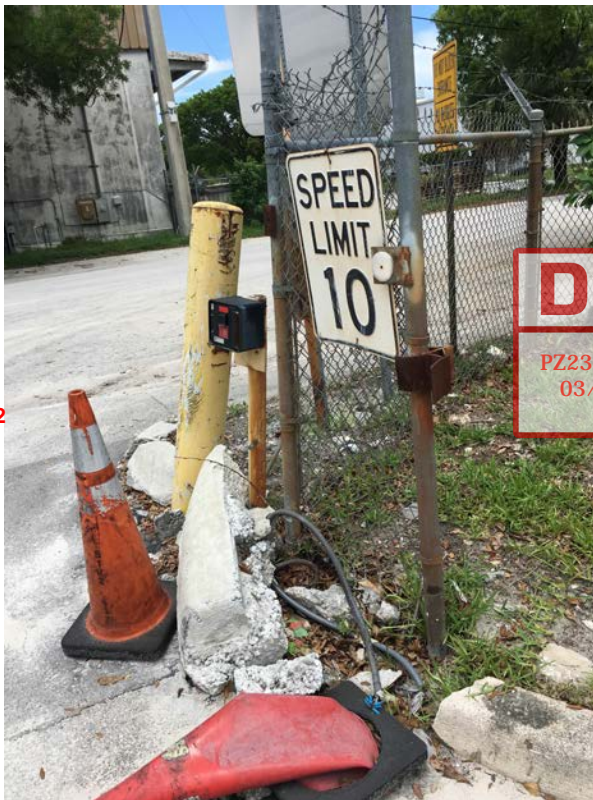
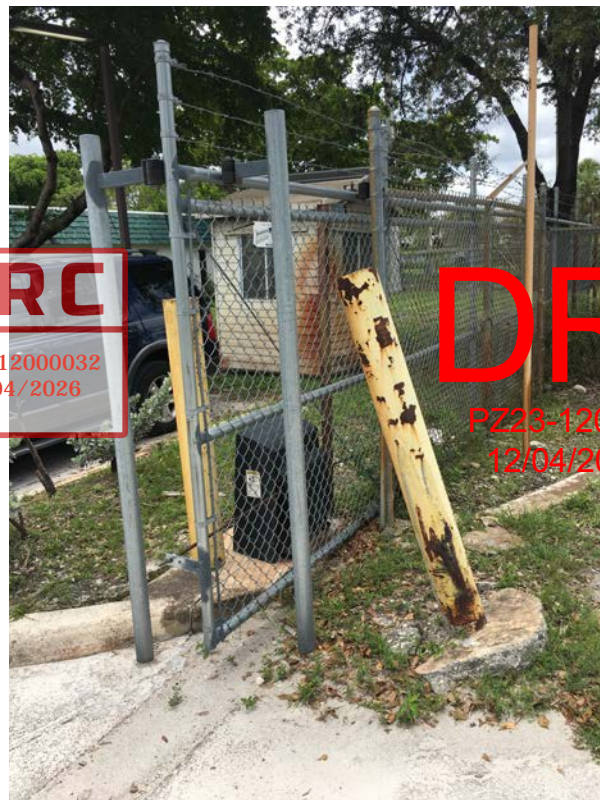
The Northwest gate is the primary entrance for administration, employee vehicles. The gate is non-functional and is in disrepair.

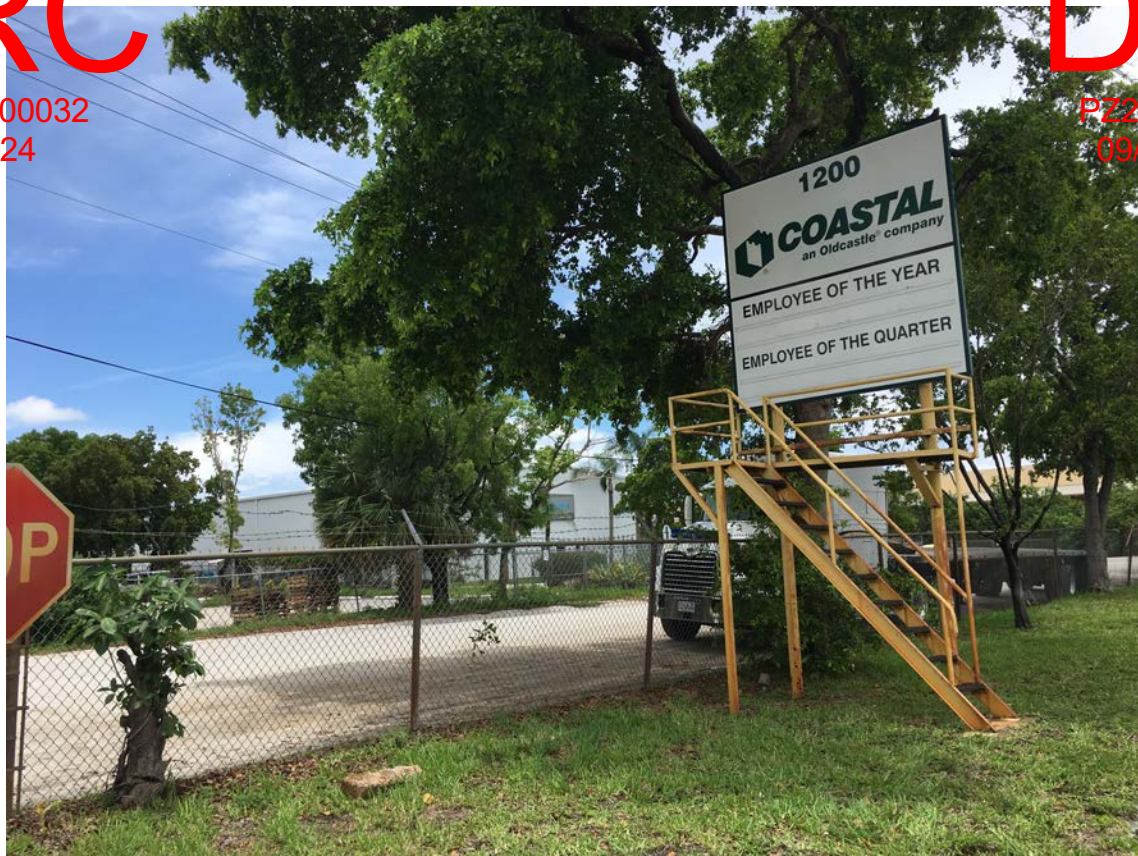
The north boundary on NW 18th Street has the marquee sign for the plant. It is difficult to see from the main road, Andrews Avenue.

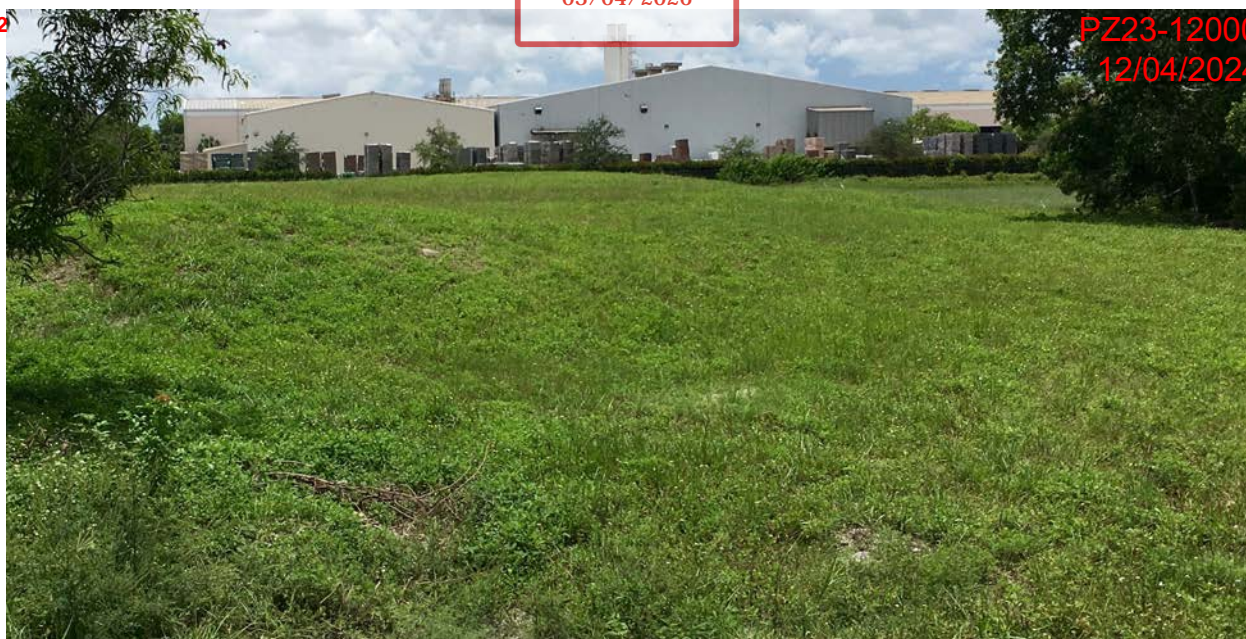
The South boundary is open real estate between the Bonsal Plant and the Oldcastle Distribution Center.

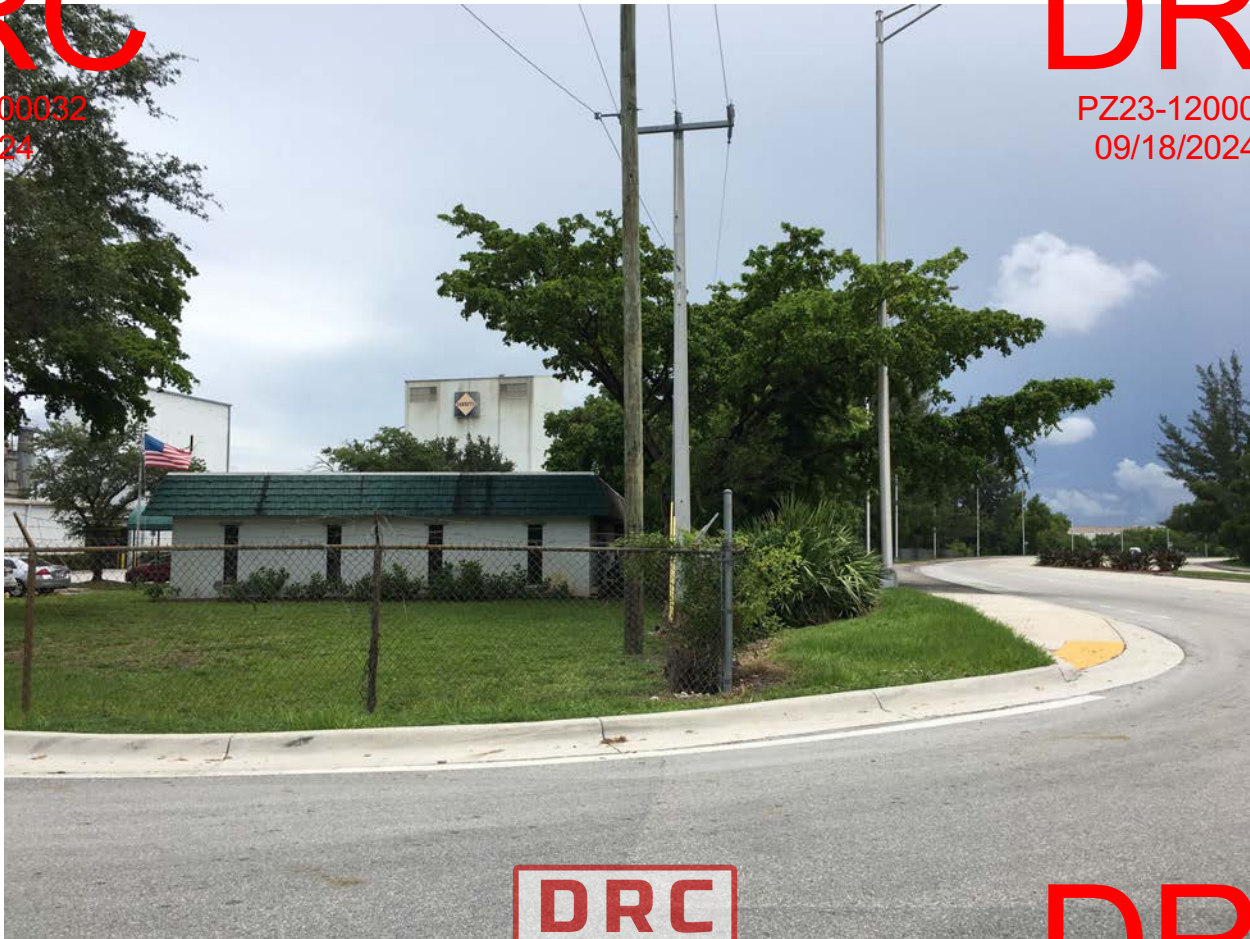
There are no controls for vehicles once trucks turn on 18^h Street. There are no barriers controlling access to the parking lot and the north side.

Site access control – The site is accessed through two vehicle entrances located on the south border of the property. Trucks and light vehicles enter on the south side, as well as employees and customers. It is proposed that the entrances will have a swinging or sliding mechanical gates and video surveillance. The sliding and swinging gates should be closed after hours, and will be used in order to stop trespass, piggybacking, and unauthorized access onto the site and into the building.

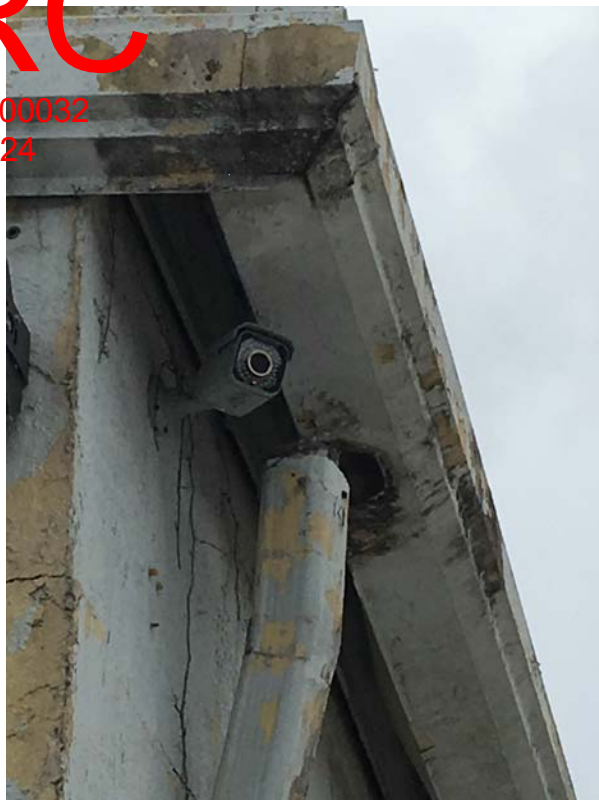
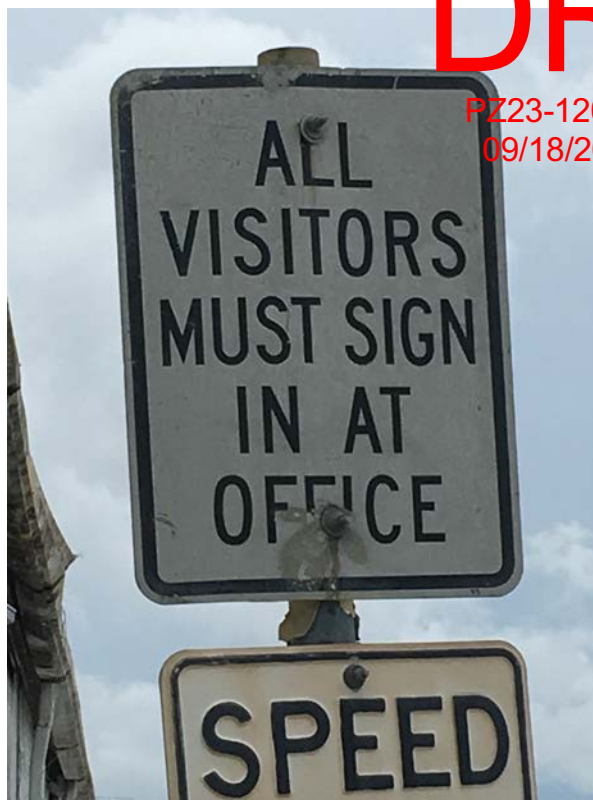
Natural surveillance of the north parking lot and northwest vehicle entrance is achievable from the windows of the administrative offices if staff is present. There is no mechanical surveillance being used on the property, on the site or inside the plant or administrative spaces. While remnants of an old CCTV system were there, it is not functional. Access to the site are not controlled by gates because of the high volume of truck traffic daily, so to prevent theft, vandalism, pilferage, or illegal dumping, vehicles and persons entering the site should be under mechanical surveillance.

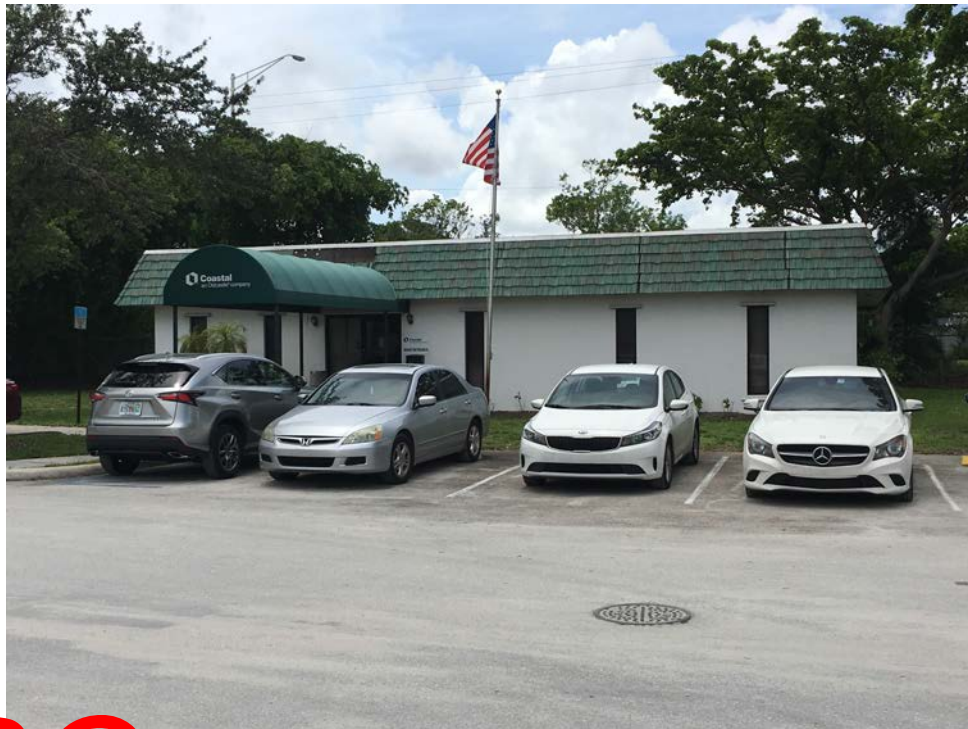
The business office entrance faces east and the north side of the site.

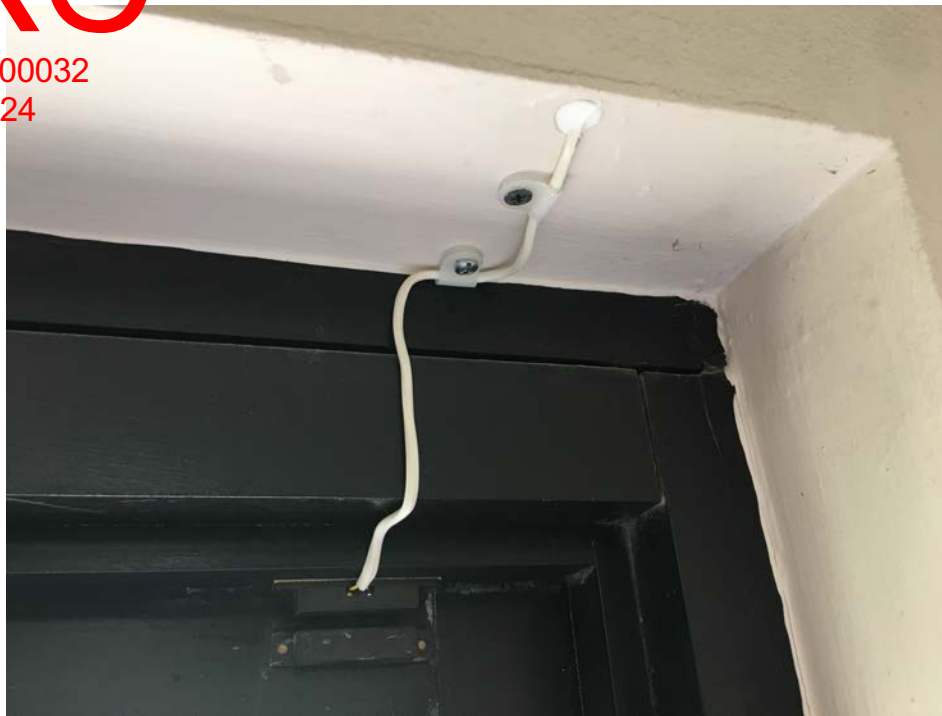
The office has a make shift security system that is monitored but needs to be updated. There is no exterior light along the east side of the business office.

Facility access control – The existing admin office building has a security burglar alarm system, with intrusion detection devices (motion sensors), and have the doors alarmed with door position switches (DPS). It is recommended that the existing building doors get rewired in a professional manner with no wires exposed, and if wires cannot be brought through the door frames, then have the wiring in security conduit. Since the factory plant is operating 24/7 their doors will be left open during operating hours, however the continual presence of staff should discourage and opportunity for criminal activity. The Alarm Company is Tyco/ADT and their service can be easily expanded to include the interior space protection alarms, the door position switches, and the proposed video surveillance system and video monitoring for the site.

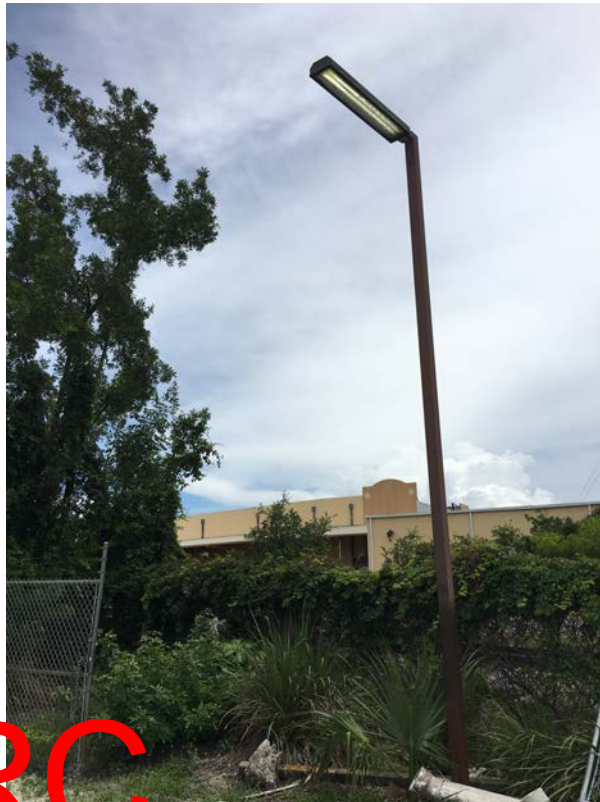
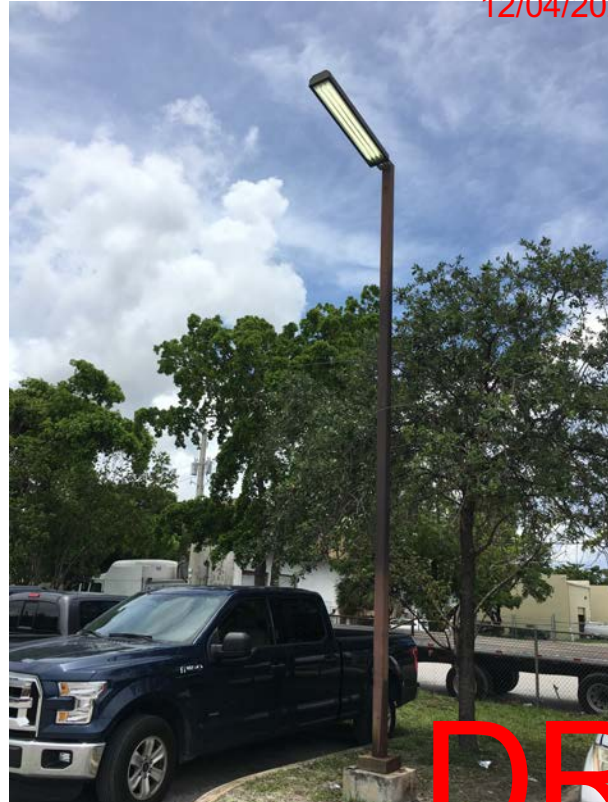
There are several large floodlights on 20-foot light poles positioned randomly in the parking areas to accomplish nighttime lighting. There are floodlights along the warehouse buildings, but the lighting is sporadic, and not up to contemporary lighting standards.

The pole lighting actually uses florescent tubes, and was turned on during daylight hours.

Perimeter Lighting – The proposed photometric lighting plan will provide adequate lighting for the site and parking areas, without the effects of light trespass or light pollution. On the west and south vehicle entrances light levels are a minimum of 1 footcandle (FC) or greater. The storage yard generally has at least ½ footcandle minimum average coverage. The plant and office buildings will have exterior lighting that illuminate the building exterior in the hours of darkness. It will be important to view any illegitimate activity on the site and around the buildings. Therefore, lighting should be uniform and consistent on the stock and pallet areas with enough lighting to be able to observe movement by any potential trespassers. The exterior showroom areas should have a minimum of ½ FC of lighting to facilitate pedestrian movement and support video surveillance. The plant's renovated lighting is adequate on the east, west and north sides. However, where the silo's are located on the south side, additional luminaires will be added, as there are vehicles parked, stock pallets, and heavy machinery that should be observable.

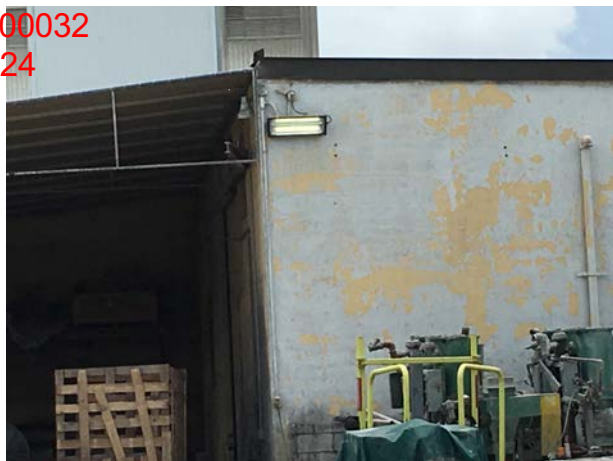
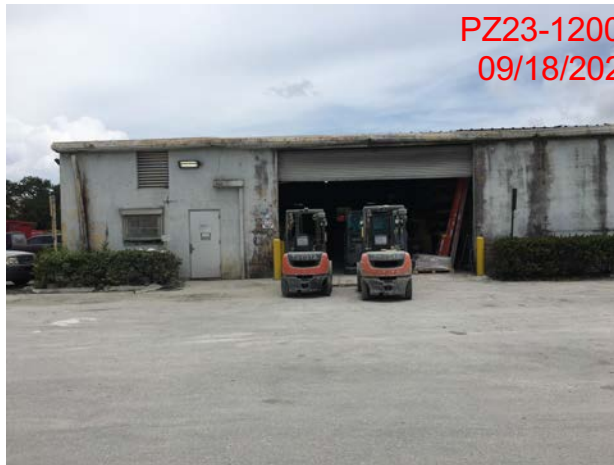
The exterior building lighting is florescent tubes, which are inadequate to properly light the grounds.

Building exterior lighting – The newly renovated and retrofitted lighting plan is providing adequate illuminate to the exterior of the buildings, the stock areas, the exterior yard area, and vehicular entrances for good visibility and accountability. Additional lighting is needed on all sides of the plant, and the three vehicle entrances to complete the lighting goals.

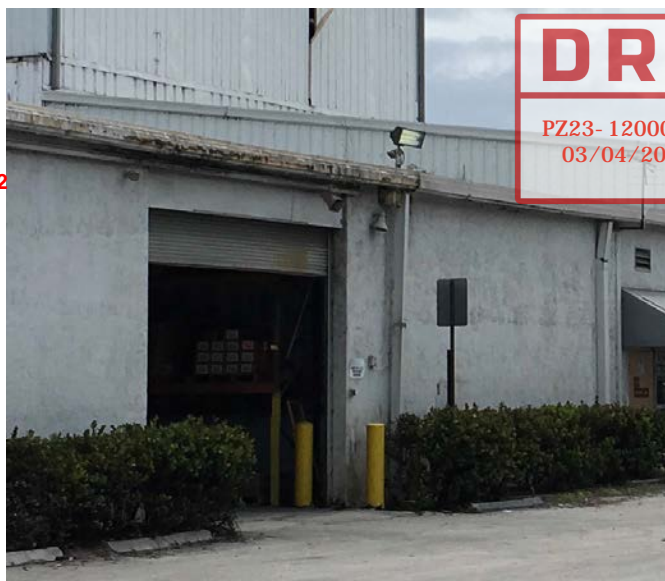
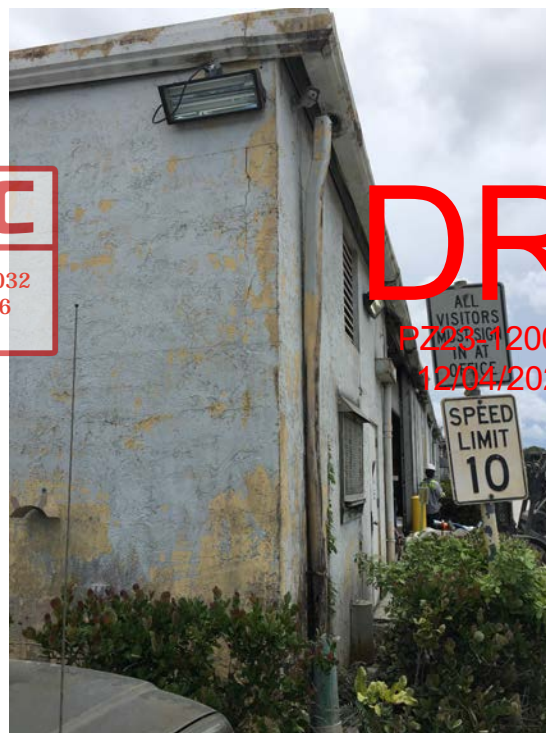
The exterior lighting using florescent tubes as the light source was inefficient and not effective to evenly light the site and building exterior.

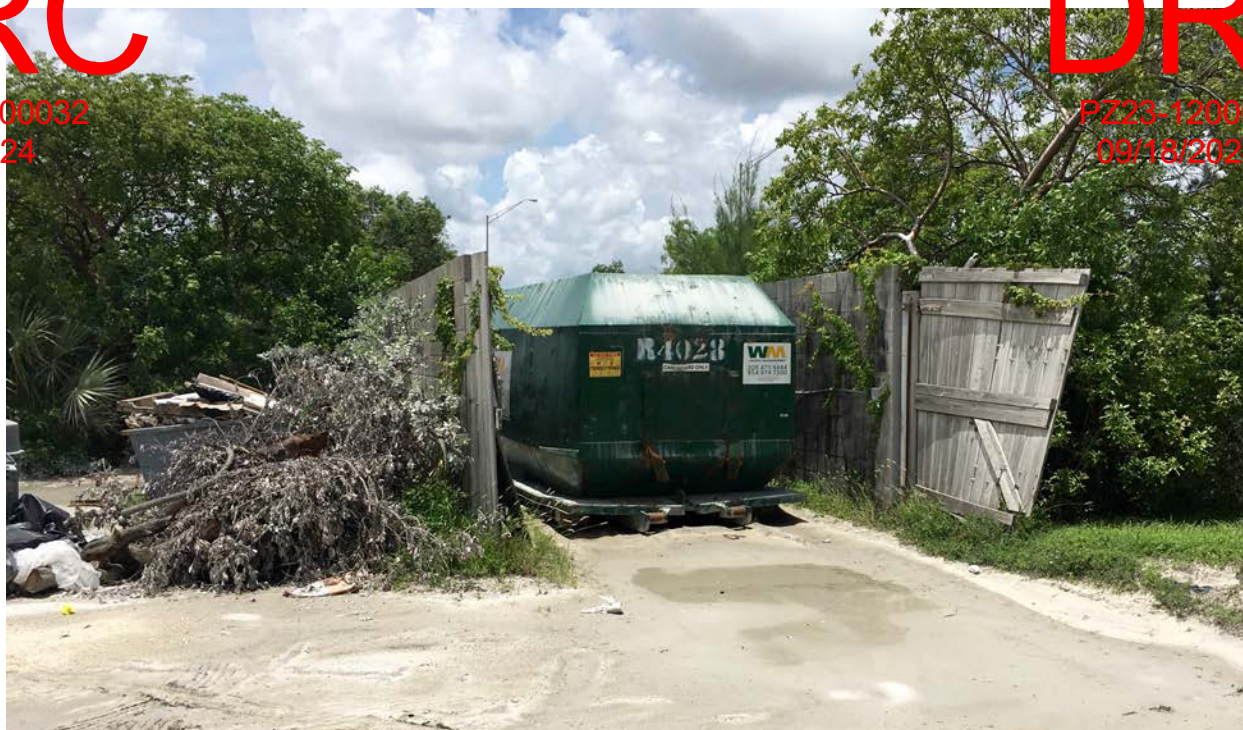
The exterior dumpster area is located in the south part of the yard area across from the Plant. The screening needs to be in working order, and lockable, and the area cleaned up. The dumpster is not set down on a concrete pad. There is no drainage capacity. The wooden gates and shielding are damaged and does not close properly. There is no locking capability to prevent outsiders from outside persons dumping trash.

The new proposed dumpster area should be on a concrete pad that can withstand picking up and dropping down by a garbage truck. There should be bollards/bumpers to prevent the truck from hitting the dumpster enclosure. The dumpster should be shielded on three sides with a screening that complies with zoning regulations. Swing gates that are locked should be used to protect the dumpster from illegal or unwanted dumpster diving or dumping. The front screening should be raised so that a person in the dumpster area can be observed from the outside. The gates should be lockable so they can be secured when not being used. If there is any trespassing in the exterior site areas, the person will stand out and be observed and challenged.

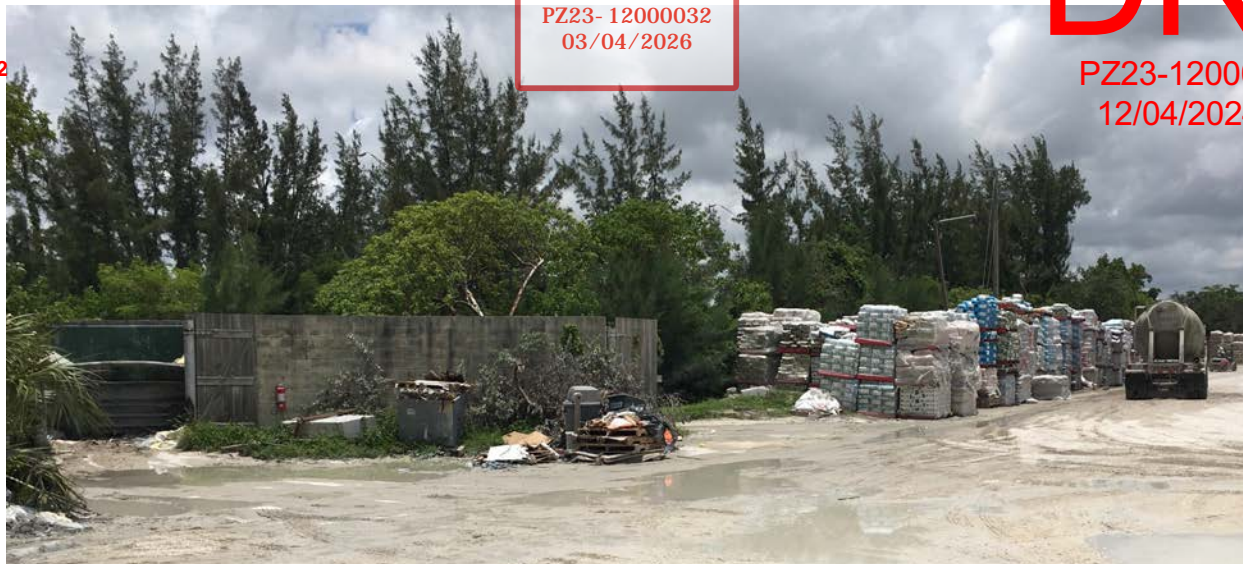
There appears to be some dumping just adjacent to the dumpster. In the new site plan the dumpster will be designed to have compliant surrounding shielding and be secured.

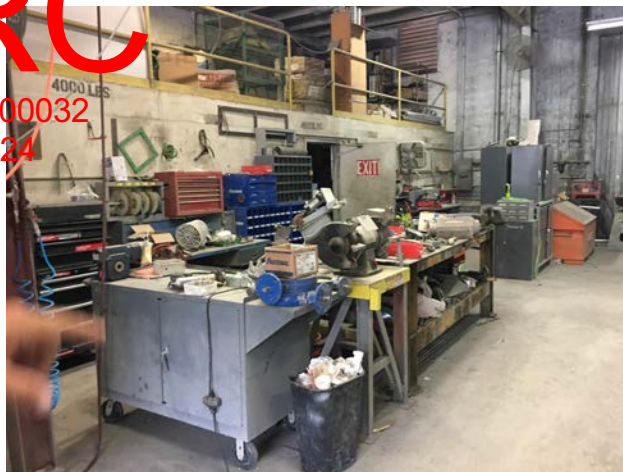
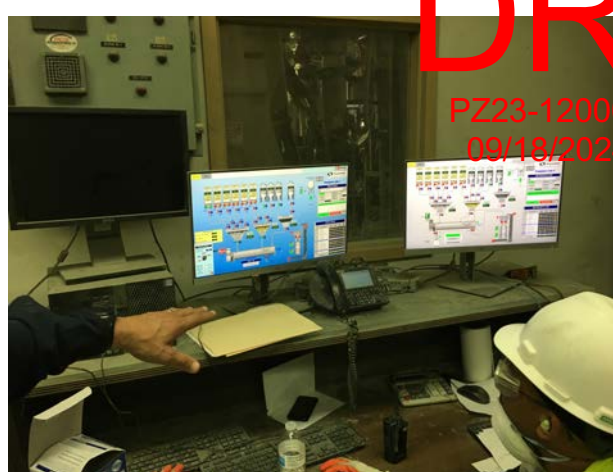
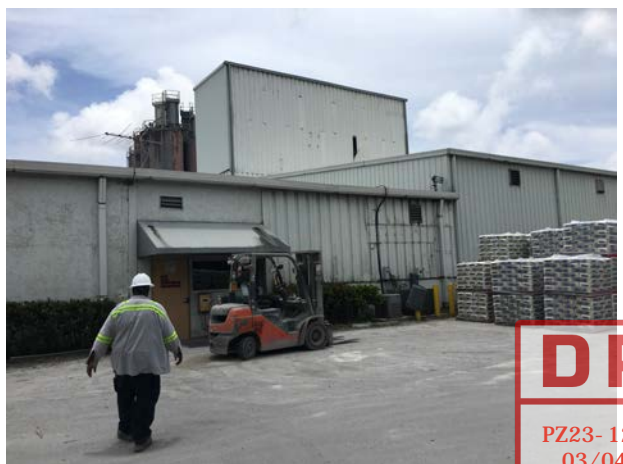
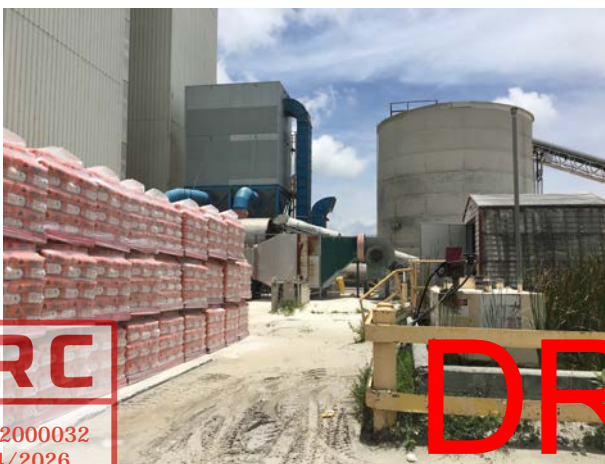
Tools and equipment is an attractive asset that need to be protected.

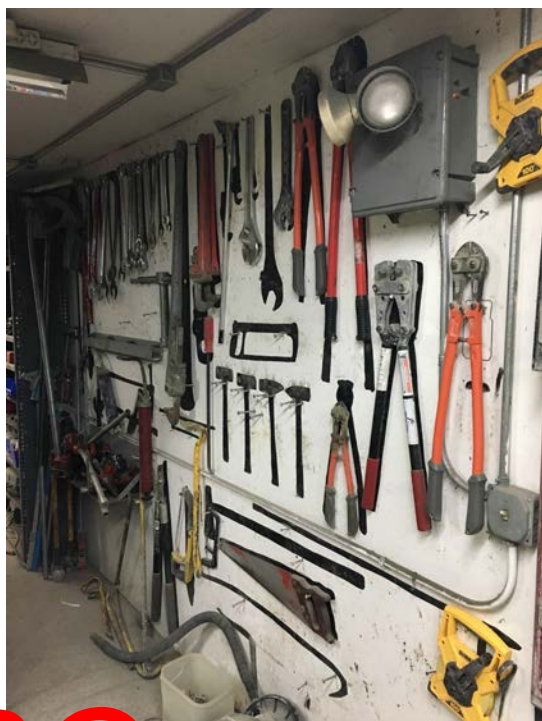
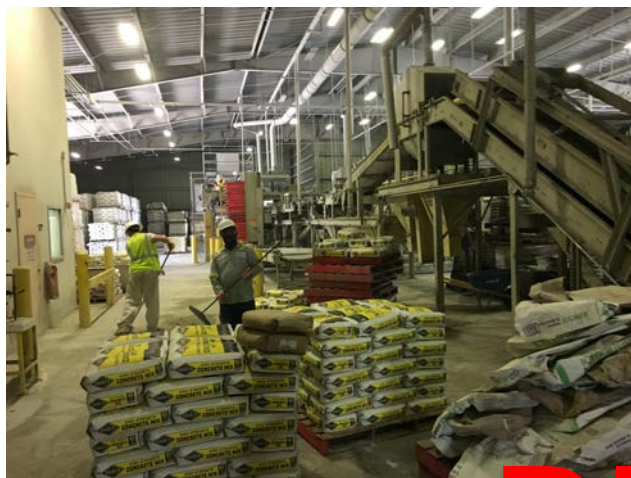
Tools and machinery must be protected from loss, theft, pilferage, or vandalism.

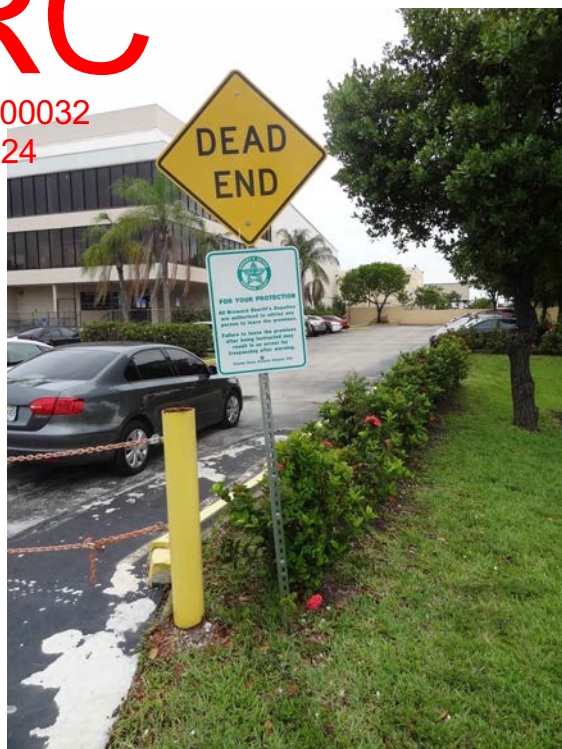
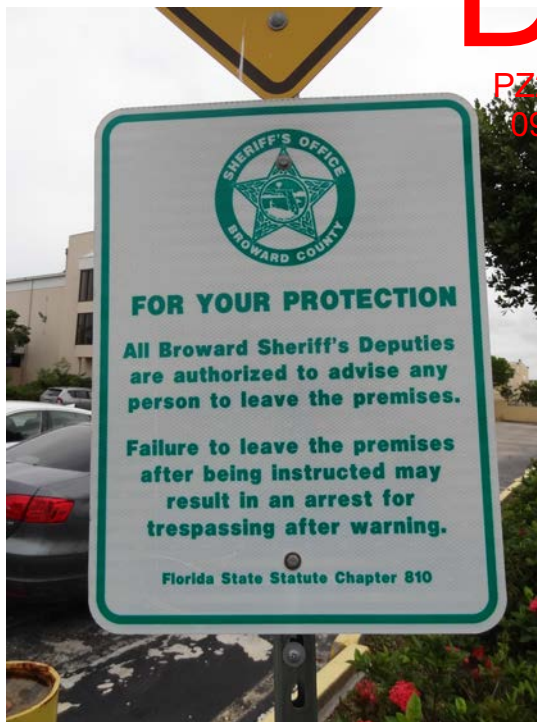
At the Baers buildings, down the street from the Oldcastle site, they have the parking lot chained off, after a couple of criminal incidents took place there. Baers posted a no trespass sign that empowered the Broward Sheriff's office to patrol the facility. Proper signage must state who is the enforcing agency and cite chapter and verse of the state law that is being enforced, as demonstrated above. This kind of signage will be added to the Oldcastle site.

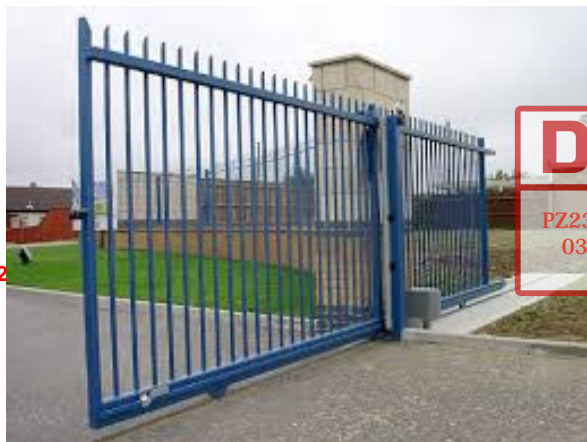
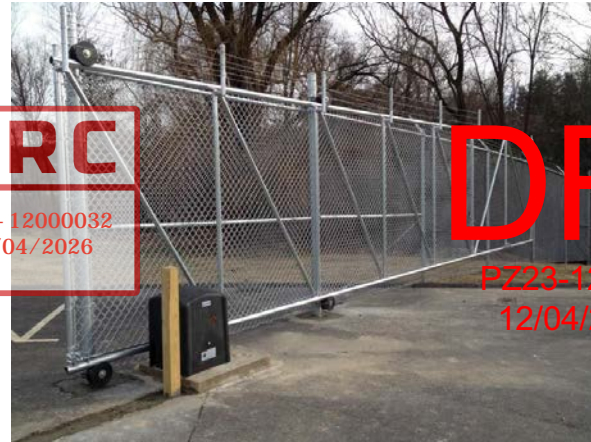
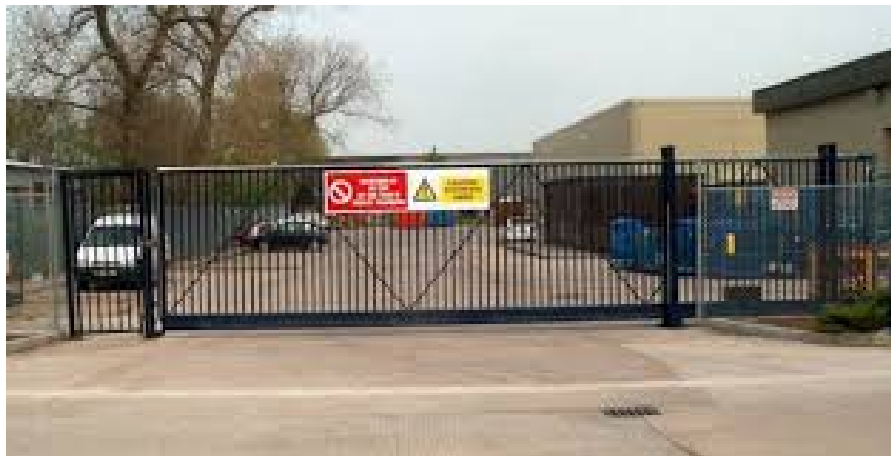
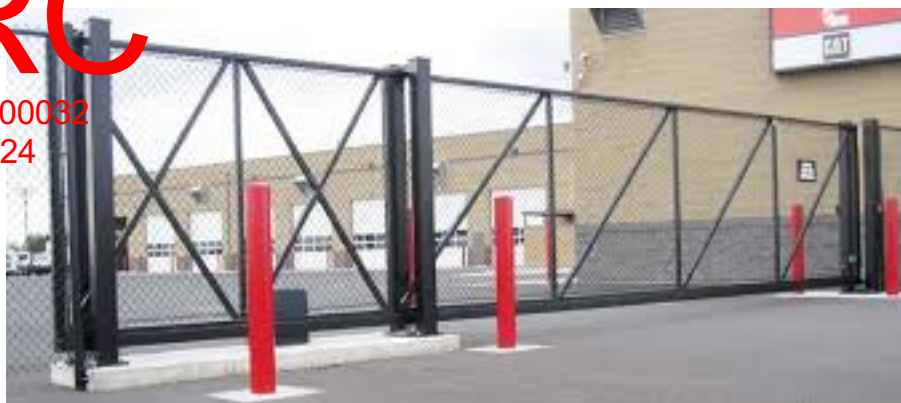
The pictures above are examples of vehicle gates and creating a secured entrance for company deliveries and vehicles.

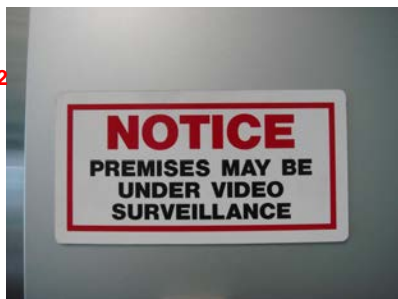
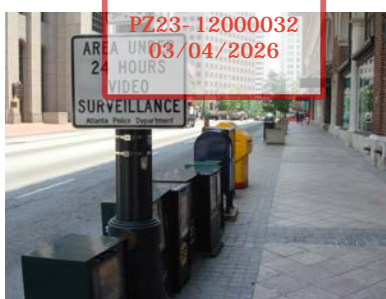
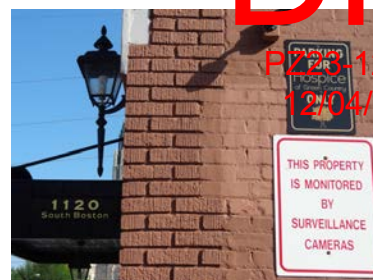
Signage creating notice of premises being monitored and under surveillance.

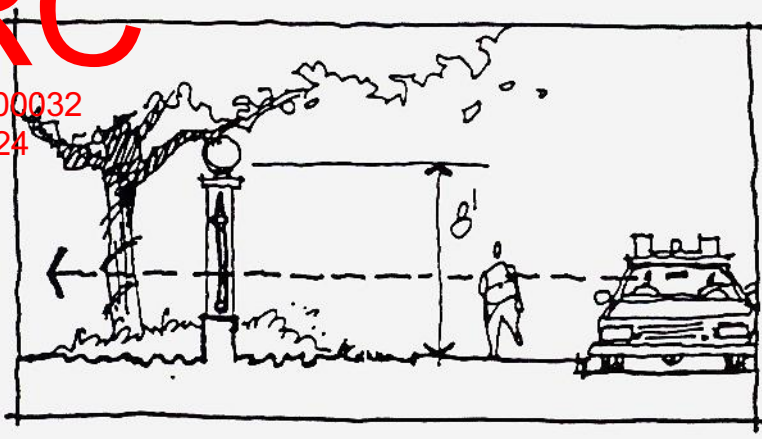
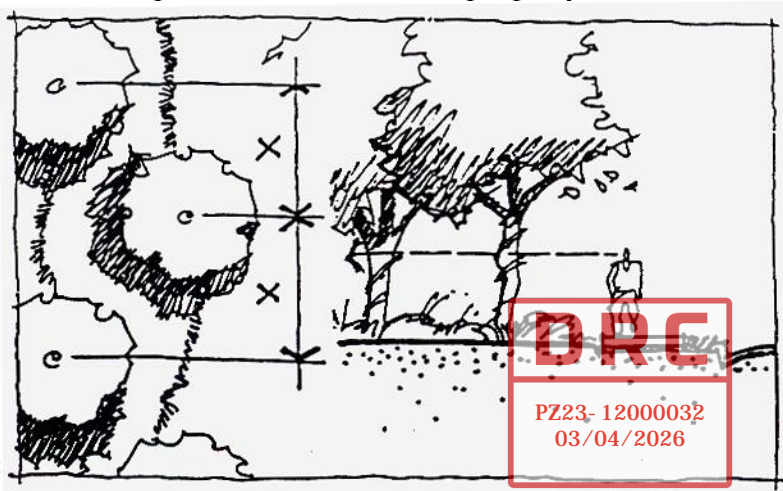
Ground plantings and hedges should be less than 3 feet and tree canopies over 8 feet to allow a clear zone of natural surveillance for police to be able to have un-obscured sight around the perimeter and into the property.
