ATLAS SAFETY & SECURITY DESIGN, INC.

RE: Oldcastle Coastal Facility – 1200 NW 18th St., Pompano Beach, CPTED/Security Public Safety Plan

I have been contracted to review the drawings for security and Crime Prevention Through Environmental Design (CPTED) features in the proposed Oldcastle Bonsal Facility site plan update that is being considered for permitting by the City of Pompano Beach.

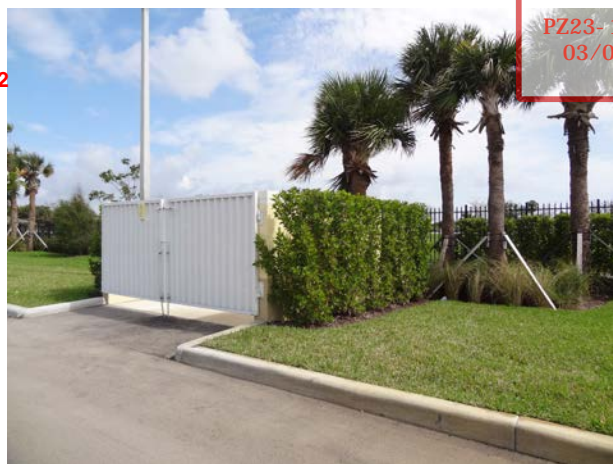
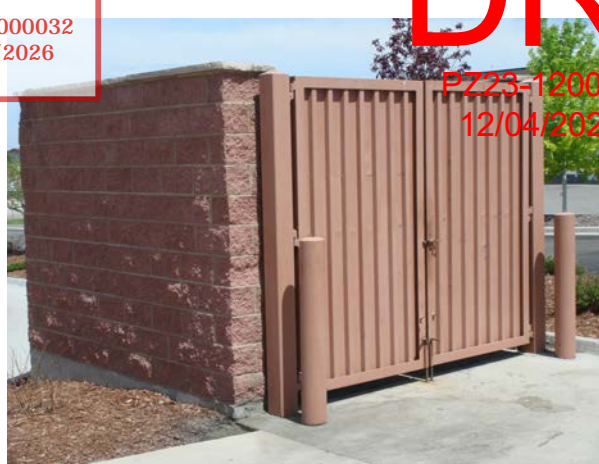
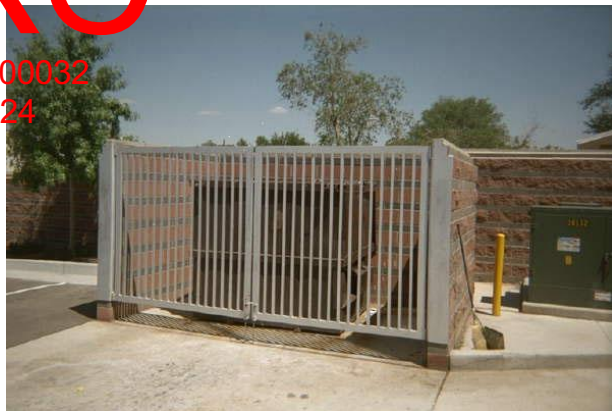
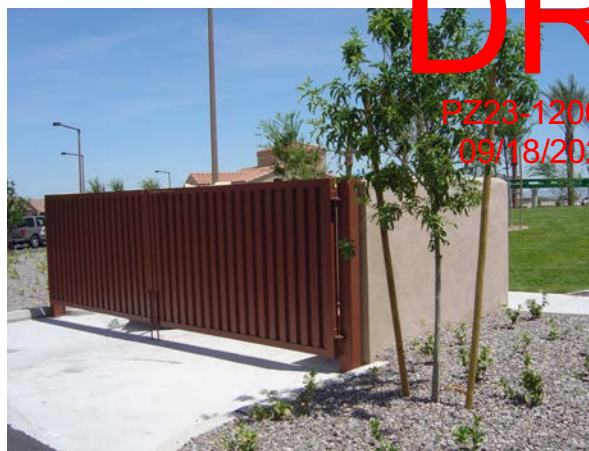
Good examples of CPTED dumpster design demonstrating three-side shielding, bumper bollards, ground level visibility, gate doors that close and lock, and ample room for garbage trucks to back up and pick up the dumpster for emptying.

The new proposed dumpster area should be on a concrete pad that can withstand picking up and dropping down by a garbage truck. There should be bollards/bumpers to prevent the truck from hitting the dumpster enclosure. The dumpster should be shielded on three sides with a screening that complies with zoning regulations. Swing gates that are locked should be used to protect the dumpster from illegal or unwanted dumpster diving or dumping. The front screening should be raised so that a person in the dumpster area can be observed from the outside. The gates should be lockable so they can be secured when not being used. If there is any trespassing in the exterior site areas, the person will stand out and be observed and challenged.
