PHASE I ENVIRONMENTAL SUBJECT PROPERTY ASSESSMENT

**SUBJECT PROPERTY: APPROXIMATE 20-
ACRE PARCEL LOCATED WITHIN THE
HARRAH'S POMPANO BEACH CASINO**

Project FE8224A

February 2024

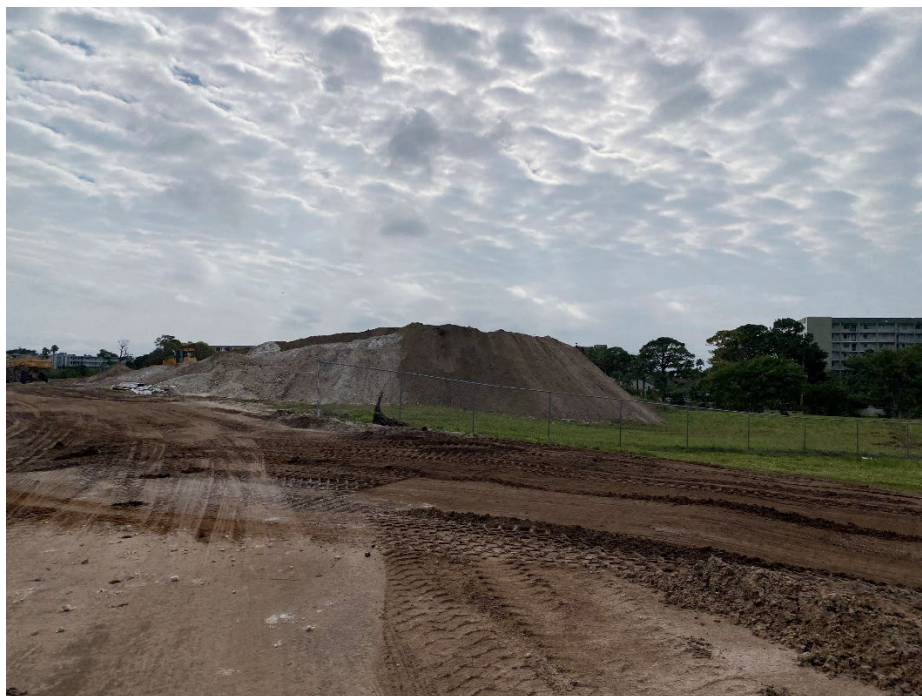
Comments: View of soil piles on southwest corner of Subject Property. No staining or odors were observed.

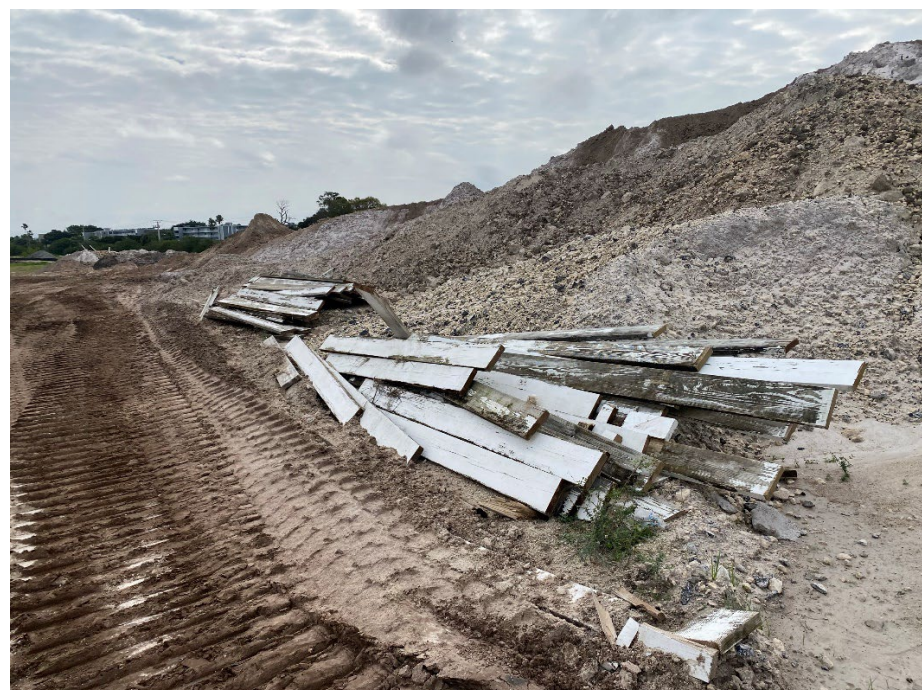
Photograph 4

Comments: View of wood debris and soil piles on southwest corner of Subject Property. No staining or odors were observed.

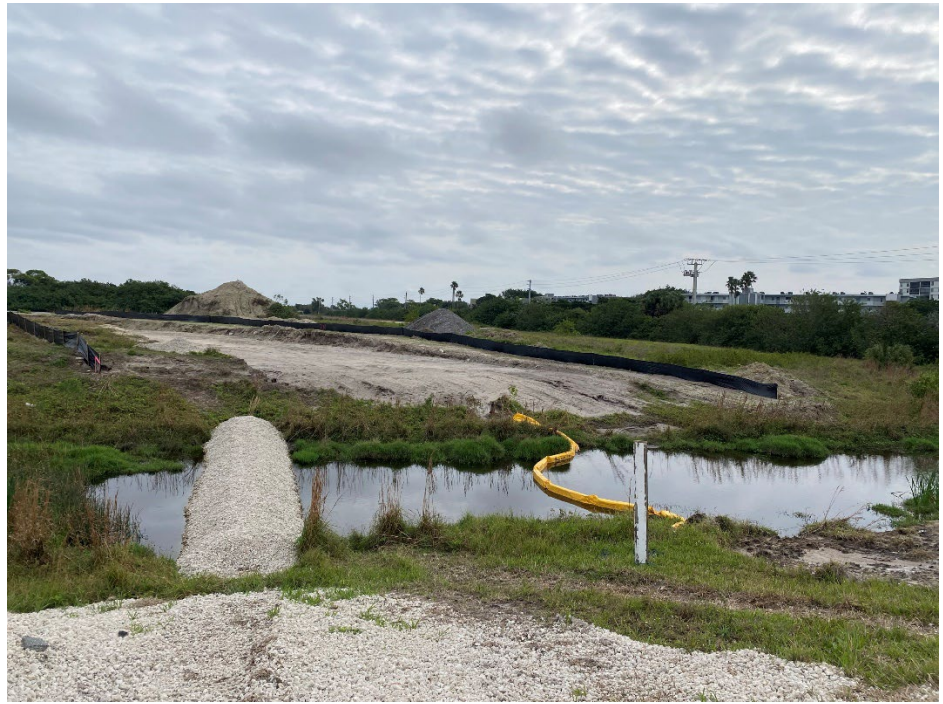
Comments: View of stormwater/drainage system leading south of Subject Property. Soil berm and booms observed (likely a part of construction erosion/sediment control procedures).

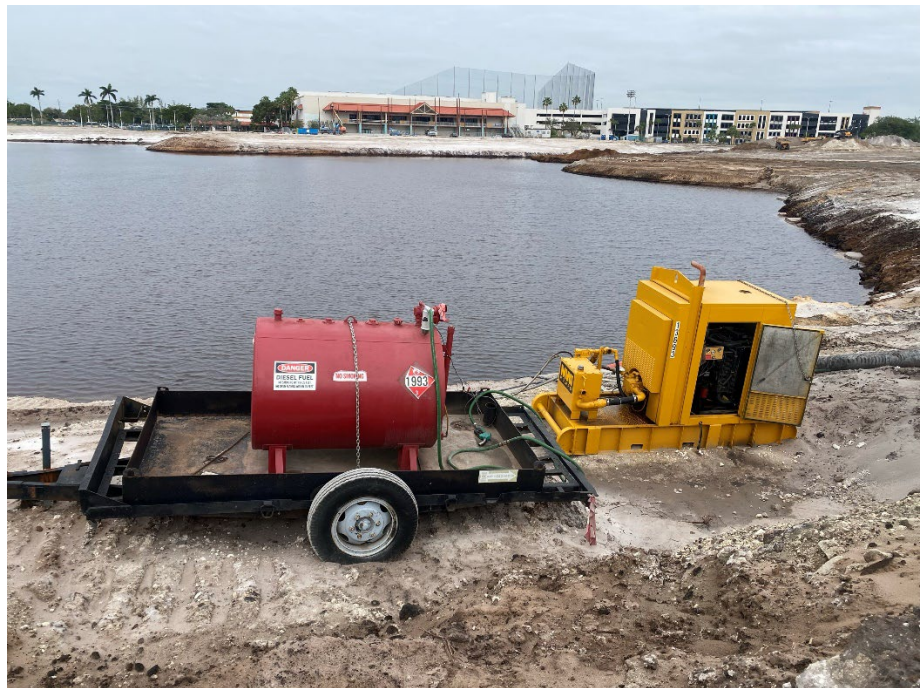
Photograph 8

Comments: View of 500-gallon tank and pump south of former retention pond but north of Subject Property boundary (on Parent Property) to convey water to southeast of Subject Property. No staining or odors were observed.

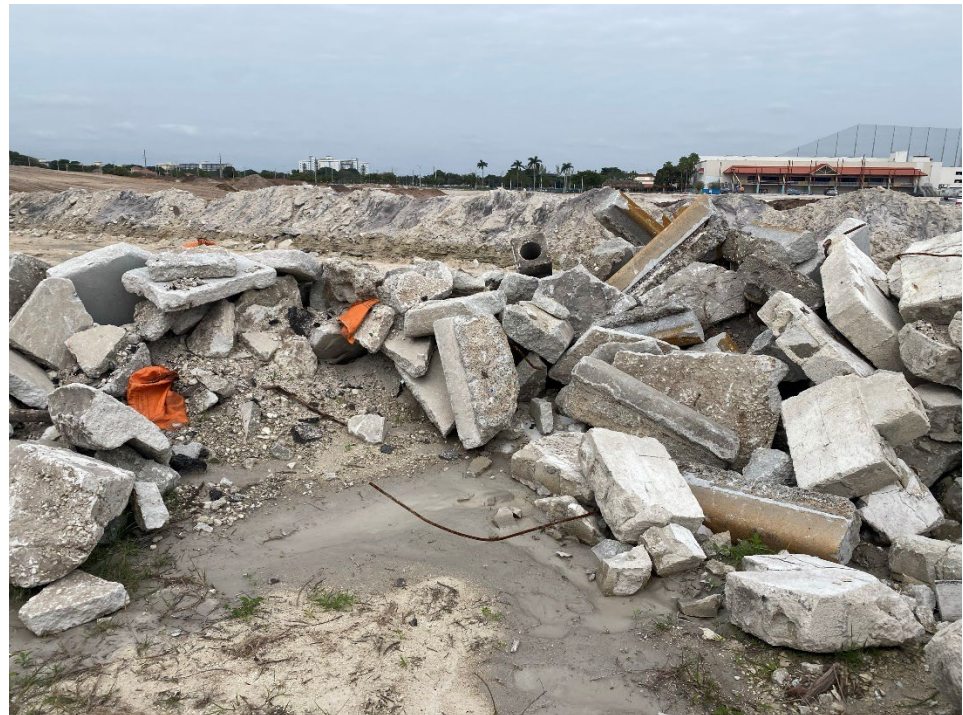
Comments: View of concrete construction debris on southeast portion of Subject Property. No staining or odors were observed.

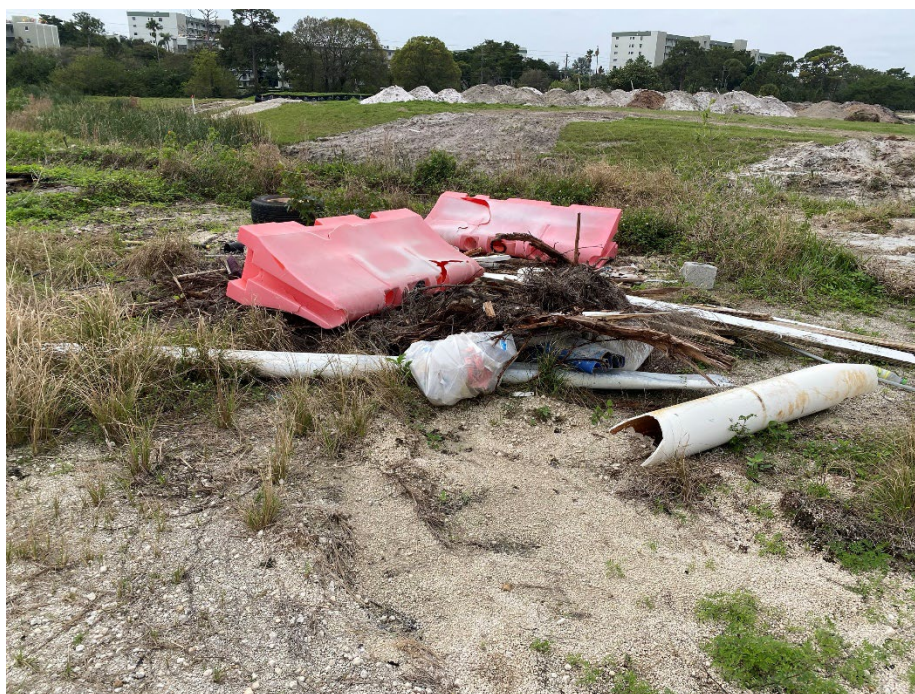
Comments: View of debris from general construction activities on southern area of Subject Property. No staining or odors were observed.

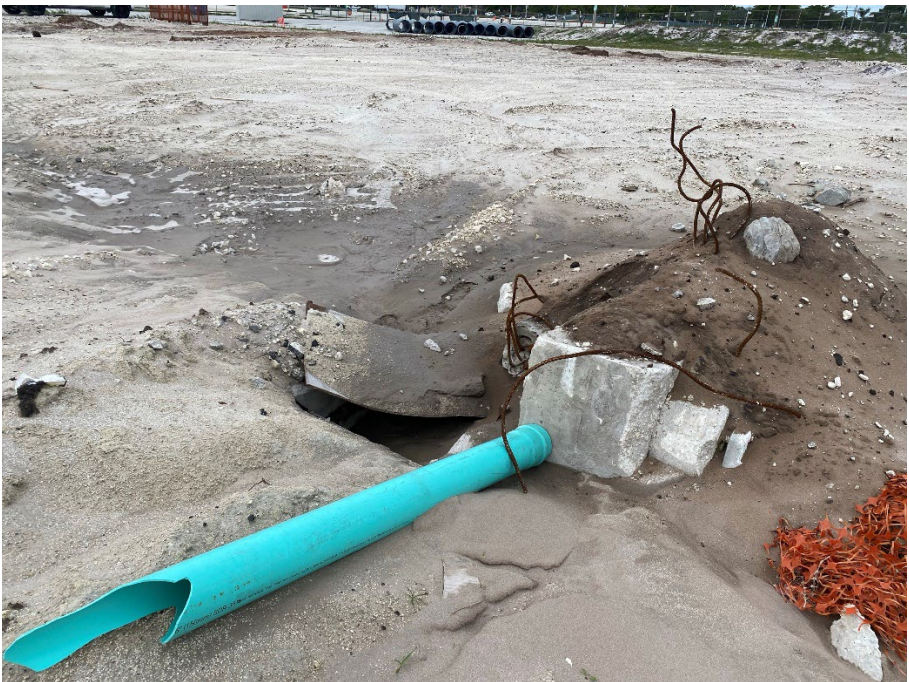
Comments: General construction debris on soil pile on northwest corner of Subject Property. No staining or odors were observed.
