ATLAS SAFETY & SECURITY DESIGN, INC.

RE: Oldcastle Coastal Facility – 1200 NW 18th St., Pompano Beach, CPTED/Security Public Safety Plan

I have been contracted to review the drawings for security and Crime Prevention Through Environmental Design (CPTED) features in the proposed Oldcastle Bonsal Facility site plan update that is being considered for permitting by the City of Pompano Beach.

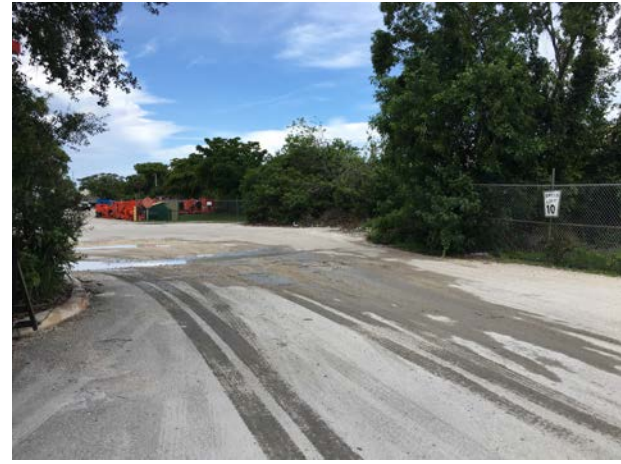
The northeast gate has been knocked off the tracks and lays against the east perimeter fence. The open access allows trucks with aggregate product to enter in the site, but also has no barriers to keep trespassers out.

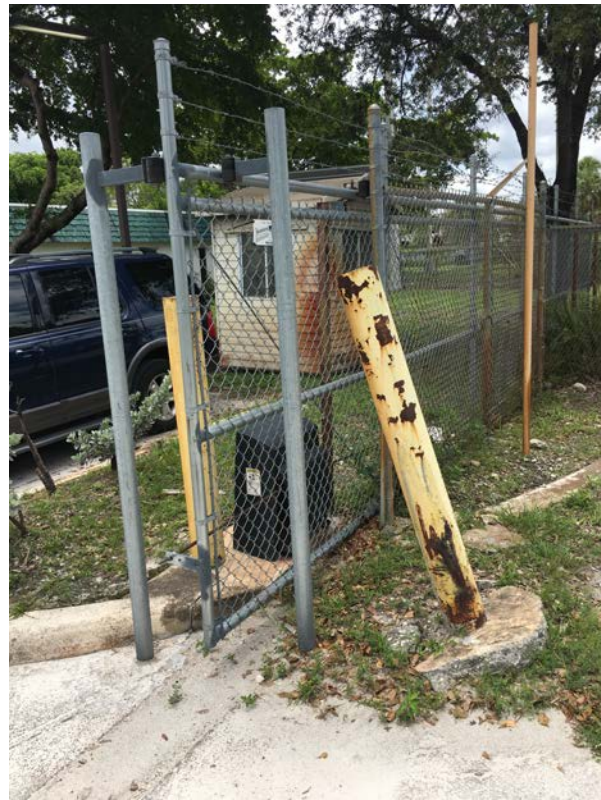
The Northwest gate is the primary entrance for administration, employee vehicles. The gate is non-functional and is in disrepair.

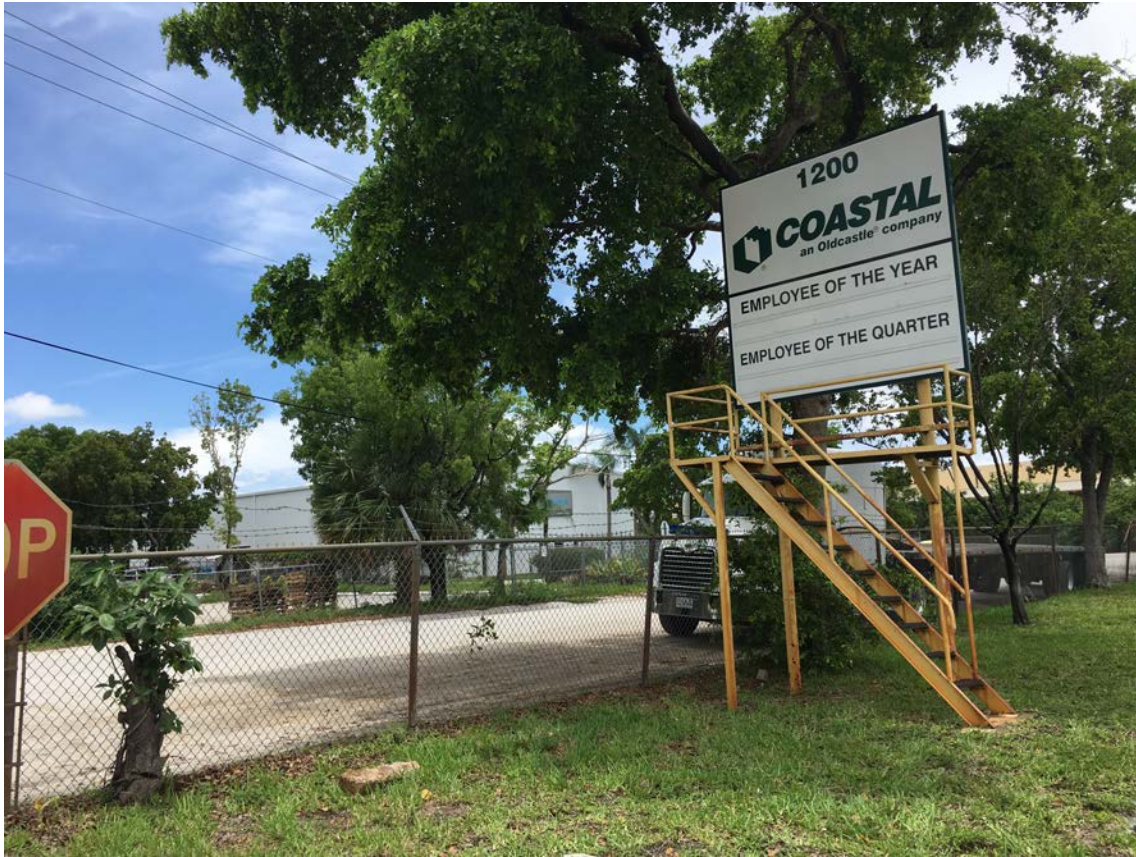
The north boundary on NW 18th Street has the marquee sign for the plant. It is difficult to see from the main road, Andrews Avenue.

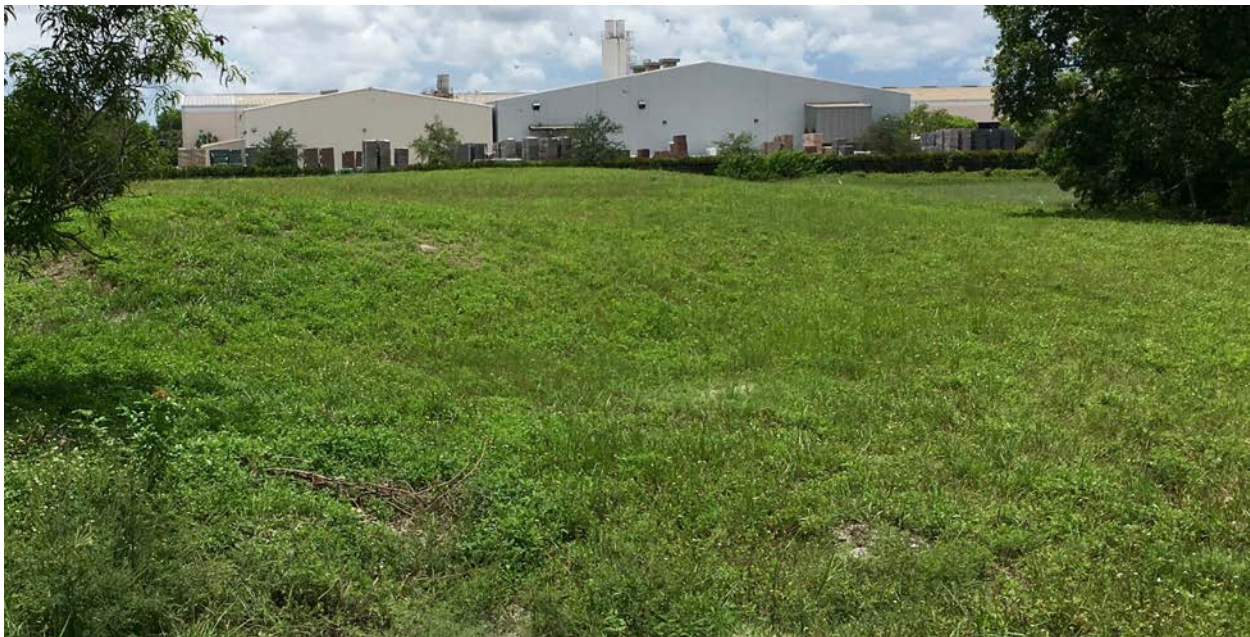
The South boundary is open real estate between the Bonsal Plant and the Oldcastle Distribution Center.

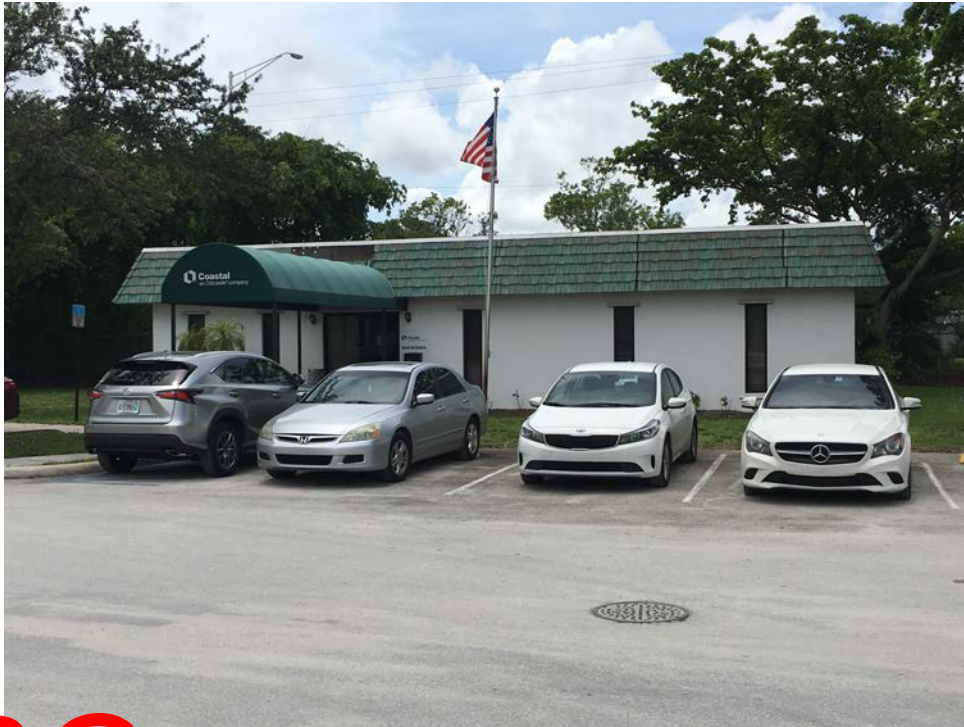
The business office entrance faces east and the north side of the site.

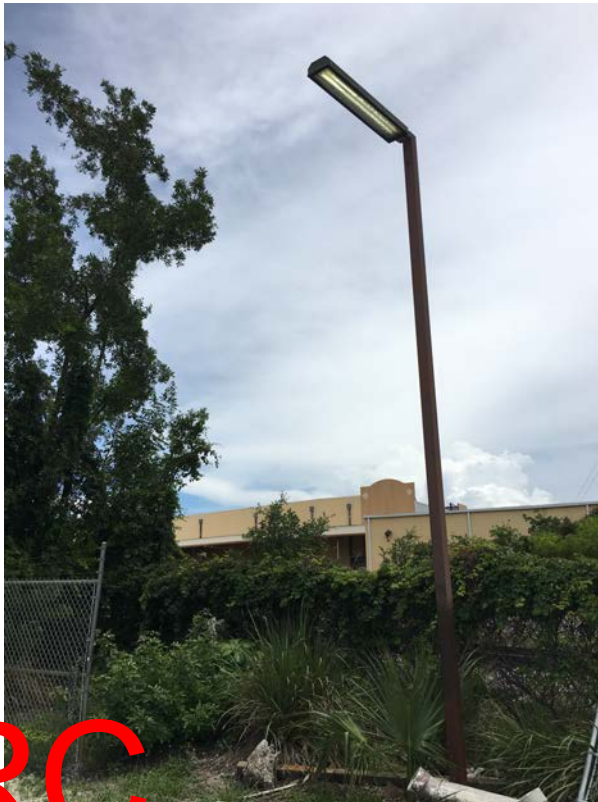
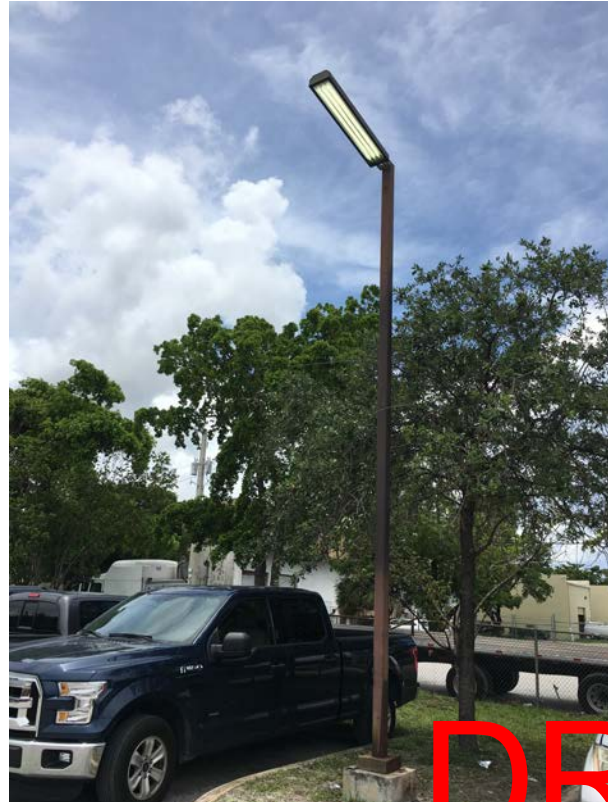
The pole lighting actually uses florescent tubes, and was turned on during daylight hours.

Perimeter Lighting – The proposed photometric lighting plan will provide adequate lighting for the site and parking areas, without the effects of light trespass or light pollution. On the west and south vehicle entrances light levels are a minimum of 1 footcandle (FC) or greater. The storage yard generally has at least ½ footcandle minimum average coverage. The plant and office buildings will have exterior lighting that illuminate the building exterior in the hours of darkness. It will be important to view any illegitimate activity on the site and around the buildings. Therefore, lighting should be uniform and consistent on the stock and pallet areas with enough lighting to be able to observe movement by any potential trespassers. The exterior showroom areas should have a minimum of ½ FC of lighting to facilitate pedestrian movement and support video surveillance. The plant's renovated lighting is adequate on the east, west and north sides. However, where the silo's are located on the south side, additional luminaires will be added, as there are vehicles parked, stock pallets, and heavy machinery that should be observable.

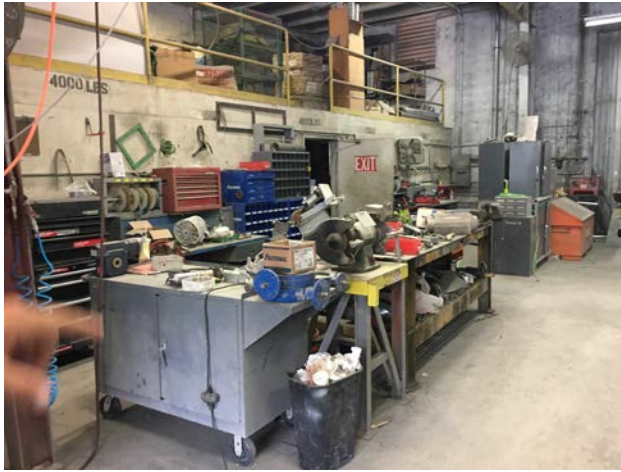
Tools and equipment is an attractive asset that need to be protected.

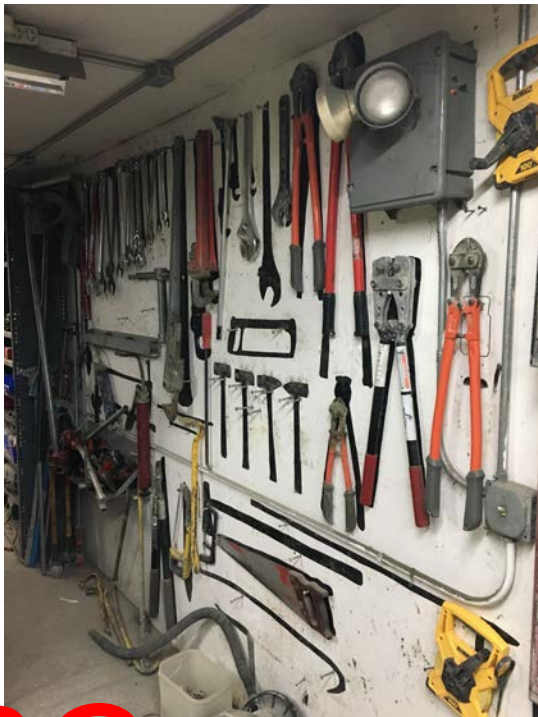
Tools and machinery must be protected from loss, theft, pilferage, or vandalism.
