Arborist Report

Alliance Gateway Industrial, SW 27th Avenue
Pompano Beach

10/13/2022

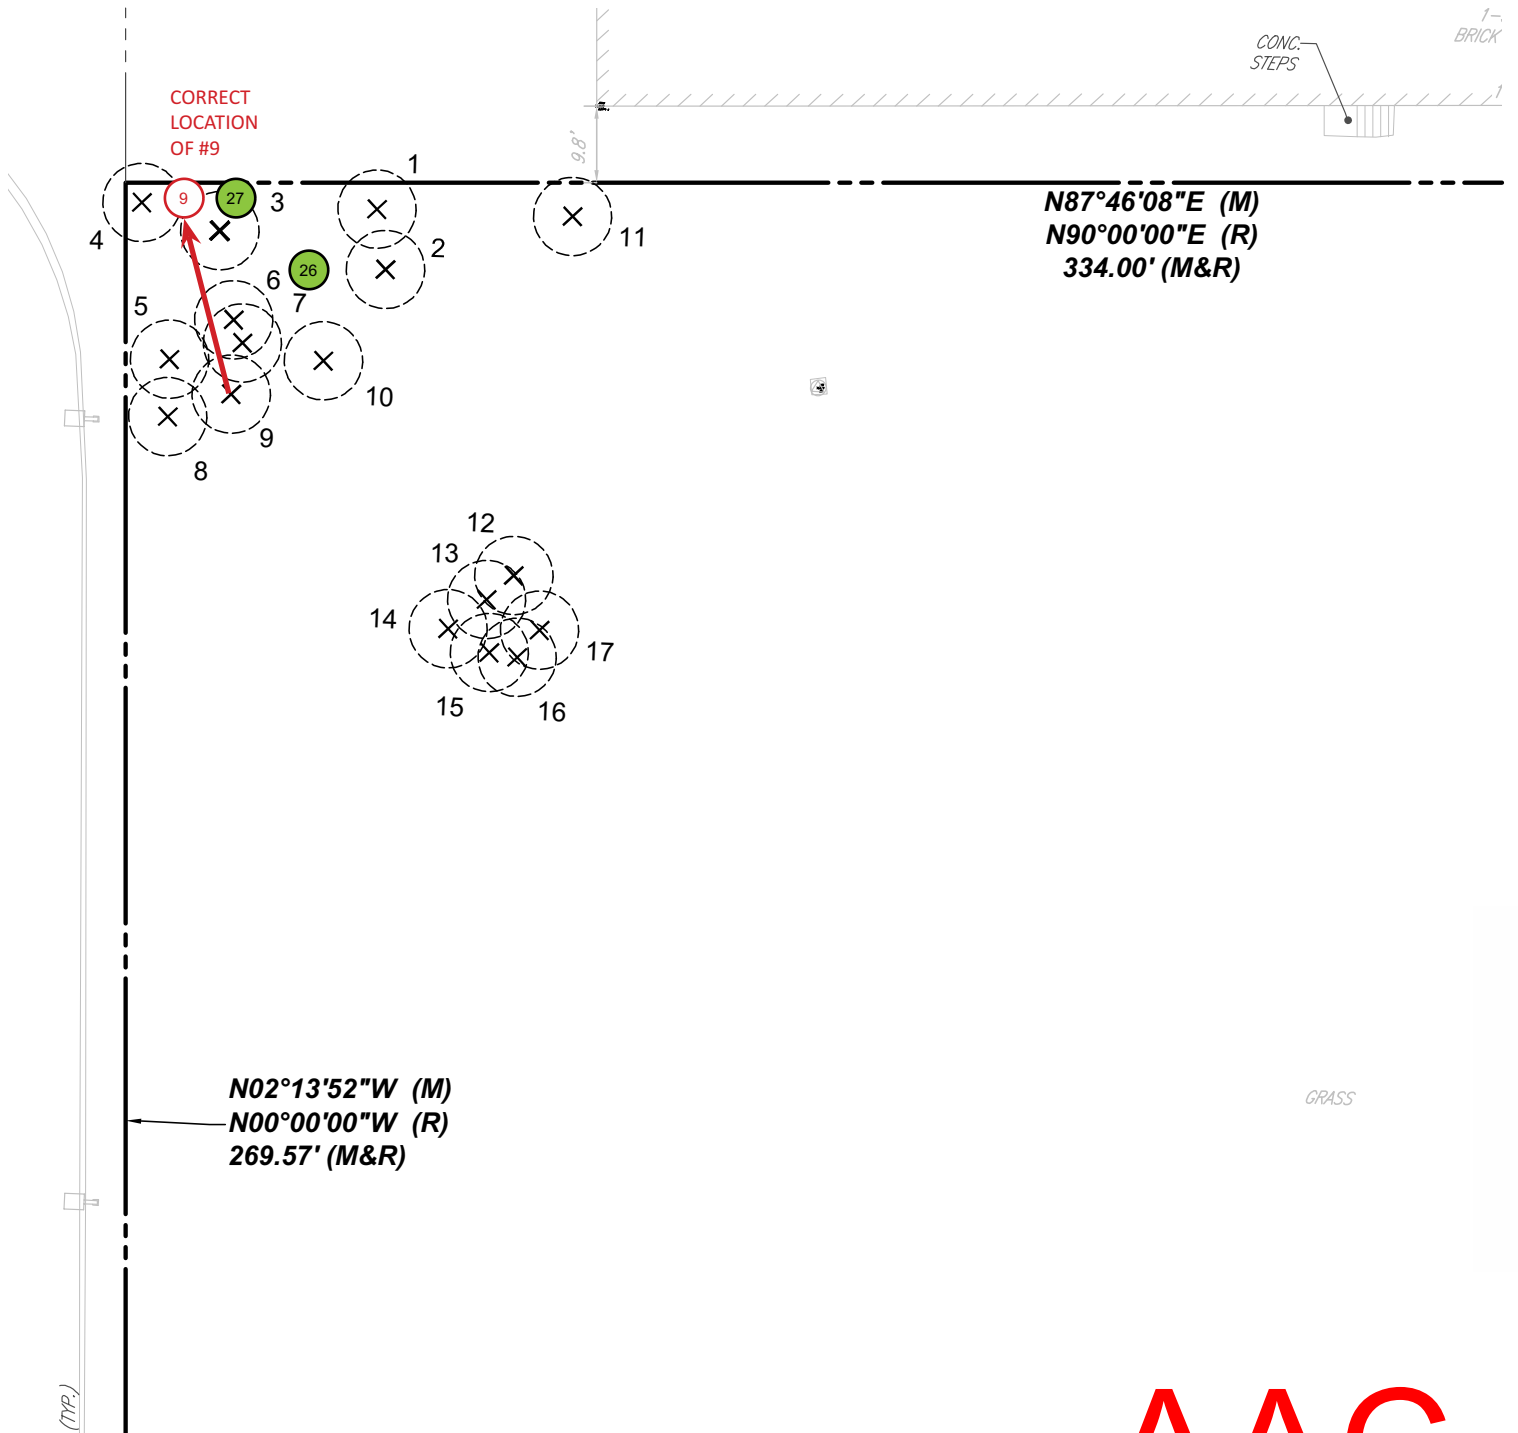
Condition -
FAIR

Tree #1 is a Live Oak located in the northwest corner of the property. It is in fair condition. The trunk divides into two with included bark. There is interior deadwood and galls are on the twigs. The canopy is thin and asymmetrical. The tree is competing with the nearby vegetation.
