July 18, 2018

RE: Oldcastle Coastal Facility – 1200 NW 18th St., Pompano Beach, CPTED/Security Public Safety Plan

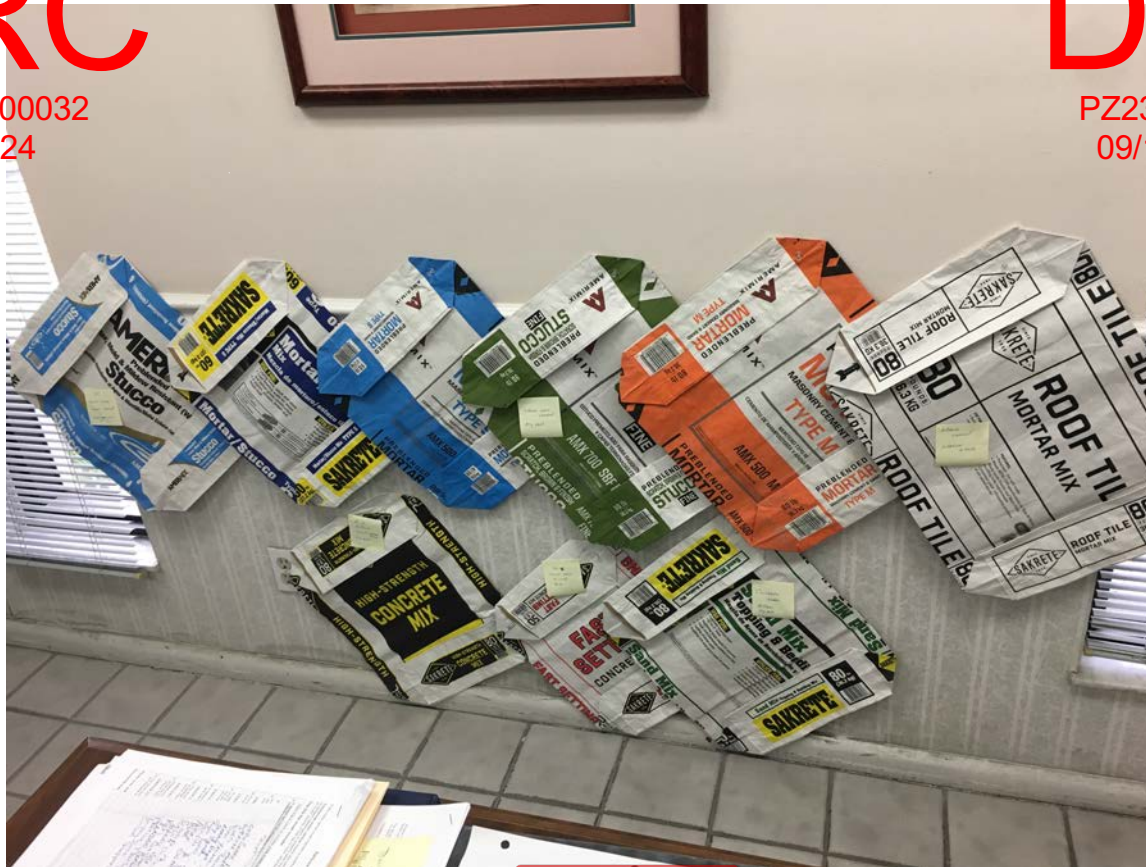
The types of products that are made at the Oldcastle Bonsal Plant.

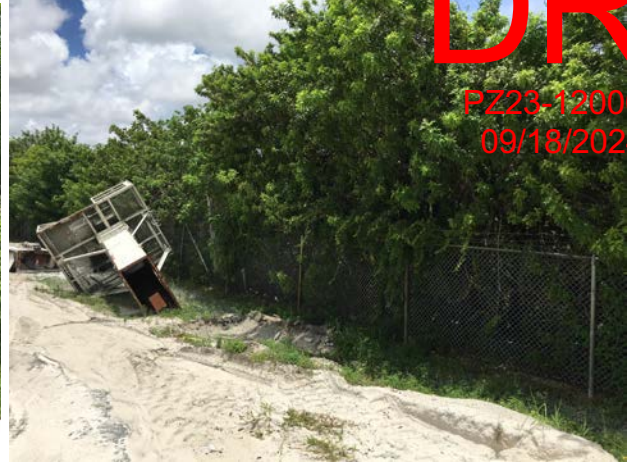
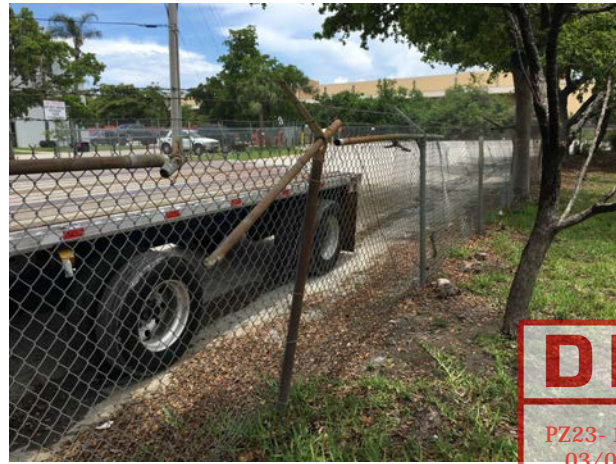
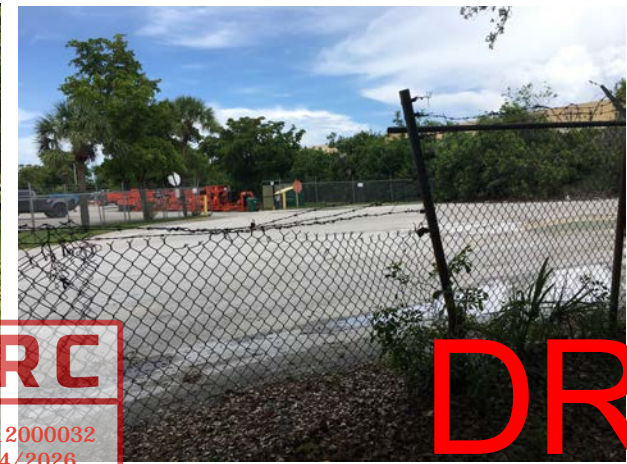
The North boundary is presently the primary access and egress points to the plant on NW 18th Street. There are two gate openings. Both gates are left open and have been damaged and non-operational. The barbed wire on the top of the chain link fencing has been damaged and not consistent.

Territorial Reinforcement /Boundary definition – Fencing and Plantings – The existing six-foot high chain link fencing requires extensive repair and maintenance on the north, south, and east sides. Plantings should be maintained to be no higher than the fence line and the boundaries. Tree canopies should be maintained clear under 8 feet, with a trunk six inches in diameter or greater. If new saplings are planted, do not mutilate them to comply with the canopy requirement until they are mature trees with a six inch diameter trunk or greater, and if the tree canopies are blocking the field of vision.

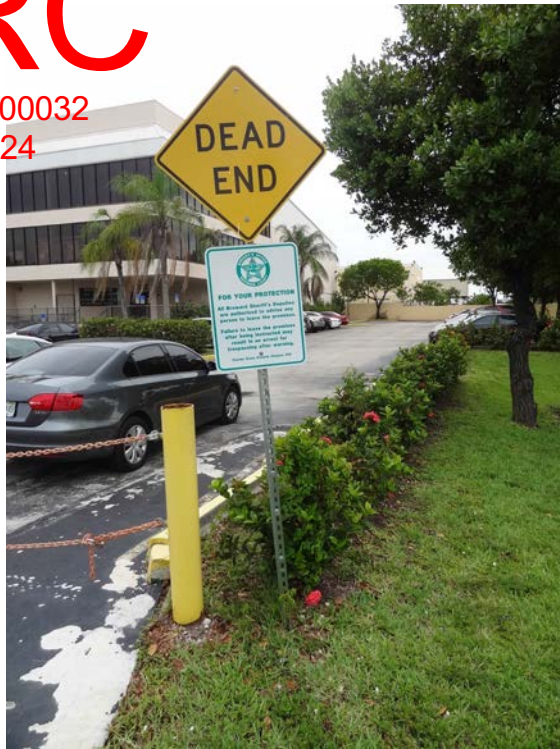
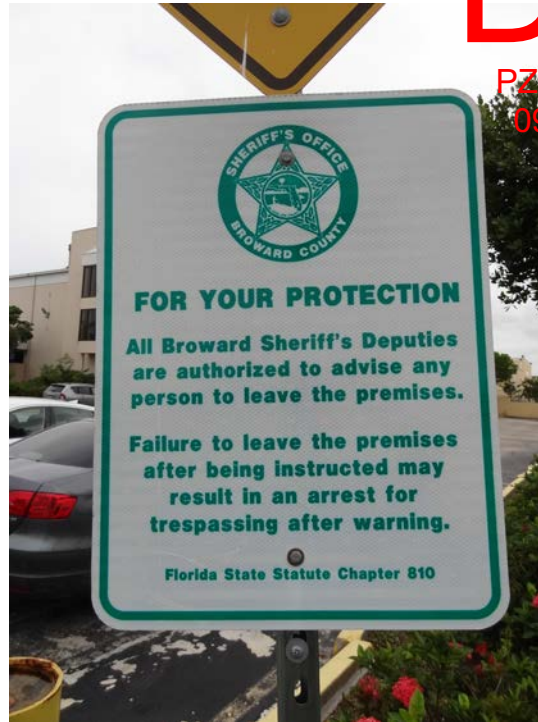
At the Baers buildings, down the street from the Oldcastle site, they have the parking lot chained off, after a couple of criminal incidents took place there. Baers posted a no trespass sign that empowered the Broward Sheriff's office to patrol the facility. Proper signage must state who is the enforcing agency and cite chapter and verse of the state law that is being enforced, as demonstrated above. This kind of signage will be added to the Oldcastle site.

Signage – It is recommended that additional legally qualified posted warning trespass signage be added on the perimeter fencing and the new and improved entrances. Groundrules signage is critical for achieving compliant behavior or employees and visitors. The present signage is unclear and does not meet the legal criteria for enforcement. In addition, no-trespass signs should cite local ordinance statute, and who is enforcing the trespass (Pompano Police or Broward’s Sheriff’s Department). The new proposed no-trespass signs will be posted on the site perimeter fencing every 100 feet and within the parking lots. Trespassers cannot be successfully arrested and prosecuted if the notice is not properly worded and posted. There should also be signage that the facility is under video surveillance, which serves as a notice to trespassers and criminals.

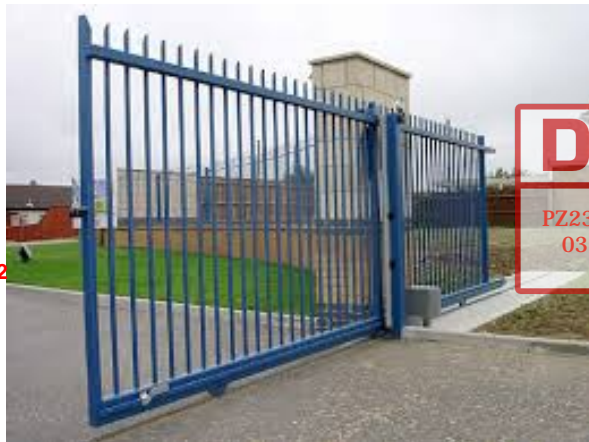
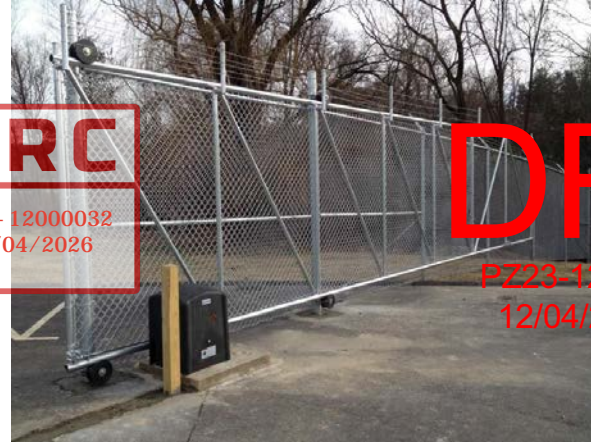
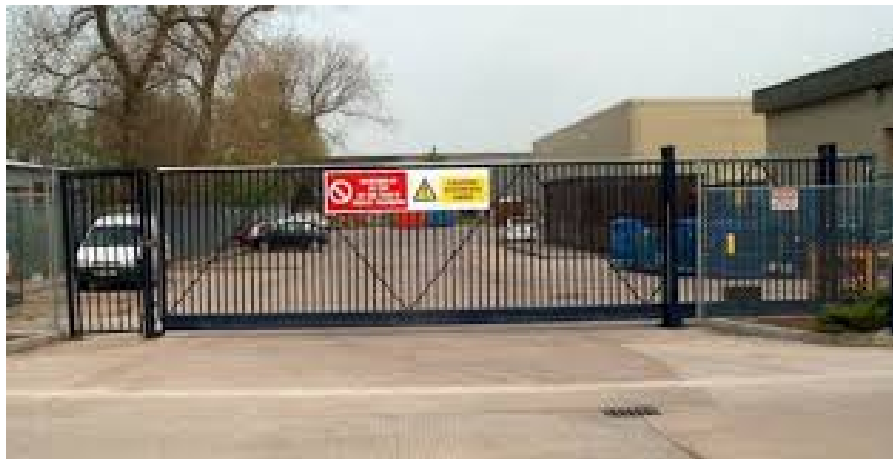
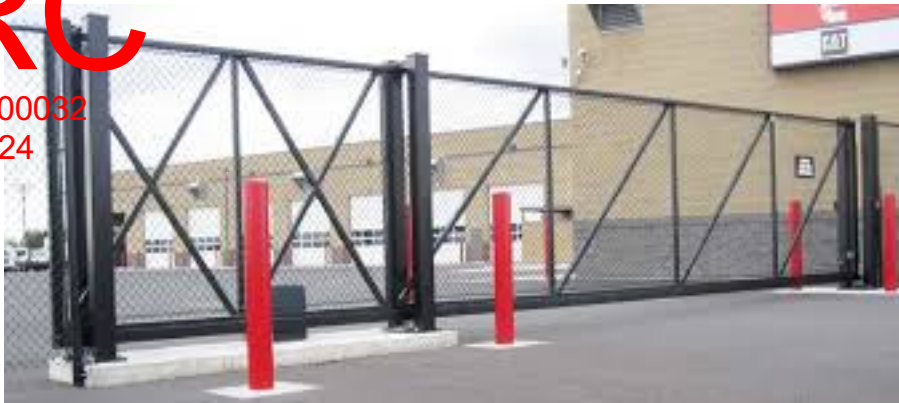
The pictures above are examples of vehicle gates and creating a secured entrance for company deliveries and vehicles.

The west border definition will be improved with an attractive picket metal code compliant fencing with plantings, and a vehicle gate. It is recommended that as the site is improved to accommodate a sidewalk connection, and new monumental sign, and additional stripping at the entrance of onto Andrews Avenue will be added to direct the heavy trucks and rigs.

The approach onto the site will remain open because of the volume of traffic by trucks and rigs picking up and dropping off product, While the gates remain open during plant operations, there is the capability to secure the site and close the manually operated gates when there are holidays.

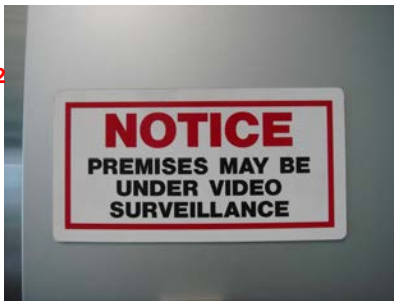
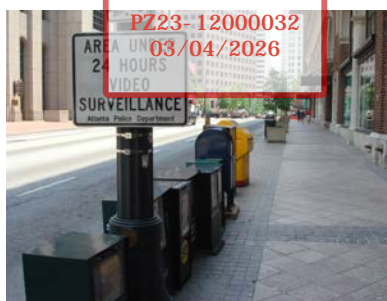
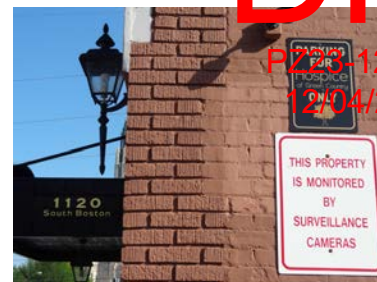
Signage creating notice of premises being monitored and under surveillance.

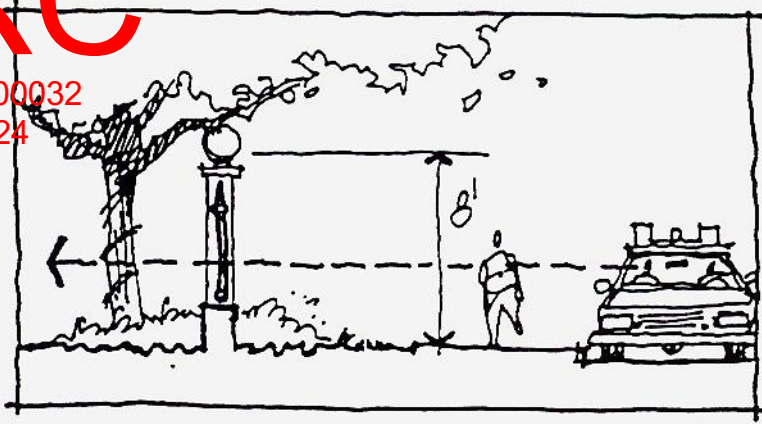
Ground plantings and hedges should be less than 3 feet and tree canopies over 8 feet to allow a clear zone of natural surveillance for police to be able to have un-obscured sight around the perimeter and into the property.

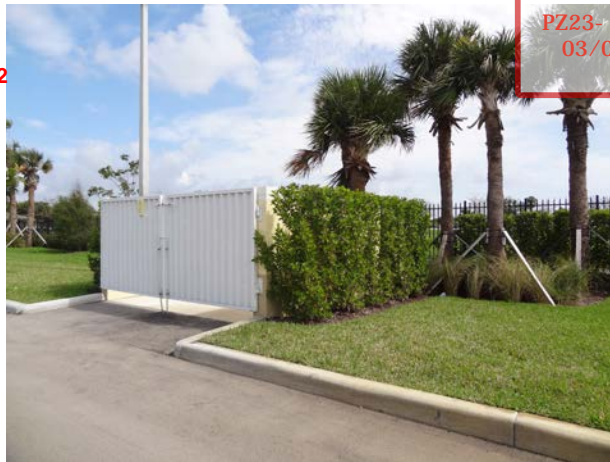
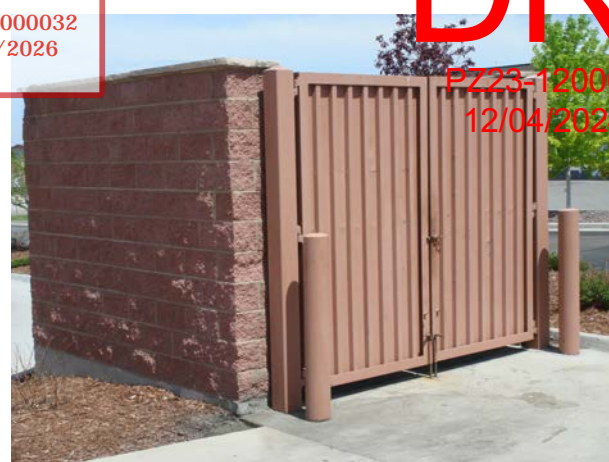
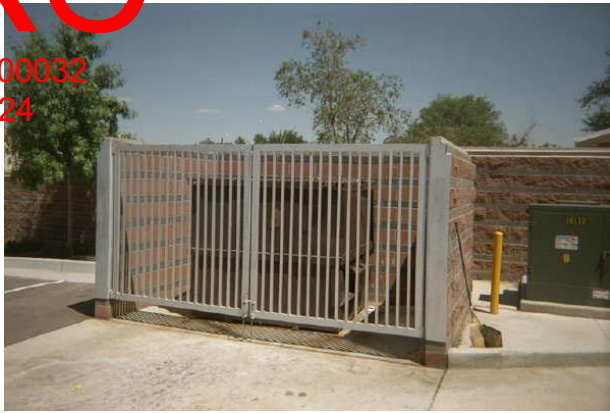
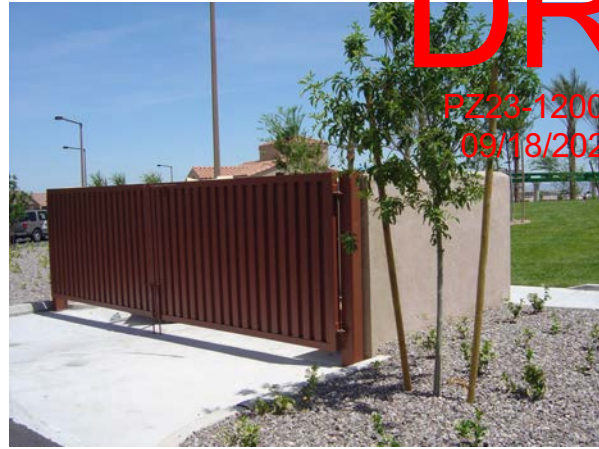
Good examples of CPTED dumpster design demonstrating three-side shielding, bumper bollards, ground level visibility, gate doors that close and lock, and ample room for garbage trucks to back up and pick up the dumpster for emptying.

The new proposed dumpster area should be on a concrete pad that can withstand picking up and dropping down by a garbage truck. There should be bollards/bumpers to prevent the truck from hitting the dumpster enclosure. The dumpster should be shielded on three sides with a screening that complies with zoning regulations. Swing gates that are locked should be used to protect the dumpster from illegal or unwanted dumpster diving or dumping. The front screening should be raised so that a person in the dumpster area can be observed from the outside. The gates should be lockable so they can be secured when not being used. If there is any trespassing in the exterior site areas, the person will stand out and be observed and challenged.
