ATLAS SAFETY & SECURITY DESIGN, INC.

RE: Oldcastle Coastal Facility – 1200 NW 18th St., Pompano Beach, CPTED/Security Public Safety Plan

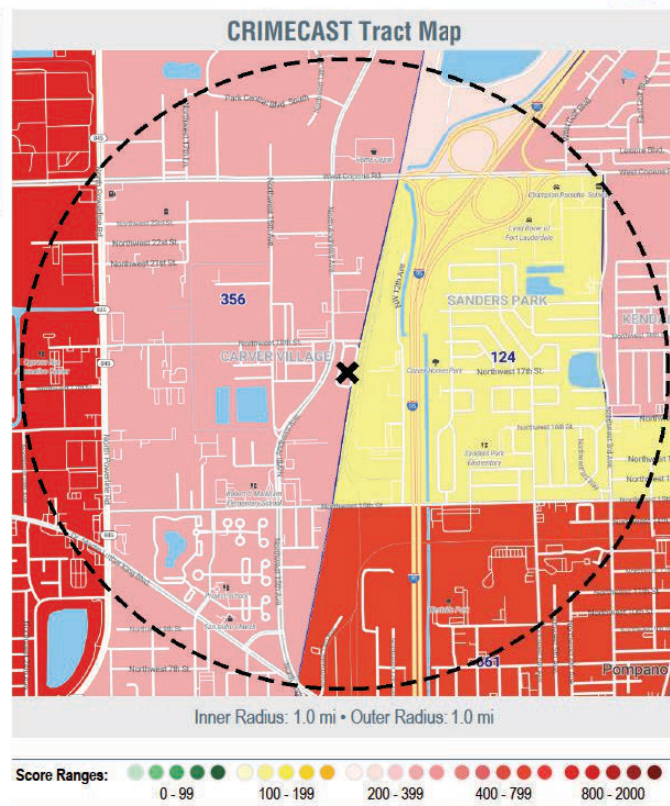
1-Mile Methodology: Tract Map

This site's 2018 National
CAP Index Score:

540

CRIMECAST Scores are based on a scale of 0 to 2000, with 0 representing the lowest risk and 2000 the highest - 100 is average. A score of 540 is 5.4 times higher than average.

Within this map, individual census tracts are color-coded to depict the level of risk within the tract and identify the potential origin of crime or criminal behavior.

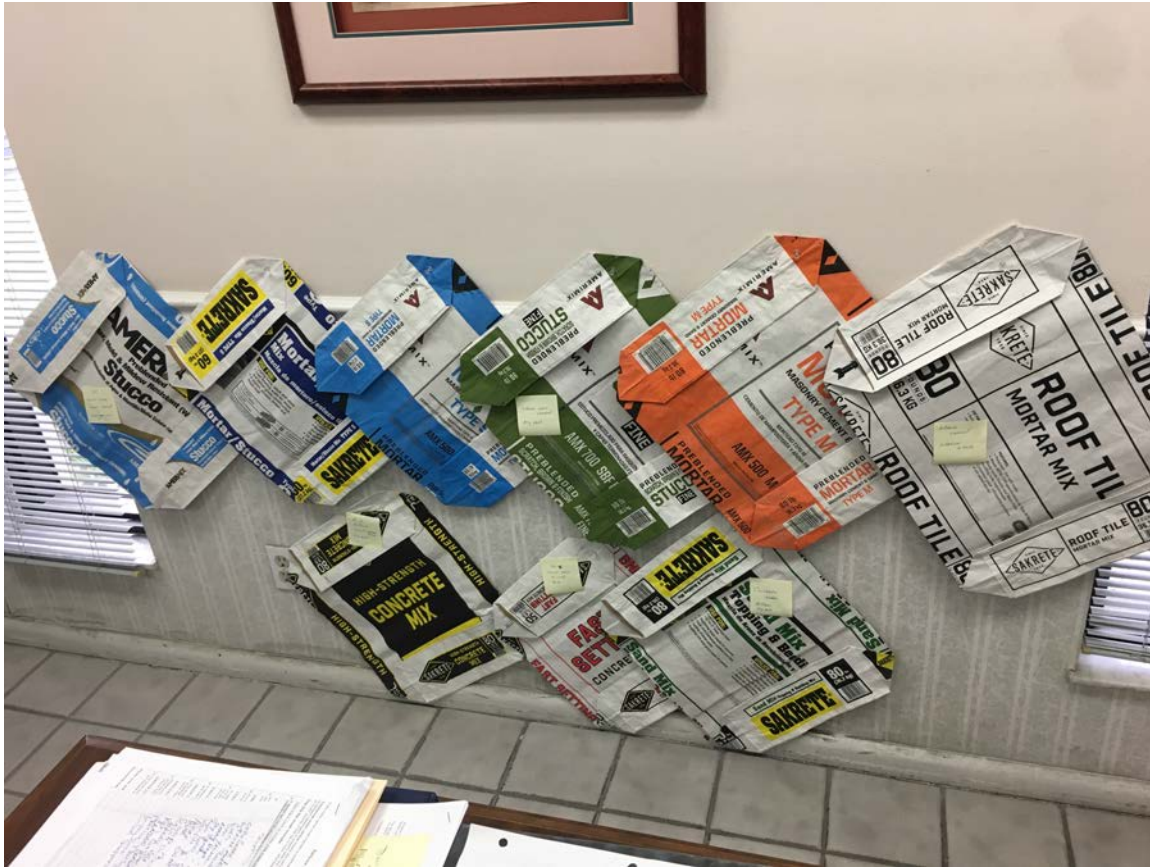
The types of products that are made at made at the Oldcastle Bonsal Plant.

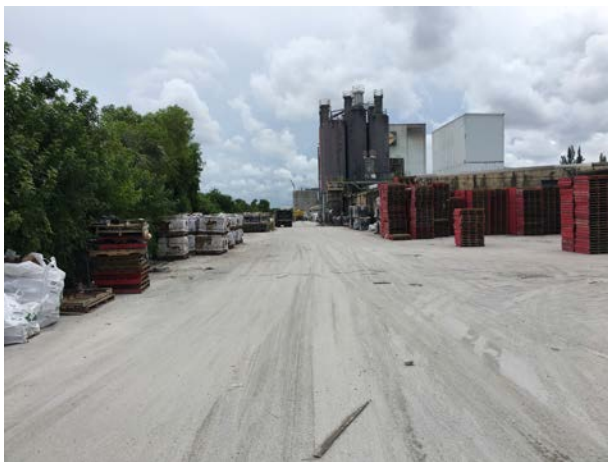
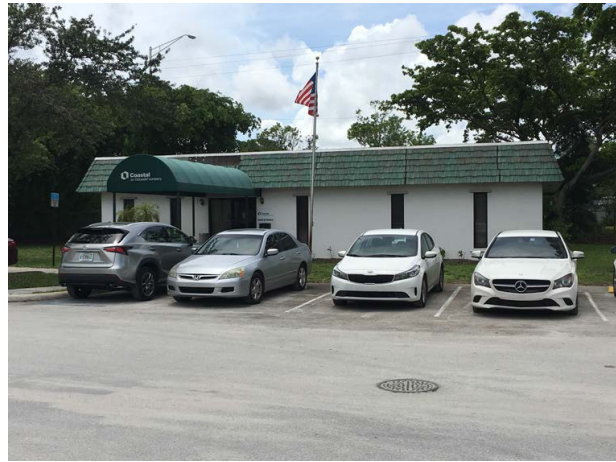
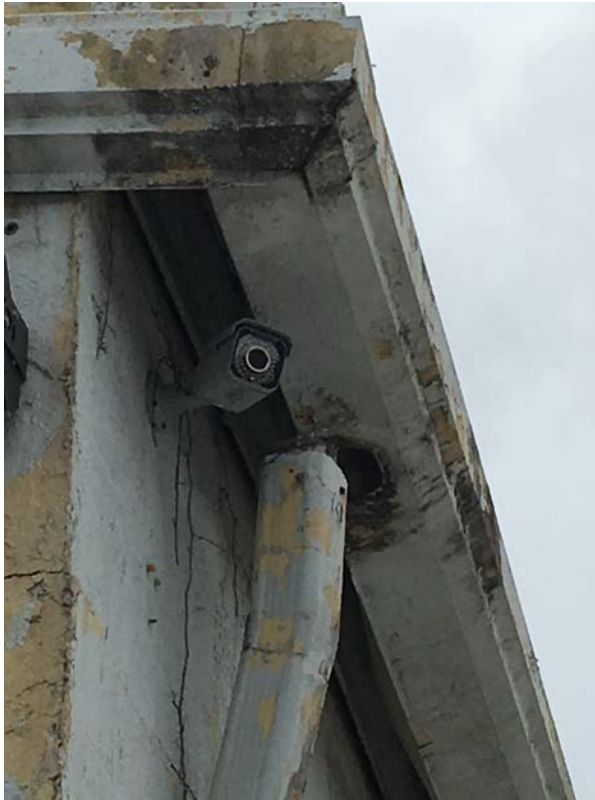
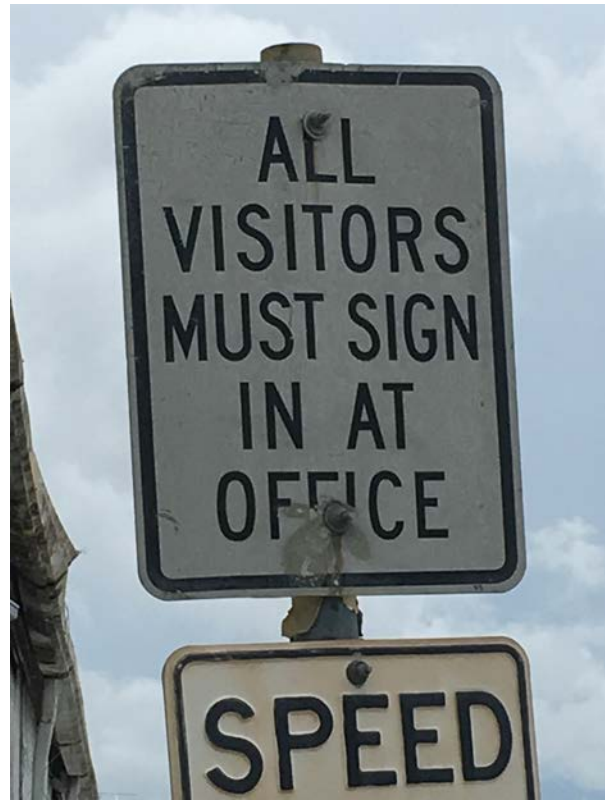
There are no controls for vehicles once trucks turn on 18^h Street. There are no barriers controlling access to the parking lot and site on the north side.

Site access control – The site is accessed through two vehicle entrances located on the south border of the property. Trucks and rigs will enter on the south side, as well as employees and customers. It is proposed that the entrances will have a swinging or sliding mechanical gates and video surveillance. The sliding and swinging gates should be closed after hours, and will be used in order to stop trespass, piggybacking, and unauthorized access onto the site and into the building.

The present entrance allows access to the Oldcastle warehouse facilities. Currently, there are no access control features in place to control deliveries, or control when and where the public has access to the site and the materials. The new site plan is proposing a vehicular and pedestrian access control gates, warning and groundrule signage, site video surveillance, improved site lighting, a new and improved monumental sign, and replacing any missed fence to close fence gaps, which will improve safety and security to the Oldcastle Coastal facility and operations.

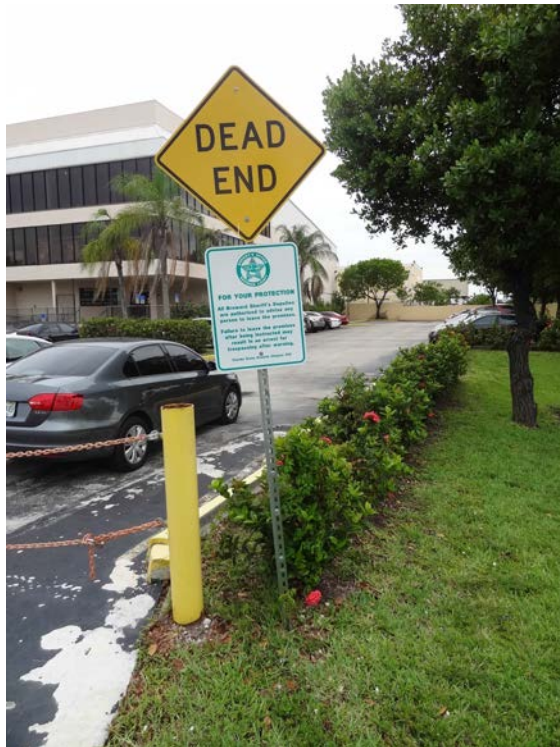
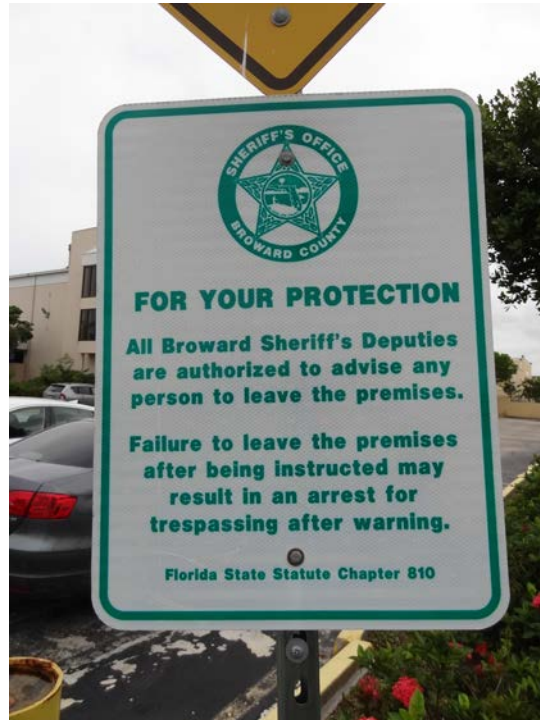
At the Baers buildings, down the street from the Oldcastle site, they have the parking lot chained off, after a couple of criminal incidents took place there. Baers posted a no trespass sign that empowered the Broward Sheriff's office to patrol the facility. Proper signage must state who is the enforcing agency and cite chapter and verse of the state law that is being enforced, as demonstrated above. This kind of signage will be added to the Oldcastle site.

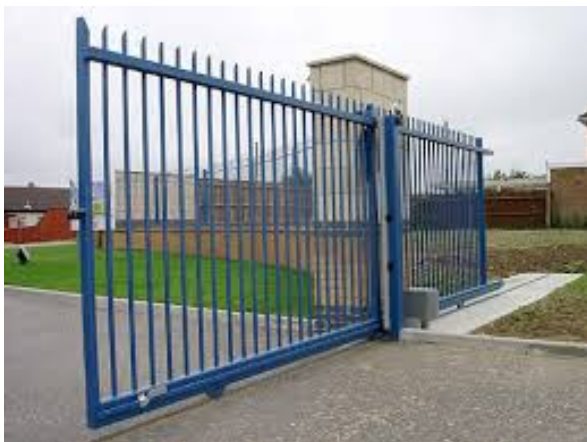
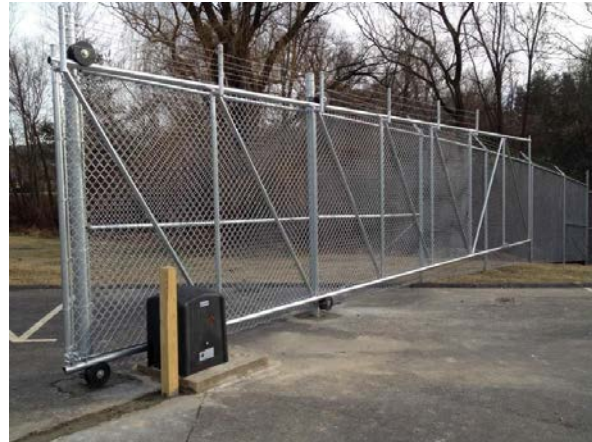
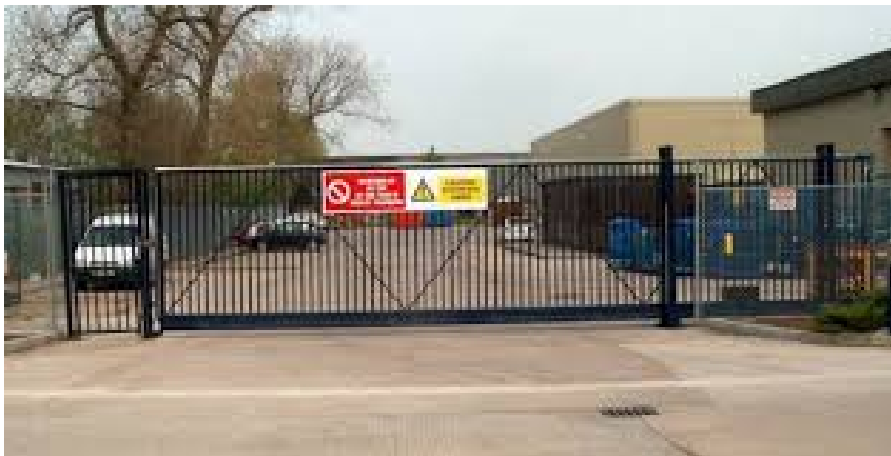
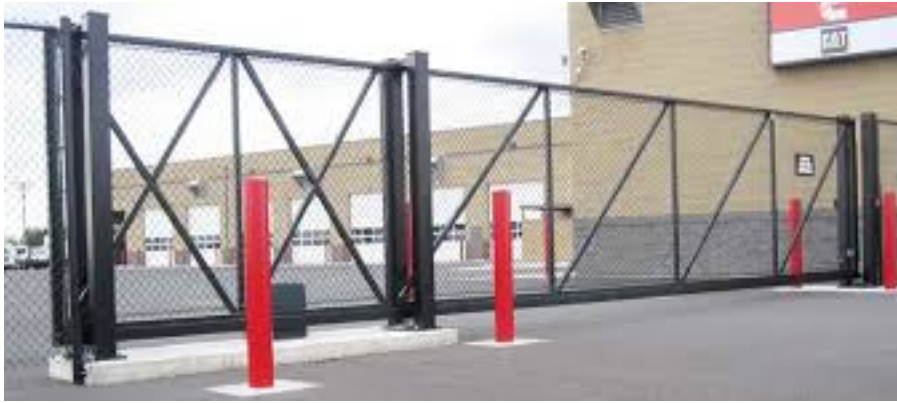
The pictures above are examples of vehicle gates and creating a secured entrance for company deliveries and vehicles.

The west border definition will be improved with an attractive picket metal code compliant fencing with plantings, and a vehicle gate. It is recommended that as the site is improved to accommodate a sidewalk connection, and new monumental sign, and additional stripping at the entrance of onto Andrews Avenue will be added to direct the heavy trucks and rigs.

The approach onto the site will remain open because of the volume of traffic by trucks and rigs picking up and dropping off product, While the gates remain open during plant operations, there is the capability to secure the site and close the manually operated gates when there are holidays.

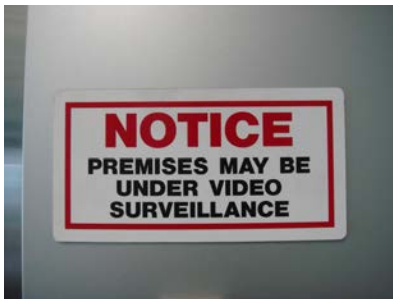
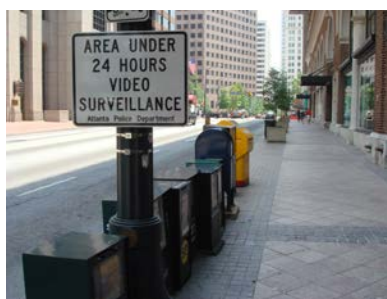
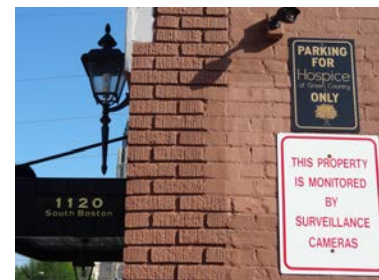
Signage creating notice of premises being monitored and under surveillance.

Signage – It is recommended that additional legally qualified posted warning trespass signage be added on the perimeter fencing and the new and improved entrances. Groundrules signage is critical for achieving compliant behavior of employees and visitors. The present signage is unclear and does not meet the legal criteria for enforcement. In addition, no-trespass signs should cite local ordinance statute, and who is enforcing the trespass (Pompano Police or Broward's Sheriff's Department). The new proposed no-trespass signs will be posted on the site perimeter fencing every 100 feet and within the parking lots. Trespassers cannot be successfully arrested and prosecuted if the notice is not properly worded and posted. There should also be signage that the facility is under video surveillance, which serves as a notice to trespassers and criminals.

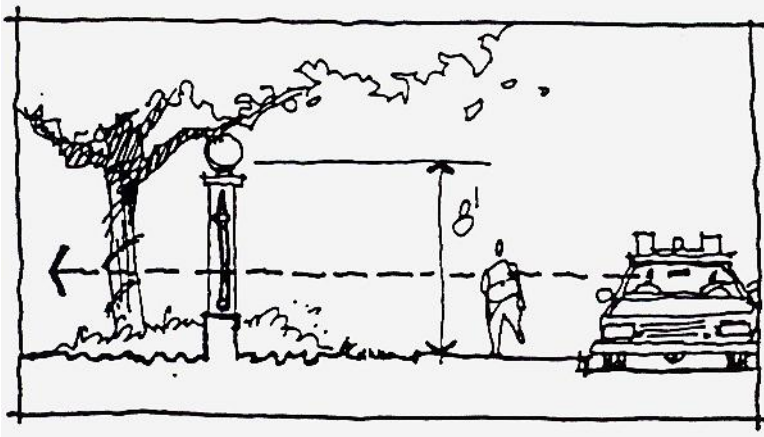
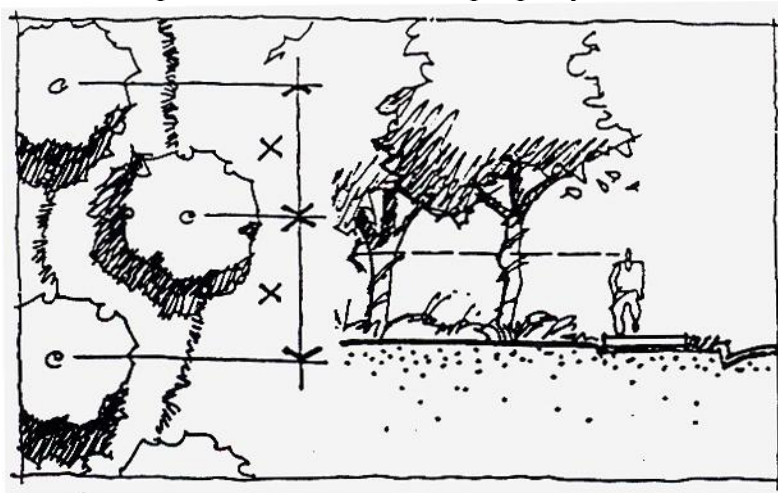
Ground plantings and hedges should be less than 3 feet and tree canopies over 8 feet to allow a clear zone of natural surveillance for police to be able to have un-obscured sight around the perimeter and into the property.

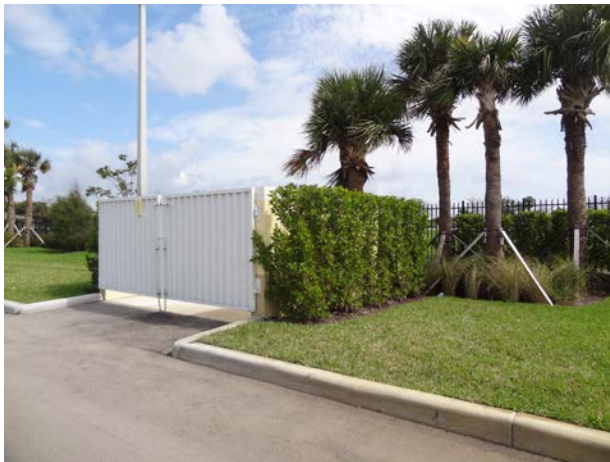
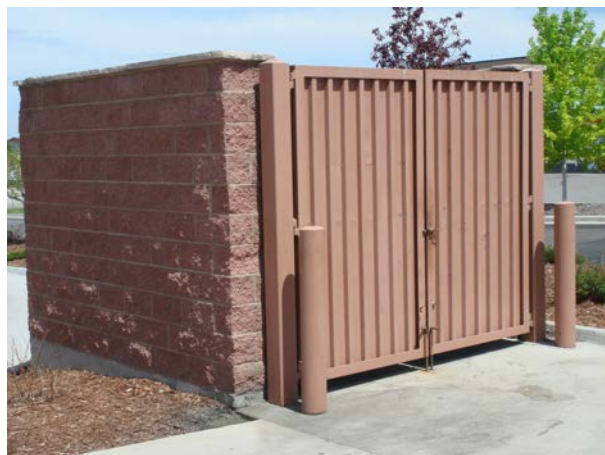
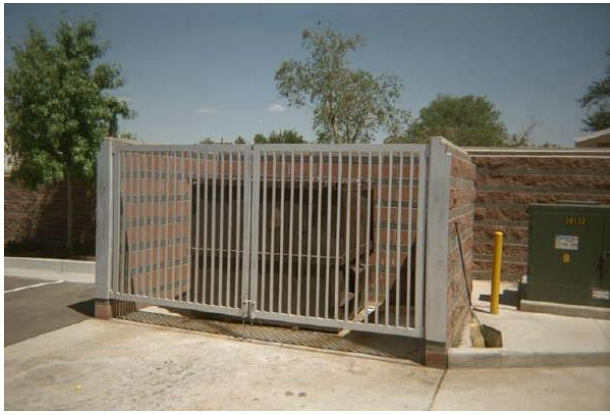
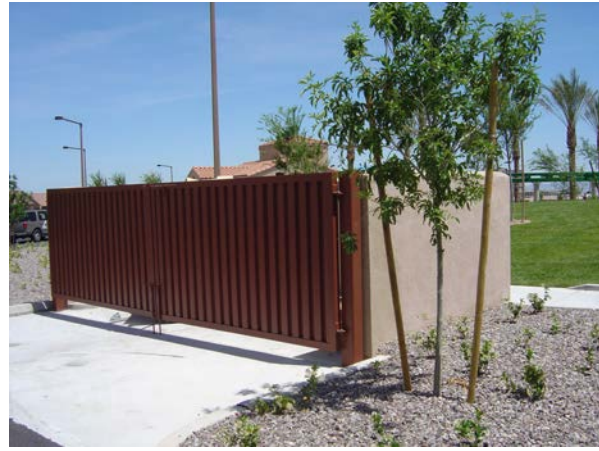
Good examples of CPTED dumpster design demonstrating three-side shielding, bumper bollards, ground level visibility, gate doors that close and lock, and ample room for garbage trucks to back up and pick up the dumpster for emptying.

The new proposed dumpster area should be on a concrete pad that can withstand picking up and dropping down by a garbage truck. There should be bollards/bumpers to prevent the truck from hitting the dumpster enclosure. The dumpster should be shielded on three sides with a screening that complies with zoning regulations. Swing gates that are locked should be used to protect the dumpster from illegal or unwanted dumpster diving or dumping. The front screening should be raised so that a person in the dumpster area can be observed from the outside. The gates should be lockable so they can be secured when not being used. If there is any trespassing in the exterior site areas, the person will stand out and be observed and challenged.
