ATLAS SAFETY & SECURITY DESIGN, INC.

RE: Oldcastle Coastal Facility – 1200 NW 18<sup>th</sup> St., Pompano Beach, CPTED/Security Public Safety Plan

I have been contracted to review the drawings for security and Crime Prevention Through Environmental Design (CPTED) features in the proposed Oldcastle Bonsal Facility site plan update that is being considered for permitting by the City of Pompano Beach.

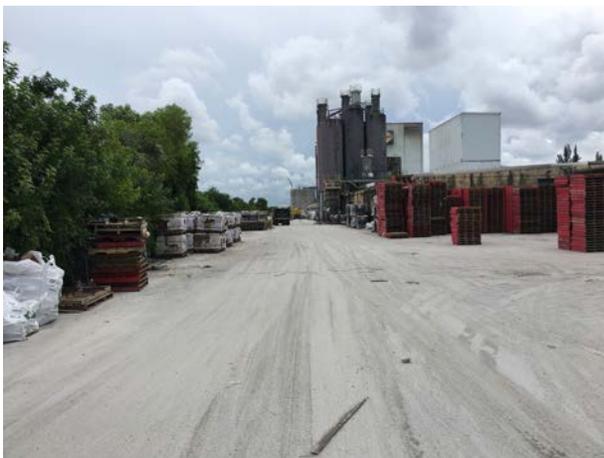
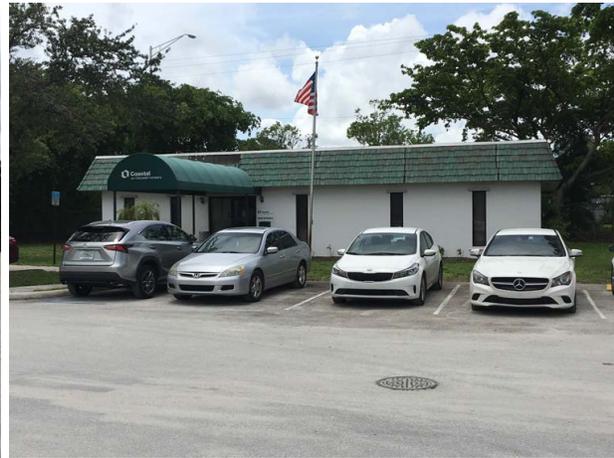
There are no controls for vehicles once trucks turn on 18<sup>h</sup> Street. There are no barriers controlling access to the parking lot and site on the north side.

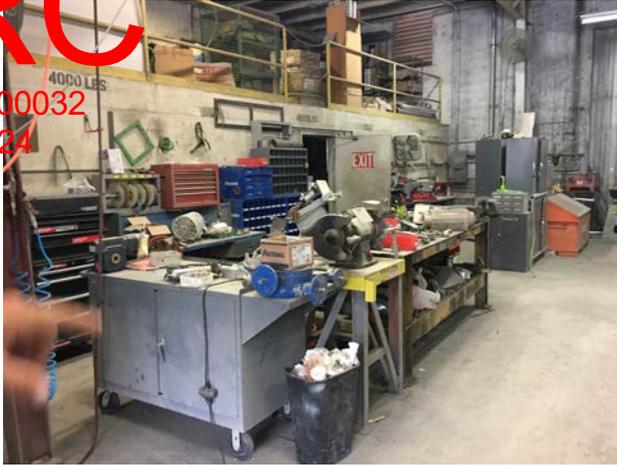
Tools and equipment is an attractive asset that need to be protected.

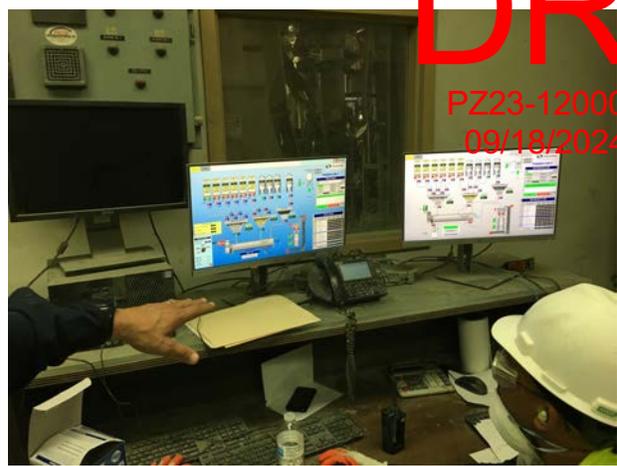
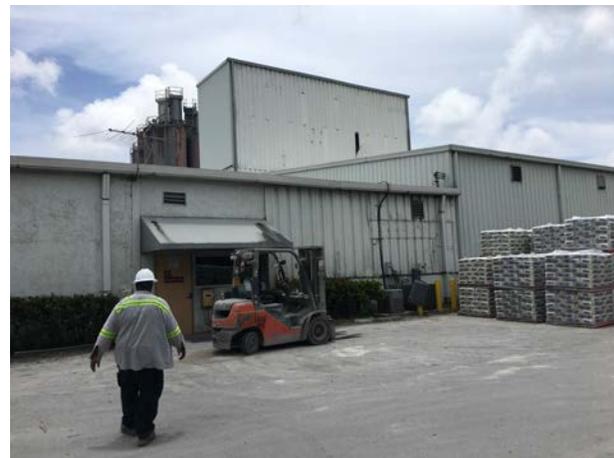
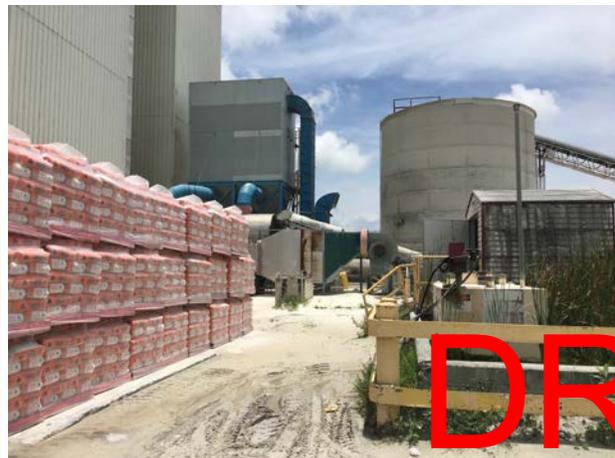
Forklifts and product stacked are assets that need to be protected.

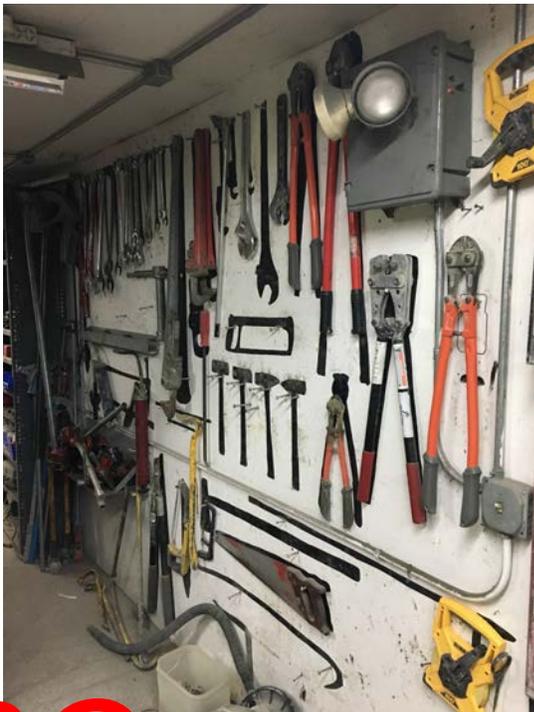
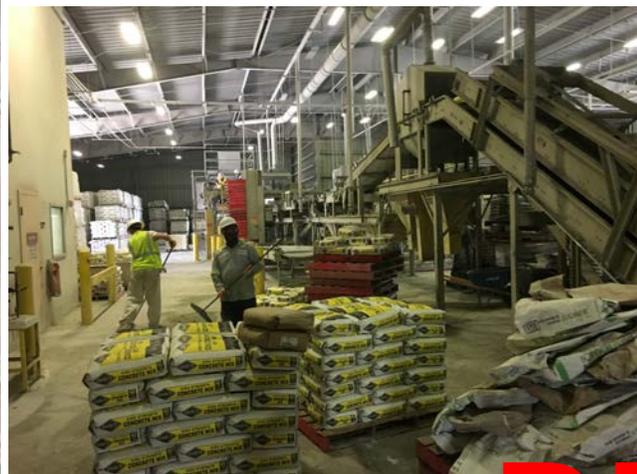
Tools and machinery must be protected from loss, theft, pilferage, or vandalism.

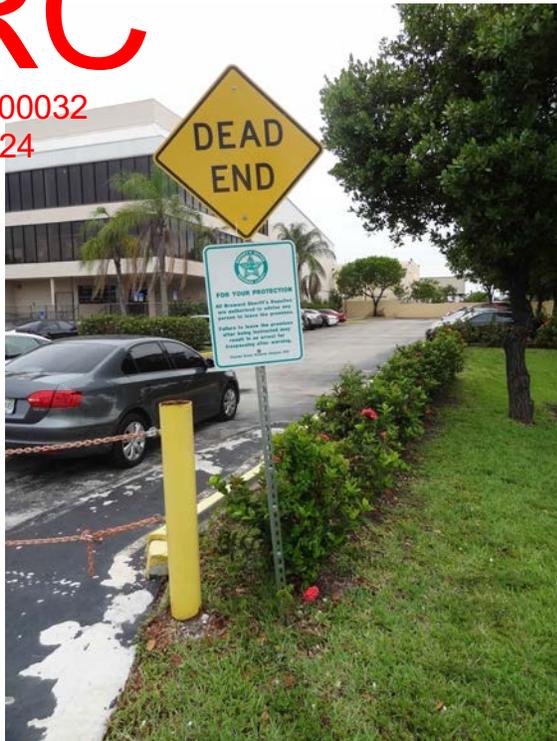
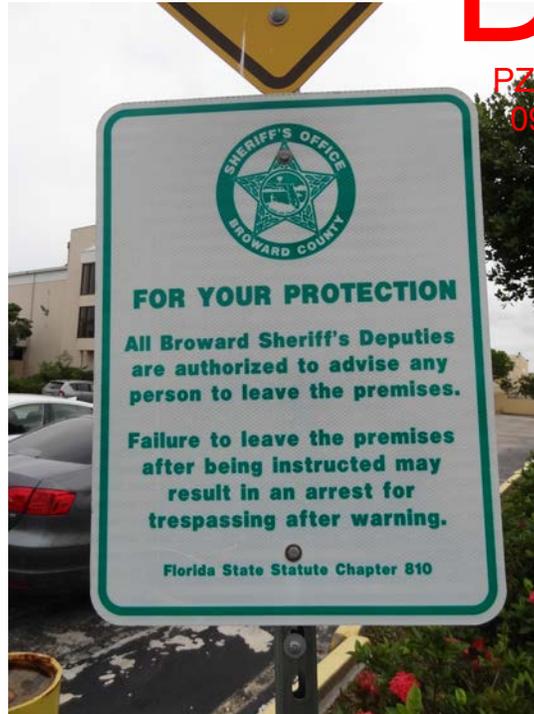
At the Baers buildings, down the street from the Oldcastle site, they have the parking lot chained off, after a couple of criminal incidents took place there. Baers posted a no trespass sign that empowered the Broward Sheriff's office to patrol the facility. Proper signage must state who is the enforcing agency and cite chapter and verse of the state law that is being enforced, as demonstrated above. This kind of signage will be added to the Oldcastle site.

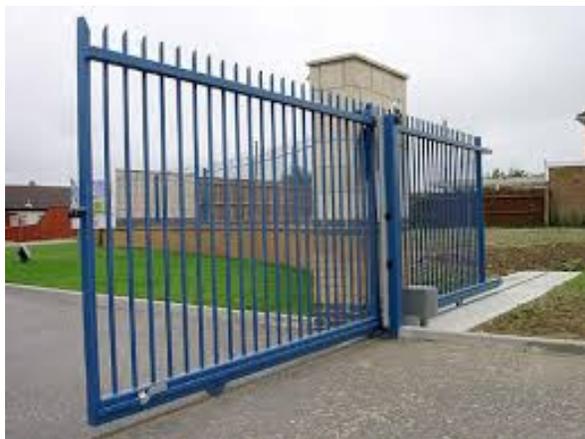
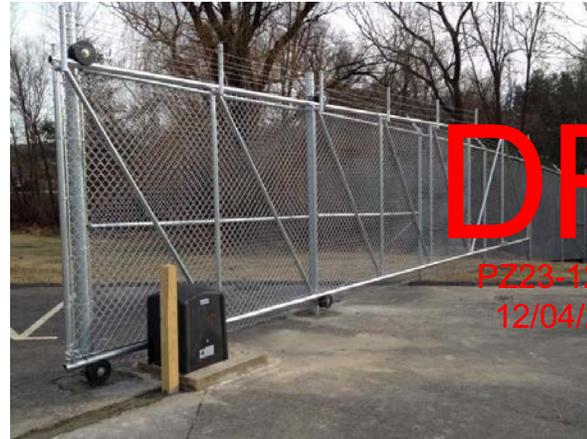
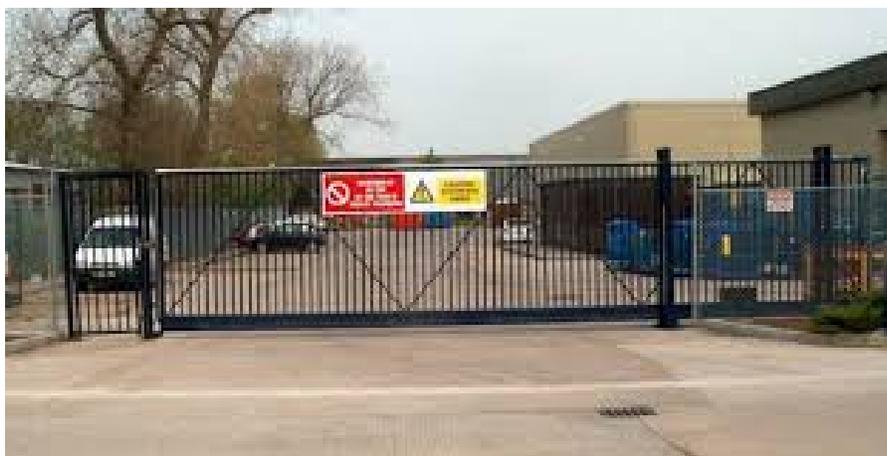
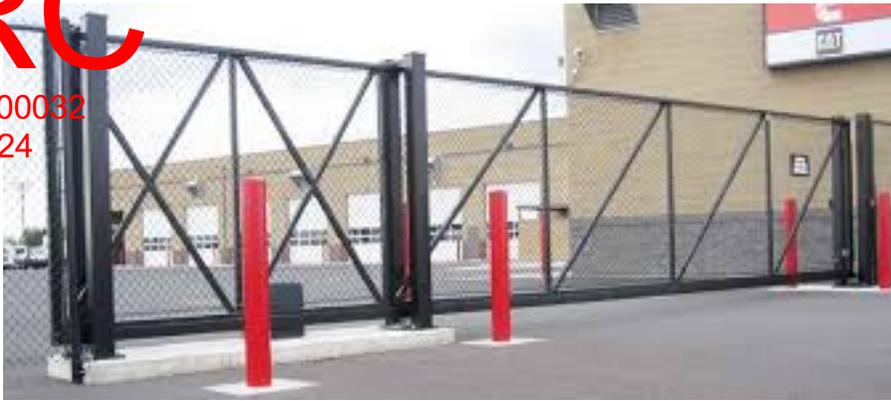
The pictures above are examples of vehicle gates and creating a secured entrance for company deliveries and vehicles.

The west border definition will be improved with an attractive picket metal code compliant fencing with plantings, and a vehicle gate. It is recommended that as the site is improved to accommodate a sidewalk connection, and new monumental sign, and additional stripping at the entrance of onto Andrews Avenue will be added to direct the heavy trucks and rigs.

The approach onto the site will remain open because of the volume of traffic by trucks and rigs picking up and dropping off product, While the gates remain open during plant operations, there is the capability to secure the site and close the manually operated gates when there are holidays.

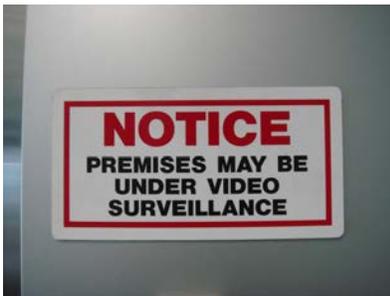
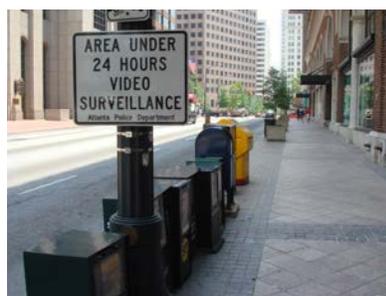
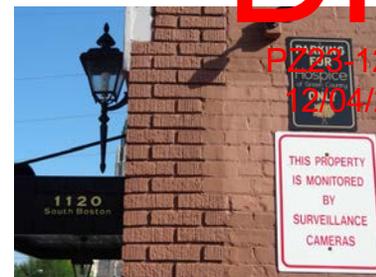
Signage creating notice of premises being monitored and under surveillance.

Signage – It is recommended that additional legally qualified posted warning trespass signage be added on the perimeter fencing and the new and improved entrances. Groundrules signage is critical for achieving compliant behavior of employees and visitors. The present signage is unclear and does not meet the legal criteria for enforcement. In addition, no-trespass signs should cite local ordinance statute, and who is enforcing the trespass (Pompano Police or Broward’s Sheriff’s Department). The new proposed no-trespass signs will be posted on the site perimeter fencing every 100 feet and within the parking lots. Trespassers cannot be successfully arrested and prosecuted if the notice is not properly worded and posted. There should also be signage that the facility is under video surveillance, which serves as a notice to trespassers and criminals.

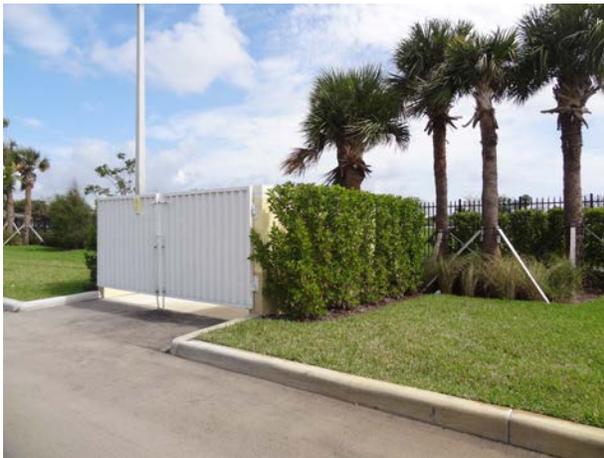
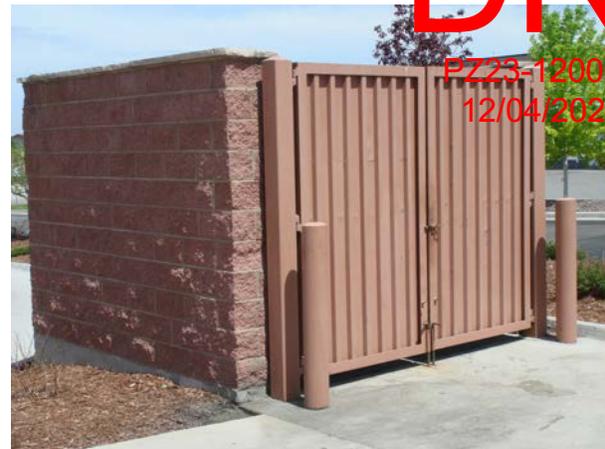
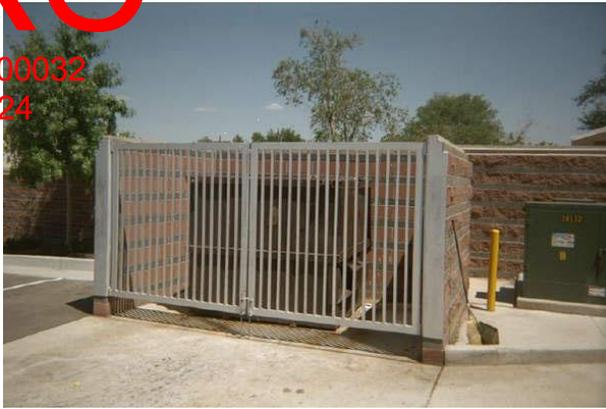
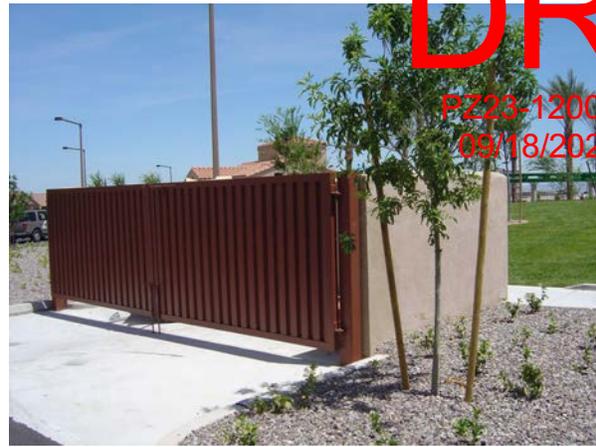
Good examples of CPTED dumpster design demonstrating three-side shielding, bumper bollards, ground level visibility, gate doors that close and lock, and ample room for garbage trucks to back up and pick up the dumpster for emptying.

The new proposed dumpster area should be on a concrete pad that can withstand picking up and dropping down by a garbage truck. There should be bollards/bumpers to prevent the truck from hitting the dumpster enclosure. The dumpster should be shielded on three sides with a screening that complies with zoning regulations. Swing gates that are locked should be used to protect the dumpster from illegal or unwanted dumpster diving or dumping. The front screening should be raised so that a person in the dumpster area can be observed from the outside. The gates should be lockable so they can be secured when not being used. If there is any trespassing in the exterior site areas, the person will stand out and be observed and challenged.
