RE: Oldcastle Coastal Facility – 1200 NW 18<sup>th</sup> St., Pompano Beach, CPTED/Security Public Safety Plan

I have been contracted to review the drawings for security and Crime Prevention Through Environmental Design (CPTED) features in the proposed Oldcastle Bonsal Facility site plan update that is being considered for permitting by the City of Pompano Beach.

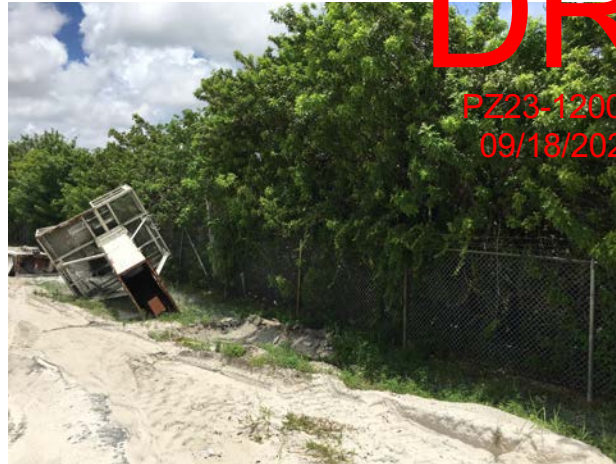
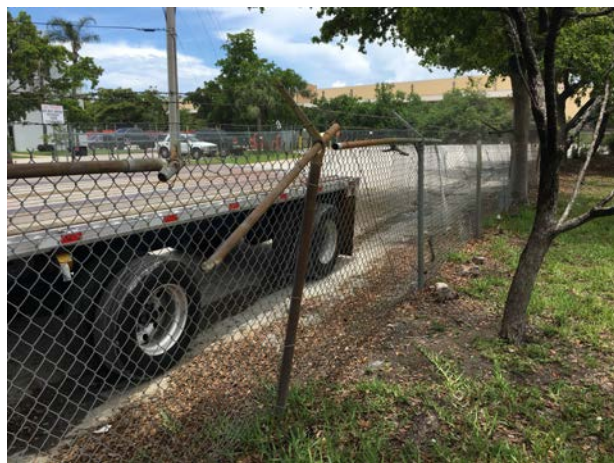
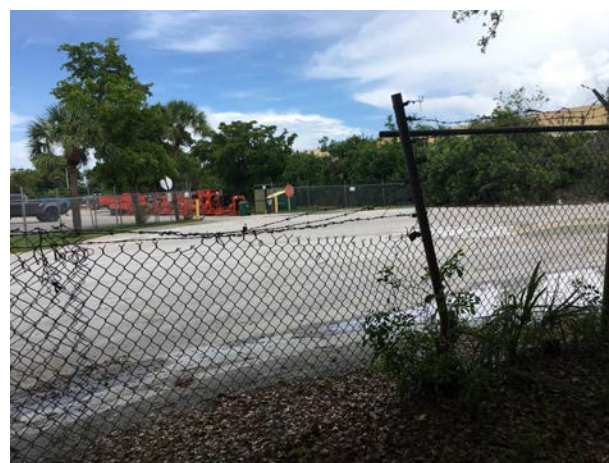
The North boundary is presently the primary access and egress points to the plant on NW 18<sup>th</sup> Street. There are two gates openings. Both gates are left open and have been damaged and non-operational. The barbed wire on the top of the chain link fencing has been damaged and not consistent.

The west border definition will be improved with an attractive picket metal code compliant fencing with plantings, and a vehicle gate. It is recommended that as the site is improved to accommodate a sidewalk connection, and new monumental sign, and additional stripping at the entrance of onto Andrews Avenue will be added to direct the heavy trucks and rigs.

The approach onto the site will remain open because of the volume of traffic by trucks and rigs picking up and dropping off product, While the gates remain open during plant operations, there is the capability to secure the site and close the manually operated gates when there are holidays.

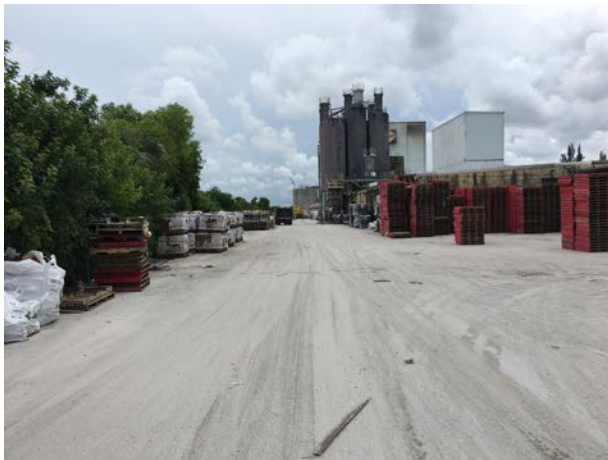
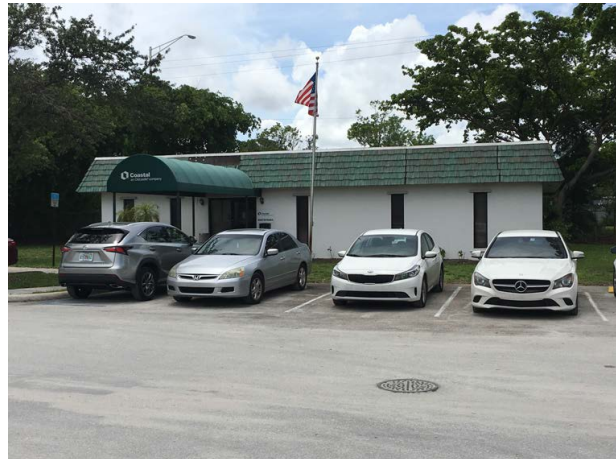
There are no controls for vehicles once trucks turn on 18<sup>h</sup> Street. There are no barriers controlling access to the parking lot and site on the north side.

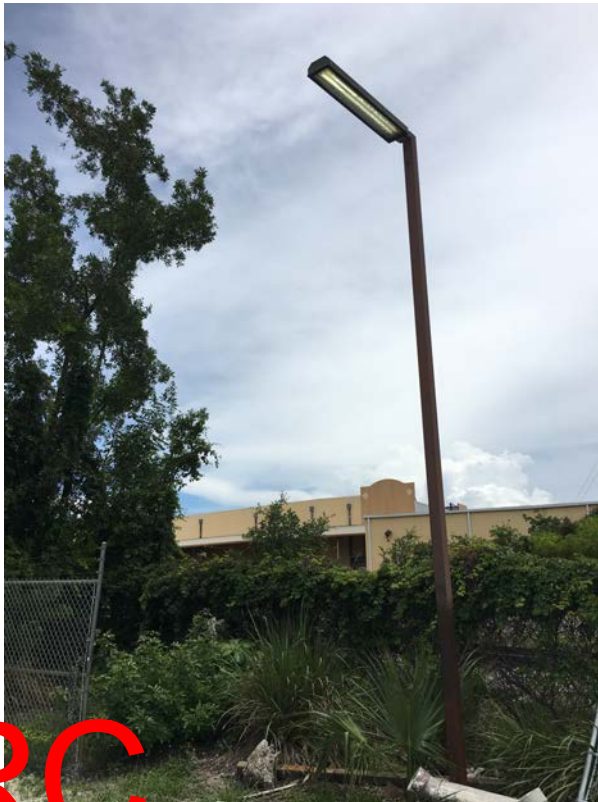
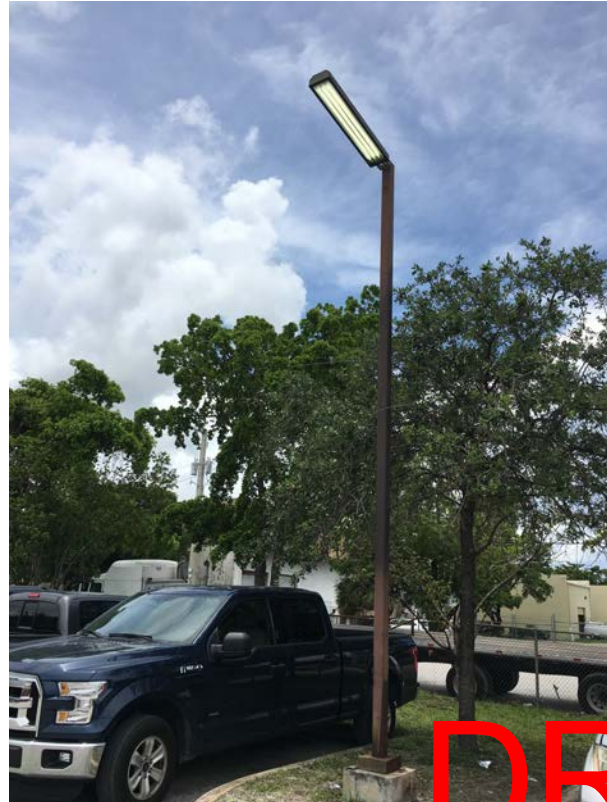
There are several large floodlights on 20-foot light poles positioned randomly in the parking areas to accomplish nighttime lighting. There are floodlights along the warehouse buildings, but the lighting is sporadic, and not up to contemporary lighting standards.

The pole lighting actually uses florescent tubes, and was turned on during daylight hours.

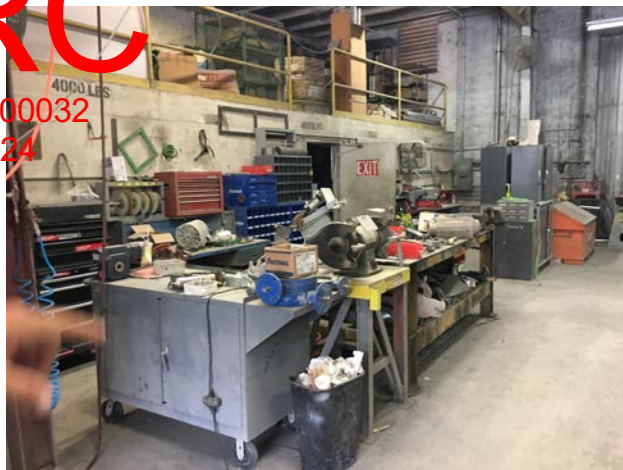
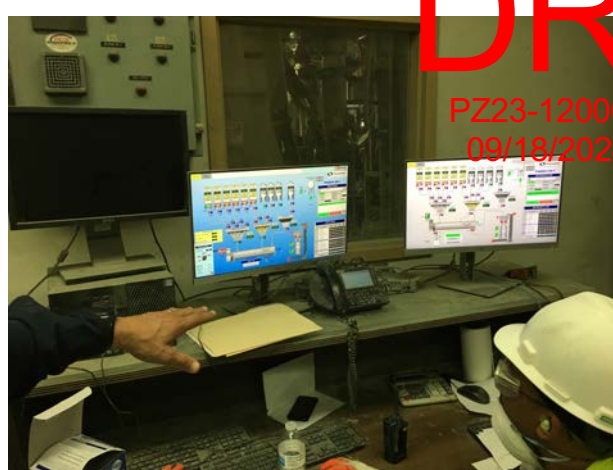
Tools and equipment is an attractive asset that need to be protected.

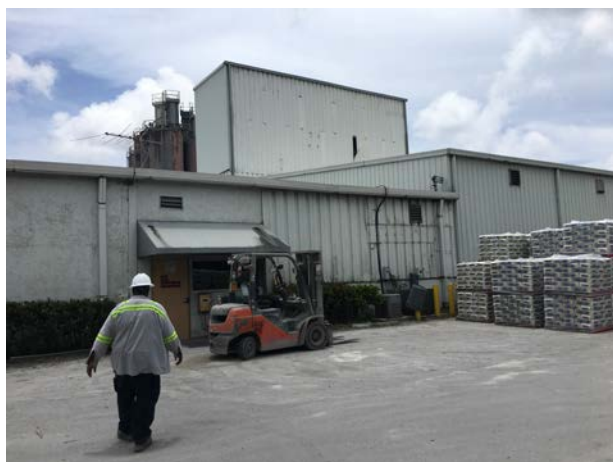
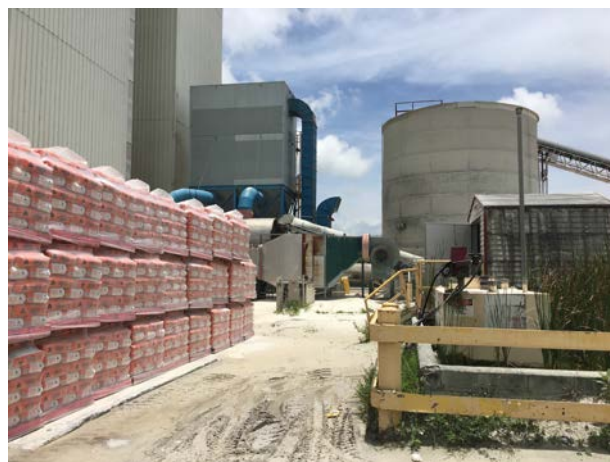
Forklifts and product stacked are assets that need to be protected.

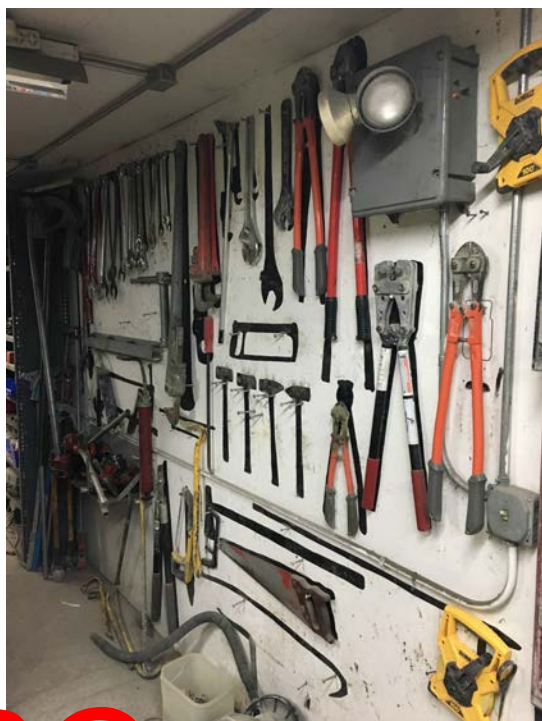
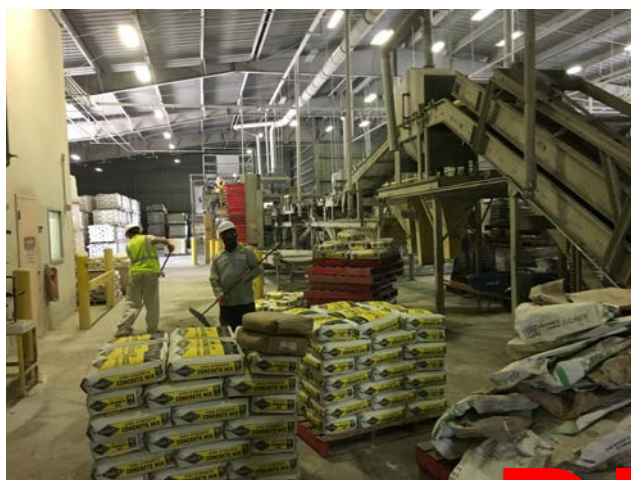
Tools and machinery must be protected from loss, theft, pilferage, or vandalism.

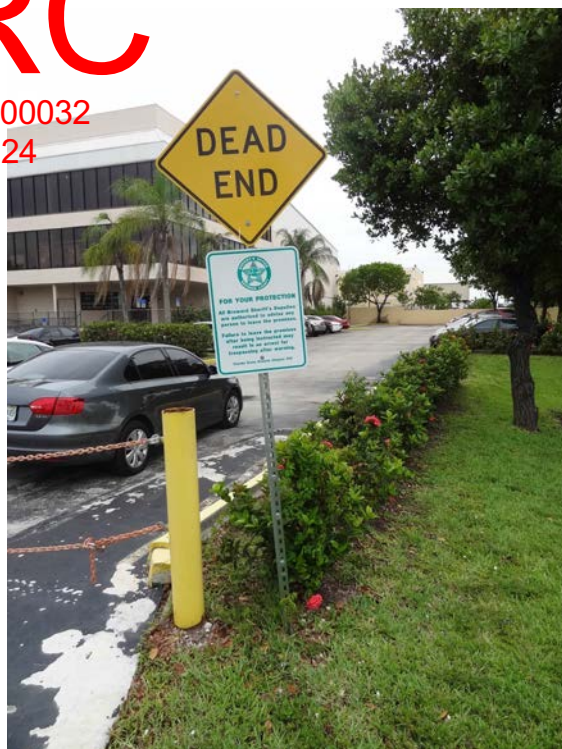
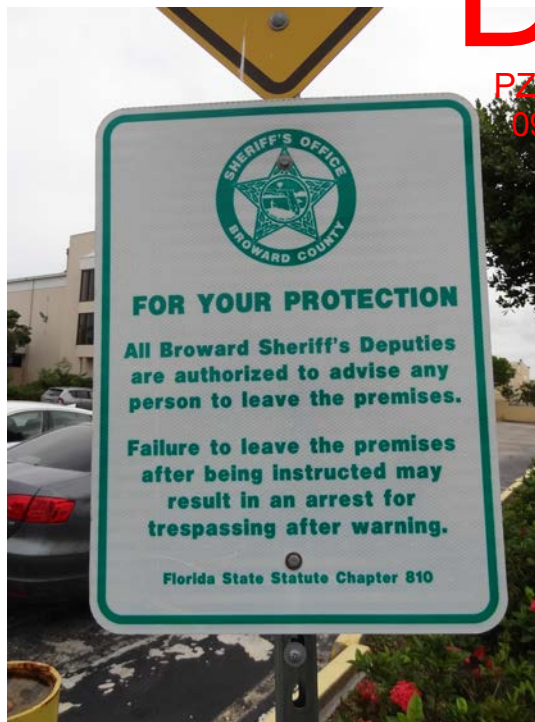
At the Baers buildings, down the street from the Oldcastle site, they have the parking lot chained off, after a couple of criminal incidents took place there. Baers posted a no trespass sign that empowered the Broward Sheriff's office to patrol the facility. Proper signage must state who is the enforcing agency and cite chapter and verse of the state law that is being enforced, as demonstrated above. This kind of signage will be added to the Oldcastle site.
