# BULKHEAD & DOCK CONDITION REPORT

## Alsdorf Park City of Pompano Beach

December 2018, Updated March 2019

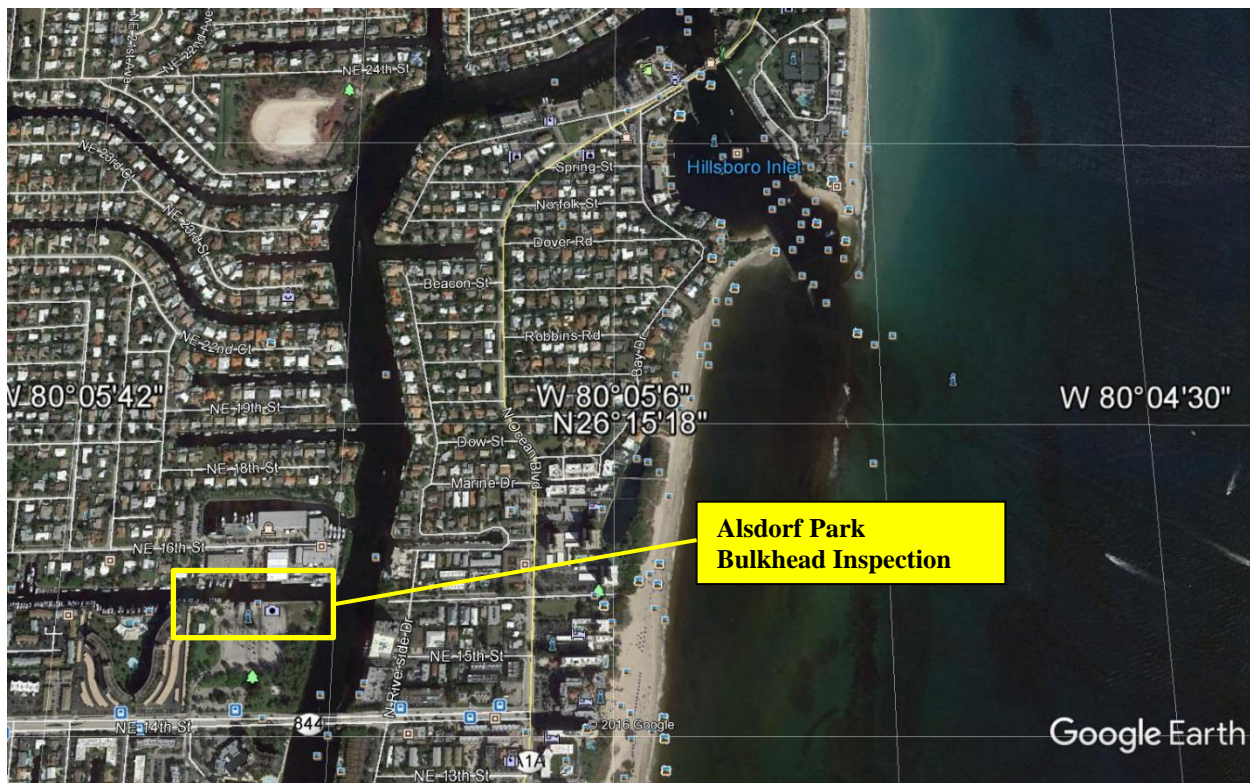
**Figure A**

Pursuant to the request of the City of Pompano Beach, Sea Diversified, Inc. (SDI), conducted a bulkhead assessment at William J. Alsdorf Boat Launching Park (Alsdorf Park) located at 2901 Northeast 14<sup>th</sup> Street on the west side of the Intracoastal Waterway (ICWW). **Reference Figure A.** The bulkhead at Alsdorf Park extends along the south side of Caliban Canal, an artificial waterway bordering the north side of the Park property. The bulkhead measures approximately 780 feet in total length extending west from the ICWW along the Park to the west side of an adjacent sheriff facility where it abuts a private residential bulkhead. SDI conducted a previous inspection of this entire bulkhead in late July and early August of 2016. The current bulkhead assessment focused specifically on a 350-foot segment of the wall extending from the boat ramps to the ICWW including a small section extending along west side of the ICWW. **Reference Figure B.** This part of the bulkhead was noted to be in poor condition in 2016 so the updated inspection was conducted for purposes of checking on current conditions in preparation for initiating necessary repairs. Field work consisted of visual observations of existing conditions by engineering staff under the direction and supervision of a Professional Engineer. The current field work was conducted in December of 2018.
