# City of Pompano Beach Water Treatment Plant Building Hurricane Hardening Study – Final Technical Memorandum

June 30, 2016

**Tetra Tech  
450 N. Park Rd., Suite 502  
Hollywood, FL 33021**

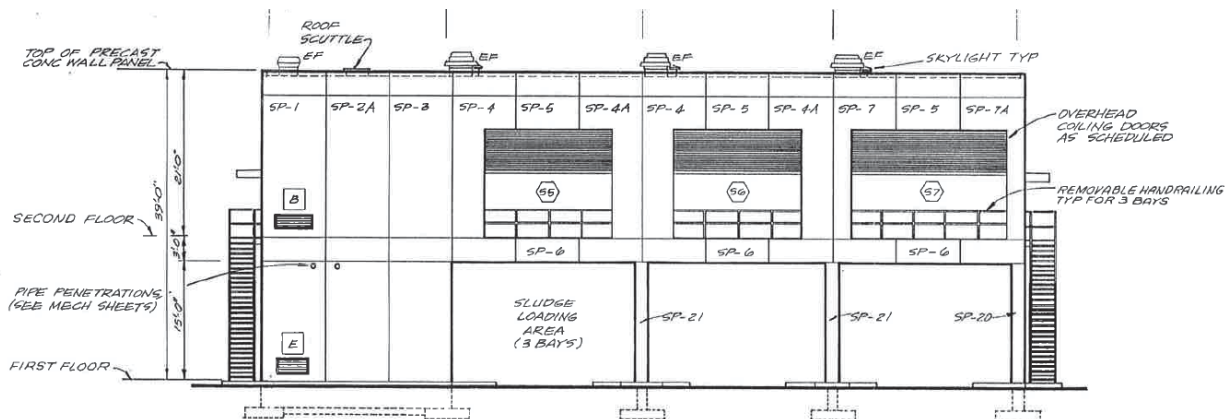
**Figure 5: Sludge Dewatering Building - South Elevation**

Building construction is steel framing with precast concrete wall panels. The precast wall panel connections are detailed to transfer out-of-plane and in-plane loads only. Gravity loads from the roof and floor are carried by the steel framing. Roof framing is a combination of W-shape steel beams and H-series bar joists that support metal roof deck. The second floor is an 8" concrete slab that acts compositely with the W-shape floor framing. The concrete foundations are mostly isolated column footings with some continuous wall footings to support the precast panels that extend to the ground level. Most structural members and components were observed to be in good condition overall, with the exception of some of the second floor steel framing that has started corroding due to loss of sprayed-on fire protection.

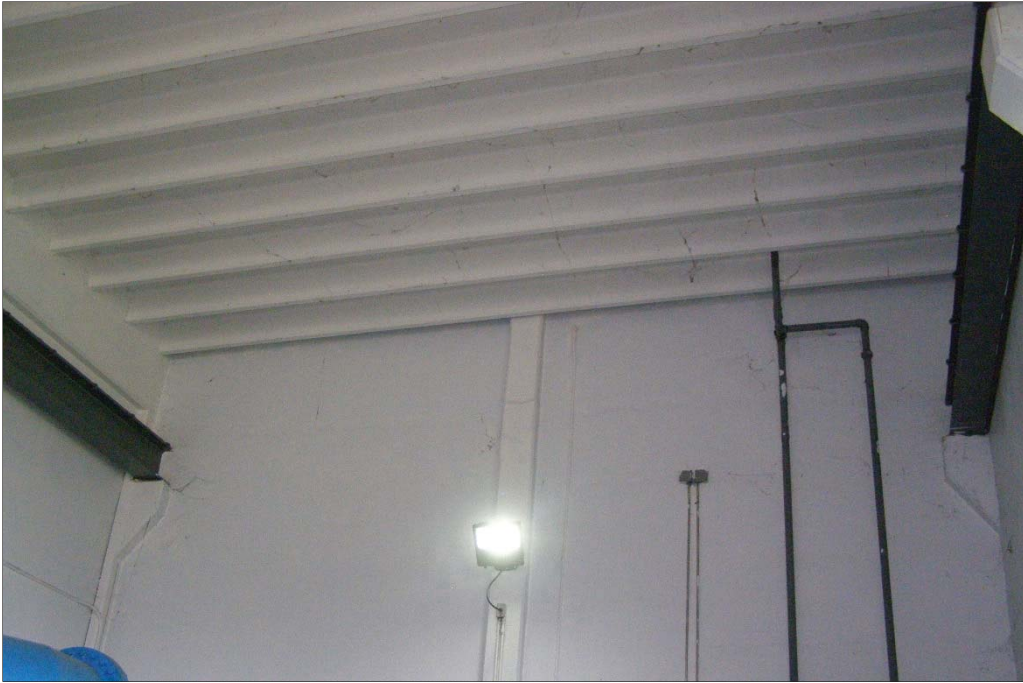
**Photo 3: Typical Double Tee Roof Structure**

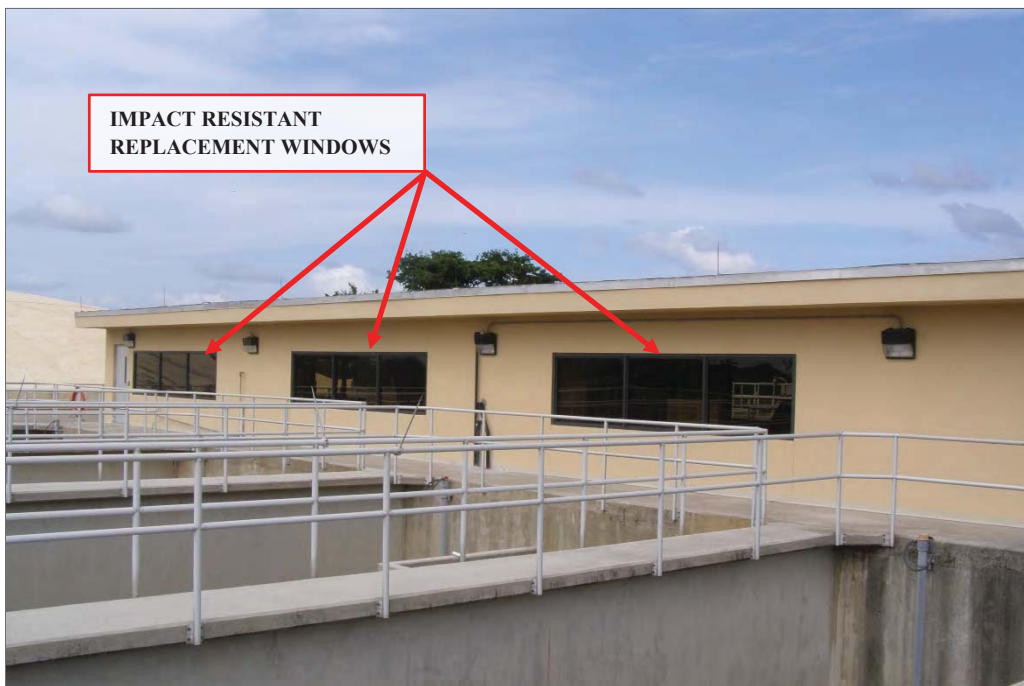
When the plant was expanded in 1983, the operation gallery was extended to the north but built with steel framing and metal stud cladding. Roof members are 8" deep wide flange beams with 1 ½" metal deck. Wall construction is 6" cold formed steel studs with stucco on metal lath over gypsum board. When analyzed for current wind loads, the structural framing and typical metal studs were verified as adequate. However, there are several deficiencies, including: metal roof deck attachment, metal stud construction/strength around large openings, lack of structural sheathing on the metal studs, and gypsum board attachment and wind/impact rating. Information regarding all three of these items is based on the record drawings and limited observation by removing sections of drywall from the building interior.

**Photo 9: Filter Operation Gallery Expansion – West View**

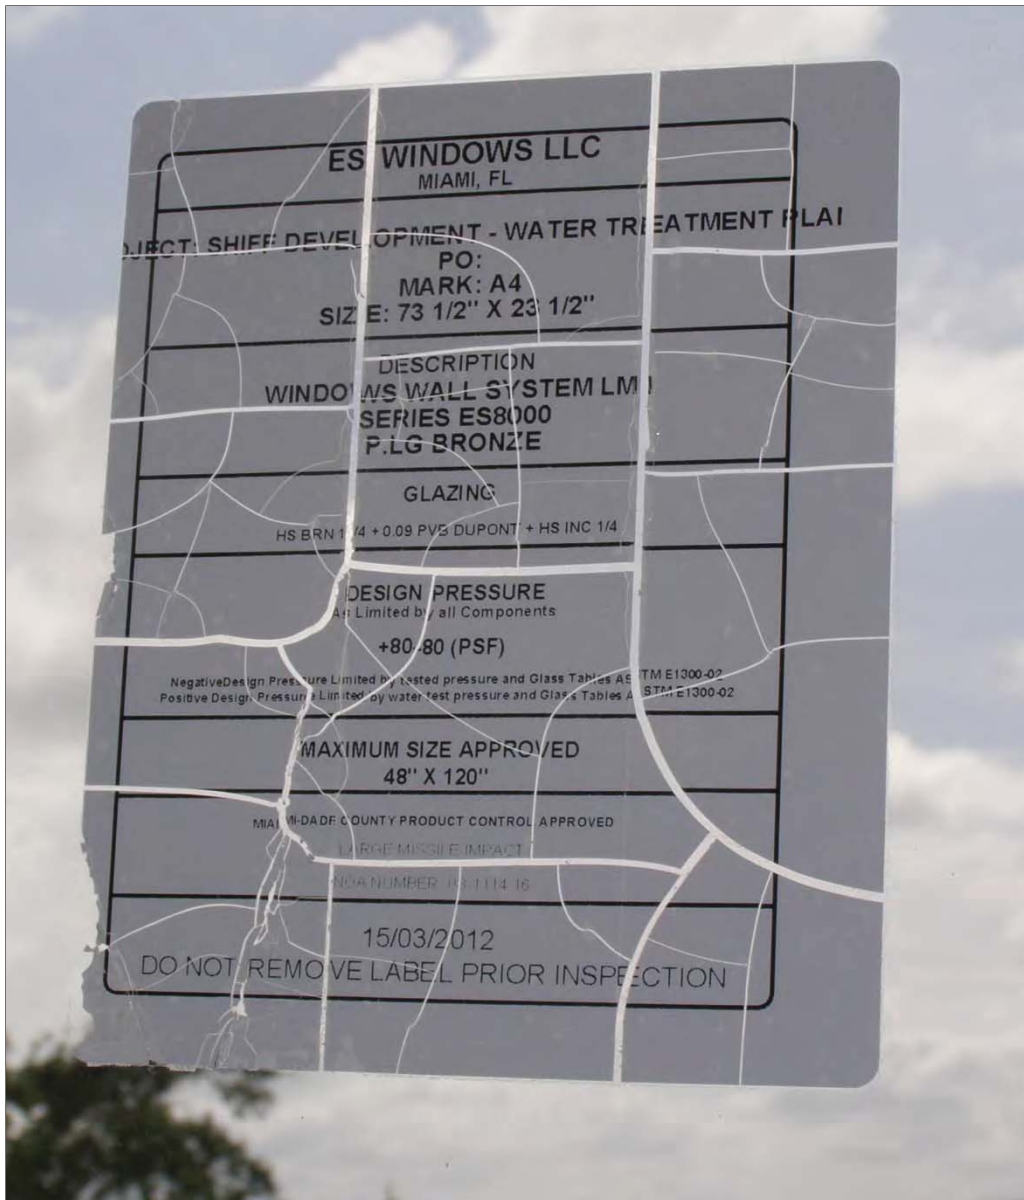
**Photo 12: Replacement Window Information**

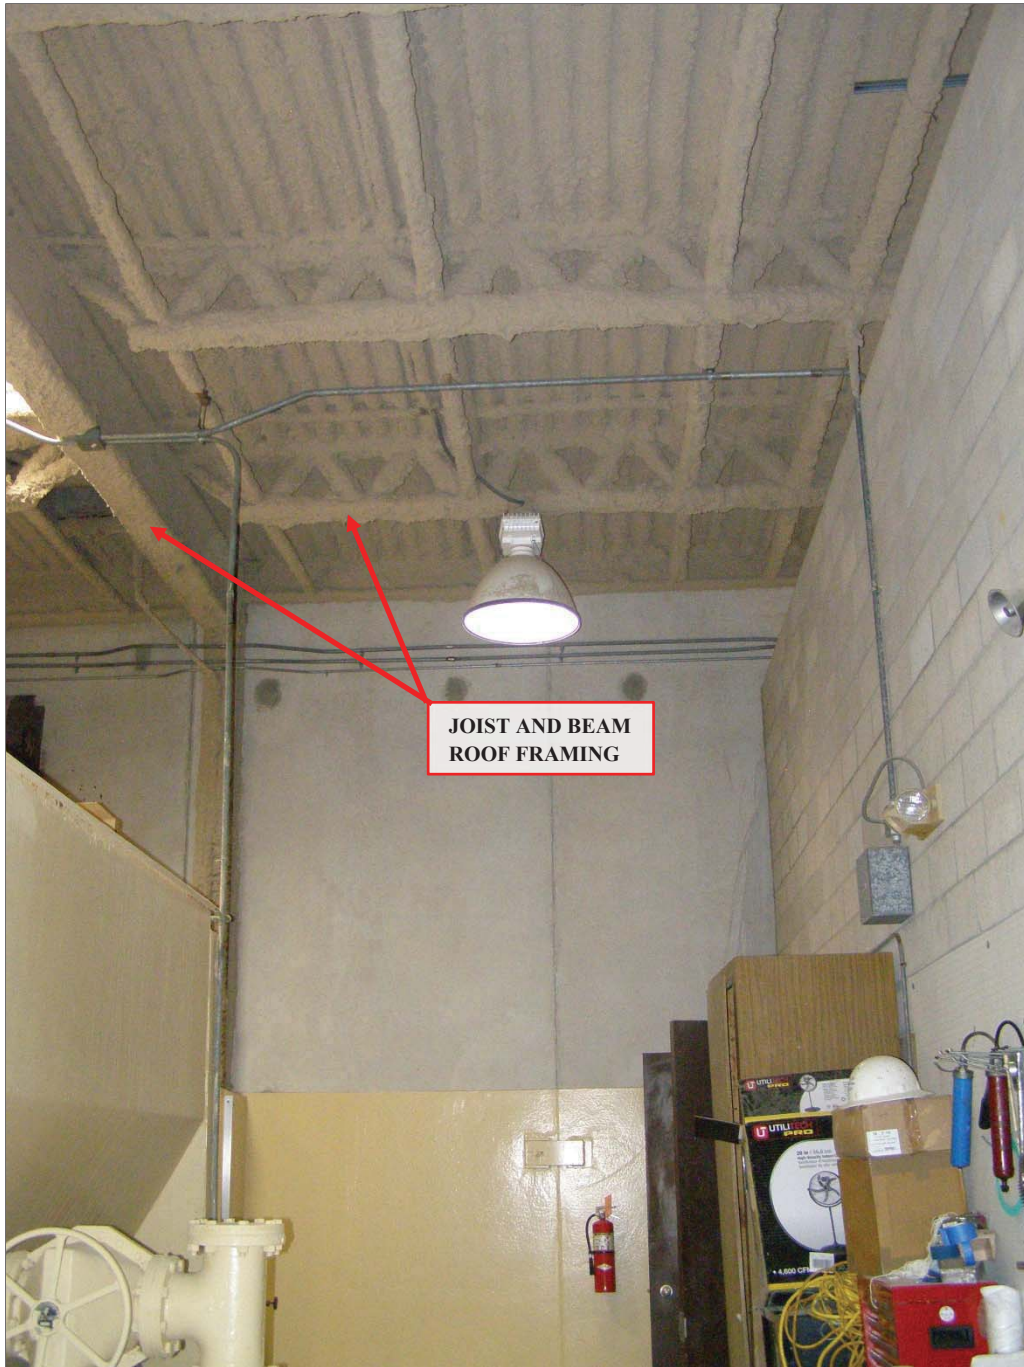
**Photo 30: Typical Roof Framing**
