City of Pompano Beach Water Treatment Plant Building Hurricane Hardening Study – Final Technical Memorandum

June 30, 2016

**City of Pompano Beach
Utilities Department
1205 NE 5th Ave
Pompano Beach, FL 33060**

**Tetra Tech
450 N. Park Rd., Suite 502
Hollywood, FL 33021**

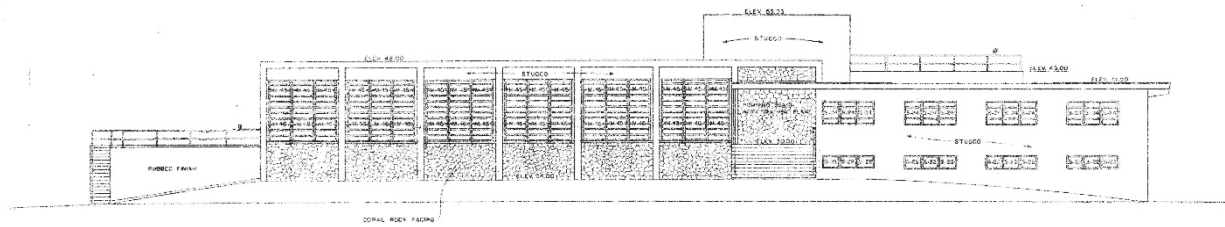
Figure 2: Filter Building - South Elevation

The original 1959 building construction is reinforced concrete tie-columns and tie-beams with load bearing 8" unreinforced CMU infill. Roof members are 12" or 14" deep x 4'-0" wide precast double tees, without composite concrete topping. The concrete foundations are a combination of continuous wall footings, isolated column footings, and grade beams. The structural members and components were observed to be in good condition overall, with the exception of some stucco and CMU cracking.

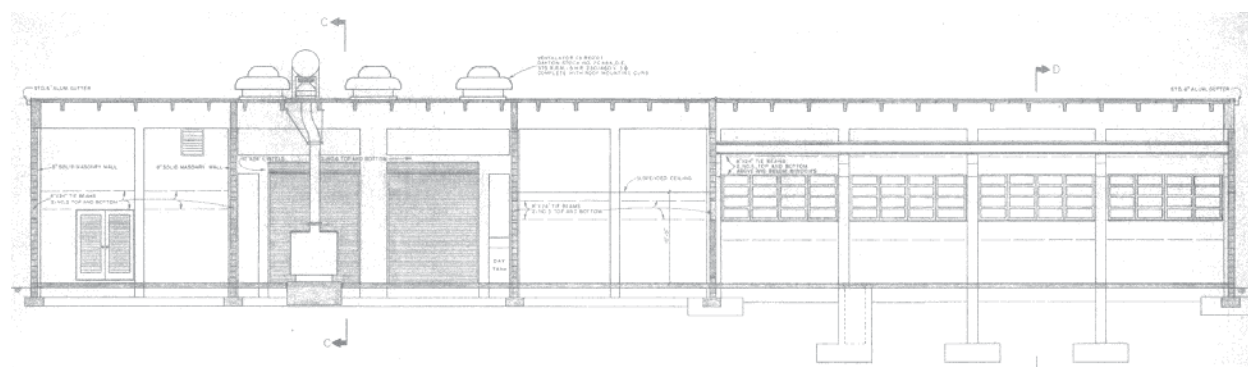
Figure 3: HSP/Electrical Equipment Building - Cross Section

Building construction is reinforced concrete tie-columns and tie-beams with load bearing 8” unreinforced CMU infill. Roof members are 14” deep x 8’-0” wide precast double tees, without composite concrete topping. The concrete foundations are a combination of continuous wall footings, isolated column footings, and grade beams. The structural members and components were observed to be in good condition overall, with the exception of some minor cracking and water damage around the windows of the HSP room, as shown in the Appendix photos.

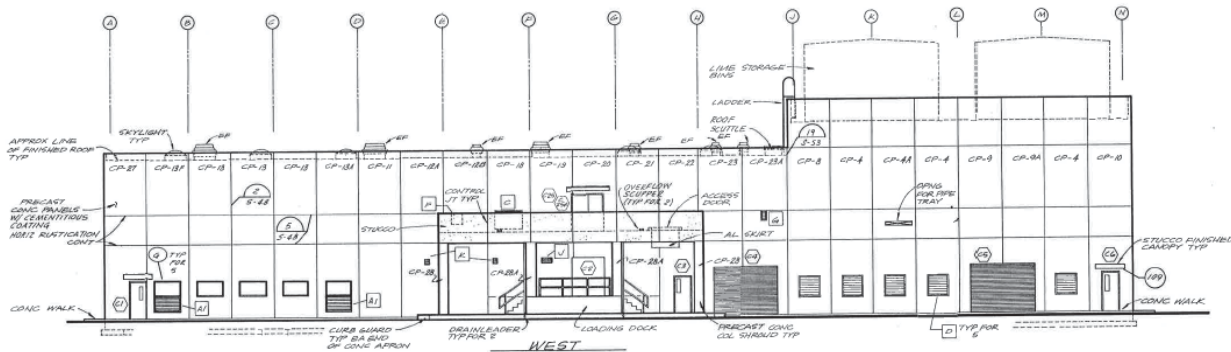
Figure 4: Chemical Building - West Elevation

Building construction is primarily steel framing and exterior precast concrete wall panels that rest on top of the floor slab. The precast wall panel connections are detailed to transfer out-of-plane and in-plane loads only. Gravity loads from the roof and floor are carried by the steel framing. Roof framing over the shop and second floor is a combination of W-shape steel beams and H-series bar joists that support metal roof deck. The roof framing around the Lime silos is W-shape steel beams that act compositely with a 6" concrete slab. The second floor is a 6½" composite metal deck slab that is supported by a combination of CMU walls and W-shape beams. The concrete foundations are comprised of piers and stem walls on monolithically poured column and wall footings. Most structural members and components were observed to be in good condition overall, with the exception of some of the steel framing that has started corroding due to loss of sprayed-on fire protection.

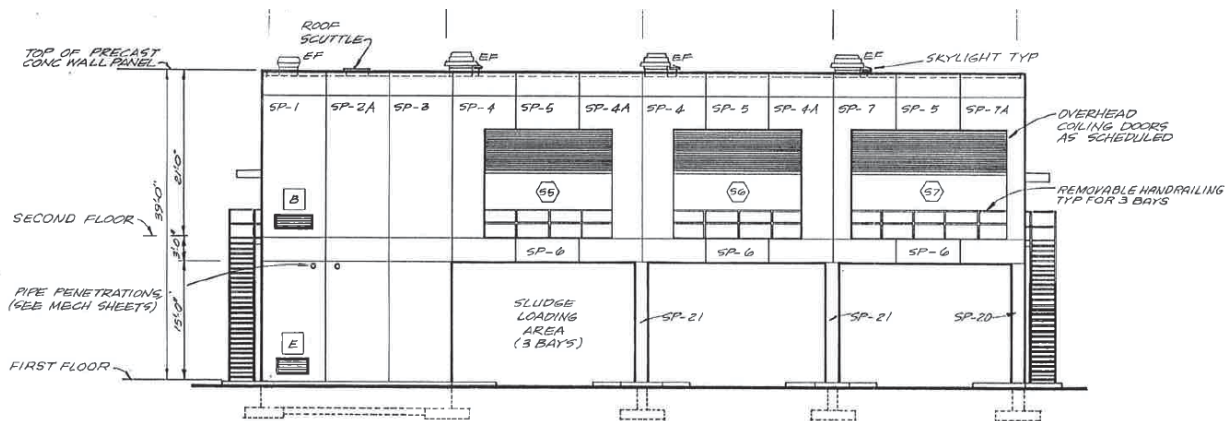
Figure 5: Sludge Dewatering Building - South Elevation

Building construction is steel framing with precast concrete wall panels. The precast wall panel connections are detailed to transfer out-of-plane and in-plane loads only. Gravity loads from the roof and floor are carried by the steel framing. Roof framing is a combination of W-shape steel beams and H-series bar joists that support metal roof deck. The second floor is an 8" concrete slab that acts compositely with the W-shape floor framing. The concrete foundations are mostly isolated column footings with some continuous wall footings to support the precast panels that extend to the ground level. Most structural members and components were observed to be in good condition overall, with the exception of some of the second floor steel framing that has started corroding due to loss of sprayed-on fire protection.

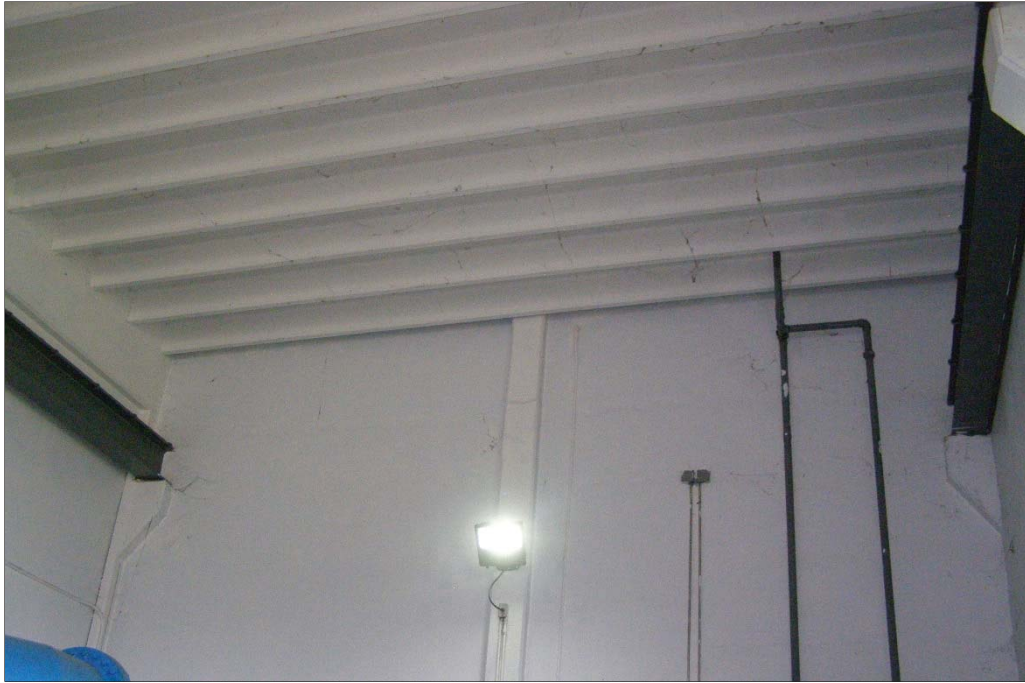
Photo 3: Typical Double Tee Roof Structure

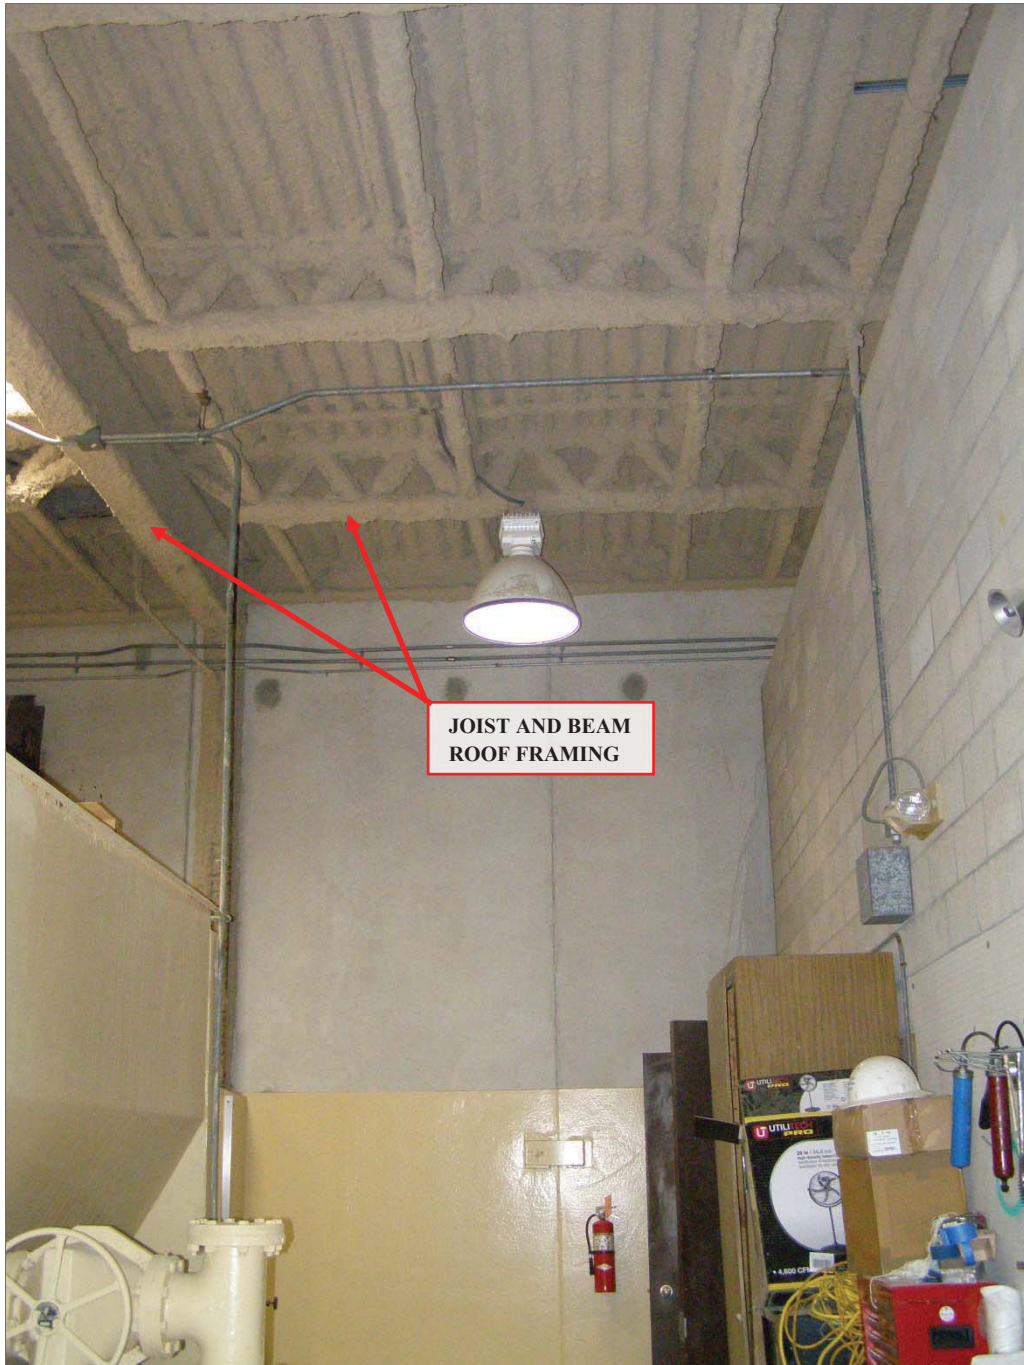
Photo 30: Typical Roof Framing
