DESCRIPTION:

PARCEL "E" OF "BROWARD COUNTY PLAT No. 2" ACCORDING TO THE PLAT THEREOF, AS RECORDED IN PLAT BOOK 159, PAGE 16, OF THE PUBLIC RECORDS OF BROWARD COUNTY, FLORIDA.

PROPERTY ADDRESS:  
1700 NW 30th AVENUE,  
POMPANO BEACH, FL 33069

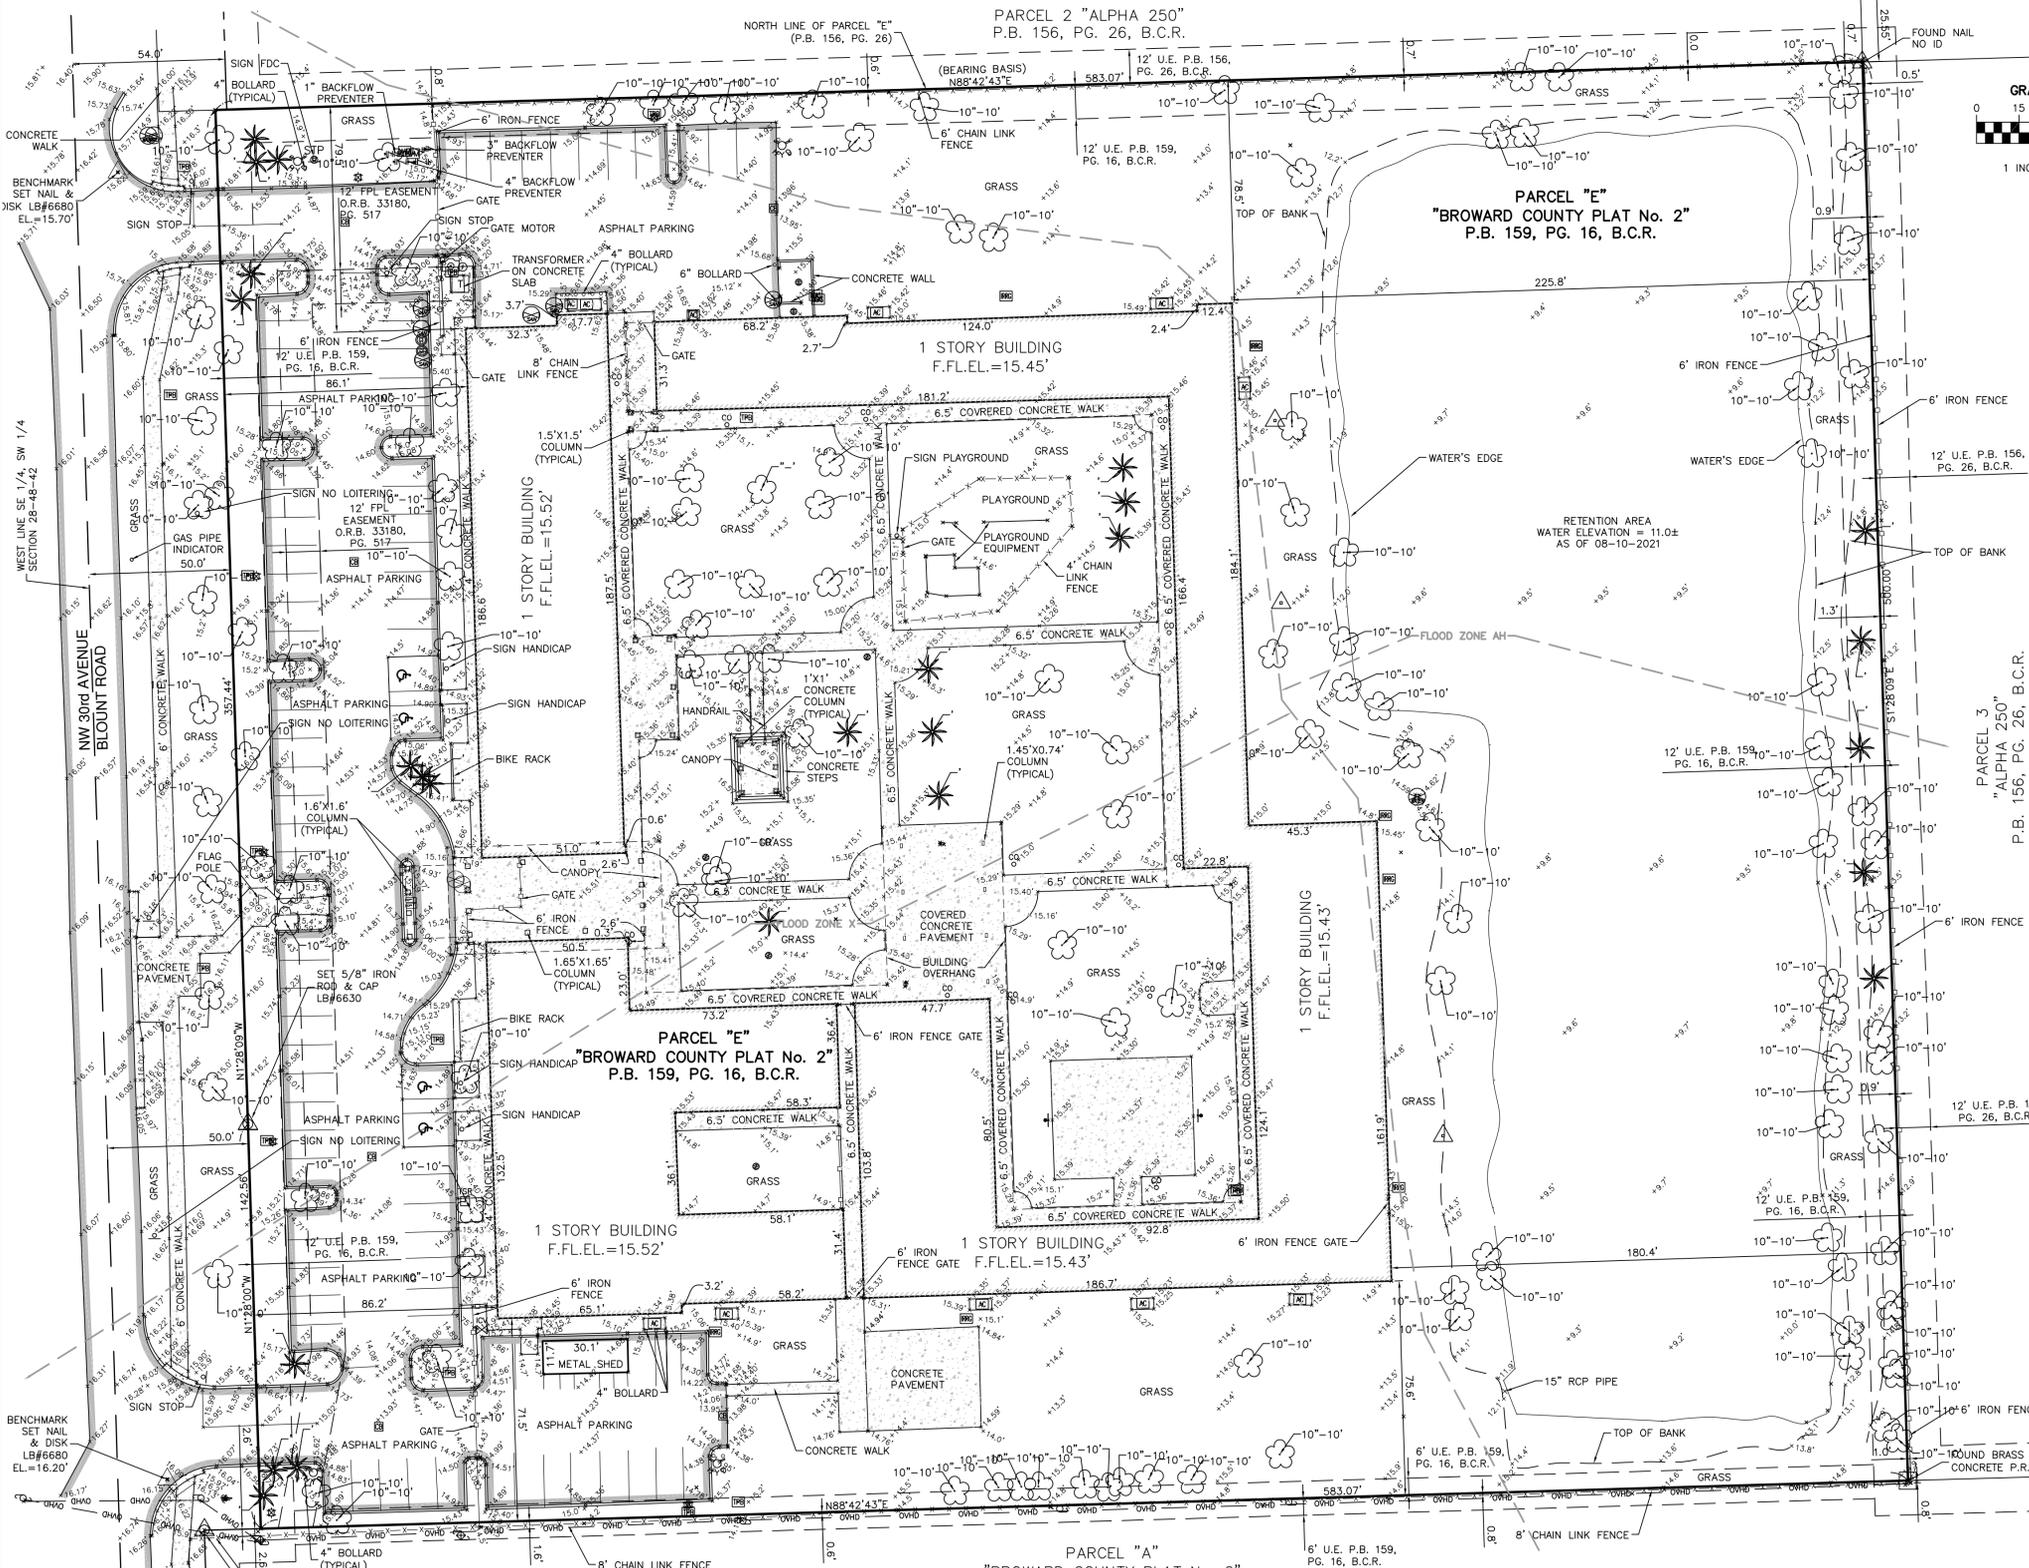
- THE SURVEY WAS MADE ON THE GROUND ON AUGUST 18, 2021 AND SHOWS THE AREA OF THE SUBJECT PROPERTY, THE NUMBER AND TYPE OF PARKING SPACES, THE LOCATION OF UTILITIES OBSERVED OR SHOWN ON RECORD DOCUMENTS AS SERVING THE SUBJECT PROPERTY.

- BURIED FOUNDATIONS AND UNDERGROUND UTILITIES, IF ANY, NOT SHOWN.
- BEARINGS SHOWN HEREON ARE BASED ON PLAT BEARING OF N88°42'43"E ALONG THE NORTH LINE OF PARCEL "E" AS SHOWN ON THE "BROWARD COUNTY PLAT No. 2", (P.B. 159, PG. 16, B.C.R.)
