OWNERSHIP AND ENCUMBRANCE REPORT, FILE NO. 484228250050 CERTIFIED THROUGH AUGUST 16, 2021 AT 11:00 PM					
ITEM NO.	INSTRUMENT	DESCRIPTION	RECORD DATA	AFFECTS	PLOT
1	PLAT	BROWARD COUNTY PLAT	P.B. 159, PG. 16	YES	YES
2	EASEMENT	WATER/SANITARY SEWER EASEMENT	O.R.B. 18771, PG. 989	NO	NO
3	EASEMENT	FPL EASEMENT	O.R.B. 18314, PG. 544	NO	NO
4	EASEMENT	WATER/SEWER EASEMENT	O.R.B. 18160, PG. 271	NO	NO
5	EASEMENT	FPL EASEMENT	O.R.B. 18057, PG. 23	NO	NO
6	EASEMENT	FPL EASEMENT	O.R.B. 9472, PG. 714	NO	NO
7	EASEMENT	FPL EASEMENT	O.R.B. 18314, PG. 544	NO	NO
8	EASEMENT	FPL EASEMENT	O.R.B. 18112, PG. 576	NO	NO
9	EASEMENT	FPL EASEMENT	O.R.B. 33180, PG. 517	YES	YES
10	EASEMENT	EASEMENT	O.R.B. 21389, PG. 958	NO	NO
11	EASEMENT	FPL EASEMENT	O.R.B. 9783, PG. 530	NO	NO
12	EASEMENT	DRAINAGE EASEMENT	O.R.B. 9704, PG. 385	NO	NO

PARCEL "E" OF "BROWARD COUNTY PLAT No. 2" ACCORDING TO THE PLAT THEREOF, AS RECORDED IN PLAT BOOK 159, PAGE 16, OF THE PUBLIC RECORDS OF BROWARD COUNTY, FLORIDA.

PROPERTY ADDRESS:  
1700 NW 30th AVENUE,  
POMPAHO BEACH, FL 33069

BC HOMELESS CENTER NORTH CAMPUS  
CITY OF POMPAHO BEACH, FL

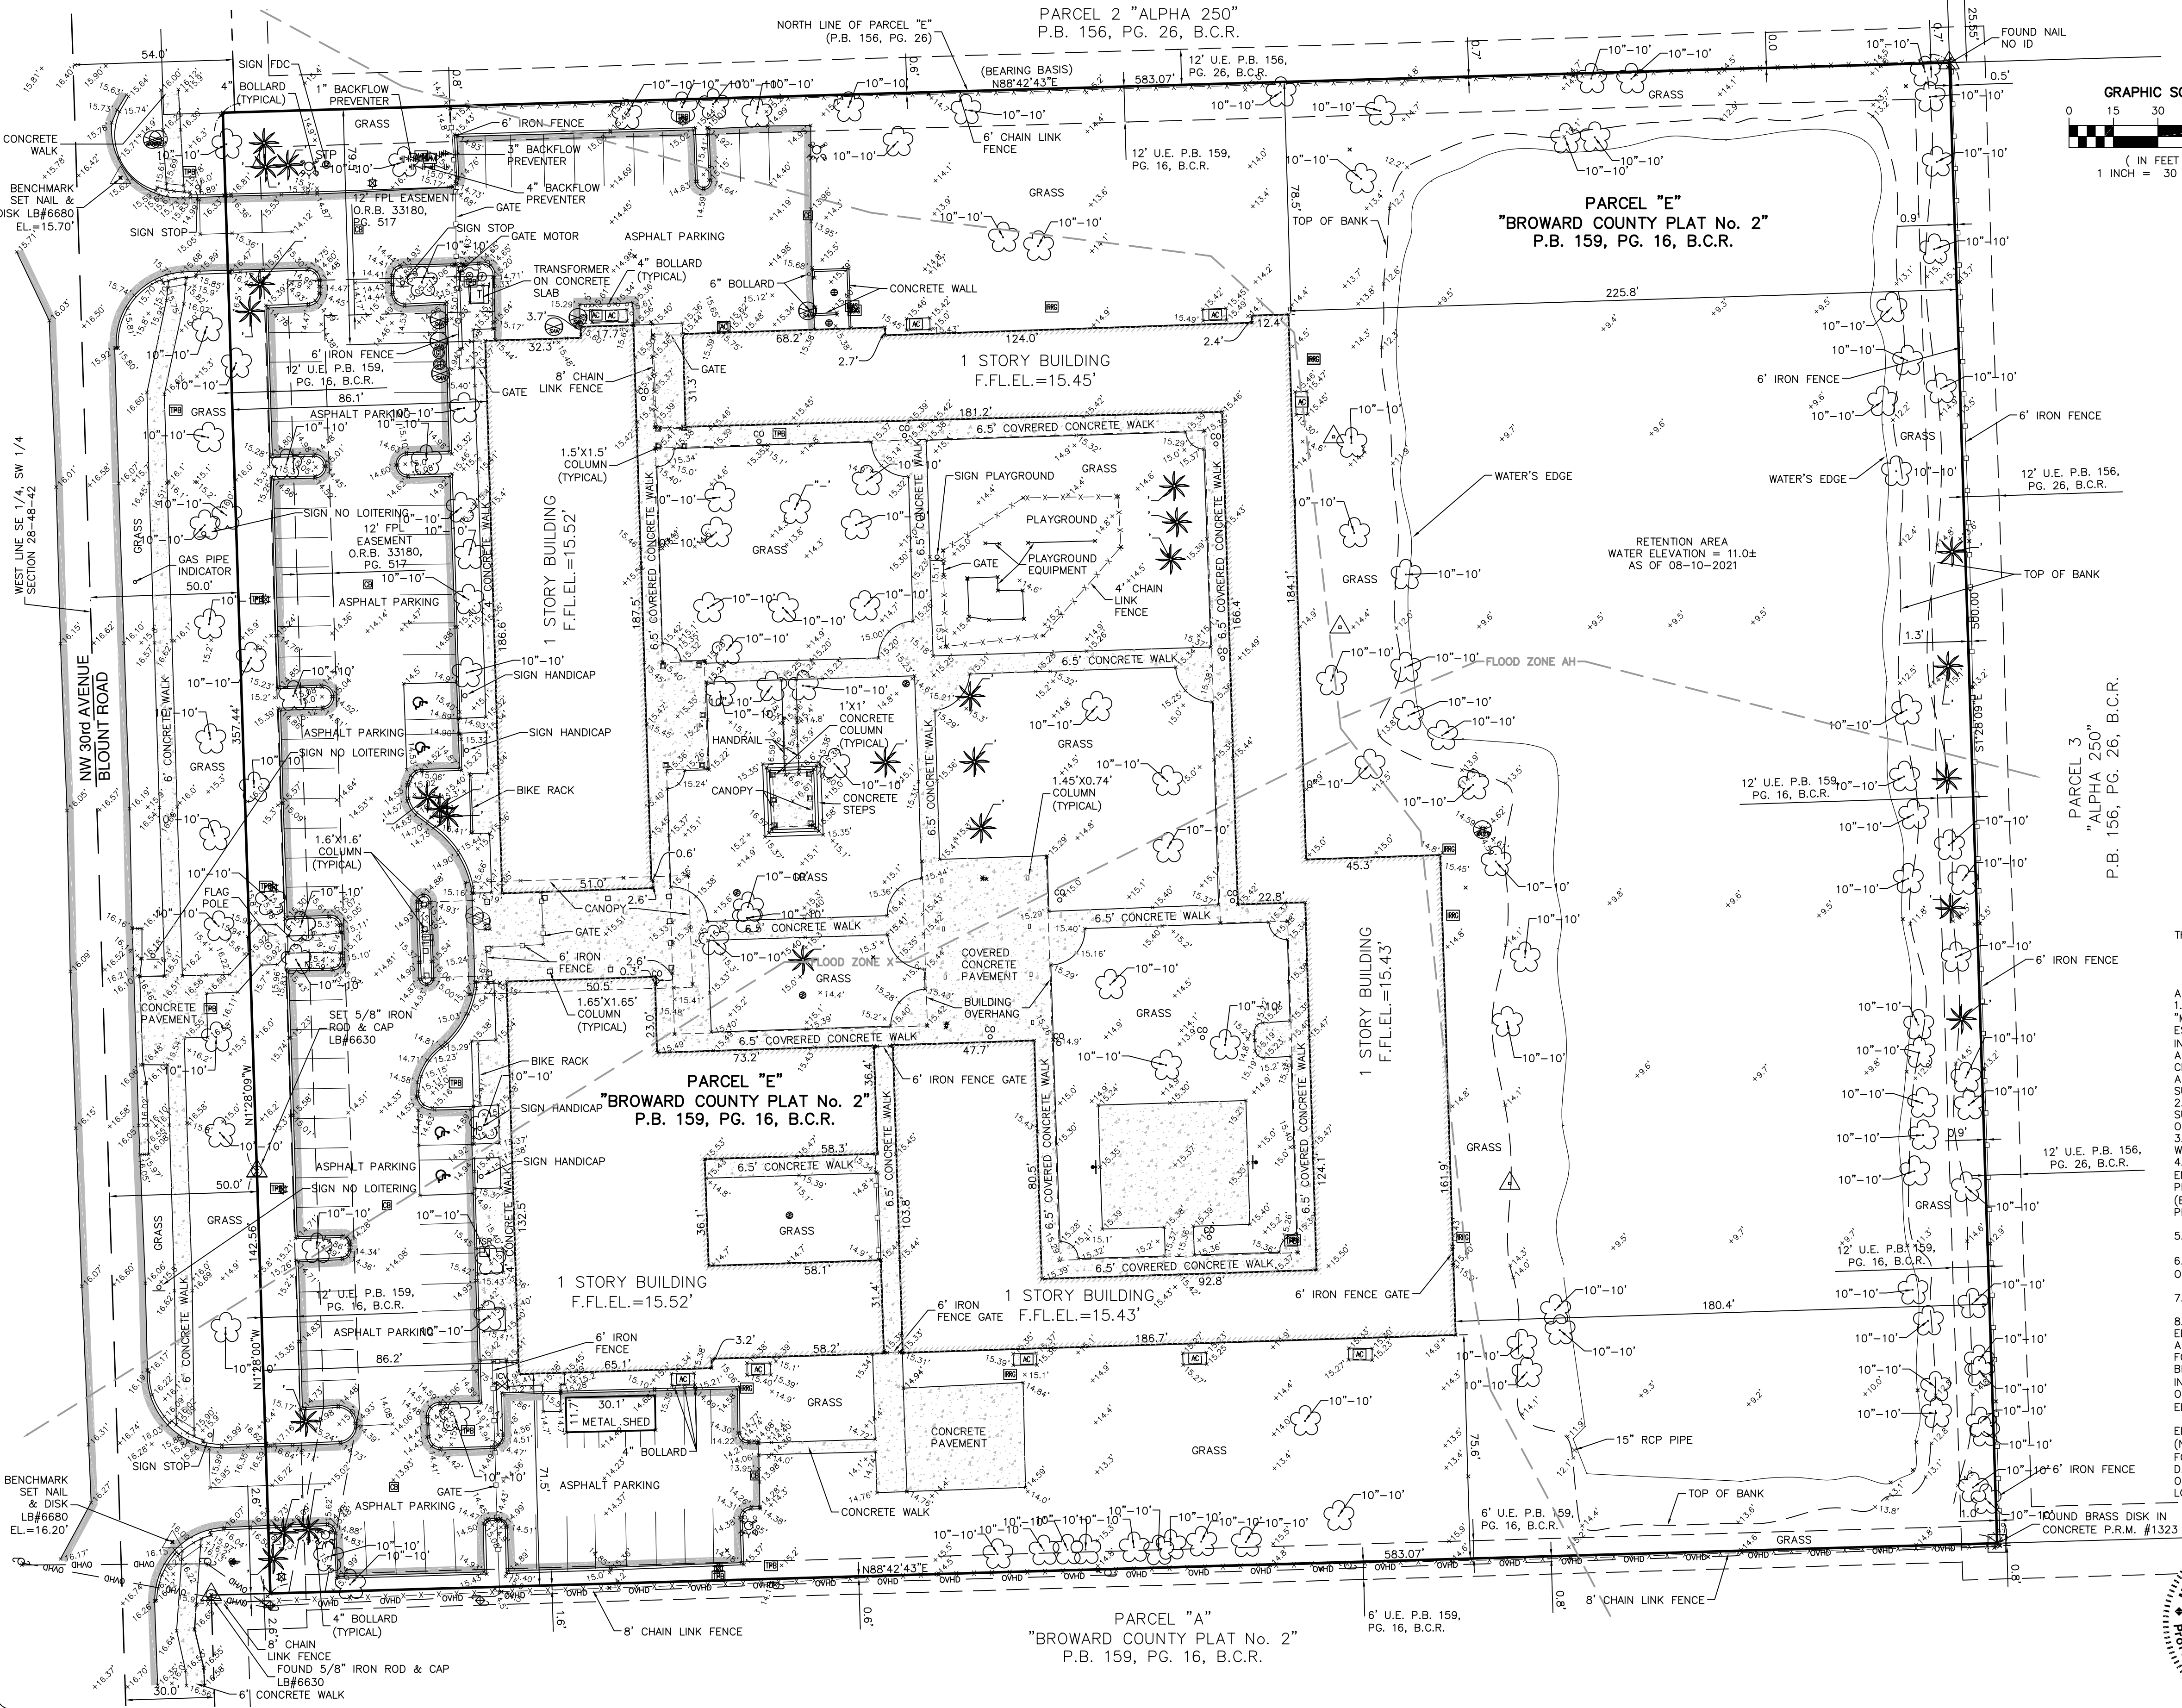
- THE SURVEY WAS MADE ON AUGUST 18TH 2021 AND SHOWS THE AREA OF THE SUBJECT PROPERTY, THE NUMBER AND TYPE OF PARKING SPACES, THE LOCATION OF UTILITIES OBSERVED OR SHOWN ON RECORD DOCUMENTS AS SERVING THE SUBJECT PROPERTY.

- BURIED FOUNDATIONS AND UNDERGROUND UTILITIES, IF ANY, NOT SHOWN.
  - BEARINGS SHOWN HEREON ARE BASED ON PLAT BEARING OF N88°42'43"E ALONG THE NORTH LINE OF PARCEL "E" AS SHOWN ON THE "BROWARD COUNTY PLAT NO. 2", (P.B. 159, PG. 16, B.C.R.)

- ELEVATIONS AS SHOWN WERE CONVERTED FROM THE NATIONAL GEODETIC VERTICAL DATUM OF 1929 (N.G.V.D. '29) TO THE NORTH AMERICAN VERTICAL DATUM OF 1988, (N.A.V.D. '88) USING THE FOLLOWING CONVERSION: N.G.V.D. '29 VERTICAL DATUM, (IN FEET) -1.57' = N.A.V.D. '88 VERTICAL DATUM. THE CONVERSION FACTOR WAS OBTAINED FROM THE NATIONAL GEODETIC SURVEY WEB SITE ORTHOMETRIC HEIGHT CONVERSION PROGRAM USING THE LATITUDE AND LONGITUDE OF THE PROJECT LOCATION TO DETERMINE A CONVERSION FACTOR FOR THIS SPECIFIC LOCATION.
