PHASE I ENVIRONMENTAL SUBJECT PROPERTY ASSESSMENT

SUBJECT PROPERTY: APPROXIMATE 20- ACRE PARCEL LOCATED WITHIN THE HARRAH'S POMPANO BEACH CASINO

Project FE8224A

February 2024

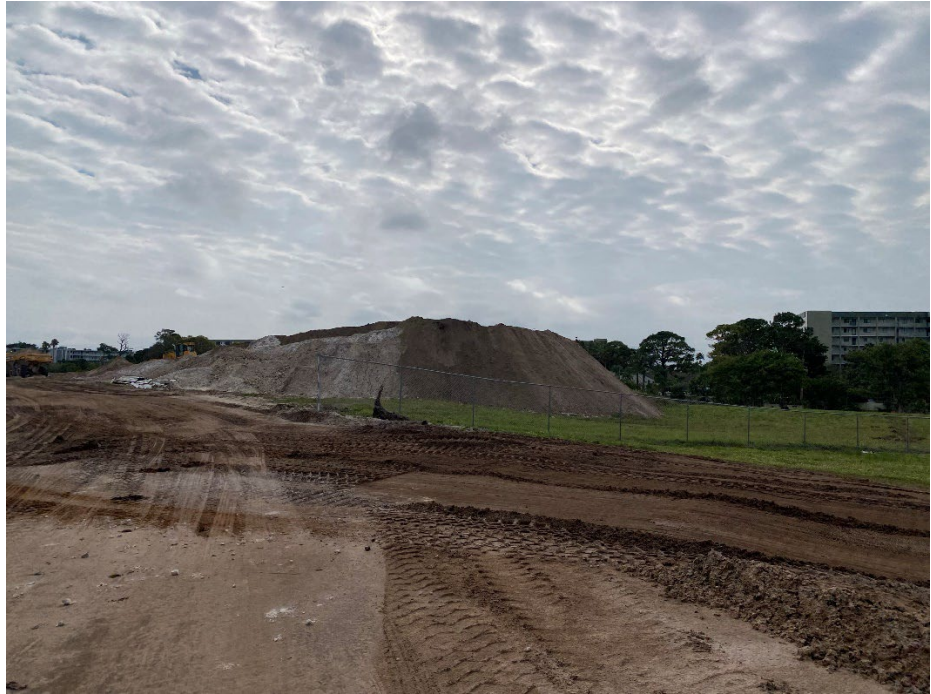
Comments: View of soil piles on southwest corner of Subject Property. No staining or odors were observed.

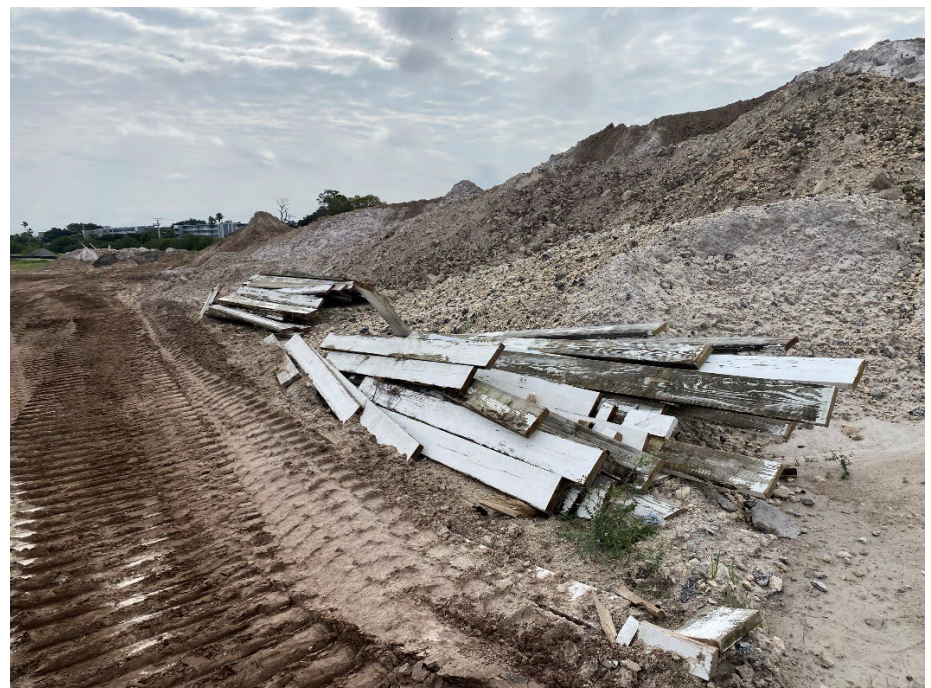
Comments: View of wood debris and soil piles on southwest corner of Subject Property. No staining or odors were observed.

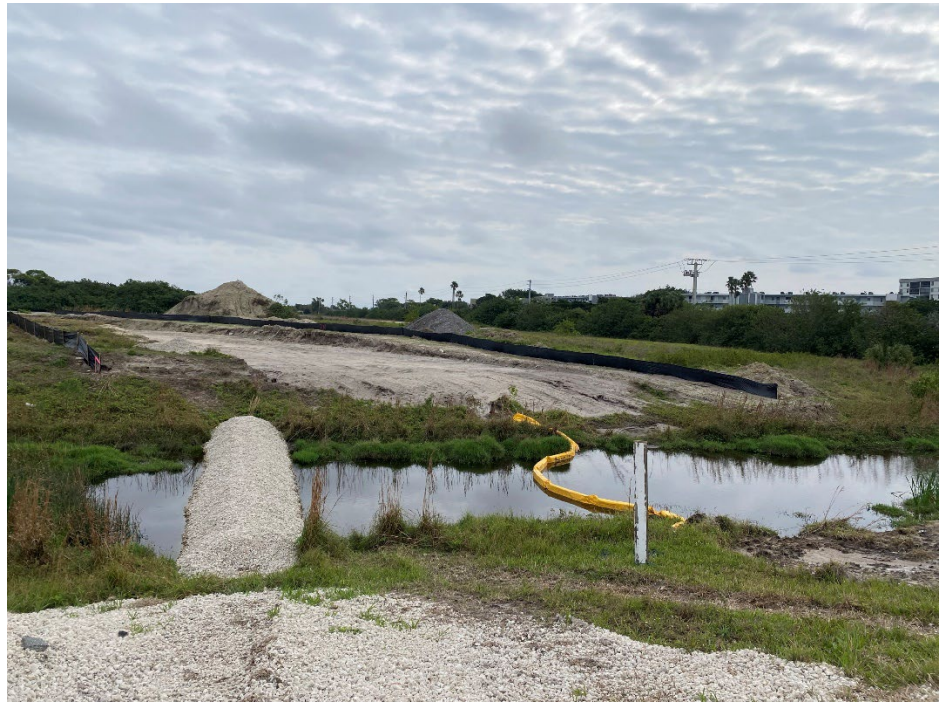
Comments: View of stormwater/drainage system leading south of Subject Property. Soil berm and booms observed (likely a part of construction erosion/sediment control procedures).

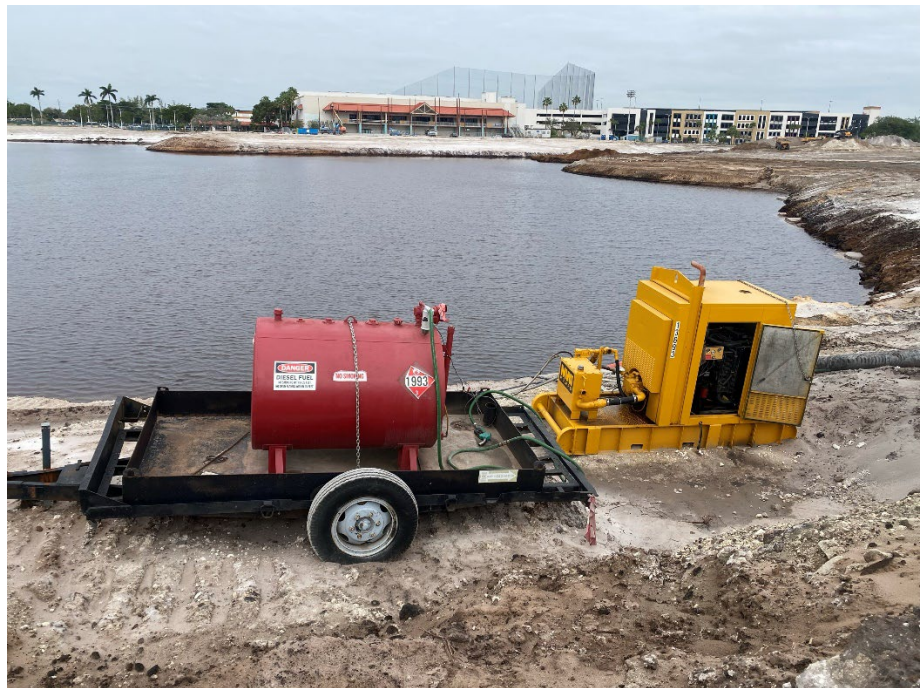
Comments: View of 500-gallon tank and pump south of former retention pond but north of Subject Property boundary (on Parent Property) to convey water to southeast of Subject Property. No staining or odors were observed.

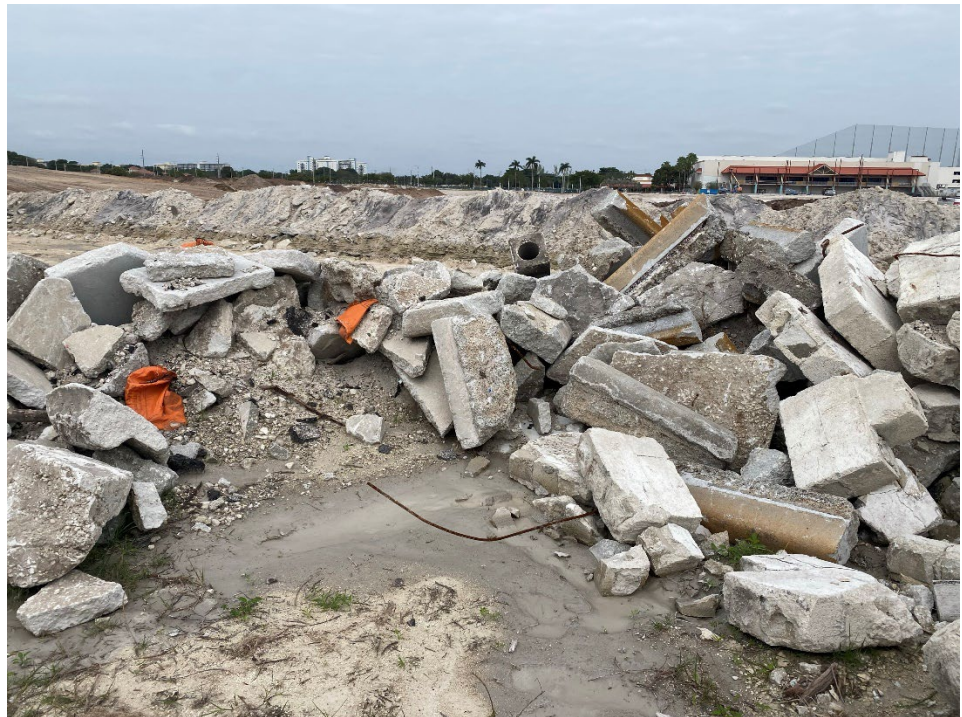
Comments: View of concrete construction debris on southeast portion of Subject Property. No staining or odors were observed.

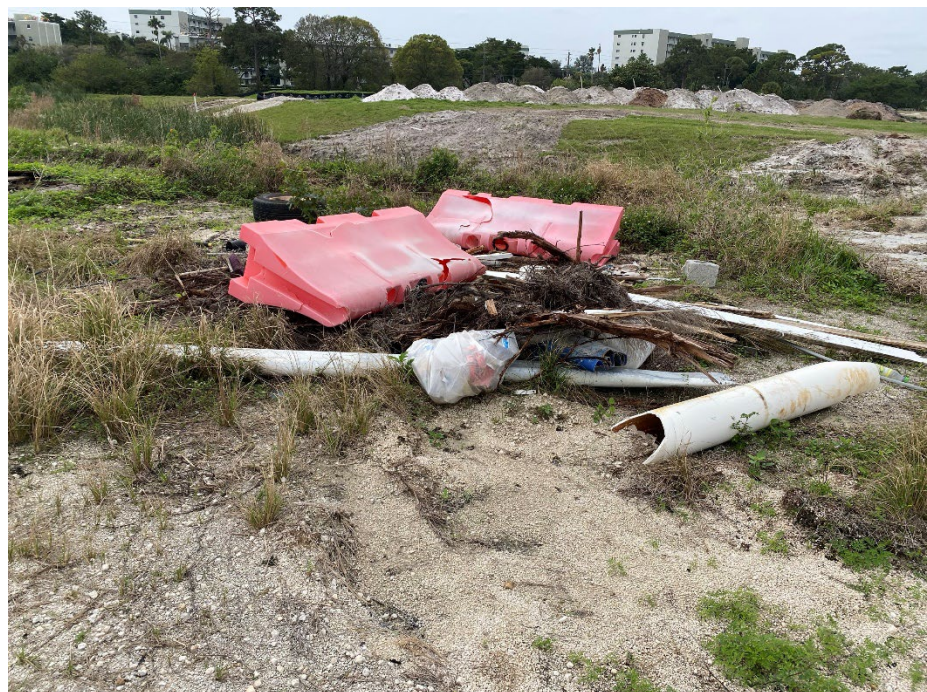
Comments: View of debris from general construction activities on southern area of Subject Property. No staining or odors were observed.

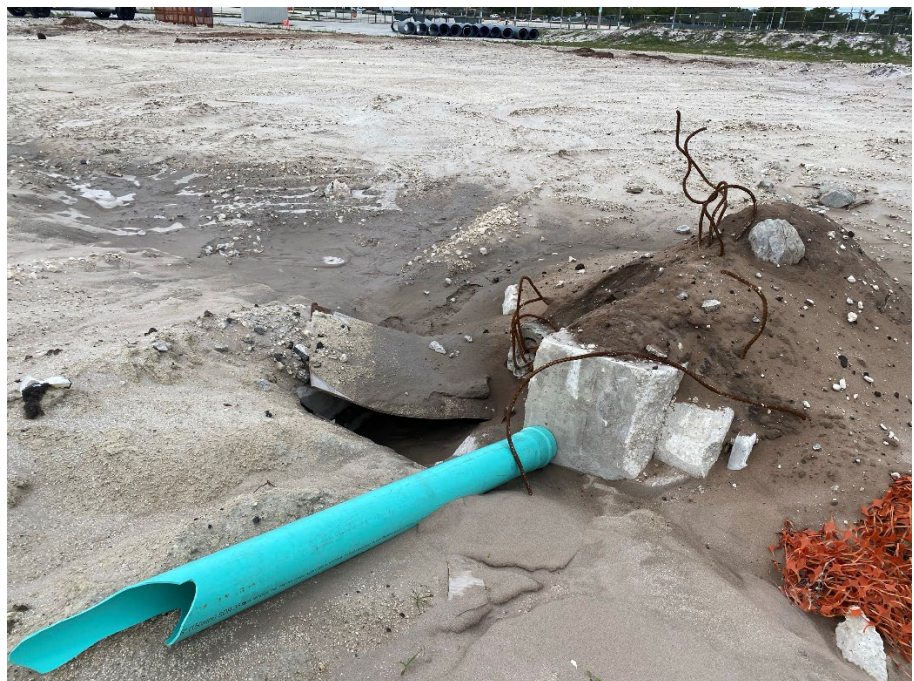
Comments: General construction debris on soil pile on northwest corner of Subject Property. No staining or odors were observed.
