FESTIVAL FLEA MARKET  
POMPAÑO, FL  
INDEX

Drawing: Index

TD-1

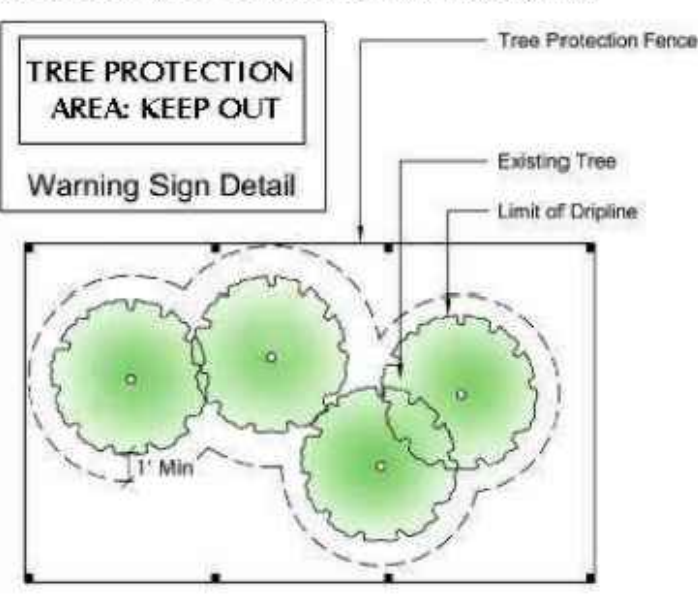
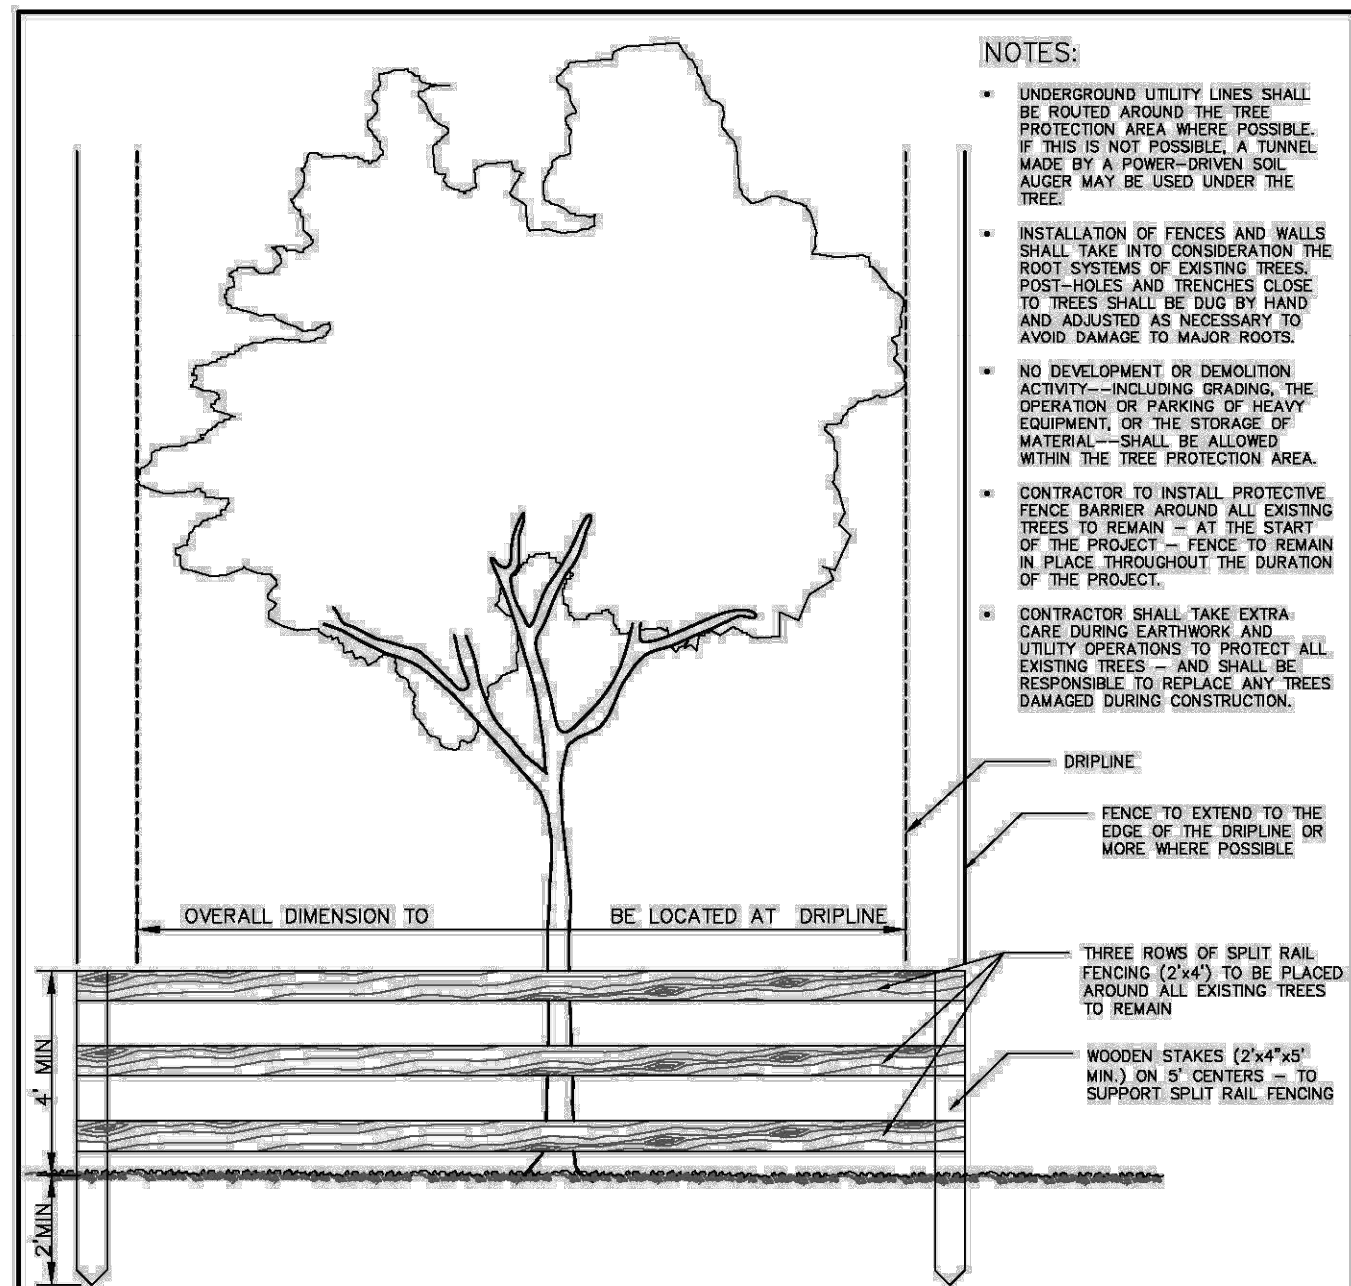
TREE PROTECTION DETAIL

Figure 155.5204.F.2: Tree protection fencing and signage.

NOTE: BARRIER TO FORM CONTINUOUS CIRCLE AROUND THE TREE OR GROUP OF TREES. SEE LANDSCAPE PLAN FOR LOCATION OF TREES TO REMAIN.
