<div>Benthic Surveys, Inc.</div> <div>Marine Studies and Investigations 954-536-5048</div>	777 S. Federal Highway, Apt. C-105 Seagrass Survey	REVISION		DATE
				8/17/2024
	Aerial Map Section 6/Township 49/Range 43 Pompano Beach, Broward County, FL			SHEET
				1 of 1
				SCALE: As Shown

Background

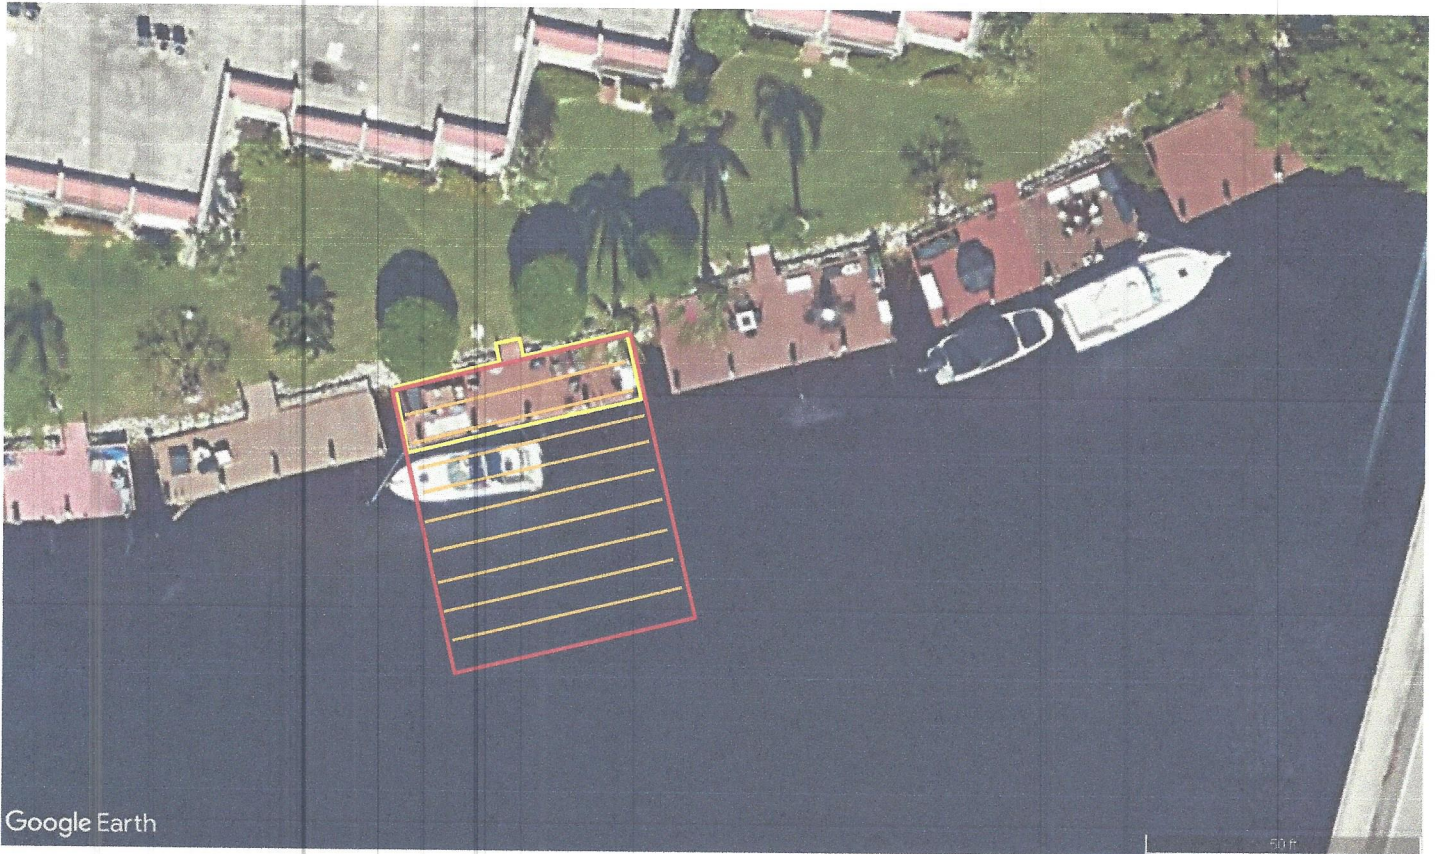
- 777 S. Fed. Hwy., Apt. C-105 Dock
- Survey Area
- Transects (50' Out)

The substrate throughout the survey area consisted of silty muck that was covered with oysters and small rocks. No regulated marine vegetation was observed in any transect. The attached aerial illustrates the survey area described.
