EXISTING TREE LIST

project:
fiberbuilt
2201 west atlantic blvd
pompano beach, fl.

existing tree plan

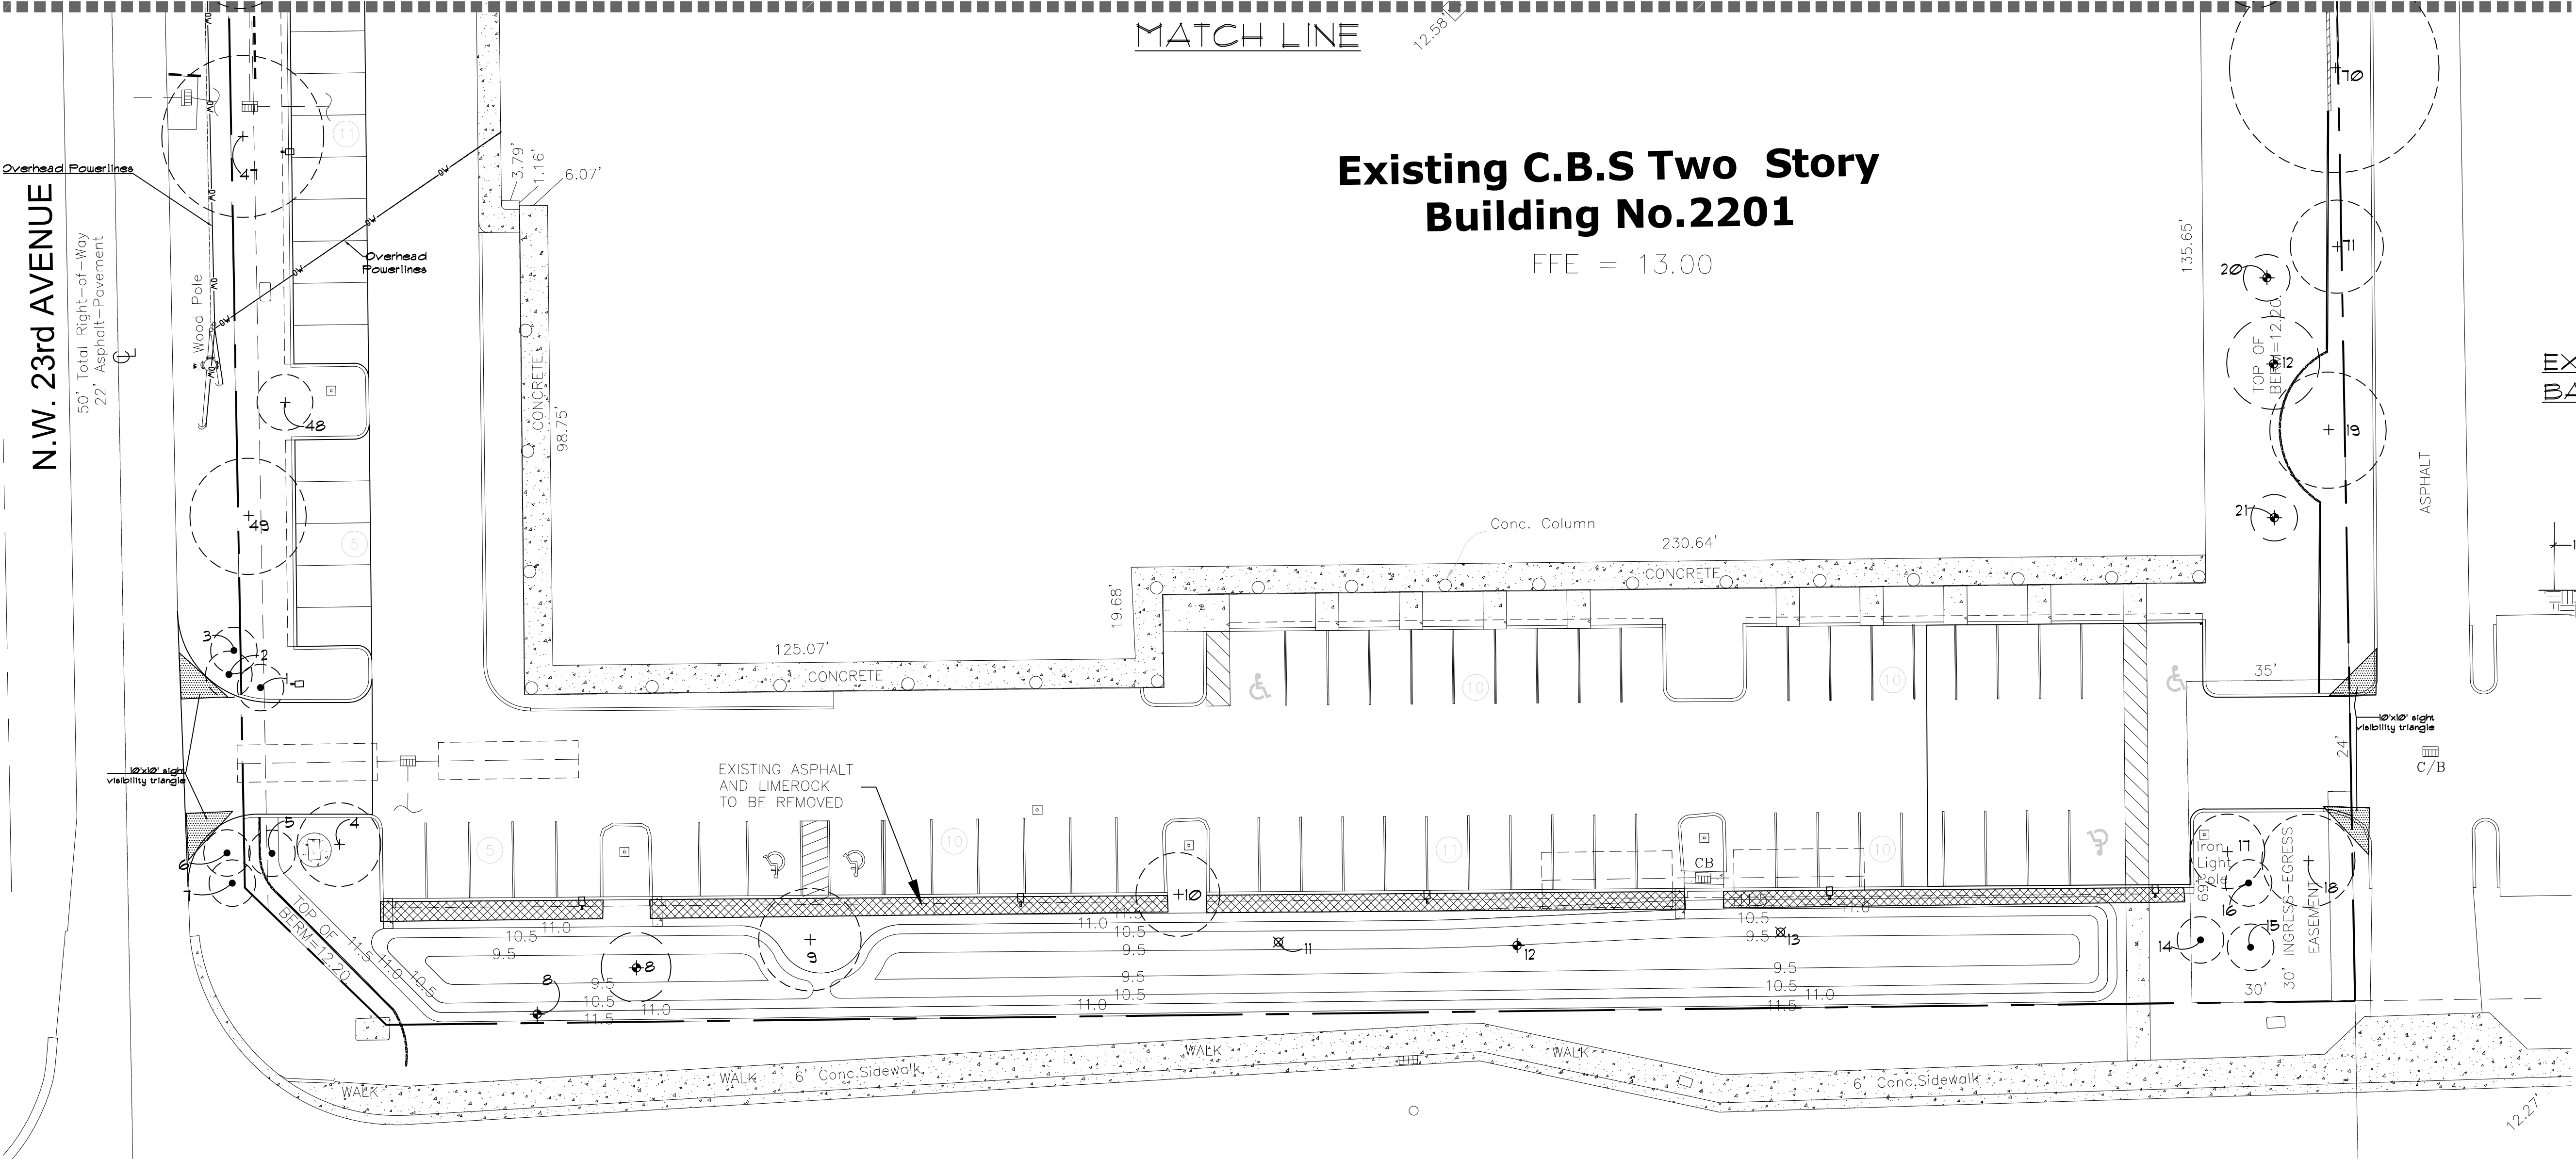
9/17/2021 Fiberbuilt - 2201 Atlantic Boulevard, Pompano Beach, FL										Revised 5.12.22
TREE #	COMMON NAME	BOTANICAL NAME	HEIGHT (ft)	WIDTH (ft)	CLEAR TRUNK (ft)	DBH (in)	HEALTH %	APPRAISAL Rule 14-40 \$	DISPOSITION	OBSERVATIONS
1	Cabbage Palm	<i>Sabal palmetto</i>	25	8	20	10	65%	\$ 406.25	Remain	
2	Cabbage Palm	<i>Sabal palmetto</i>	20	10	15	11	70%	\$ 437.50	Remain	
3	Cabbage Palm	<i>Sabal palmetto</i>	25	10	20	13	60%	\$ 375.00	Remain	Trunk scars
4	Live Oak	<i>Quercus virginiana</i>	20	18	8	8	70%	\$ 1,283.30	Remain	
5	Cabbage Palm	<i>Sabal palmetto</i>	20	8	15	10	65%	\$ 406.25	Remain	Minor nutritional deficiencies
6	Cabbage Palm	<i>Sabal palmetto</i>	20	8	15	10	60%	\$ 375.00	Remain	Trunk scars, corrected lean
7	Cabbage Palm	<i>Sabal palmetto</i>	20	8	15	11	85%	\$ 500.00	Remain	(See Arbolist Report)
8	Live Oak	<i>Quercus virginiana</i>	23.7	17	9	9	85%	\$ 1,753.07	Relocate	4.5' radius rootball 3-4 months for root pruning (See Arbolist Report)

9	Mahogany	<i>Swietenia mahagoni</i>	25	25	15	60%	\$ 1,687.50	Remain	Minor vertical canopy, poor structure	
10	Live Oak	<i>Quercus virginiana</i>	15	20	9	75%	\$ 1,546.83	Remain		
11	Mahogany	<i>Swietenia mahagoni</i>	10	10	5	30%	\$ 381.25	Remove	Storm damage, broken leader, poor form	
12	Live Oak	<i>Quercus virginiana</i>	18	22	10	75%	\$ 1,675.73	Relocate	*15' radius rootball, 3-4 months root pruning (See Arbolist Report)	
13	Mahogany	<i>Swietenia mahagoni</i>	25	20	9	60%	\$ 1,012.50	Remove		
14	Cabbage Palm	<i>Sabal palmetto</i>	20	6	14	8	55%	\$ 343.75	Remain	Thin trunk, nutritional deficiencies
15	Cabbage Palm	<i>Sabal palmetto</i>	22	8	18	11	65%	\$ 406.25	Remain	Wedge-like damage, trunk constriction
16	Cabbage Palm	<i>Sabal palmetto</i>	20	8	14	11	50%	\$ 312.50	Remain	Trunk damage, nutritional deficiencies
17	Live Oak	<i>Quercus virginiana</i>	20	16	7	70%	\$ 1,122.88	Remain	Overcrowded on east side

18	Mahogany	<i>Swietenia mahagoni</i>	20	20	9	65%	\$ 1,066.68	Remain	Minor lean and asymmetrical canopy	
19	Mahogany	<i>Swietenia mahagoni</i>	40	40	27	60%	\$ 3,037.50	Remain	Codominant trunks, overfilled, limited root space	
20	Live Oak	<i>Quercus virginiana</i>	17.9	10	6	60%	\$ 824.98	Relocate	Broken leader, minor trunk damage *15' radius rootball, 2 months root pruning (See Arbolist Report)	
21	Live Oak	<i>Quercus virginiana</i>	23.4	10	6	6	70%	\$ 882.27	Relocate	3' radius root ball, 2 months root pruning (See Arbolist Report)
22	Live Oak	<i>Quercus virginiana</i>	10	6	4	30%	\$ 274.99	Remove	Leaning, appears to have been run over, recommend removal	
23	Cabbage Palm	<i>Sabal palmetto</i>	22.1	10	15	13	70%	\$ 437.50	Relocate	Near overhead powerlines, minor directional pruning, parasites (See Arbolist Report)
24	Cabbage Palm	<i>Sabal palmetto</i>	18	8	15	14	60%	\$ 375.00	Remain	Beneath wires, curved trunk

25	Black Olive	<i>Bucida buxus</i>	20	20	8	70%	\$ 1,050.00	Remove	Old storm damage in upper canopy, overcrowded, lean and deflected roots	
26	Black Olive	<i>Bucida buxus</i>	35	35	22	55%	\$ 2,268.75	Remove		
27	Live Oak	<i>Quercus virginiana</i>	15.6	15	5	5	60%	\$ 687.48	Relocate	Minor lean, overcrowded, lost central leader, heading oak *12' radius rootball, 2 months root pruning (See Arbolist Report)
28	Black Olive	<i>Bucida buxus</i> 'Shady Lady'	25	25	10	65%	\$ 1,216.75	Remove	Minor lean	
29	Live Oak	<i>Quercus virginiana</i>	22.4	26	9	70%	\$ 1,483.81	Relocate	14.5' radius rootball, 3-4 months root pruning, minor trunk lean (See Arbolist Report)	
30	Mahogany	<i>Swietenia mahagoni</i>	30	20	11	60%	\$ 1,237.50	Remove	Poor structure, multiple codominant limbs upper half of canopy	
31	Mahogany	<i>Swietenia mahagoni</i>	25	20	9	55%	\$ 828.13	Remove	No leader, overcrowded, poor form	
32	Green Buttonwood	<i>Conocarpus erectus</i>	35	30	11	55%	\$ 1,031.25	Remove	Lean, trunk damage

33	Black Olive	<i>Bucida buxus</i>	30	30	10	65%	\$ 1,216.75	Remove		
34	Black Olive	<i>Bucida buxus</i>	45	50	35	45%	\$ 2,953.13	Remove	Codominant trunks with inclusion, limited root space with deflected roots and dieback of limbs	
35	Black Olive	<i>Bucida buxus</i>	45	55	30	60%	\$ 3,375.00	Remain	Minor storm damage, limited root space with deflected roots	
36	Cabbage Palm	<i>Sabal palmetto</i>	18	10	12	16	60%	\$ 375.00	Remain	Wires, nutritional deficiencies
37	Cabbage Palm	<i>Sabal palmetto</i>	20	10	15	16	70%	\$ 437.50	Remain	
38	Strangler Fig	<i>Ficus aurea</i>	20	20	20	62	40%	\$ 5,166.68	Remain	Directly beneath wires, utility pruned, heading cuts, poor form and structure
39	Cabbage Palm	<i>Sabal palmetto</i>	20	8	15	11	30%	\$ 187.50	Remain	Strangled by f. aurea, beneath wires, utility pruned
40	Cabbage Palm	<i>Sabal palmetto</i>	15	8	10	18	30%	\$ 187.50	Remain	Suppressed by 40A
40A	Strangler Fig	<i>Ficus aurea</i>	15	25	18	35%	\$ 1,312.48	Remain	Hatrazed on one side, leaning, poor form, overhead wires, vines

40B	Cabbage Palm	<i>Sabal palmetto</i>	15	8	8	70%	\$ 363.75	Remain	Booted, underneath wires	
41	Black Olive	<i>Bucida buxus</i>	40	45	19	60%	\$ 2,137.50	Remove	Competing trunks and rubbing limbs, poor form	
42	Cabbage Palm	<i>Sabal palmetto</i>	35	10	30	12	70%	\$ 437.50	Remain	
43	Cabbage Palm	<i>Sabal palmetto</i>	20	8	15	12	50%	\$ 312.50	Remain	Overhead powerlines, fronds touching with necrosis
44	Mahogany	<i>Swietenia mahagoni</i>	40	30	28	50%	\$ 2,825.00	Remain	Directionally pruned on one side, asymmetrical canopy, root deflection	
45	Mahogany	<i>Swietenia mahagoni</i>	35	30	22	40%	\$ 1,650.00	Remain	Codominant trunks, directionally pruned on one side, damage on large limb with decay, root damage	
46	Mahogany	<i>Swietenia mahagoni</i>	20	15	6	65%	\$ 731.25	Remain	Overhead powerlines	
47	Green Buttonwood	<i>Conocarpus erectus</i>	25	30	11	65%	\$ 1,340.63	Remain	Overhead powerlines, codominant trunks

48	Silver Buttonwood	<i>Conocarpus erectus</i> 'Santitas'	25	15	7	60%	\$ 1,155.00	Remain	Leaning, poor form	
49	Mahogany	<i>Swietenia mahagoni</i>	25	25	14	75%	\$ 1,968.75	Remain		
50	Cabbage Palm	<i>Sabal palmetto</i>	25	12	15	18	50%	\$ 312.50	Remain	Overhead powerlines
51	Umbrella Tree	<i>Schefflera spp.</i>	10	6	10	45%	\$ 100.00	Remove	Attached to wall, Prohibited Species	
52	Strangler Fig	<i>Ficus aurea</i>	40	45	65	45%	\$ 6,093.65	Remove	Multiple trunks, poor form and structure, storm damage, large dead limbs	
53	Lead Tree	<i>Leucaena leucophylla</i>	50	60	35	40%	\$ -	Remove	Three codominant trunks, Prohibited Species	
54	Strangler Fig	<i>Ficus aurea</i>	35	35	27	50%	\$ 2,812.48	Remove	Codominant trunks, poor form and structure, insects

TREE #	COMMON NAME	BOTANICAL NAME	HEIGHT (ft)	WIDTH (ft)	CLEAR TRUNK (ft)	DBH (in)	HEALTH %	APPRAISAL Rule 14-40 \$	DISPOSITION	OBSERVATIONS
55	Cabbage Palm	<i>Sabal palmetto</i>	21.3	10	11.7	10	70%	\$ 437.50	Relocate	*[See Arbolist Report]
56	Cabbage Palm	<i>Sabal palmetto</i>	20	10	12	10	65%	\$ 406.25	Relocate	Minor nutritional deficiencies, low number of fronds
57	Earleaf Acacia	<i>Acacia auriculiformis</i>	40	40	32"	40%	\$ -	Remove	Prohibited Species, codominant trunks with damage, within powerlines	
58	Strangler Fig	<i>Ficus aurea</i>	40	40	42	60%	\$ 5,249.62	Remove	Directionally pruned due to powerlines, vines	
59	Mango	<i>Mangifera indica</i>	25	35	10	55%	\$ 1,375.00	Remove	Codominant trunks	
60	Mango	<i>Mangifera indica</i>	30	30	16	55%	\$ 2,200.00	Remove	Poor form	
61	Laurel Oak	<i>Quercus laurifolia</i>	30	20	9	65%	\$ 804.38	Remove	Overcrowded	
62	Mango	<i>Mangifera indica</i>	18	15	13	30%	\$ 375.00	Remove	Codominant trunks, declining

63	Black Olive	<i>Bucida buxus</i>	50	50	24	55%	\$ 2,475.00	Remain-off site	Storm damage with old heading cuts, root damage and limited root space	
64	Black Olive	<i>Bucida buxus</i>	50	40	20	55%	\$ 2,062.50	Remain-off site	Codominant trunks, old heading cuts with regrowth	
65	Black Olive	<i>Bucida buxus</i>	45	30	24	30%	\$ 1,350.00	Remain-off site	Extensive dieback, declining, recommend removal	
66	Gumbo Limbo	<i>Bursera simaruba</i>	16	24	11	70%	\$ 1,604.14	Remain-off site	Codominant trunks, poor branch arrangement, limited root space	
67	Black Olive	<i>Bucida buxus</i>	40	40	19	60%	\$ 2,137.50	Remain-off site		
68	Black Olive	<i>Bucida buxus</i>	50	40	26	50%	\$ 2,437.50	Remain-off site	Multiple codominant trunks, minor dieback, limited root space	
69	Black Olive	<i>Bucida buxus</i>	45	40	22	60%	\$ 2,475.00	Remain-off site	Dieback of limbs, poor branch arrangement	
70	Black Olive	<i>Bucida buxus</i>	45	40	22	70%	\$ 2,867.50	Remain-off site

71	Gumbo Limbo	<i>Bursera simaruba</i>	20	20	9	65%	\$ 1,218.73	Remain-off site	Low vigor, leaf color is yellow and sparse	
72	Cabbage Palm	<i>Sabal palmetto</i>	18	10	10	65%	\$ 406.25	Remain	Booted, leaning, overcrowded	
73	Cabbage Palm	<i>Sabal palmetto</i>	15	10	8	50%	\$ 281.25	Remain	Curved, overcrowded, undersized head	
Total Mitigation Value=									\$35,122.91
