PZ23-12000001
05/03/2023:122L

SCHULZ
LANDSCAPE
SERVICE

*1300 N RIVERSIDE DRIVE
POMPAÑO BEACH
FLORIDA*

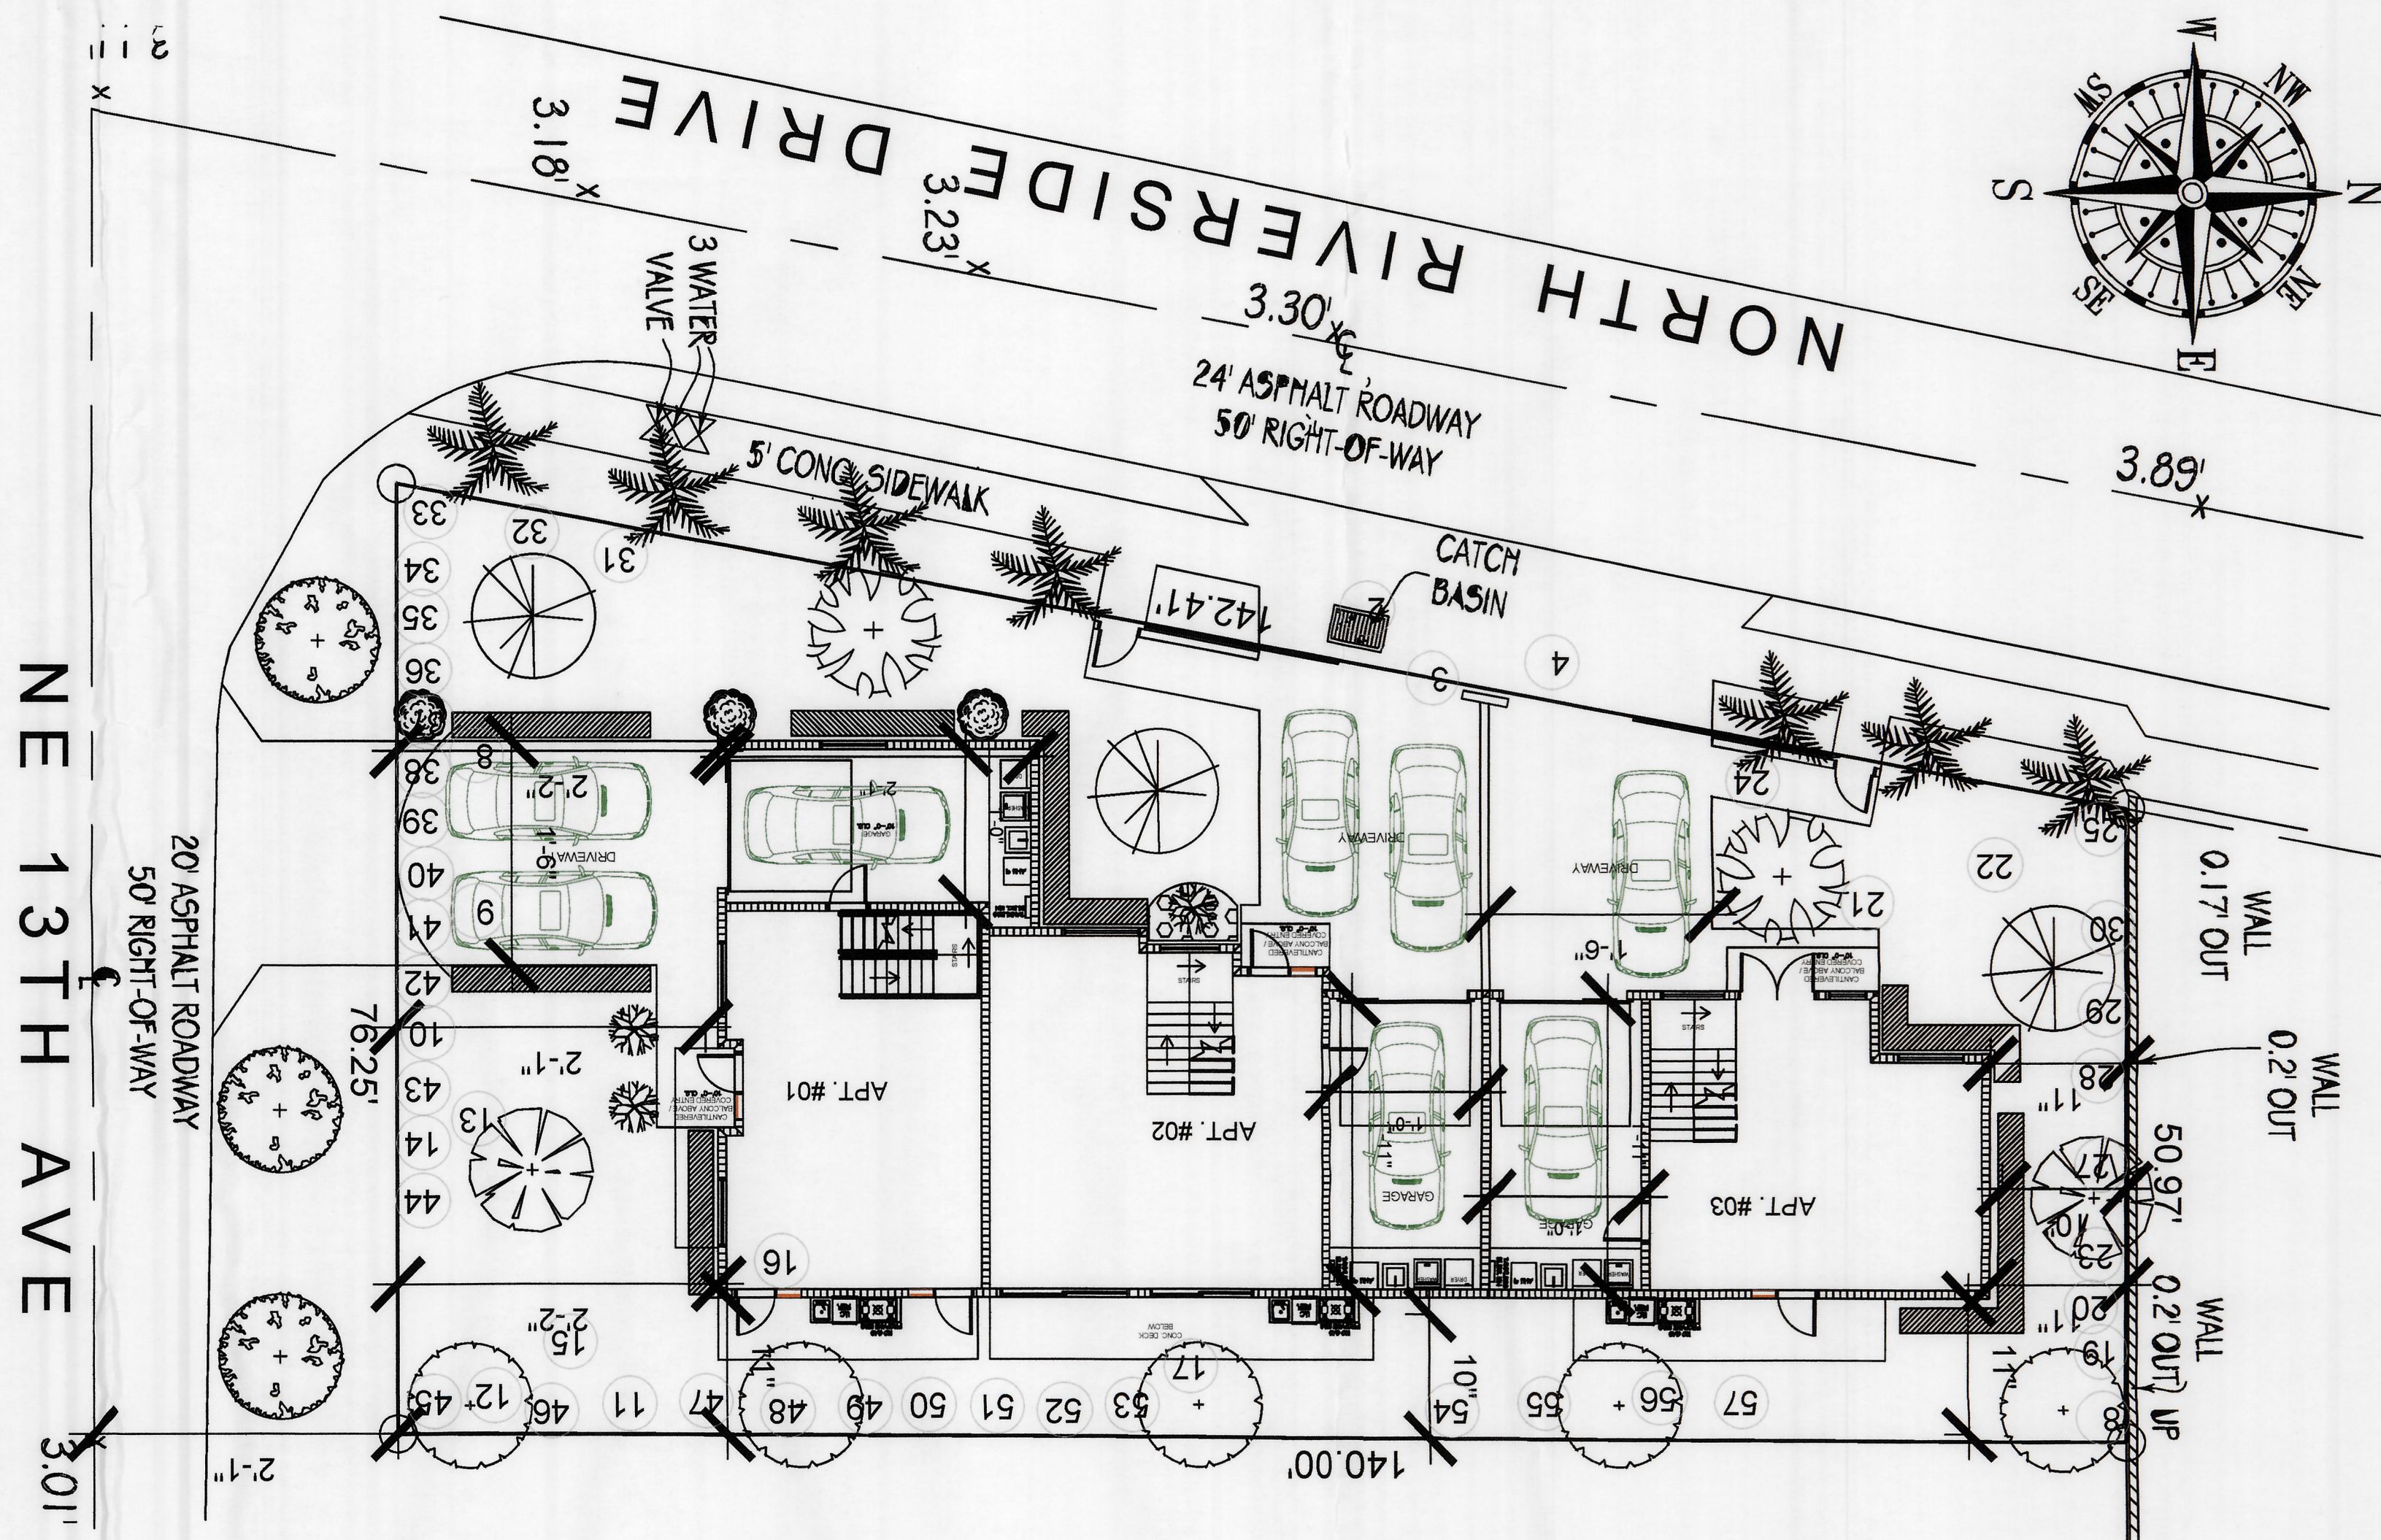
TREE #	COMMON NAME	BOTANICAL NAME	DBH (in)	Height (ft)	Width	DISPOSITION	PERCENT RATING	Condition and observations	Tree value
1	Coccoloba Palm	Coccoloba nucifera	9	25	18	Remove	40%	Appears to have Lateral	
2	Acacia Palm	Dipsakia microcarpa	multi stem	6	6	Remove	60%	Good	
3	Fraxinus Palm	Fraxinus densata	co-dominant	3	10	Remove	80%	Good	
4	Coccoloba Palm	Coccoloba nucifera	10	30	12	Remove	40%	Appears to have Lateral	
5	Albizia	Triplaris decurrens	14	18	6	Remove	80%	Good	
6	Triplaris Palm	Triplaris decurrens	14	18	6	Remove	80%	Good	
7	Coccoloba Palm	Coccoloba nucifera	10	30	18	Remove	40%	Appears to have Lateral	
8	Coccoloba Palm	Coccoloba nucifera	9	25	20	Remove	40%	Appears to have Lateral	
9	Coccoloba Palm	Coccoloba nucifera	9	25	20	Remove	40%	Appears to have Lateral	
10	Coccoloba Palm	Coccoloba nucifera	10	30	18	Remove	70%	Appears to have Lateral	
11	Coccoloba Palm	Coccoloba nucifera	12	30	20	Remove	70%	Appears to have Lateral

12	Coccoloba Palm	Coccoloba nucifera	12	30	20	Remove	70%	Appears to have Lateral	
13	Mango	Mangifera indica	4 Trunks 10"	20	15	Remove	60%	Fair "quad dominant"	
14	Coccoloba Palm	Coccoloba nucifera	10	20	18	Remove	70%	Appears to have Lateral Growing at 110 & 140 are the same	
15	Salvia Palm	Salvia Palmensis	14	18	9	Remove	80%	Growing against the roof of palm - different angles	
16	Schreberia	Heptapleurum	8	24	12	Remove	n/a	Exotic muscivore	
17	Coccoloba Palm	Coccoloba nucifera	10	30	20	Remove	40%	Appears to have Lateral	
18	Ceanothus	Banksia laurifolia	12	25	25	Remove	40%	Flower "glowing"	
19	Ceanothus	Banksia laurifolia	12	25	25	Remove	70%	Flower "glowing"	
20	Triplaris Palm	Triplaris densata	multi stem	18	10	Remove	70%	Flower "glowing"	
21	Triplaris Palm	Triplaris densata	multi stem	20	10	Remove	60%	Flower "glowing"	
22	Triplaris Palm	Triplaris densata	multi stem	20	10	Remove	60%	Flower "glowing"

23	Triplaris Palm	Triplaris densata	multi stem	20	10	Remove	60%	Flower "glowing"	
24	Coccoloba Palm	Coccoloba nucifera	12	30	20	Remove	40%	Appears to have Lateral	
25	Albizia	Albizia column	0	18	10	Remove	80%	Good "healthy palm" - no trunk	
26	Pigeon	Pigeon	4	7	6	Remove	80%	Good	
27	Triplaris Palm	Triplaris densata	multi stem	15	10	Remove	80%	Good	
28	Triplaris Palm	Triplaris densata	multi stem	15	10	Remove	80%	Good	
29	Triplaris Palm	Triplaris densata	multi stem	15	10	Remove	80%	Good	
30	Triplaris Palm	Triplaris densata	multi stem	15	10	Remove	80%	Good	
31	Triplaris Palm	Triplaris densata	multi stem	15	10	Remove	80%	Good	
32	Triplaris Palm	Triplaris densata	multi stem	15	10	Remove	80%	Good	
33	Triplaris Palm	Triplaris densata	multi stem	15	10	Remove	80%	Good	
34	Triplaris Palm	Triplaris densata	multi stem	15	10	Remove	80%	Good	
35	Triplaris Palm	Triplaris densata	multi stem	15	10	Remove	80%	Good	
36	Triplaris Palm	Triplaris densata	multi stem	15	10	Remove	80%	Good

37	Triplaris Palm	Triplaris densata	multi stem	15	10	Remove	80%	Good	
38	Triplaris Palm	Triplaris densata	multi stem	15	10	Remove	80%	Good	
39	Triplaris Palm	Triplaris densata	multi stem	15	10	Remove	80%	Good	
40	Triplaris Palm	Triplaris densata	multi stem	15	10	Remove	80%	Good	
41	Triplaris Palm	Triplaris densata	multi stem	15	10	Remove	80%	Good	
42	Triplaris Palm	Triplaris densata	multi stem	15	10	Remove	80%	Good	
43	Triplaris Palm	Triplaris densata	multi stem	15	10	Remove	80%	Good	
44	Triplaris Palm	Triplaris densata	multi stem	15	10	Remove	80%	Good	
45	Triplaris Palm	Triplaris densata	multi stem	15	10	Remove	80%	Good	
46	Triplaris Palm	Triplaris densata	multi stem	15	10	Remove	80%	Good	
47	Triplaris Palm	Triplaris densata	multi stem	15	10	Remove	80%	Good	
48	Triplaris Palm	Triplaris densata	multi stem	15	10	Remove	80%	Good	
49	Triplaris Palm	Triplaris densata	multi stem	15	10	Remove	80%	Good	
50	Triplaris Palm	Triplaris densata	multi stem	15	10	Remove	80%	Good

51	Triplaris Palm	Triplaris densata	multi stem	15	10	Remove	80%	Good	
52	Triplaris Palm	Triplaris densata	multi stem	15	10	Remove	80%	Good	
53	Triplaris Palm	Triplaris densata	multi stem	15	10	Remove	80%	Good	
54	Triplaris Palm	Triplaris densata	multi stem	15	10	Remove	80%	Good	
55	Triplaris Palm	Triplaris densata	multi stem	15	10	Remove	80%	Good	
56	Triplaris Palm	Triplaris densata	multi stem	15	10	Remove	80%	Good	
57	Triplaris Palm	Triplaris densata	multi stem	15	10	Remove	80%	Good
