SHEET TITLE
Tree disposition plan

SHEET NUMBER
L-101

324 NW 6th Street
324 NW 6th Street
Pompano Beach, Florida 33060

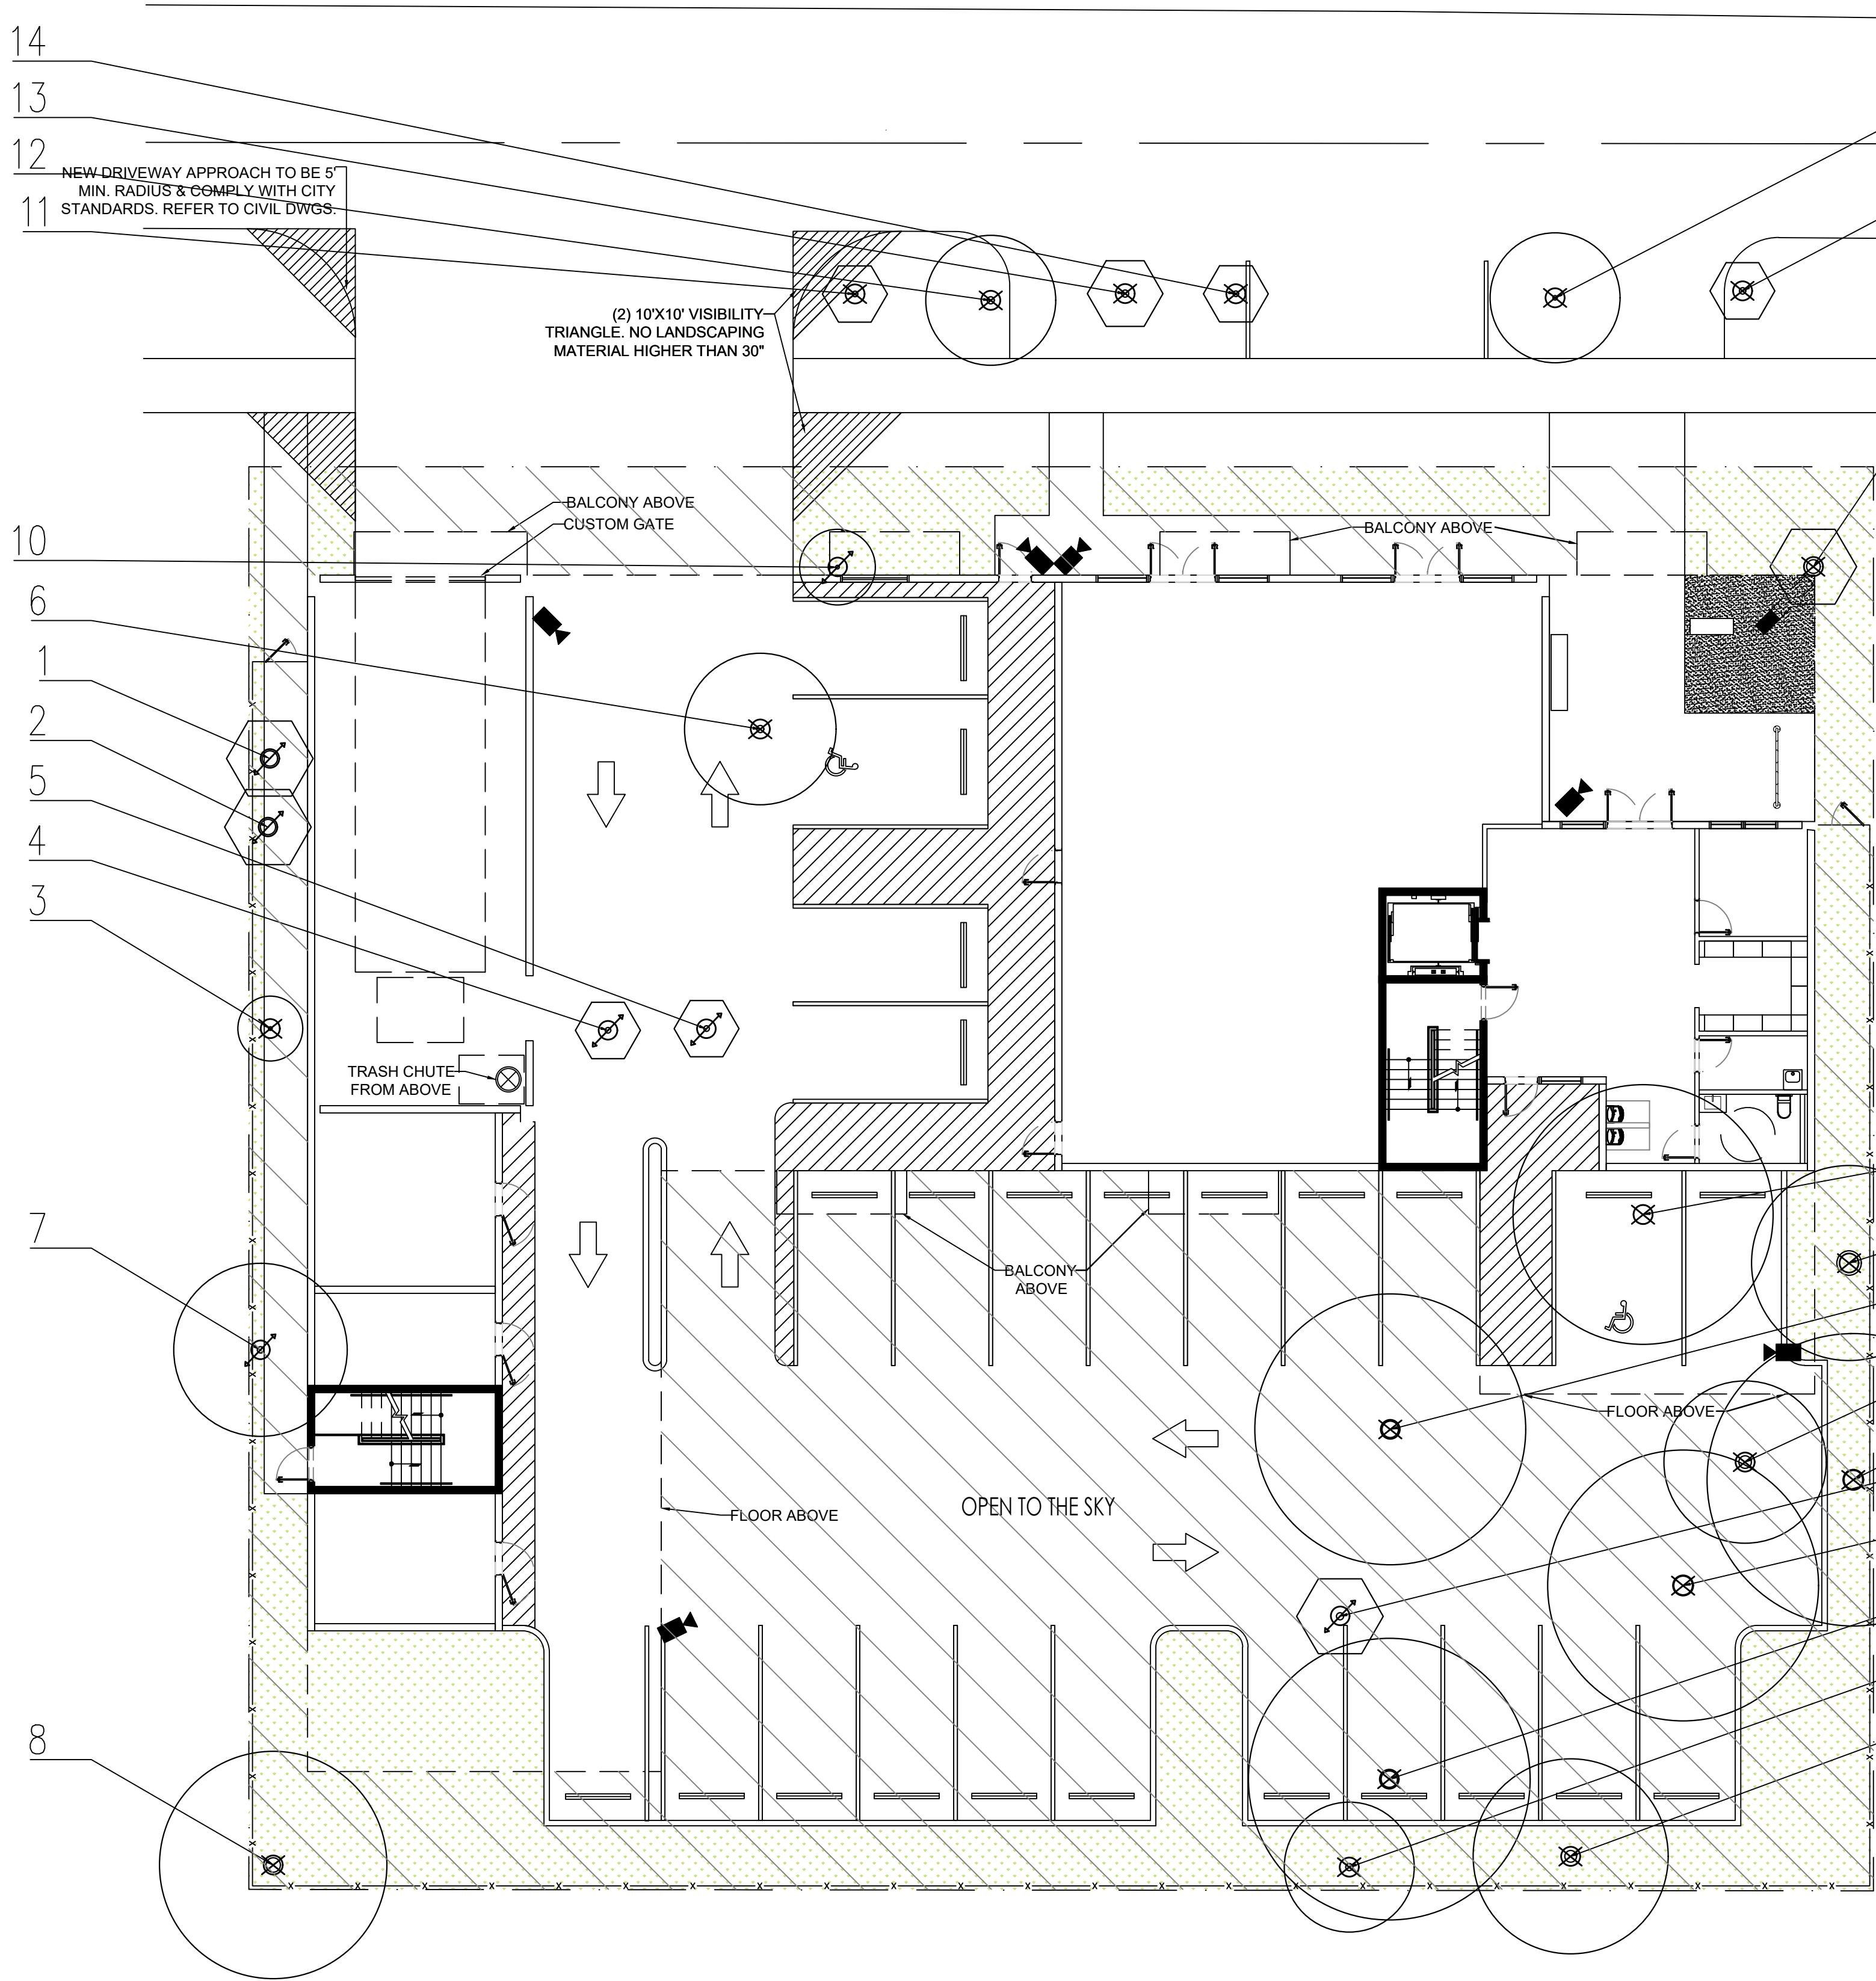
EXISTING TREES & PALMS														
Number	Common name	Botanical Name	Height (')	DBH (")	Spread (')	Category	Condition	HEALTH CONDITION	%	RULE 14-10 APPRAISAL (2020) \$	Relocation Candidate (Y/N)	OBSERVATIONS	Disposition	Mitigation
1	Sabal Palm	<i>Sabal palmetto</i>	20	17	8	Property tree	Good	70%		\$ 192.50	Y		To relocate	
2	Sabal Palm	<i>Sabal palmetto</i>	18	17	8	Property tree	Good	70%		\$ 192.50	Y		To relocate	
3	Gumbo Limbo	<i>Bursera simaruba</i>	11	4	6	Property tree	Good	65%		\$ 262.71	Y		To remove	N/A
4	Bottle Palm	<i>Hyophorbe lagenicaulis</i>	8	6	6	Property tree	Good	65%		\$ 600.00	Y		To relocate	
5	Bottle Palm	<i>Hyophorbe lagenicaulis</i>	10	6	6	Property tree	Good	65%		\$ 600.00	Y		To relocate	
6	Green Buttonwood	<i>Conocarpus erectus</i>	18	8	14	Property tree	Fair	47%		\$ 631.56	N	Poor structure, trunk lean, visual evidence of decay, confined root space	To remove	
7	Gumbo Limbo	<i>Bursera simaruba</i>	17	7	16	Property tree	Good	65%		\$ 621.53	Y		To relocate

8	Royal Poinciana	<i>Delonix regia</i>	17	16	21	Property tree	Fair	45%		\$ 3,360.02	N	Poor structure, confined root space, trunk engulfed fence	To remove	**
10	Green Buttonwood	<i>Conocarpus erectus</i>	14	4	7	Property tree	Fair	57%		\$ 306.38	Y	Trunk wound	To relocate	
11	Montgomery Palm	<i>Veitchia arecina</i>	17	6	6	Property tree	Fair	52%		\$ 302.12	N	Nutrient deficiencies	To remove	*
12	Silver Buttonwood	<i>Conocarpus erectus var. sericeus</i>	18	8	12	Property tree	Fair	48%		\$ 1,116.00	N	Poor structure, visual evidence of decay, unbalanced crown	To remove	*
13	Montgomery Palm	<i>Veitchia arecina</i>	26	8	7	Property tree	Fair	54%		\$ 489.51	N	Nutrient deficiencies	To remove	*
14	Montgomery Palm	<i>Veitchia arecina</i>	16	6	6	Property tree	Fair	54%		\$ 306.18	N	Nutrient deficiencies	To remove	*
14a	Silver Buttonwood	<i>Conocarpus erectus var. sericeus</i>	14	5	12	Property tree	Fair	54%		\$ 486.00	N	Poor structure, heading out	To remove	**

14b	Montgomery Palm	<i>Veitchia arecina</i>	17	7	6	Property tree	Fair	52%		\$ 305.76	N	Nutrient deficiencies	To remove	*
15	Sabal Palm	<i>Sabal palmetto</i>	24	15	8	Property tree	Good	70%		\$ 192.50	Y		To relocate	
16	Mango	<i>Mangifera indica</i>	32	21	24	Property tree	Fair	54%		\$ 2,677.46	N		To remove	N/A
17	Mango	<i>Mangifera indica</i>	26	27	18	Property tree	Poor	40%		\$ 2,473.30	N	Poor structure, deadwood, canopy dieback, visual evidence of decay, canopy crowding	To remove	**
18	Mango	<i>Mangifera indica</i>	35	18	25	Property tree	Fair	53%		\$ 2,225.67	N	Poor structure, canopy dieback, chlorotic foliage, deadwood	To remove	N/A
19	Mango	<i>Mangifera indica</i>	28	14	15	Property tree	Fair	52%		\$ 1,728.98	N	Poor structure, deadwood, canopy crowding	To remove	N/A
20	Sapodilla	<i>Manilkara zapota</i>	39	23	27	Property tree	Fair	55%		\$ 2,770.63	N	Visual evidence of decay, storm damage, large trunk wound, deadwood	To remove	**

21	Sabal Palm	<i>Sabal palmetto</i>	14	8	8	Property tree	Good	70%		\$ 192.50	Y	Immature palm	To relocate	
22	Mango	<i>Mangifera indica</i>	33	23	24	Property tree	Fair	53%		\$ 2,844.29	N	Poor structure, canopy dieback, storm damage, canopy crowding	To remove	N/A
23	Mango	<i>Mangifera indica</i>	31	18	26	Property tree	Fair	50%		\$ 2,099.97	N	Poor structure, large diameter deadwood, canopy dieback, canopy crowding	To remove	N/A
24	Mango	<i>Mangifera indica</i>	15	8	12	Property tree	Poor	30%		\$ 559.99	N	Poor structure, storm damage, visual evidence of decay, canopy crowding	To remove	**
25	Royal Poinciana	<i>Delonix regia</i>	28	13	18	Property tree	Poor	40%		\$ 2,426.68	N	Visual evidence of decay, deadwood	To remove	**
TOTAL DBH REMOVED												99		
TOTAL PALMS REMOVED												4
